PHASE 1 - FEASIBILITY ANALYSIS

Yeameans Street

(Broadway to Park Ave.)

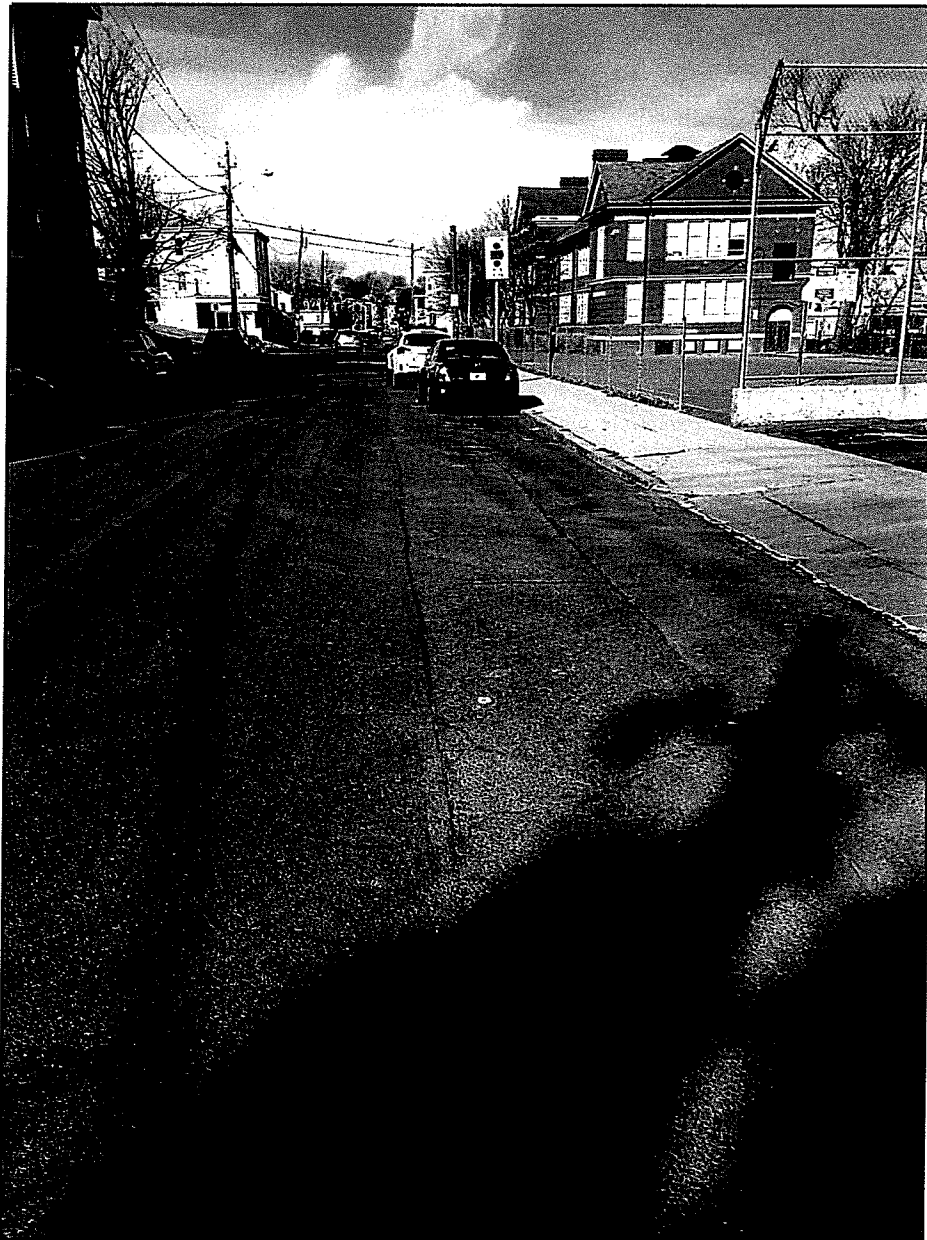
Looking towards McKinley School

Photo shows cracking of wearing surface of roadway, but extensive settlement not seen.

Not deterioration of concrete driveway edge. Driveway could edge could be saw cut clean prior to paving as a cost saving measure compared to replacing the entire apron.

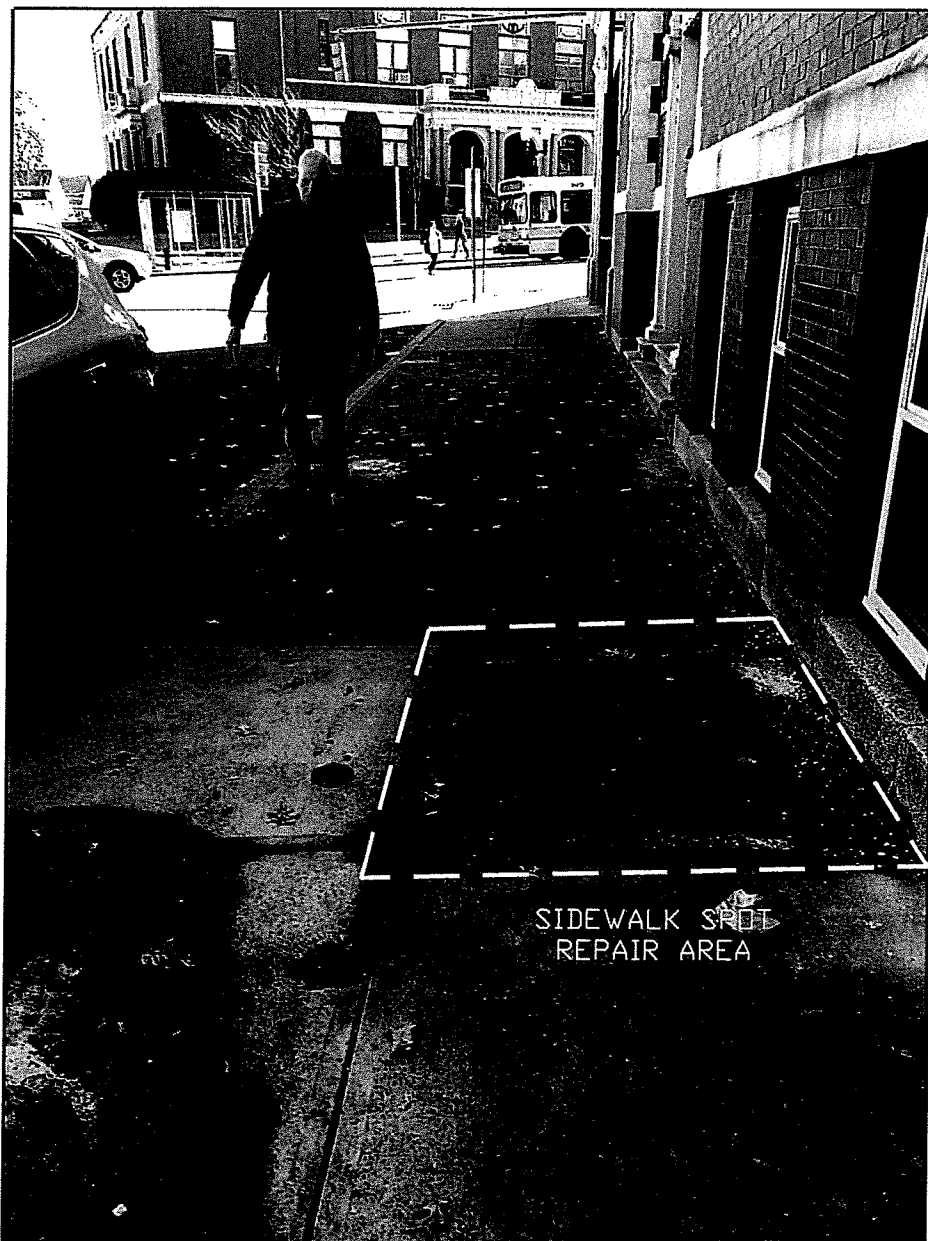
Looking towards Broadway.

Sidewalk spot repair area shown.
Sidewalks mostly in good condition on Yeamans,
some spot repairs required, but not
extensive.

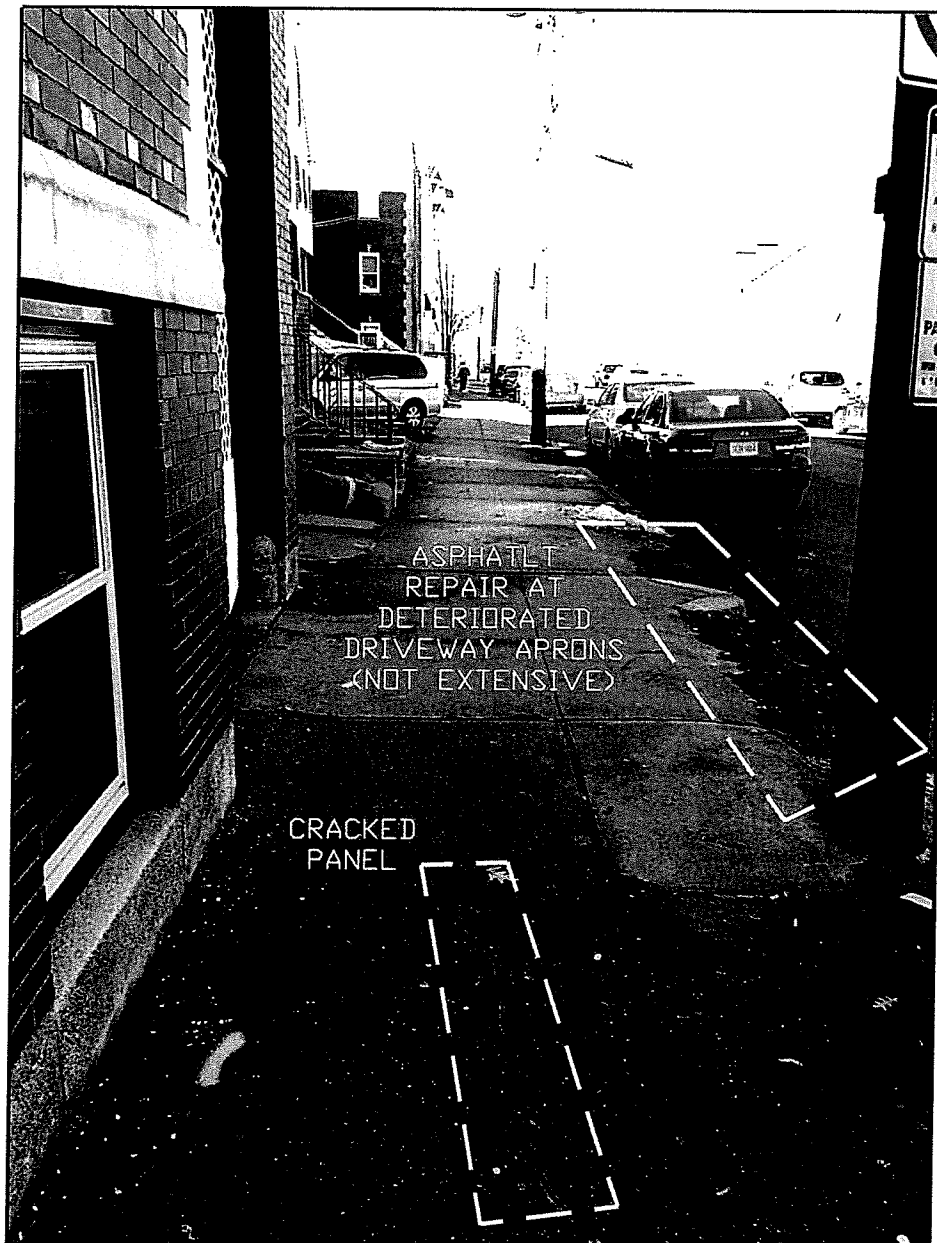
Looking towards McKinley School

Photo shows areas of driveway apron deterioration, asphalt applied over failed concrete. These driveway aprons should be replaced prior to paving.

Cracked sidewalk panel shown, repair of these types of cracks will ultimately be dependent on available budget.

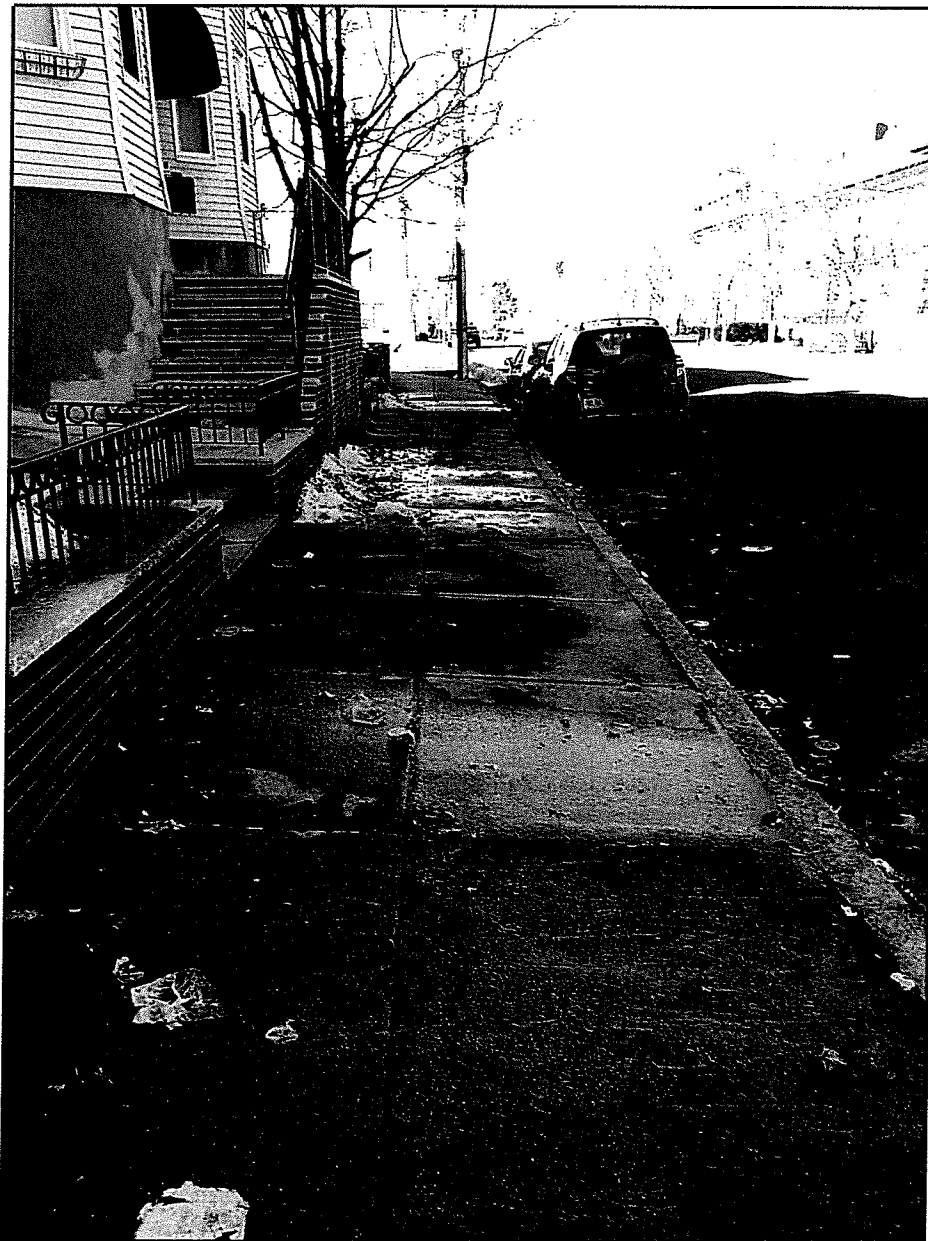
Looking towards McKinley School.

Photo shows typical condition of sidewalk and curbing. Both are in fairly good condition and consistent throughout the entire street.

Recommend spot repairs as necessary prior to paving.

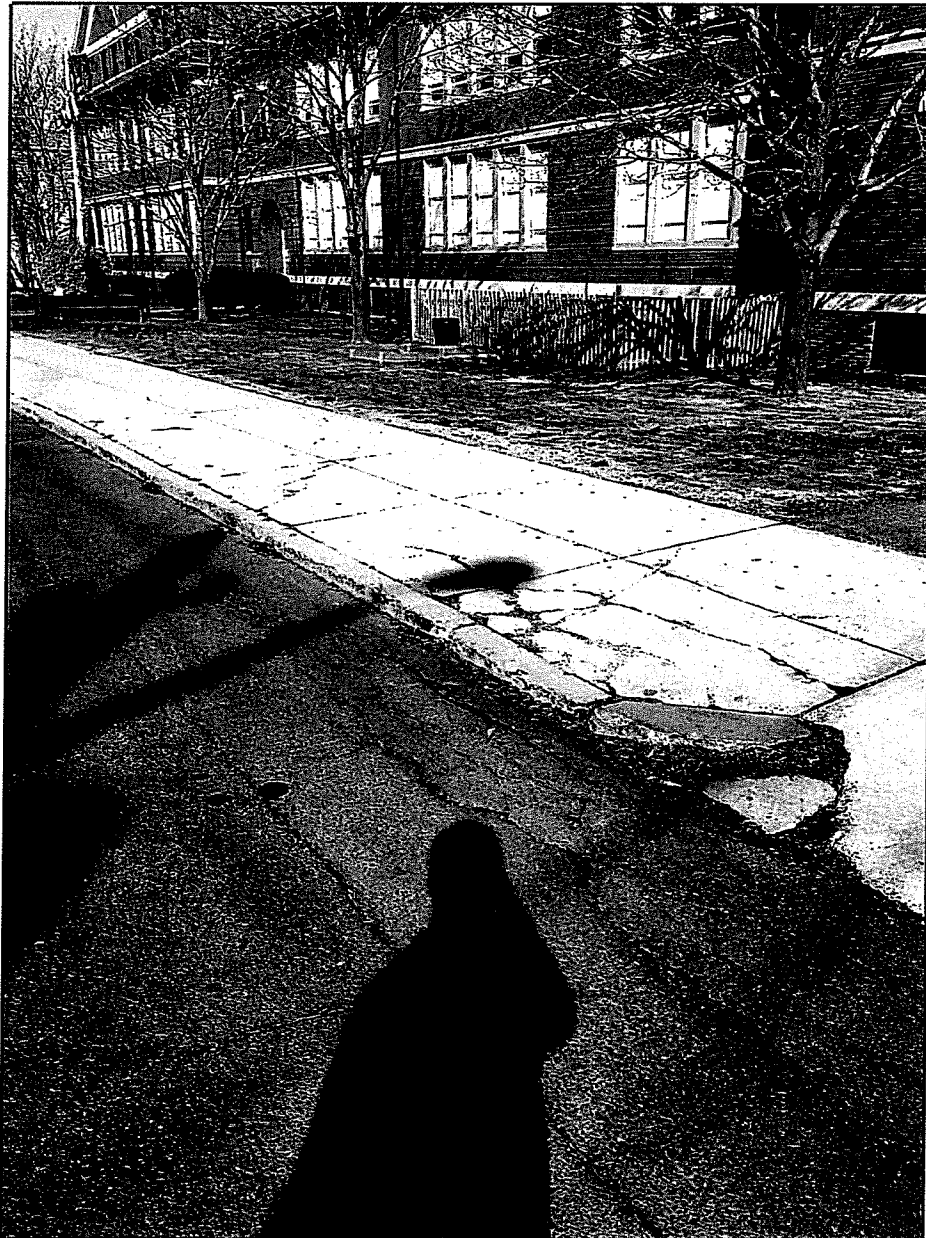
Looking towards McKinley School.

Cracked sidewalk panels just beyond driveway.

This condition is not extensive on the street,
limited to this area.

Recommend replacing such panels prior to paving.
Possibly install steel reinforcing in this area to
strengthen concrete.

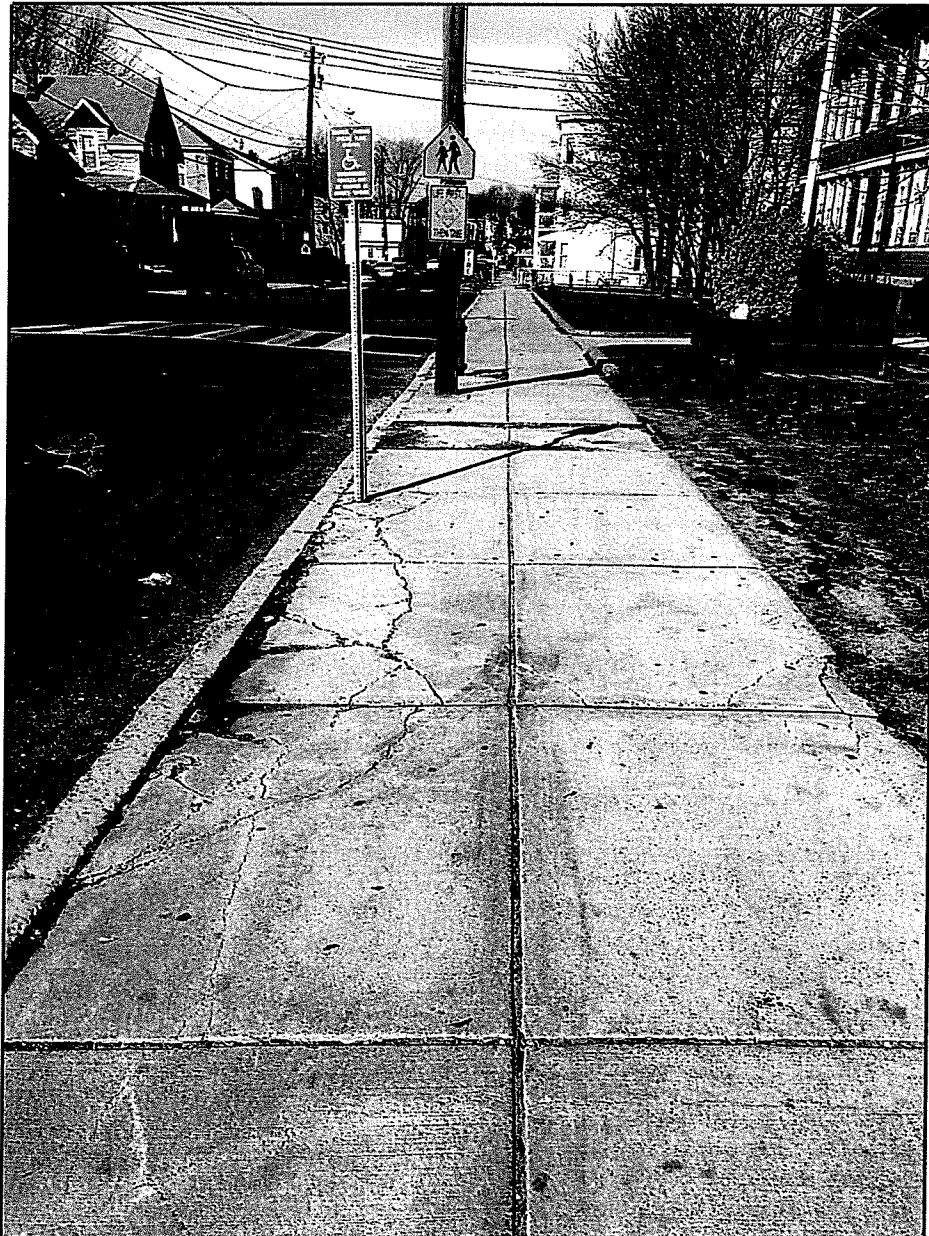
at McKinley School looking towards Park Ave.

More cracked sidewalk panels just beyond last photo. Failure likely due to vehicles parking with wheels on the sidewalk.

Recommend replacing panels prior to paving. Possibly install steel reinforcing in this area to strengthen concrete.

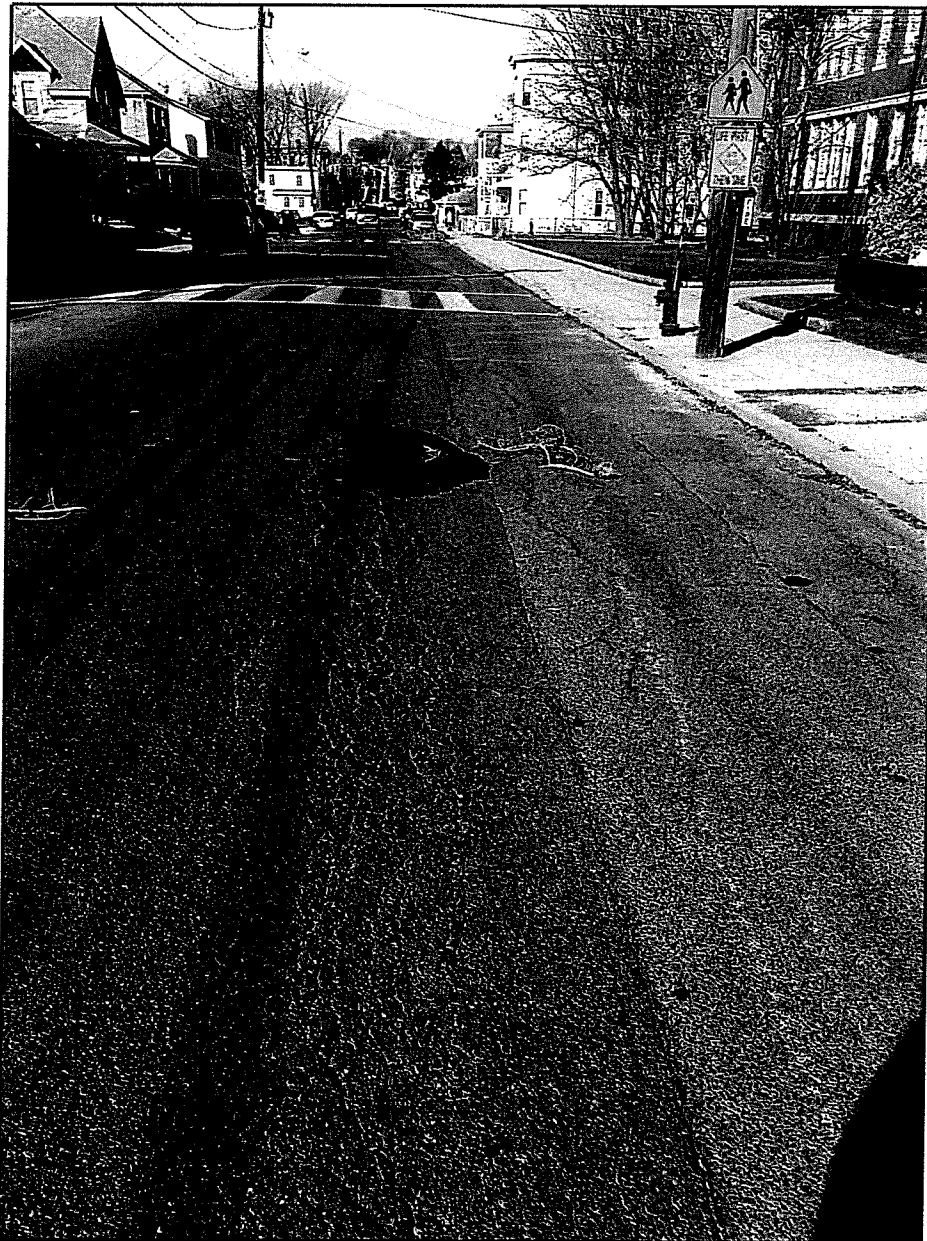
Looking towards McKinley School.

Water Main replacement trench shown. Date of repair unknown. Trench in good condition, does not show settlement. Alligator cracking seen adjacent to trench, but not present on entire roadway. Base of road assumed to be suitable.

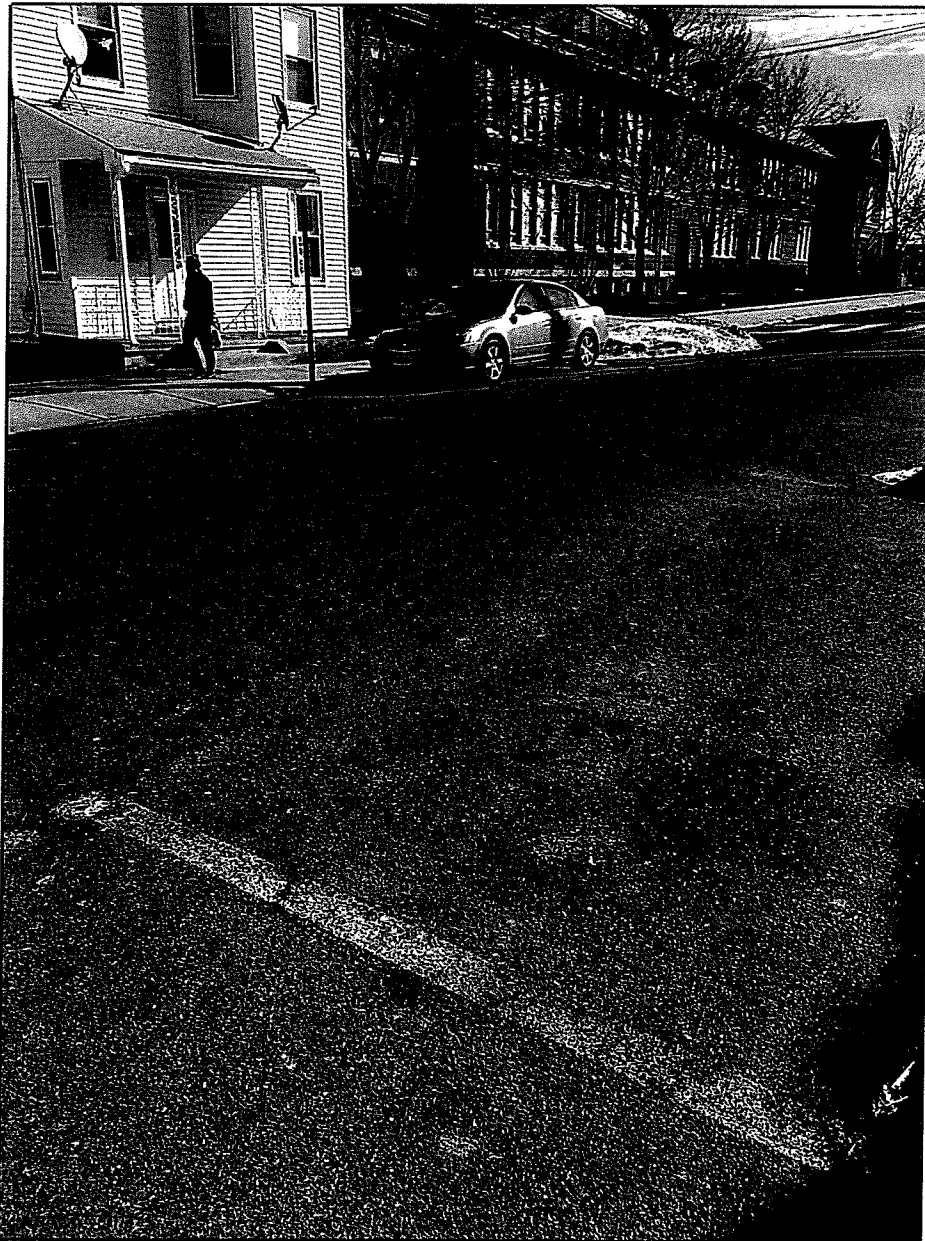
Looking east towards McKinley School

Deterioration of wearing course of roadway shown. Failure may be beyond surface treatment such as cracksealing, but does not show settlement, therefore base assumed to be in good condition and road suitable for milling and paving.

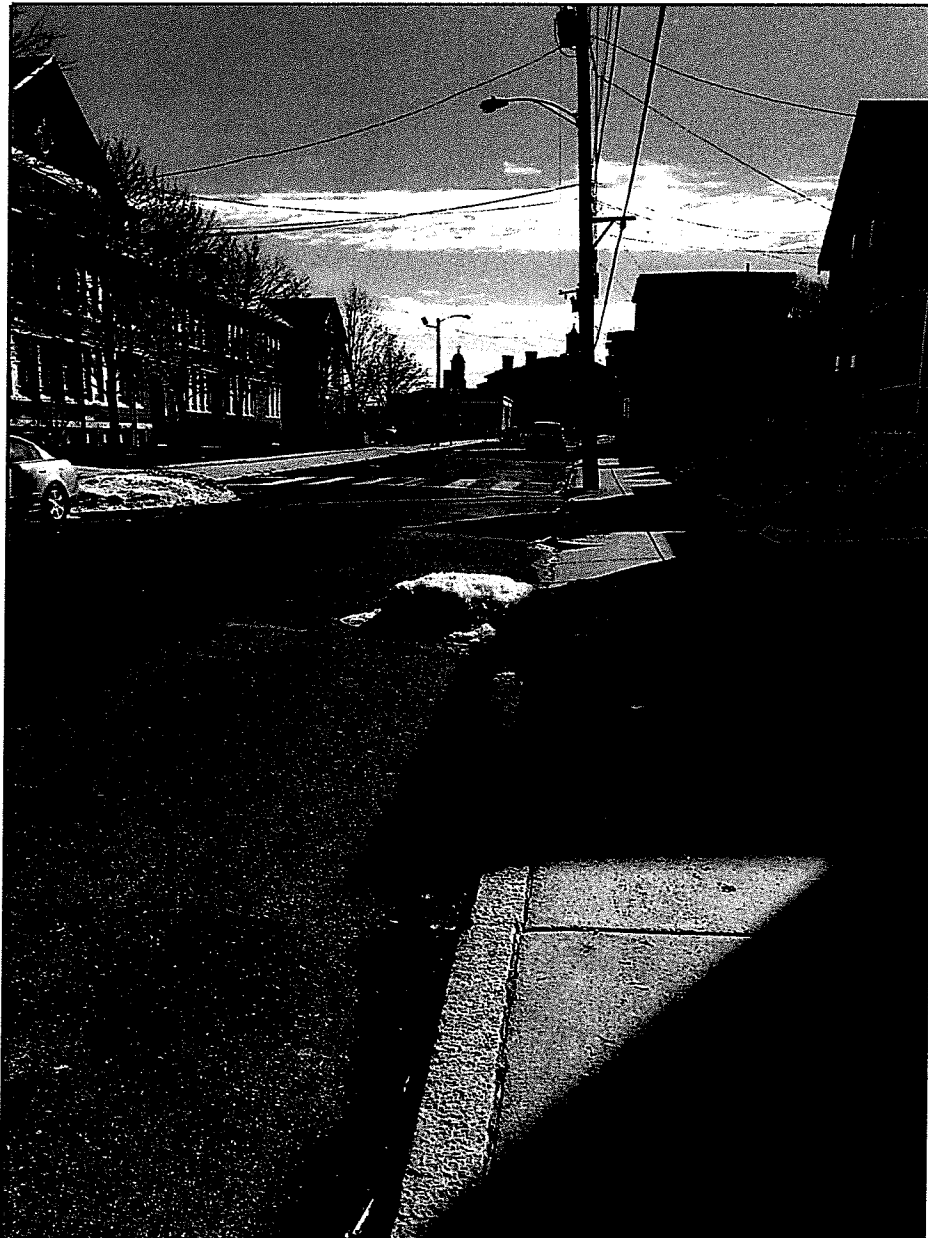
Looking east towards Broadway.

Photo shows good condition of sidewalk and curbing. Surface failure of asphalt evident but failure lacks settlement, therefor base is most likely stable and milling and paving is an appropriate repair on this street.

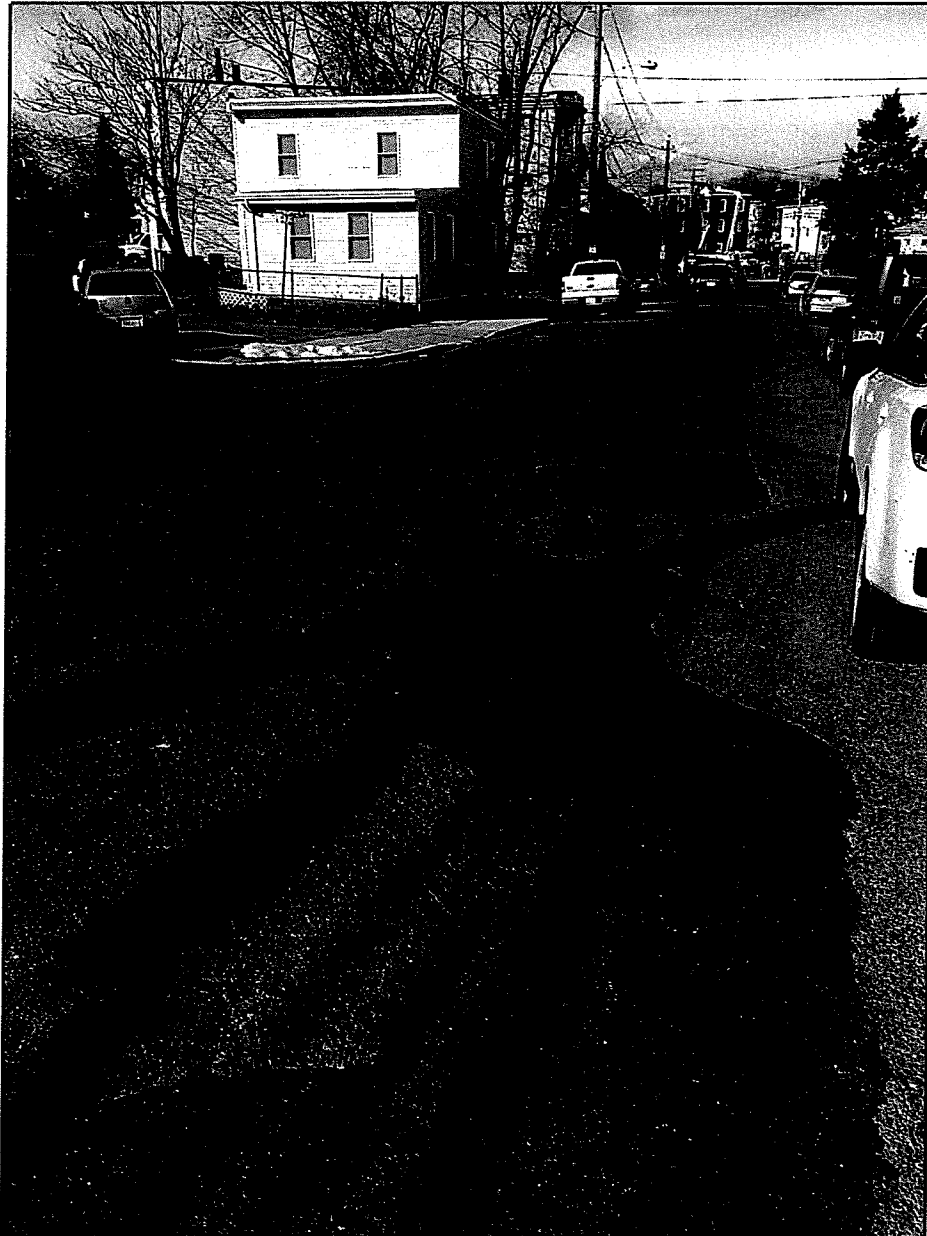
Looking towards Park Ave.

Pothole repairs shown as well as extensive cracking. If road is milled and cracking is evident in the exposed binder asphalt layer, such areas should be dug out and repaired prior to paving. Extent will be know after roadway is milled.

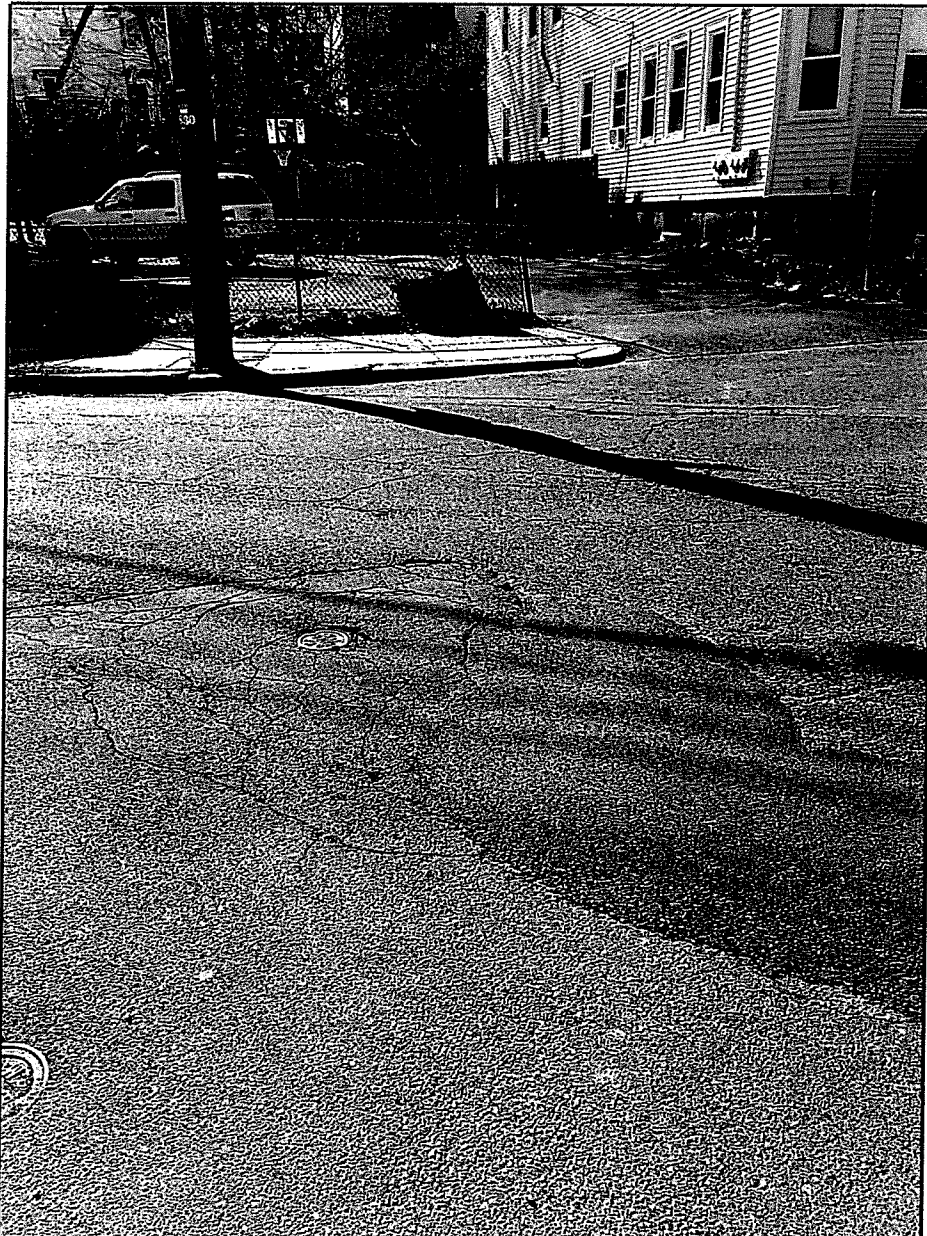
Looking towards south side of
Warren Street Intersection

Condition of road base will become evident after
roadway is milled.

Sidewalk lacks hanicap ramp, ramps should be
installed prior to paving.

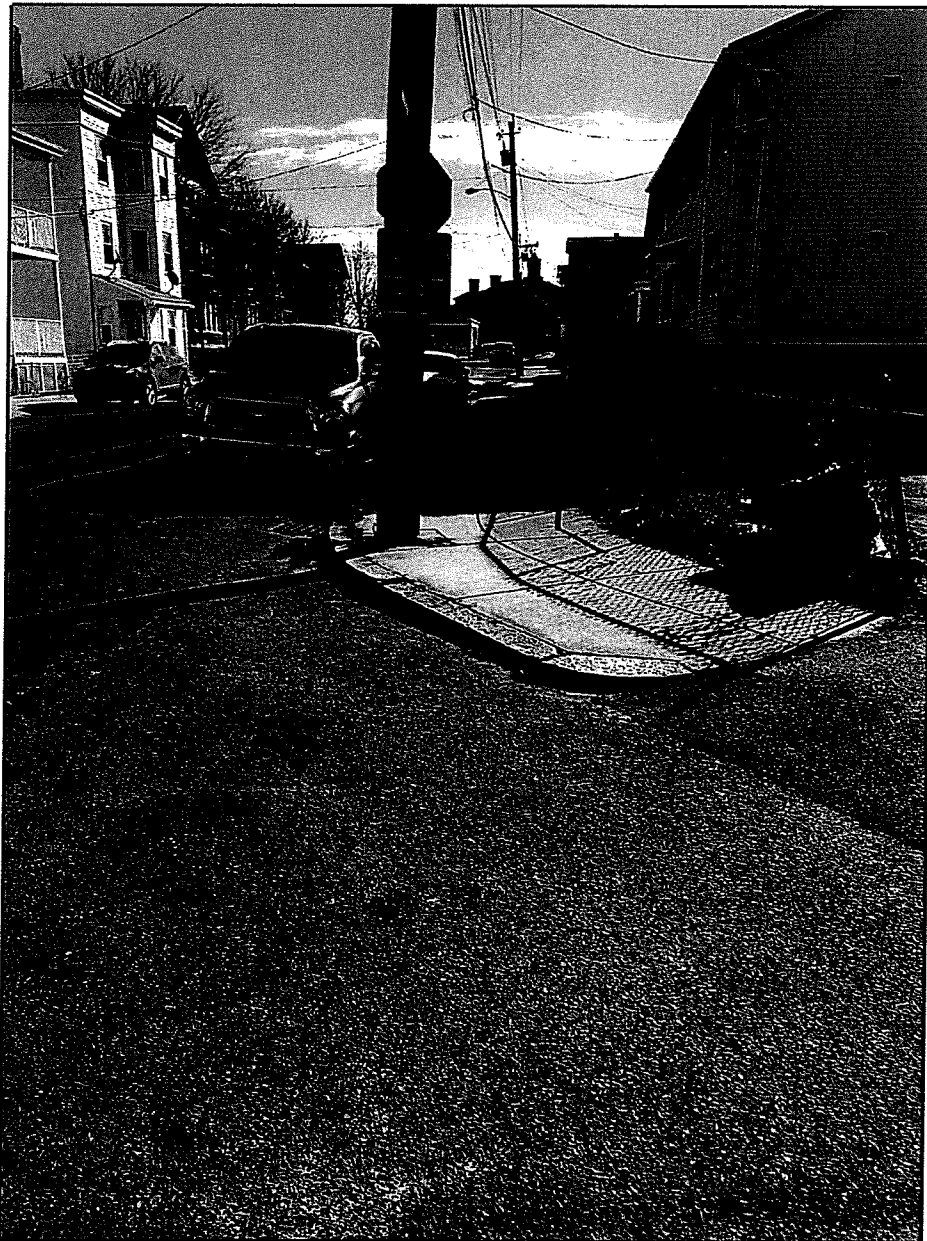
Looking at south side of Warren Street.

Photo highlights proposed handicap ramp area. Note, back of sidewalk must drop in order to install ramp. This will cause issues at chain link fence, fence footings may become exposed, fence may require replacement after ramp is installed. Driveway apron will also likely need to be replaced to meet new grade of ramp system.

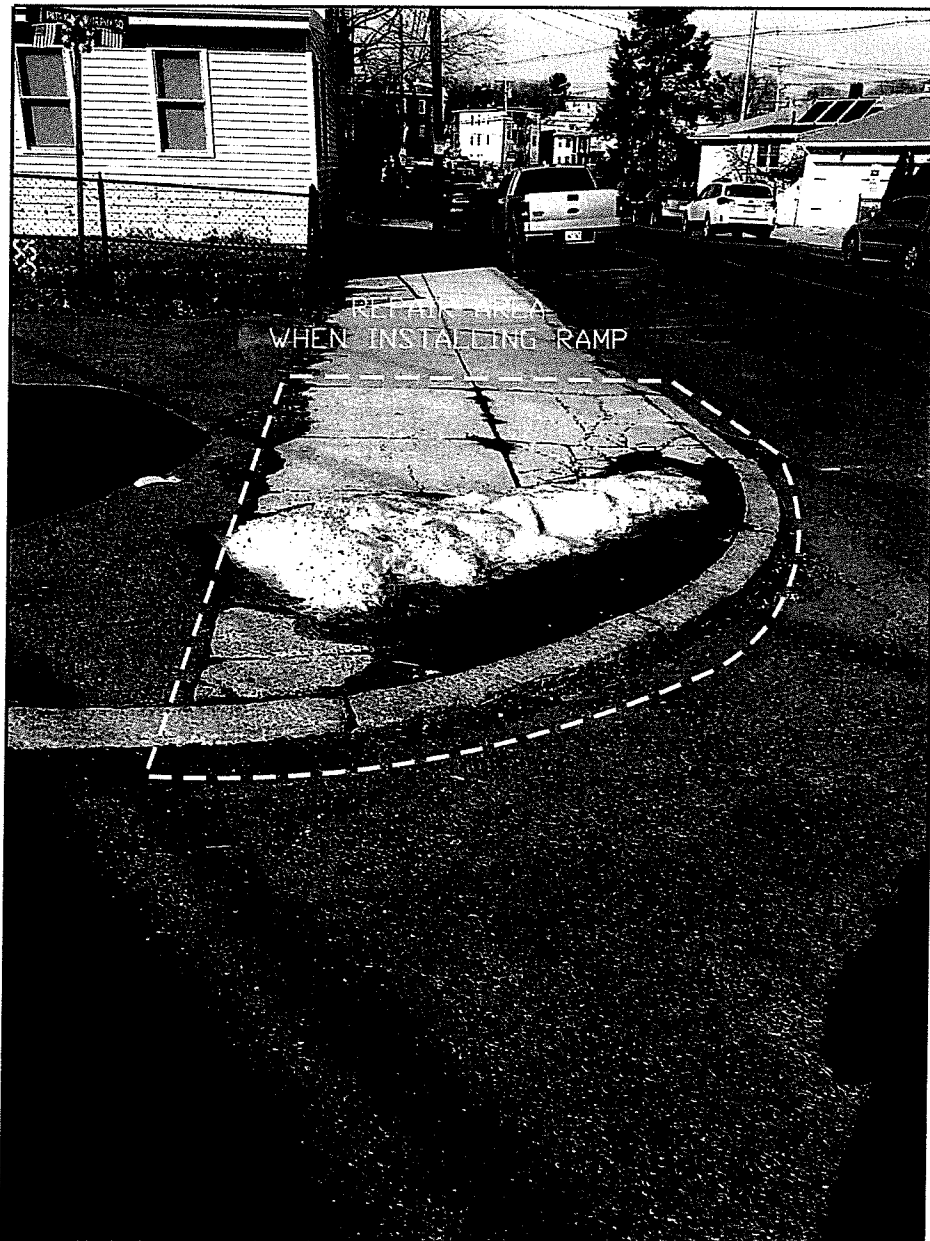
Looking at north side of Warren St. Intersection

Accessible ramp should be installed at this location also. Grades less challenging at this location.

Panels are cracked in this location and require replacement, repair should encompass area shown.

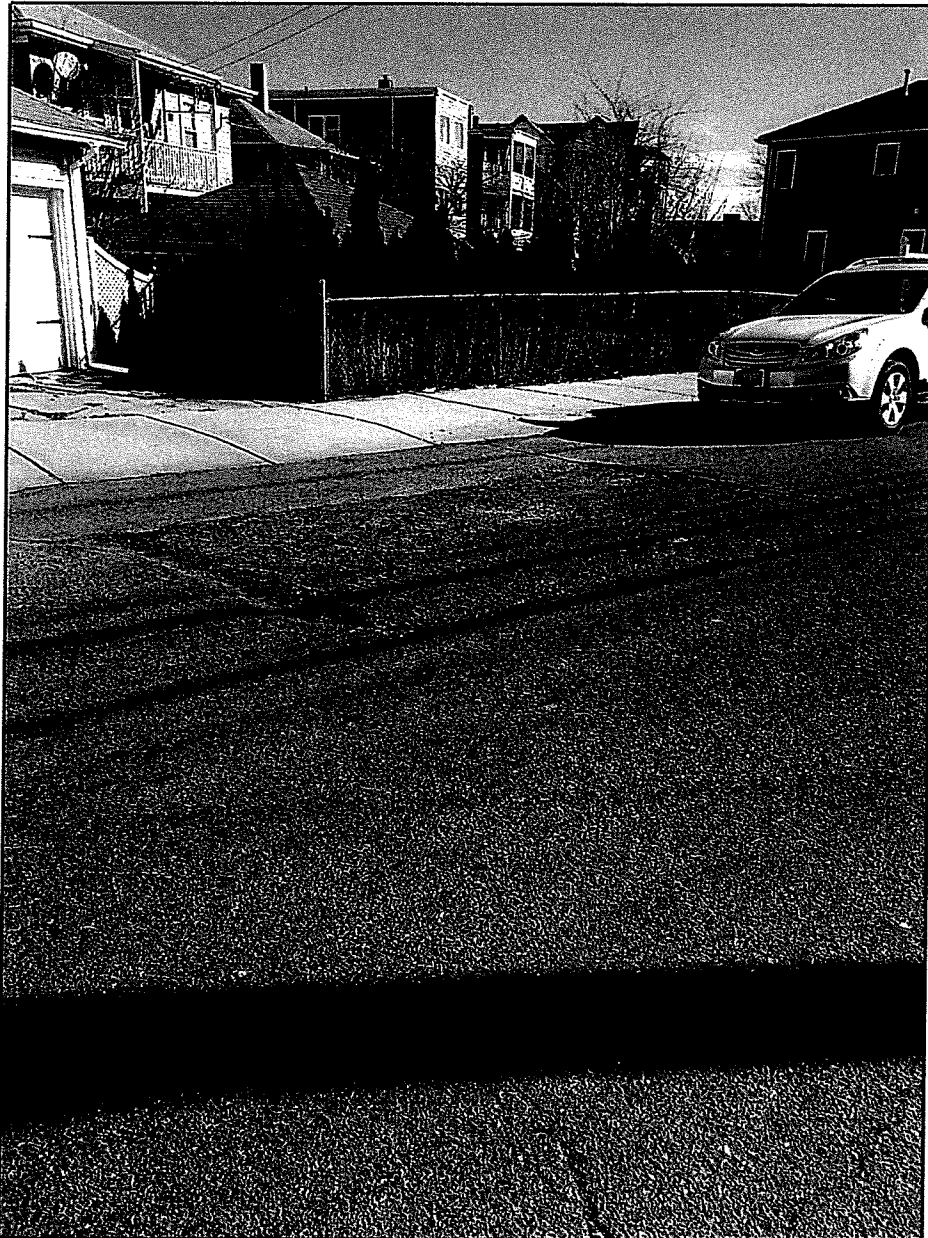
Photo of roadway patch repair.

Patch is showing signs of surface failure, but does not show extensive settlement, therefor this patch can likely be milled and paved over with out further repair.

If milling exposes further failures, further repairs may be required.

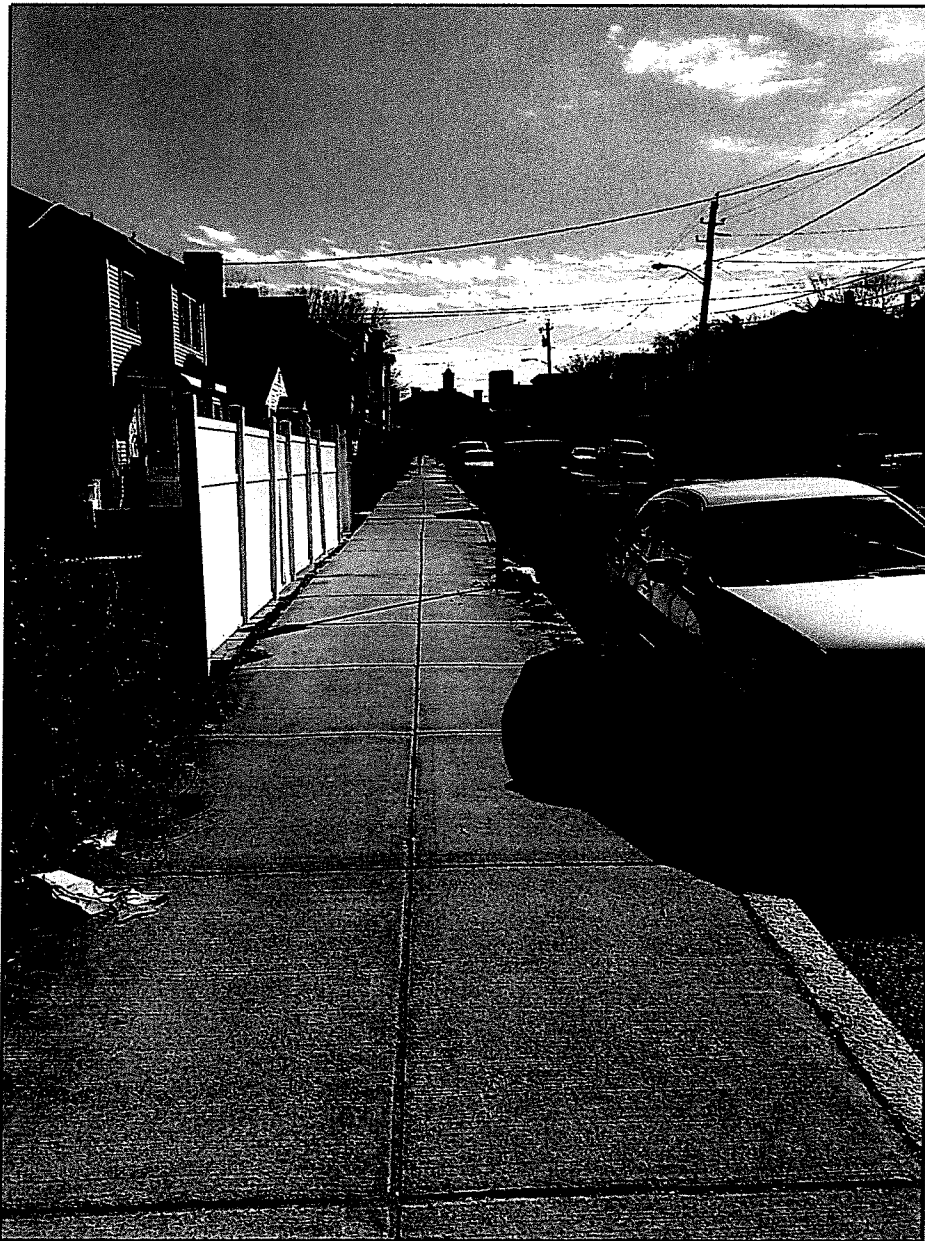
Near Park Ave. looking towards Broadway

Photo shows good condition of curbing and sidewalk. Only minor amount of sidewalk repairs are required on Yeamans Street.

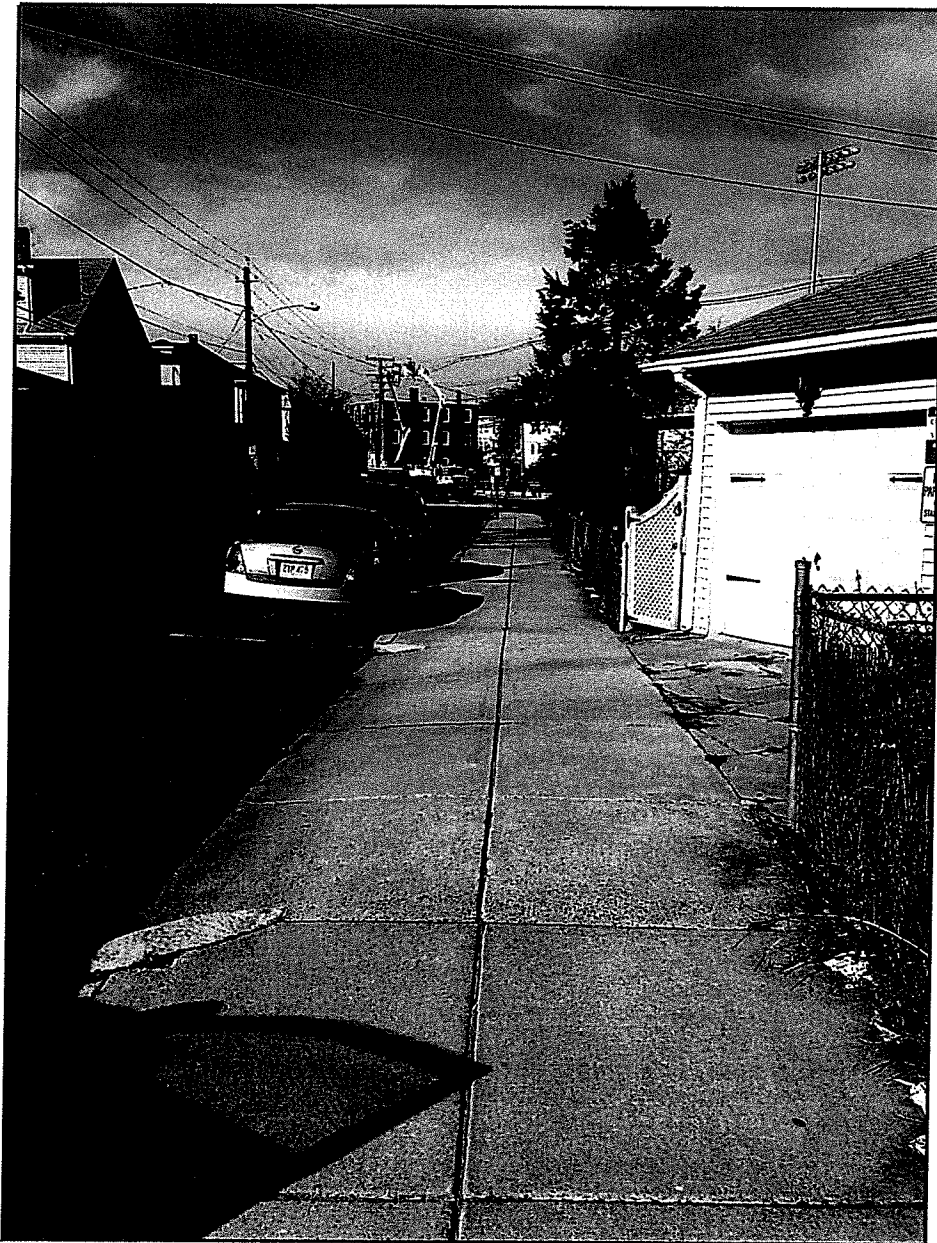
Near Park Ave. looking towards Broadway

Photo shows good condition of curbing and sidewalk. Only minor amount of sidewalk repairs are required on Yeamans Street.
