PHASE 1 - FEASIBILITY ANALYSIS

Cambridge Street

(Park Ave. to Mountain Ave.)

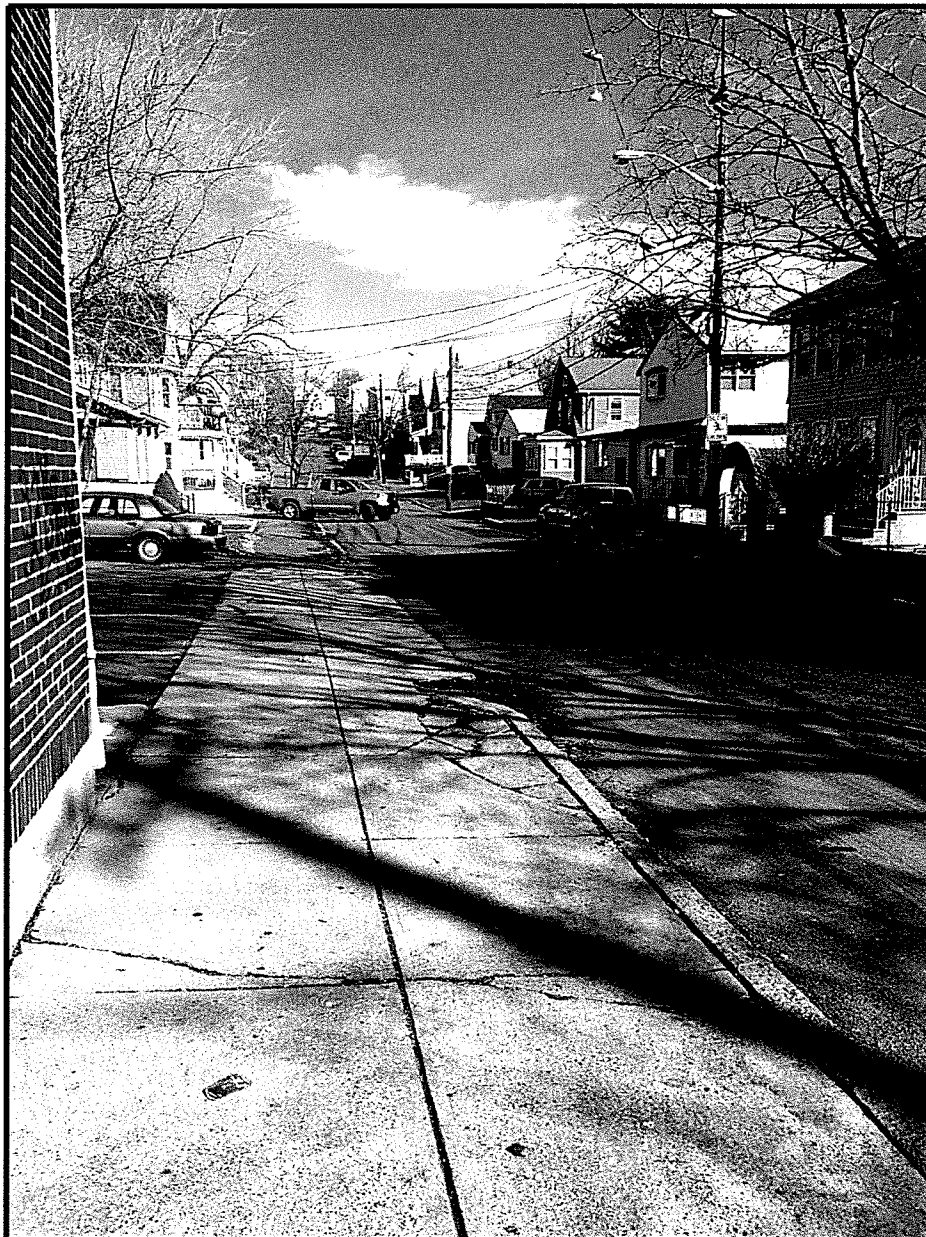
At Park Ave. looking north.
Granite curb exists on the street,
needs to be removed and reset.

Picture shows small section on
concrete sidewalks close to Park Ave.
broken and needs replacement

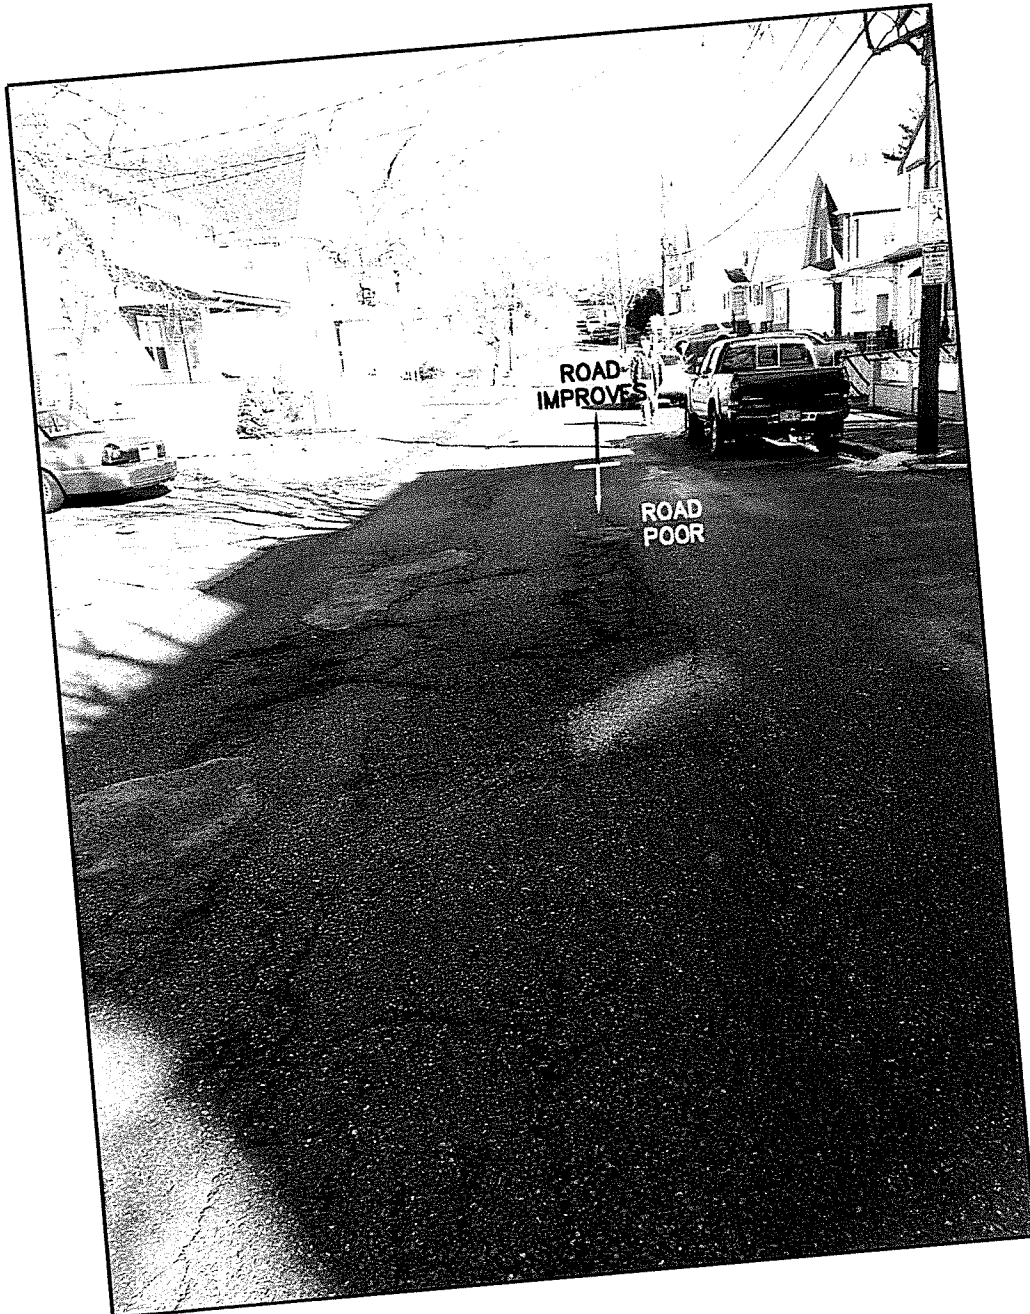
Just north of Park Ave. looking north.

Lower end of road near Park Ave.
is in the worst overall condition, note pothole
repairs. Condition improves as you head toward
Mountain Ave.

Existing asphalt sidewalks in mediocre condition.

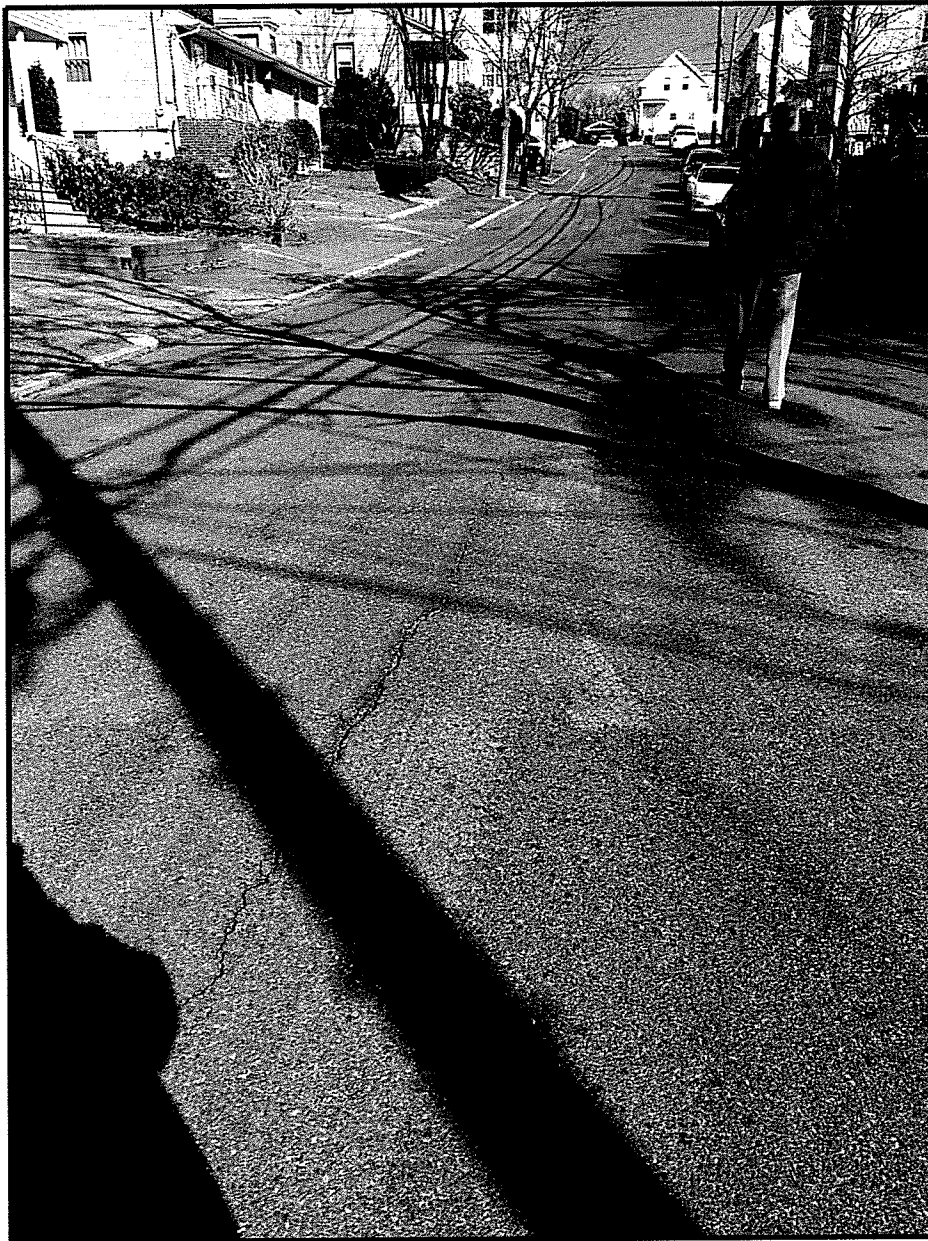
Photo looking north.
Shows typical initial cracking of roadway.

Sidewalks in mediocre condition
Curbing settled and needs
to be removed and reset.

Crackseal could extend life of the road,
reconstruction not immediately necessary.

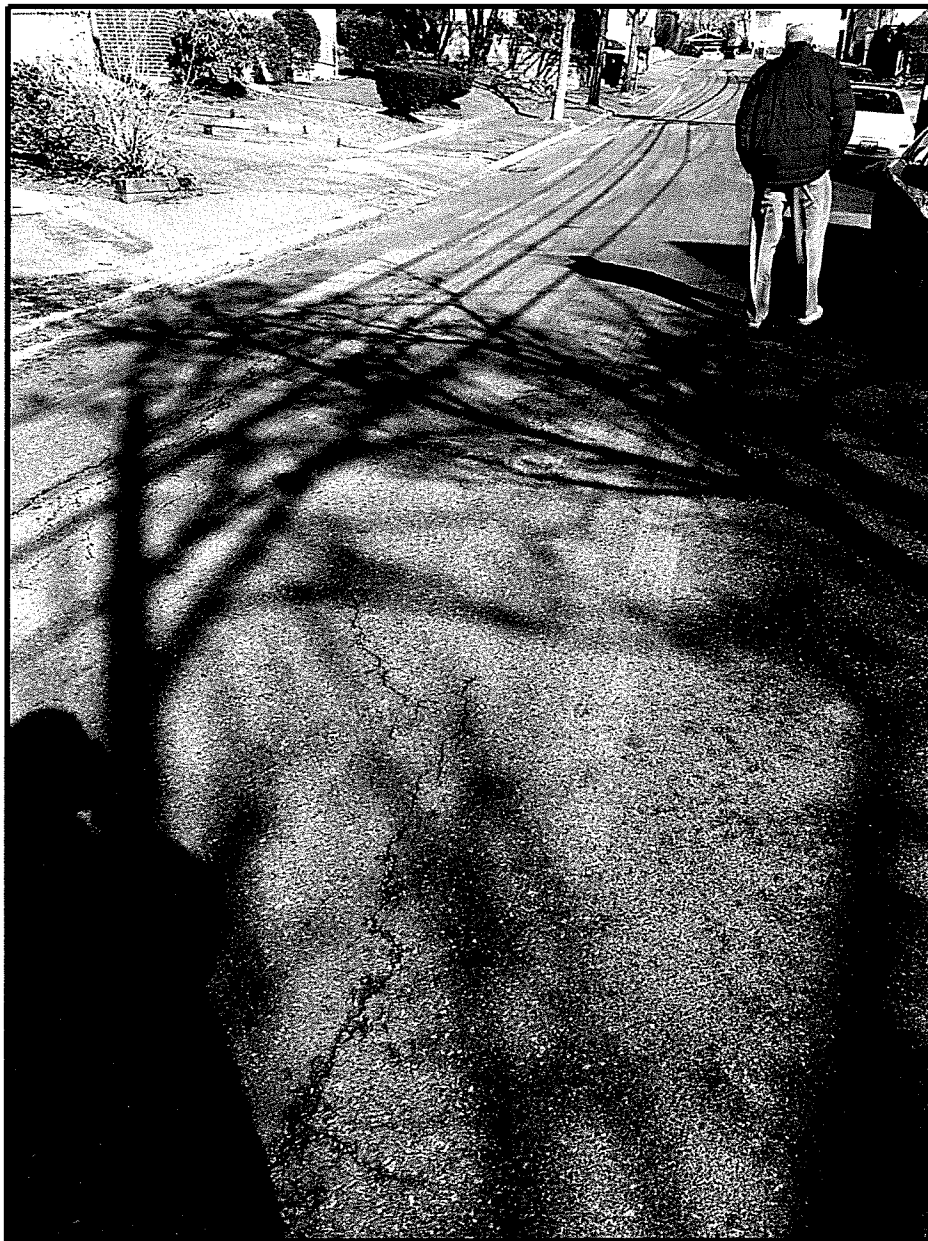
Looking towards Mountain Ave.

Photo shows cracks in roadway beginning to spread, alligator cracks beginning to form. Sidewalks in poor condition, curbing needs to be removed and reset.

The roadway is in better condition than the sidewalks.

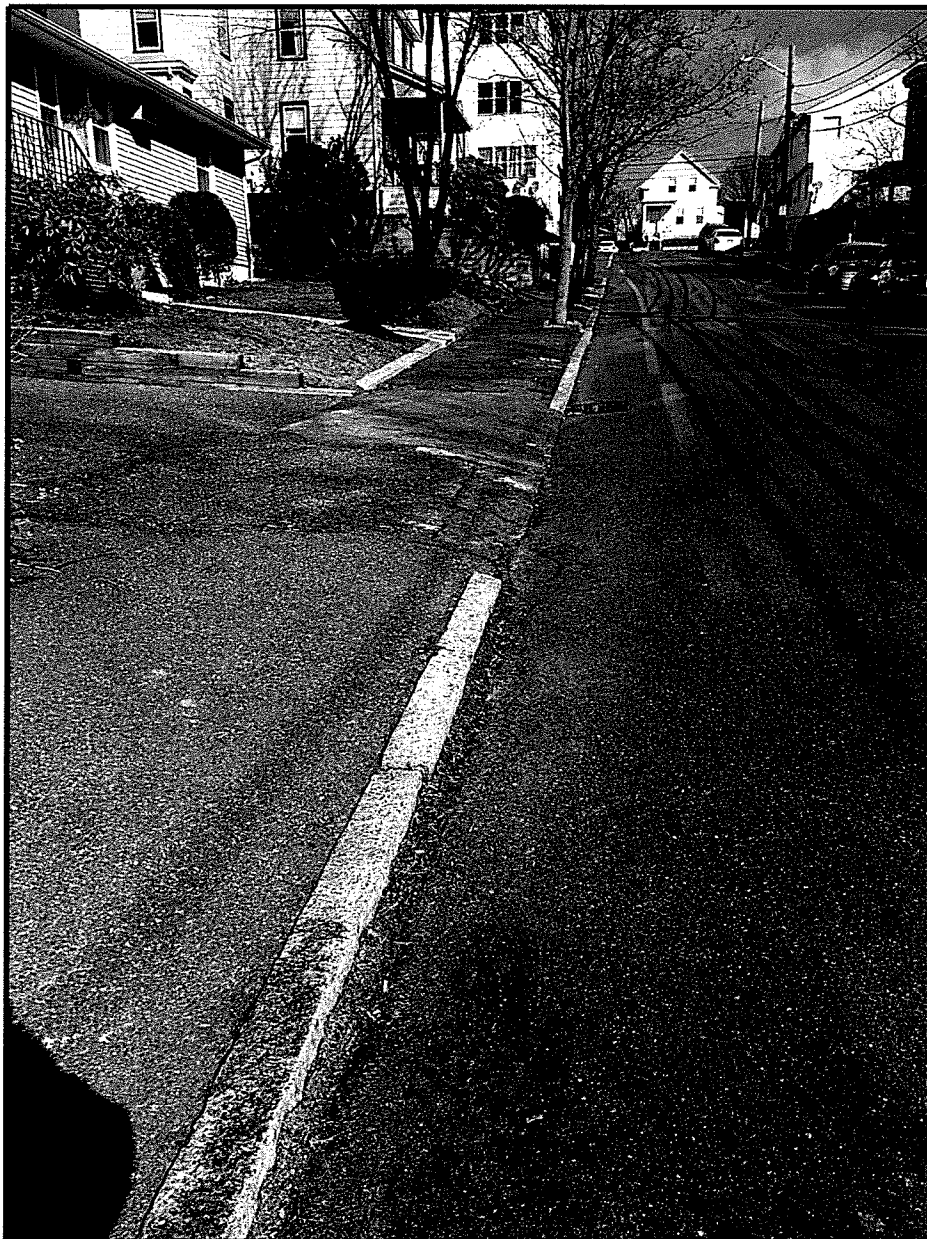
Looking north towards Mountain Ave.

Photo shows road in better condition than the sidewalks.
