PHASE 1 - FEASIBILITY ANALYSIS

Arlington Ave.

(Centennial Ave. to Dead End)

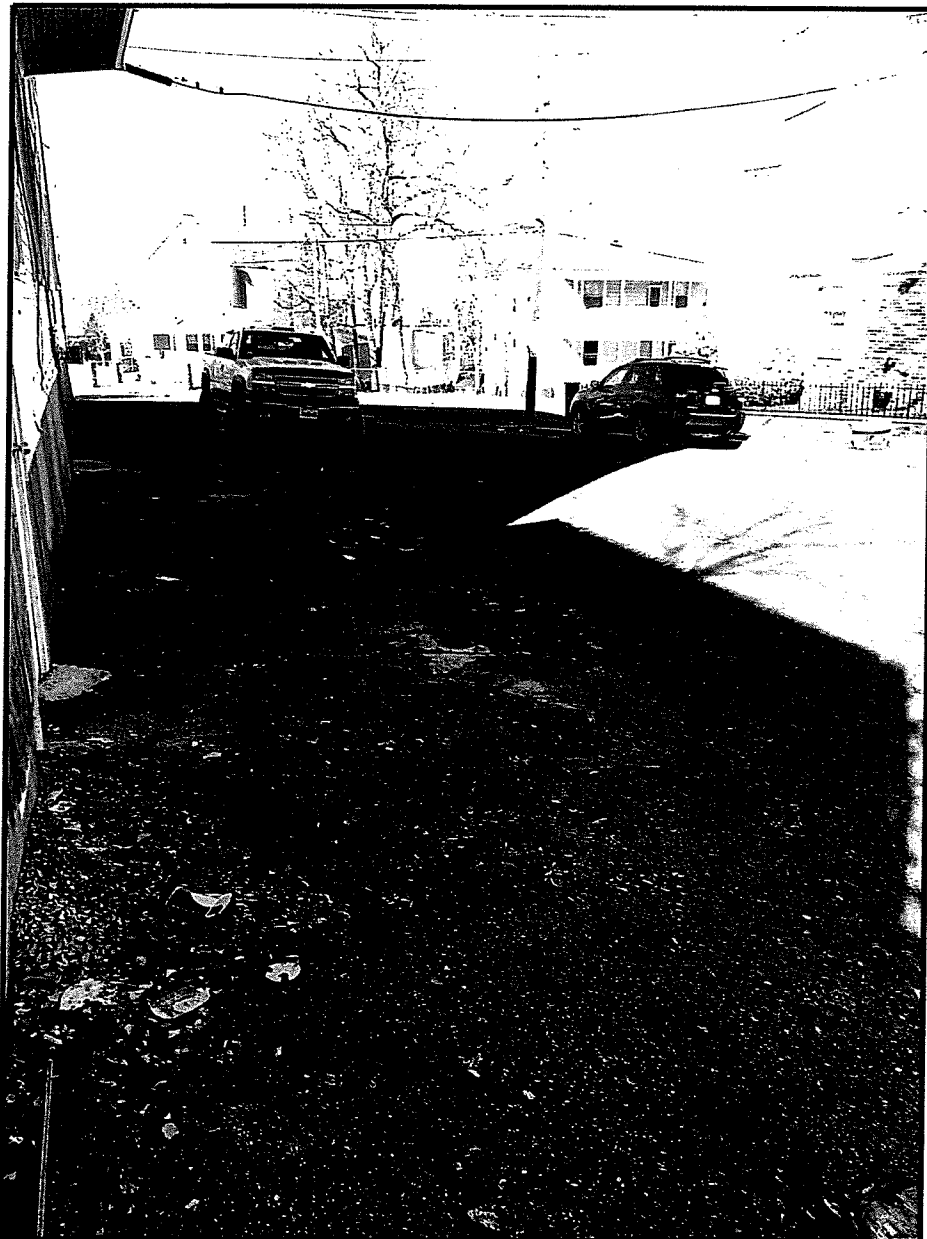
Looking north towards Centennial Ave.

Asphalt sidewalk shown in poor condition. No curbing exists.

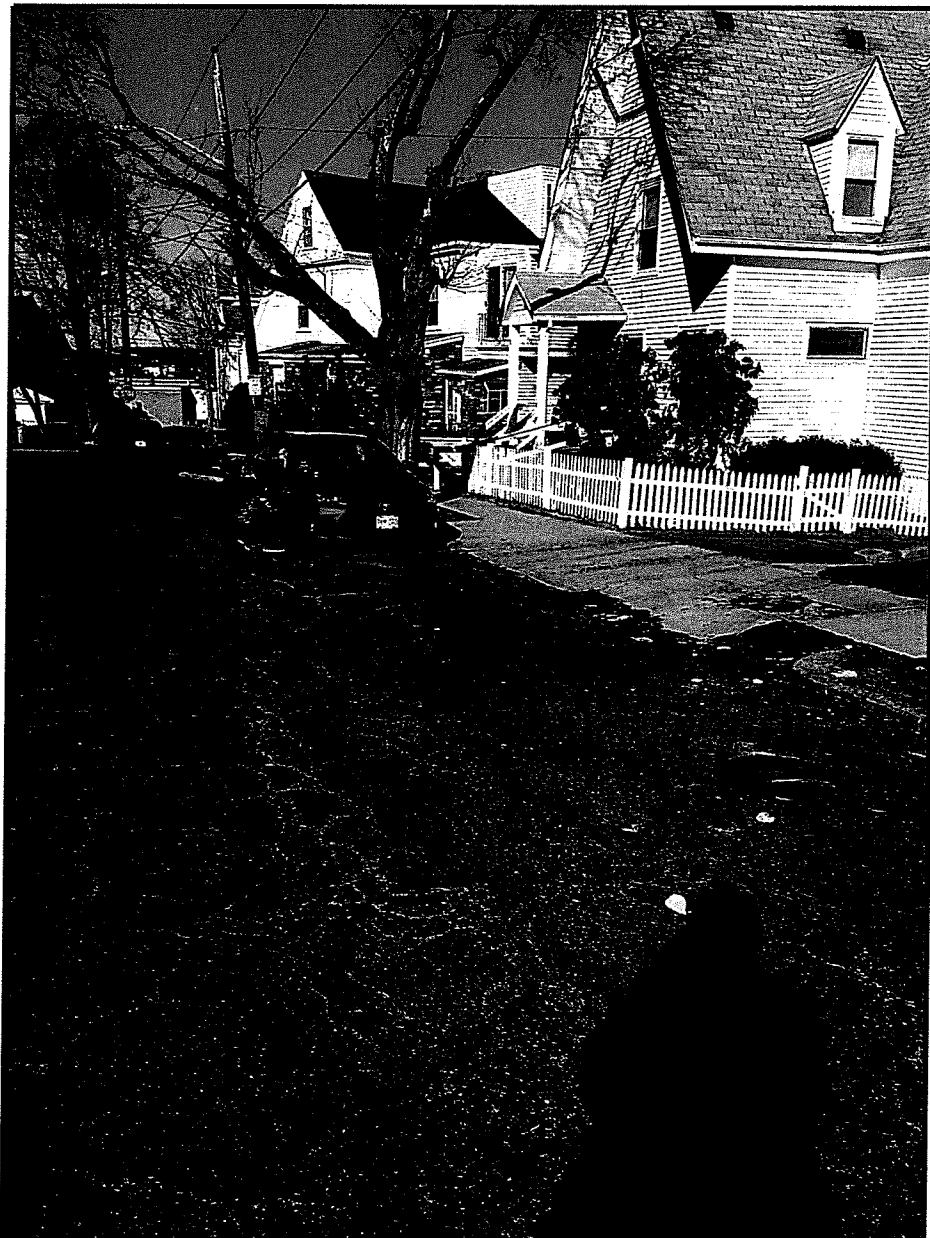
Looking north towards Centennial Ave.

Photo shows concrete sidewalk section
breaking up and multiple
pothole repairs of the roadway
over the years.

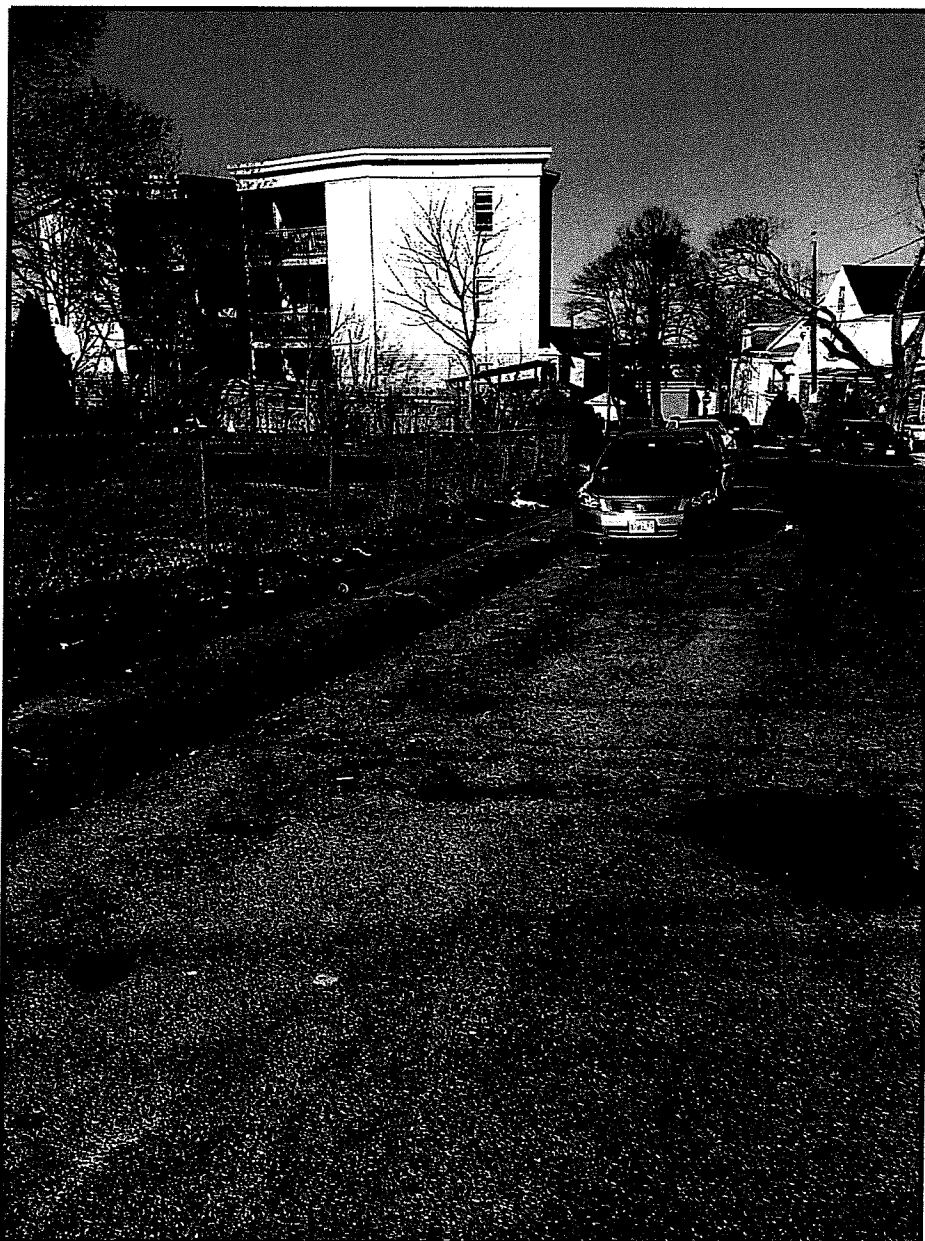
Heading south on Arlington Ave.

Photo shows roadway deteriorating and inconsistent sidewalk materials on the street.

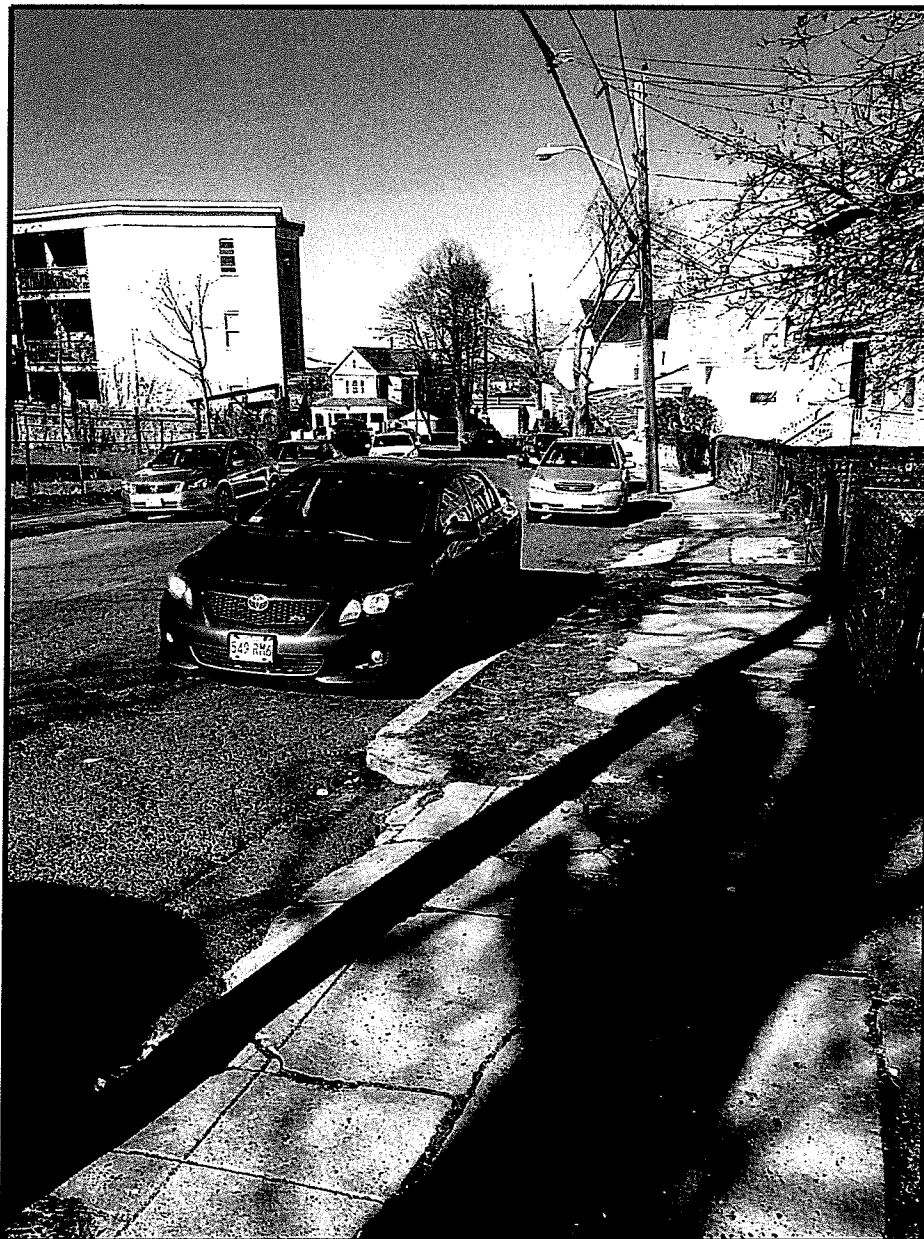
At Park Ave. looking north.

Photo shows roadway and concrete sidewalk breaking up. Curbing settling and rolling over, curbing in poor condition as well.

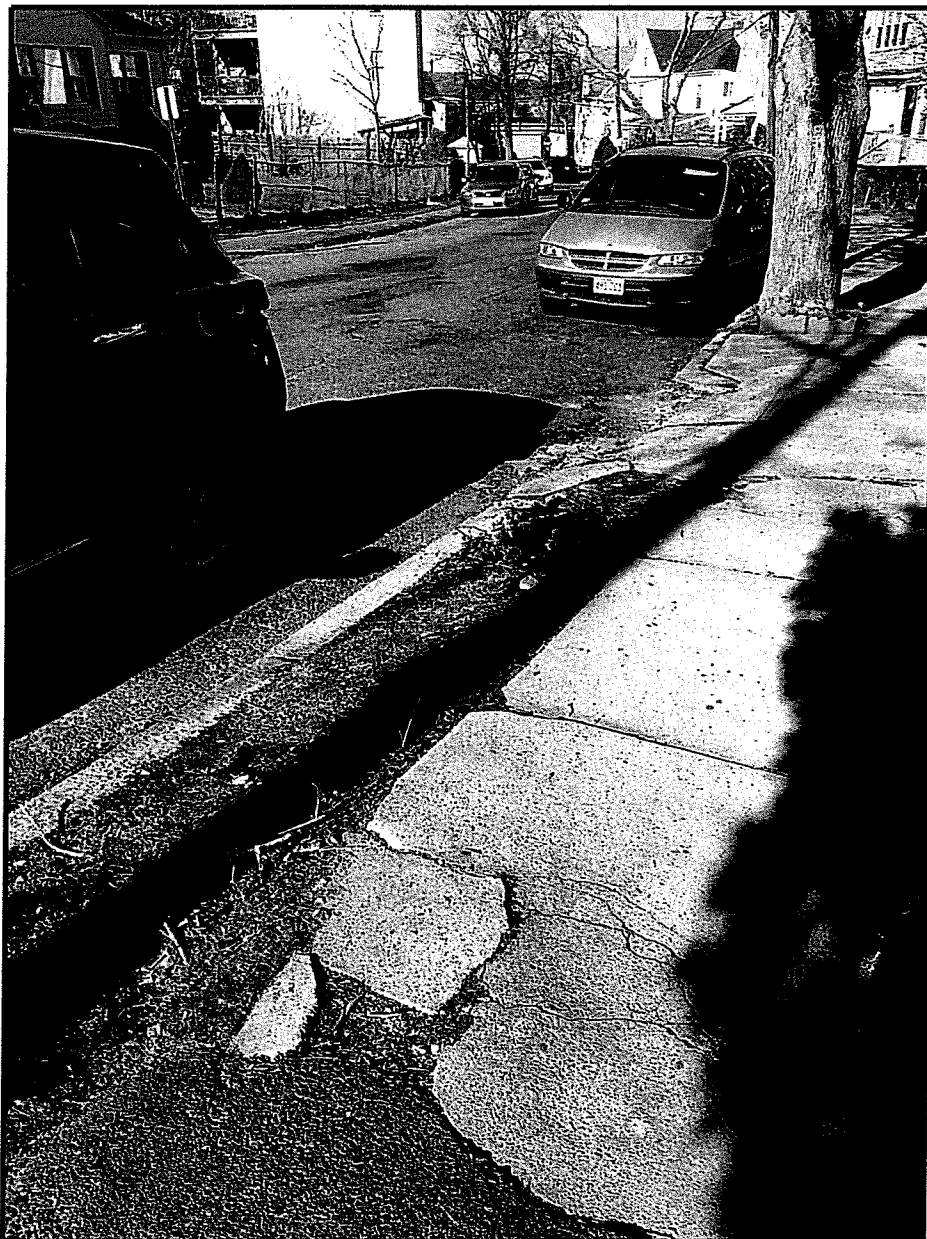
At Park Ave. looking north.

Continuing south on Arlington, the condition of the road, curb and sidewalk is consistent. Note asphalt sidewalks on far side of road. Sidewalks inconsistent.

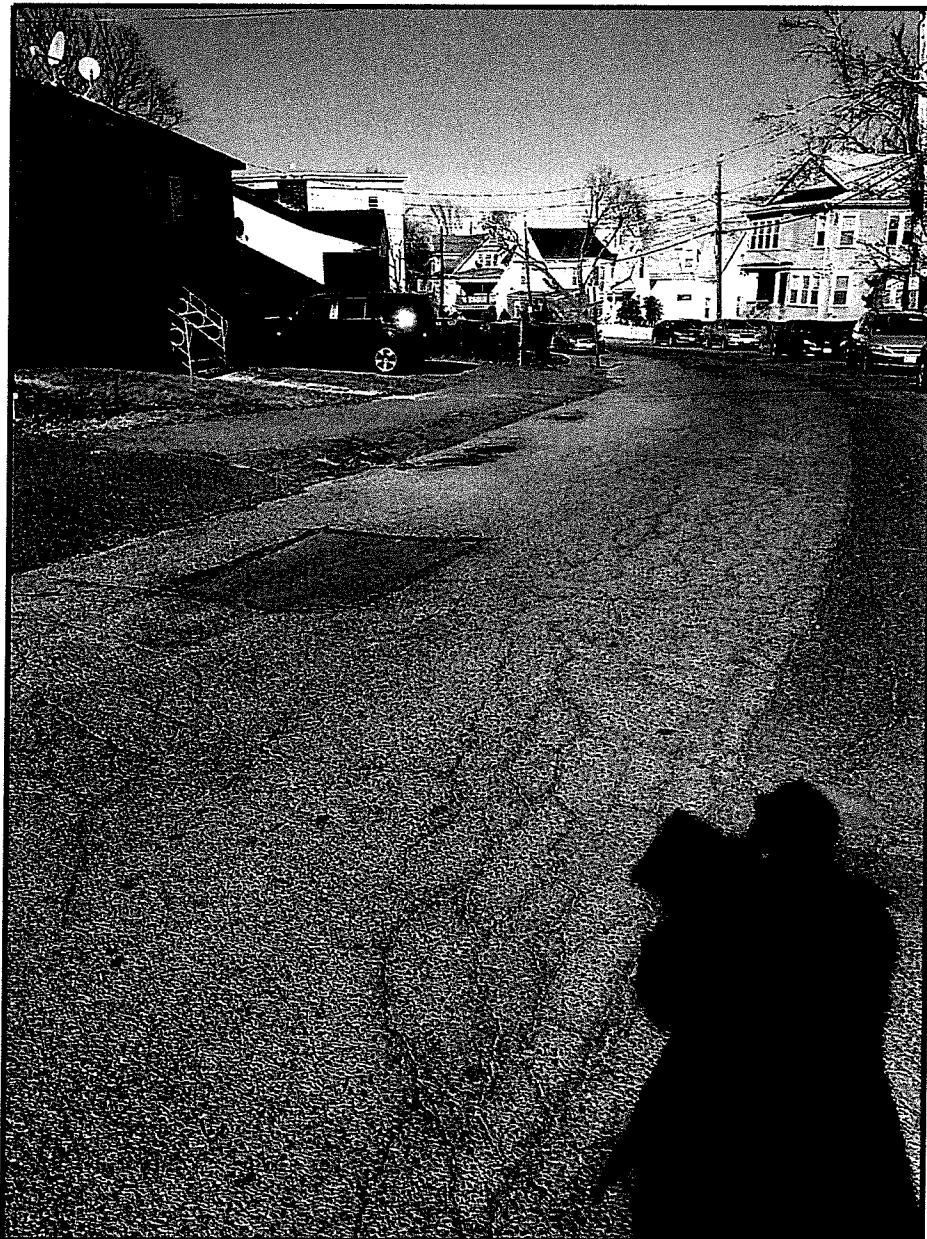
Continuing south on Arlington Ave.

Alligator cracking of roadway continues. Utility trench shown. Roadway will begin to fall apart in near future thus requiring extensive pothole repairs.

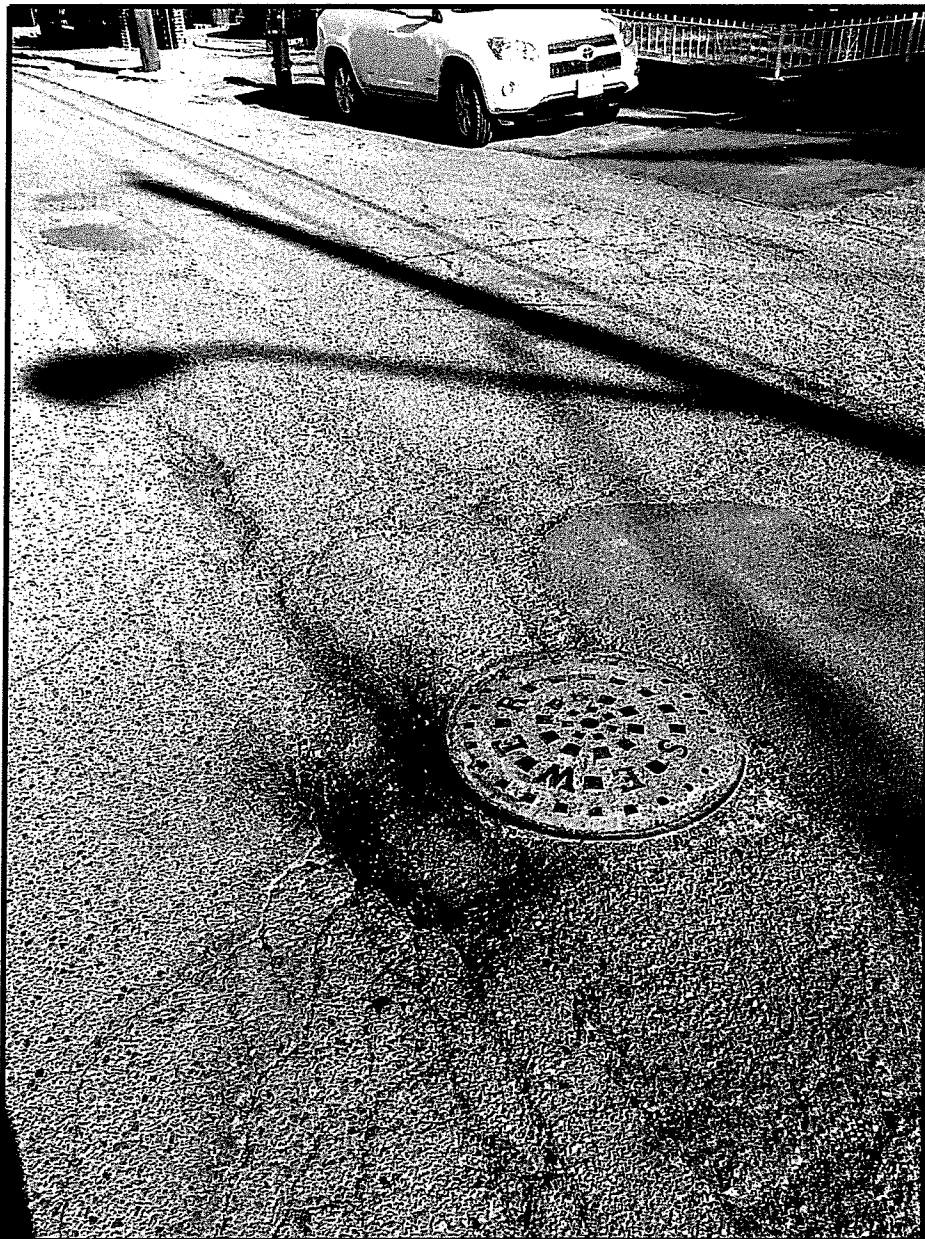
Continuing south on Arlington Ave.

Top layer of asphalt broken away at utility casting. Solid asphalt exists below top layer. Road should support milling and paving.

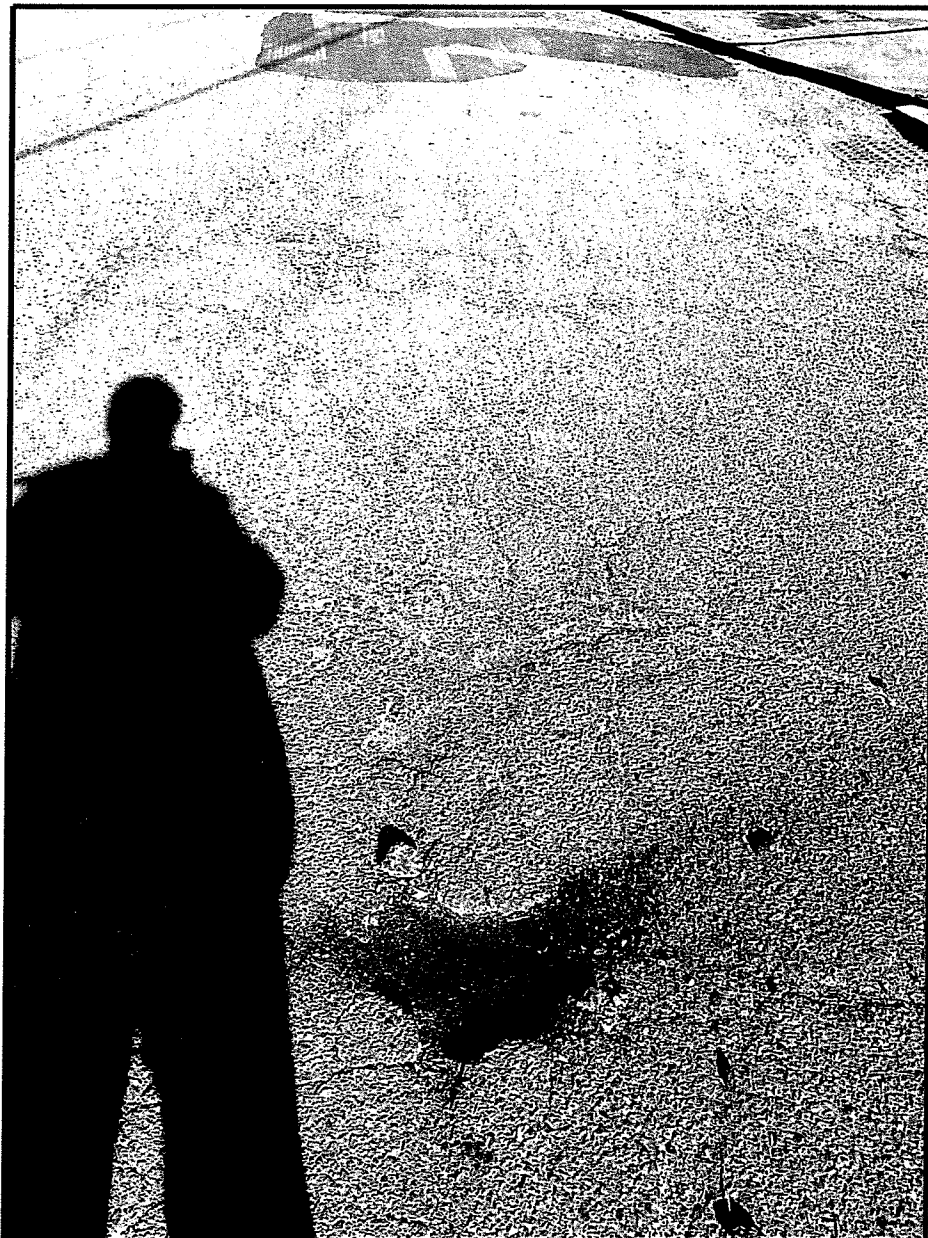
Another photo of a pothole on Arlington.

Solid asphalt exists beneath the top layer, therefore the road should support milling and paving.

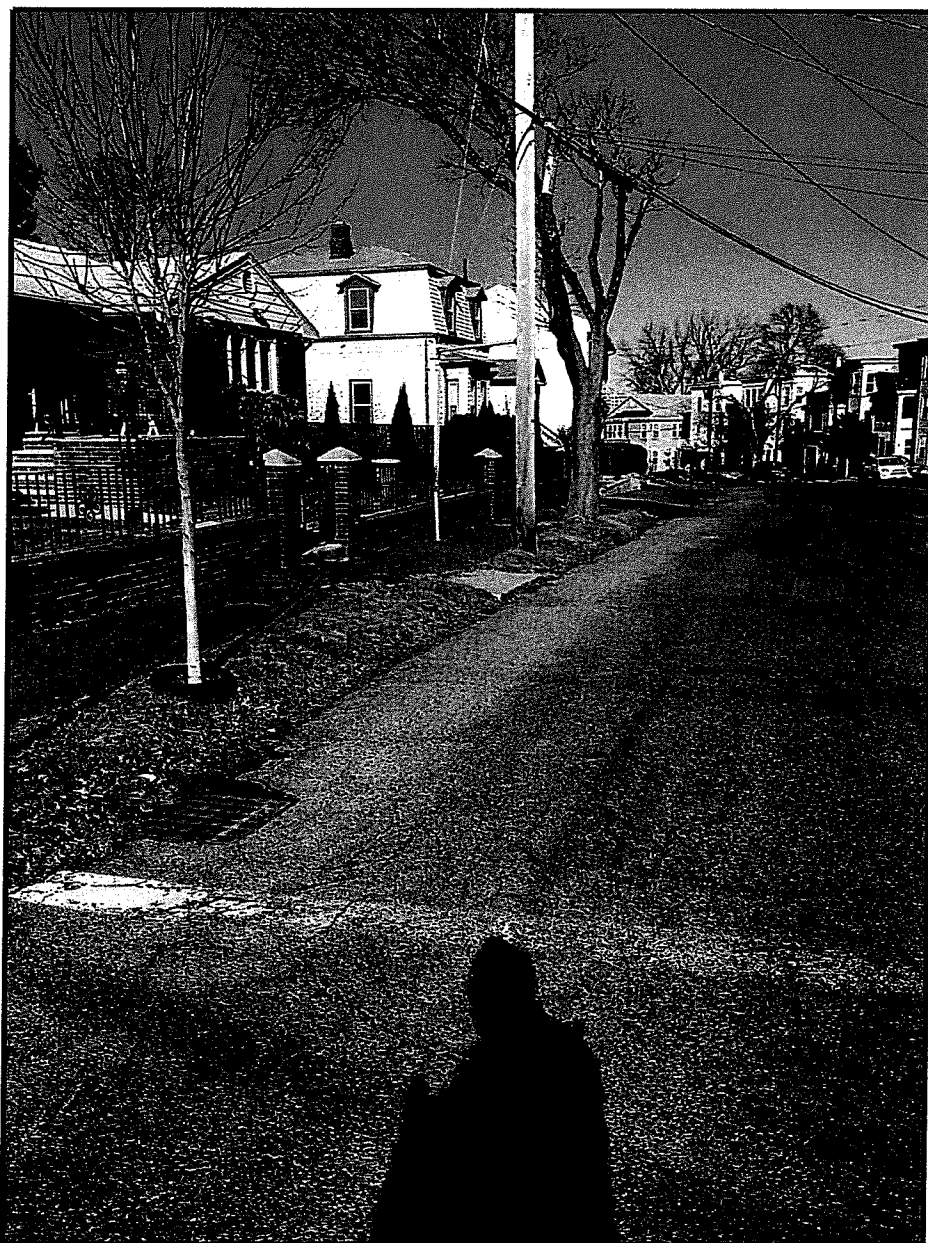
At James St. looking north

Asphalt sidewalks in decent condition at brick wall, but in poor condition beyond that house.

Cracking of roadway is consistent along the road.

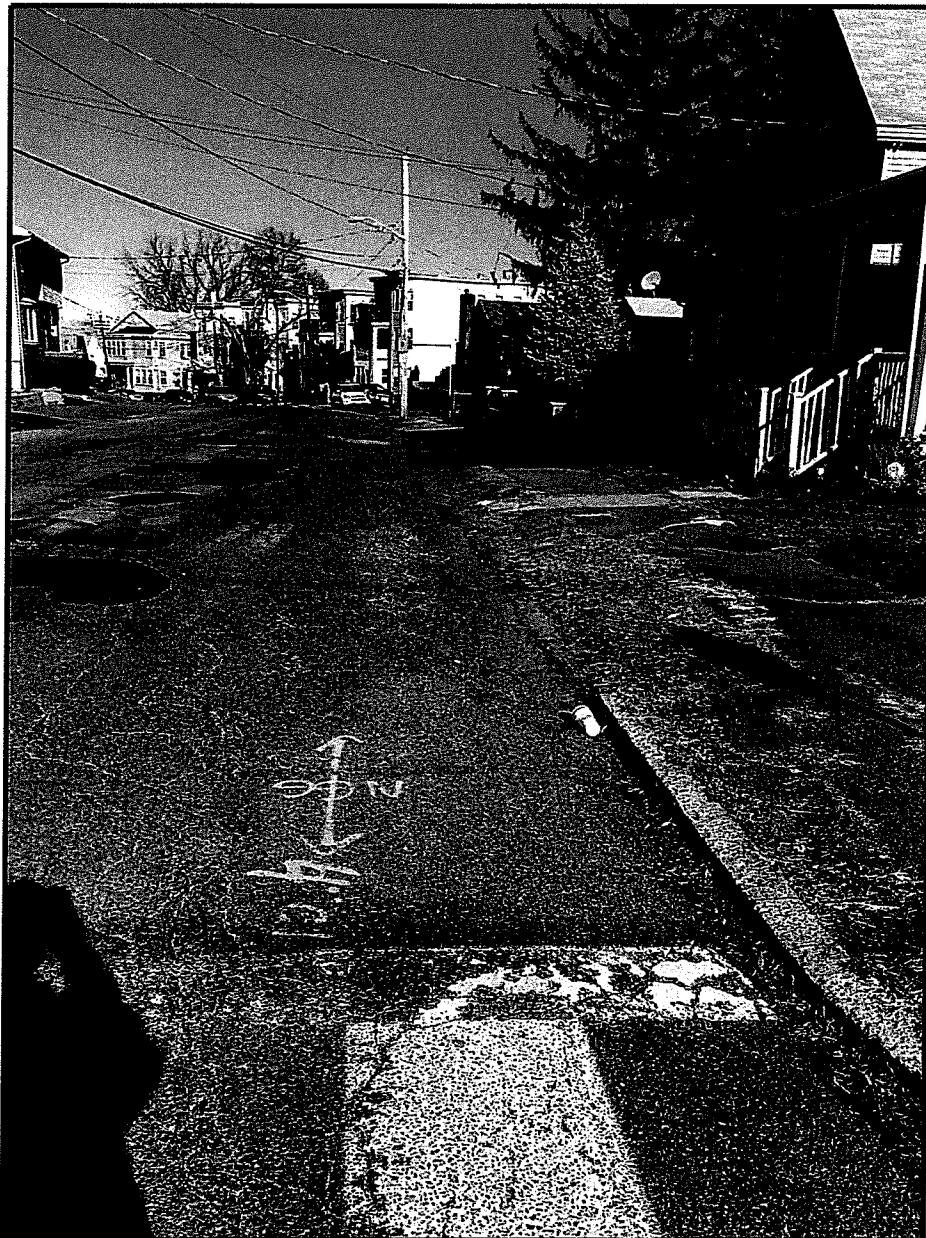
At James Street looking north

Photo highlights multiple pothole repairs as alligator cracking breaks away. Note inconsistent nature of curbing and sidewalk materials and poor condition of asphalt sidewalks.

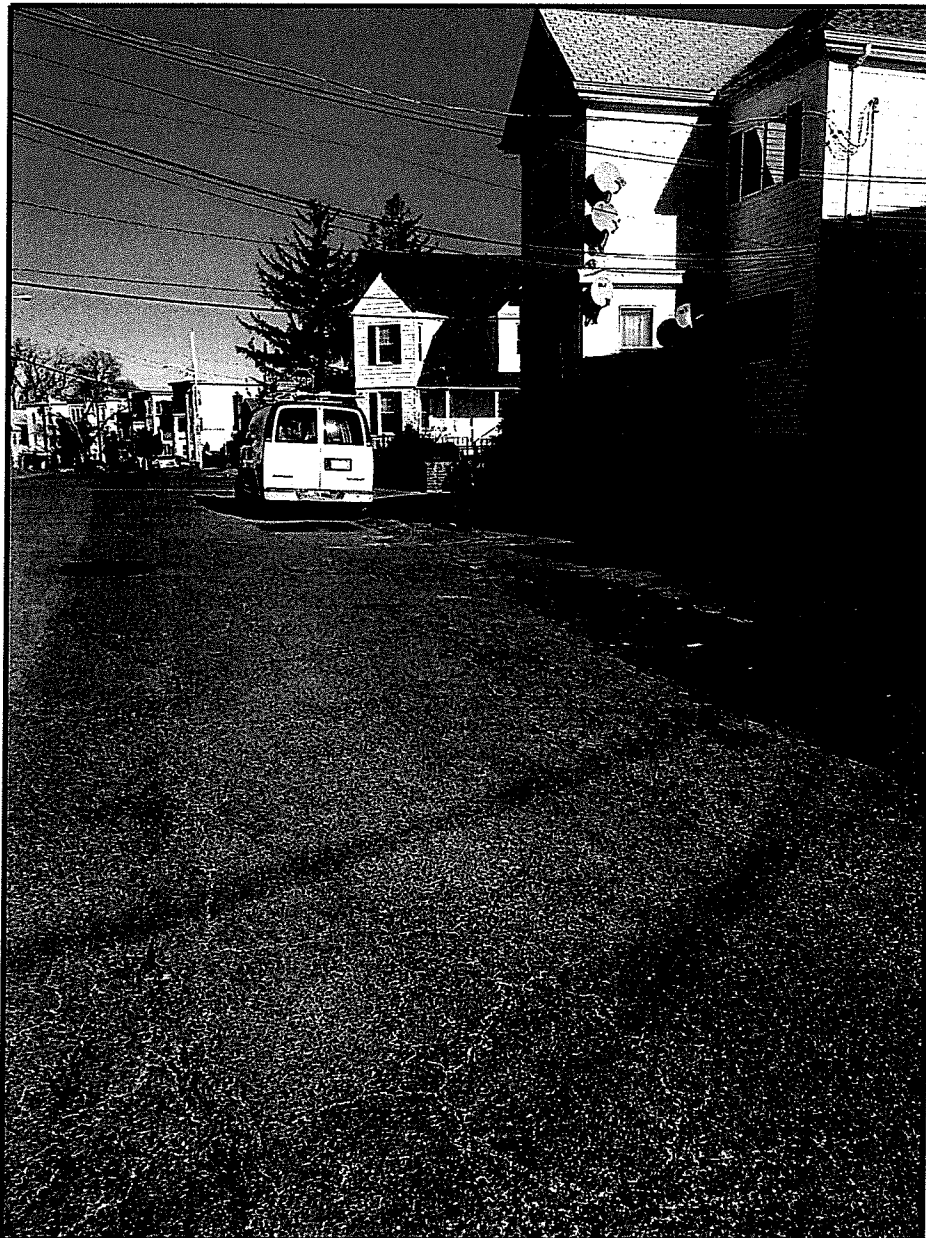
South of James St. looking north

The dead end block of Arlington lacks curbing.
Condition of roadway and asphalt sidewalks poor.
Roadway beginning to break up, note pothole
repair.

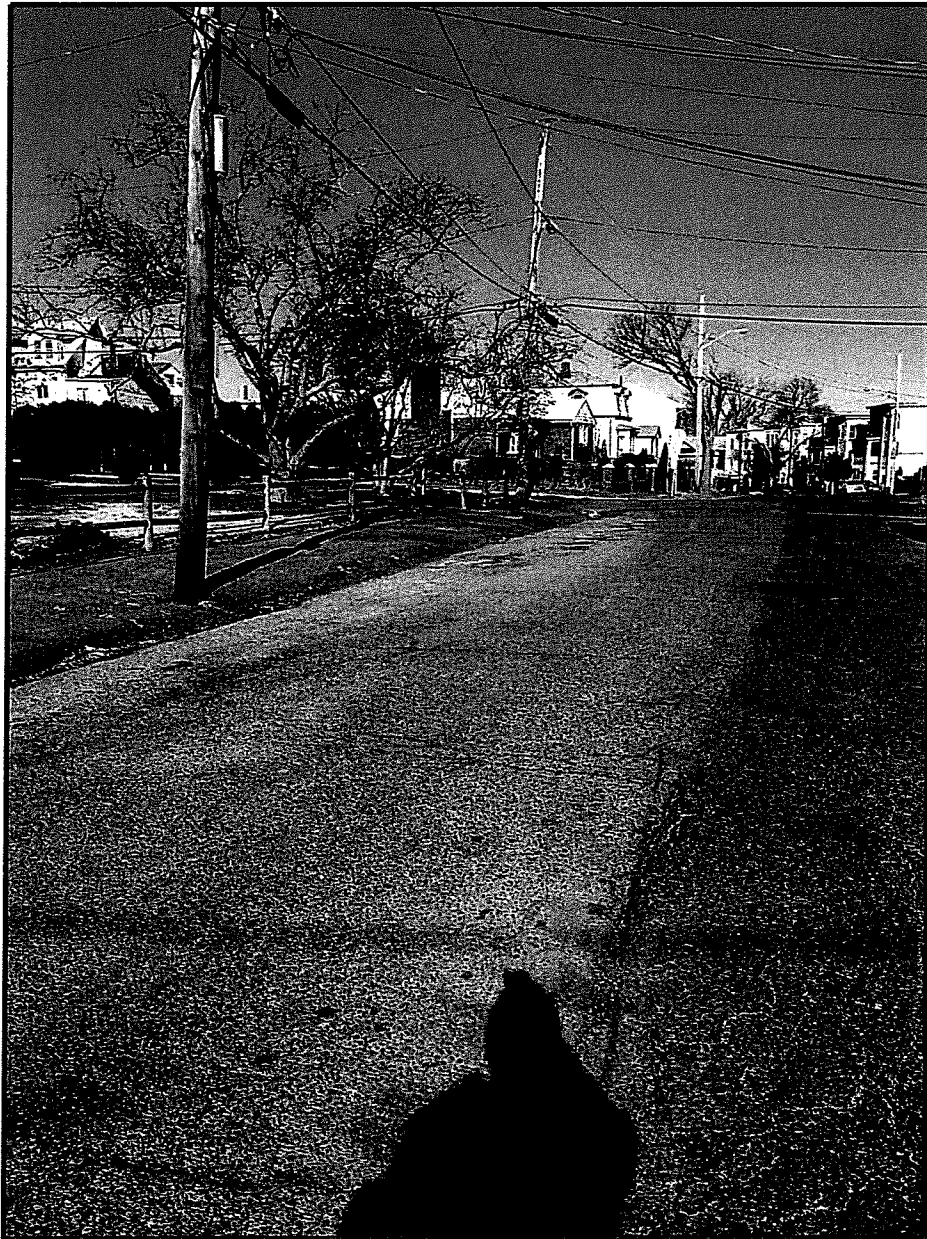
Continuing south, looking north

Condition of roadway and sidewalks
continues consistently

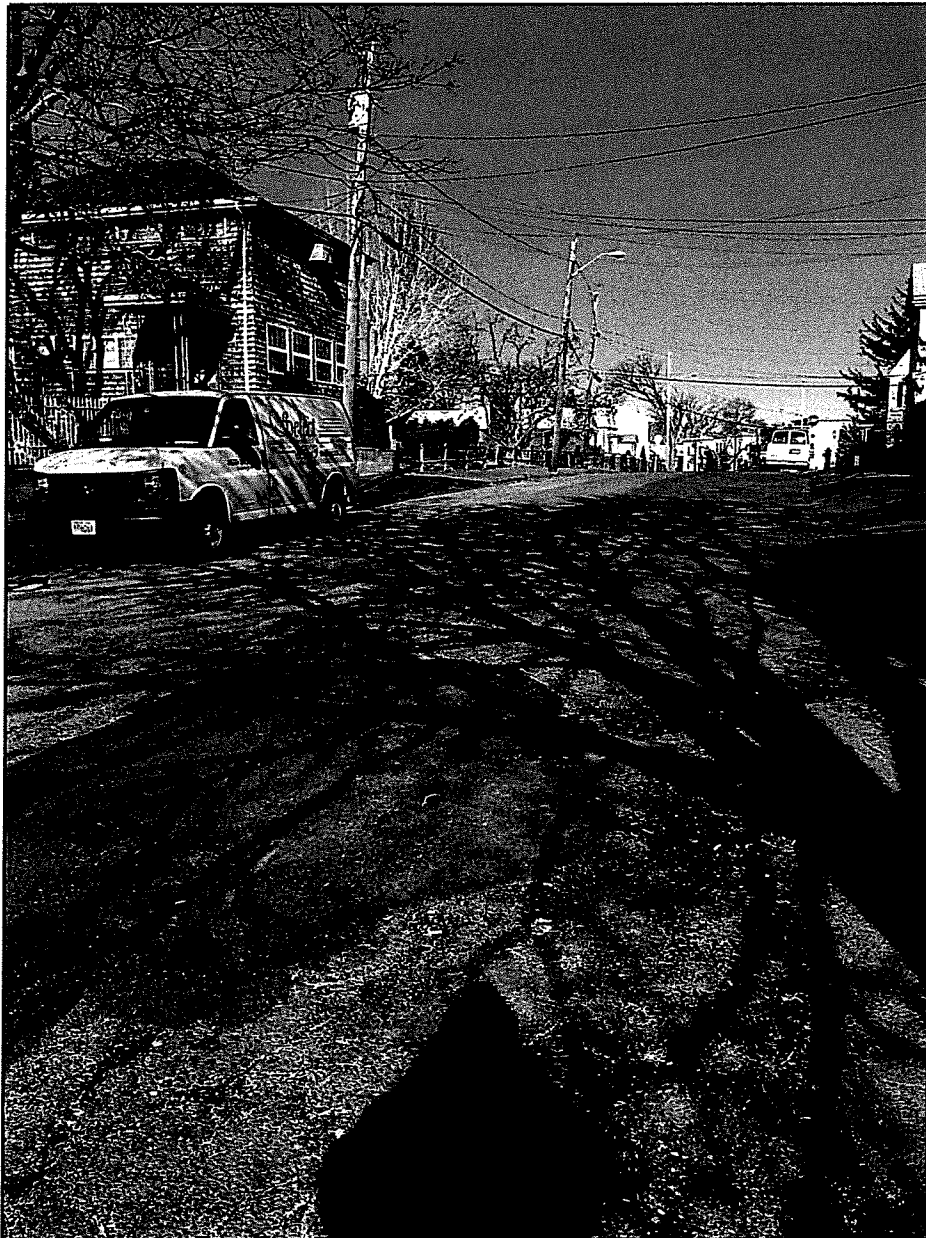
Continuing south, looking north

Large pothole repair shown.
Roadway breaking up in area surrounding pothole
repair. Deterioration will continue into the
future thus requiring more pothole repairs.

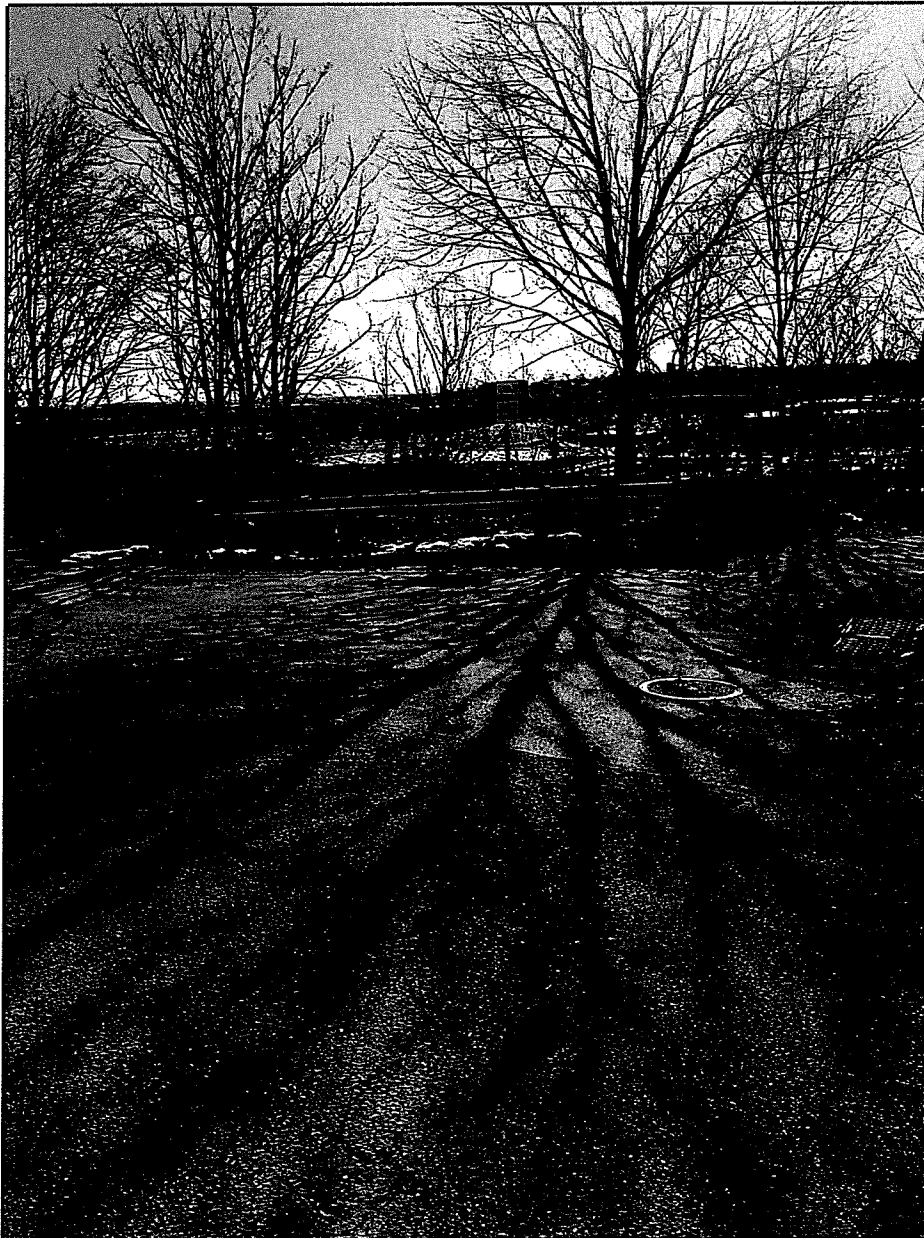
Looking south at dead end

Dead end of Arlington has drainage installed.

No downstream erosion conditions have been mentioned, opposed to dead end of Walnut Ave. where no drainage exists and erosion of the downstream sloped hill is extremely apparent.
