PHASE 2 – FEASIBILITY ANALYSIS CONANT STREET

Conant Street
(Between Fenley and Malden)

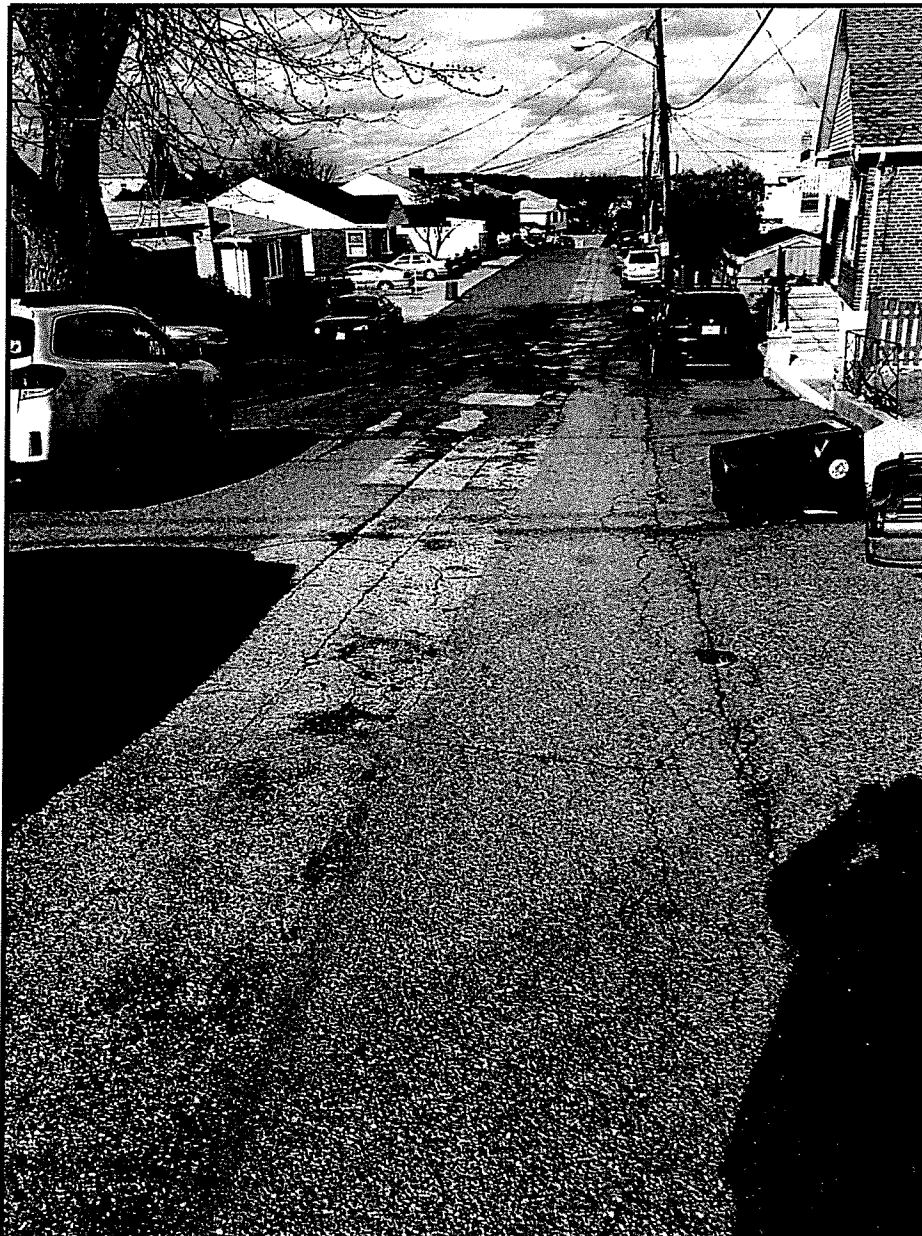
Roadway showing alligator cracking. Condition of gas trench and adjacent roadway typically in worse condition than remainder of roadway.

Overall roadway and sidewalks in poor condition. Sidewalks do not meet handicap code in many locations.

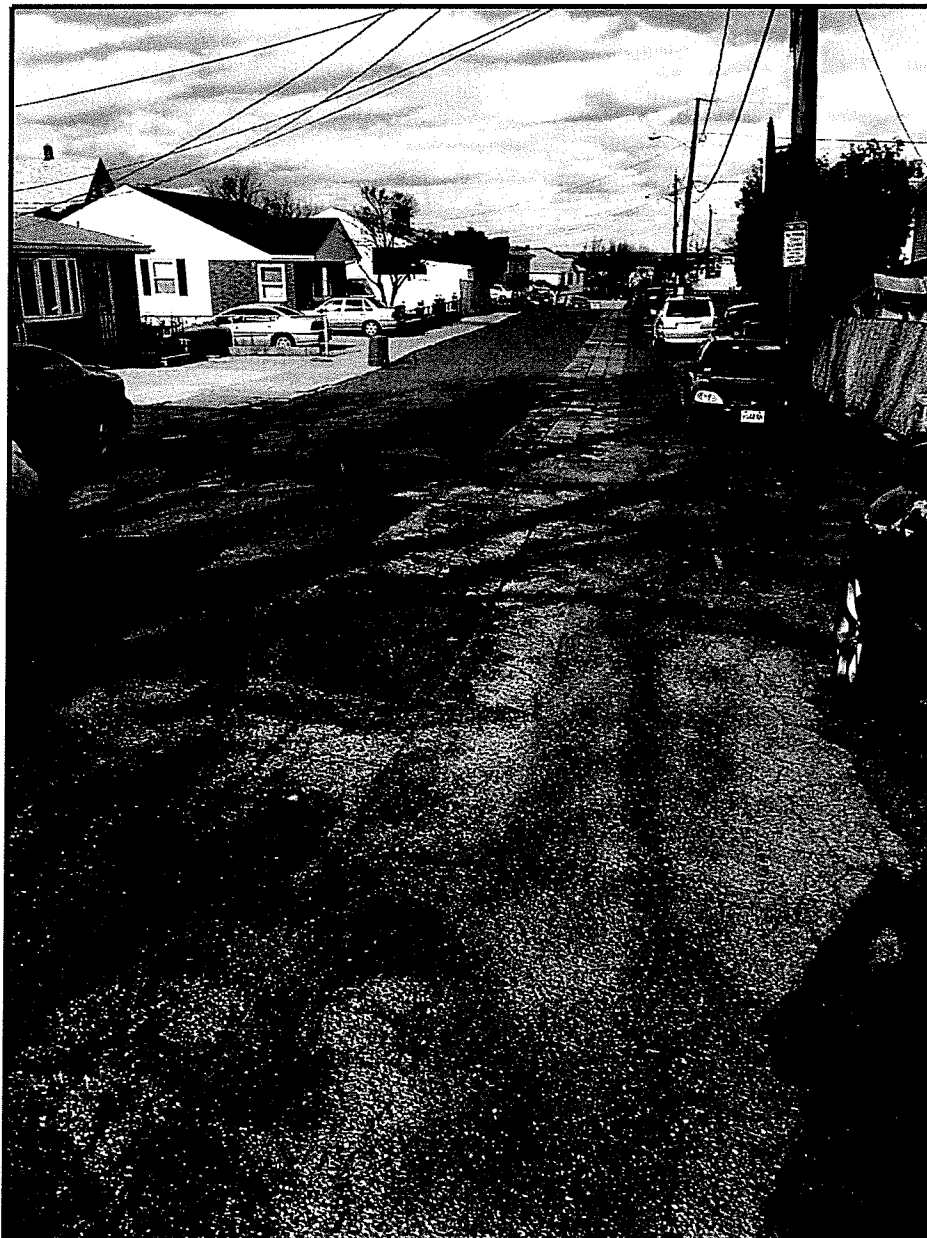
Conant Street
(Between Fenley and Malden)

Trench in very poor condition, roadway in poor condition.

No curbing exists for majority of roadway.
Cars park on asphalt shoulders / sidewalks
along the majority of the street.

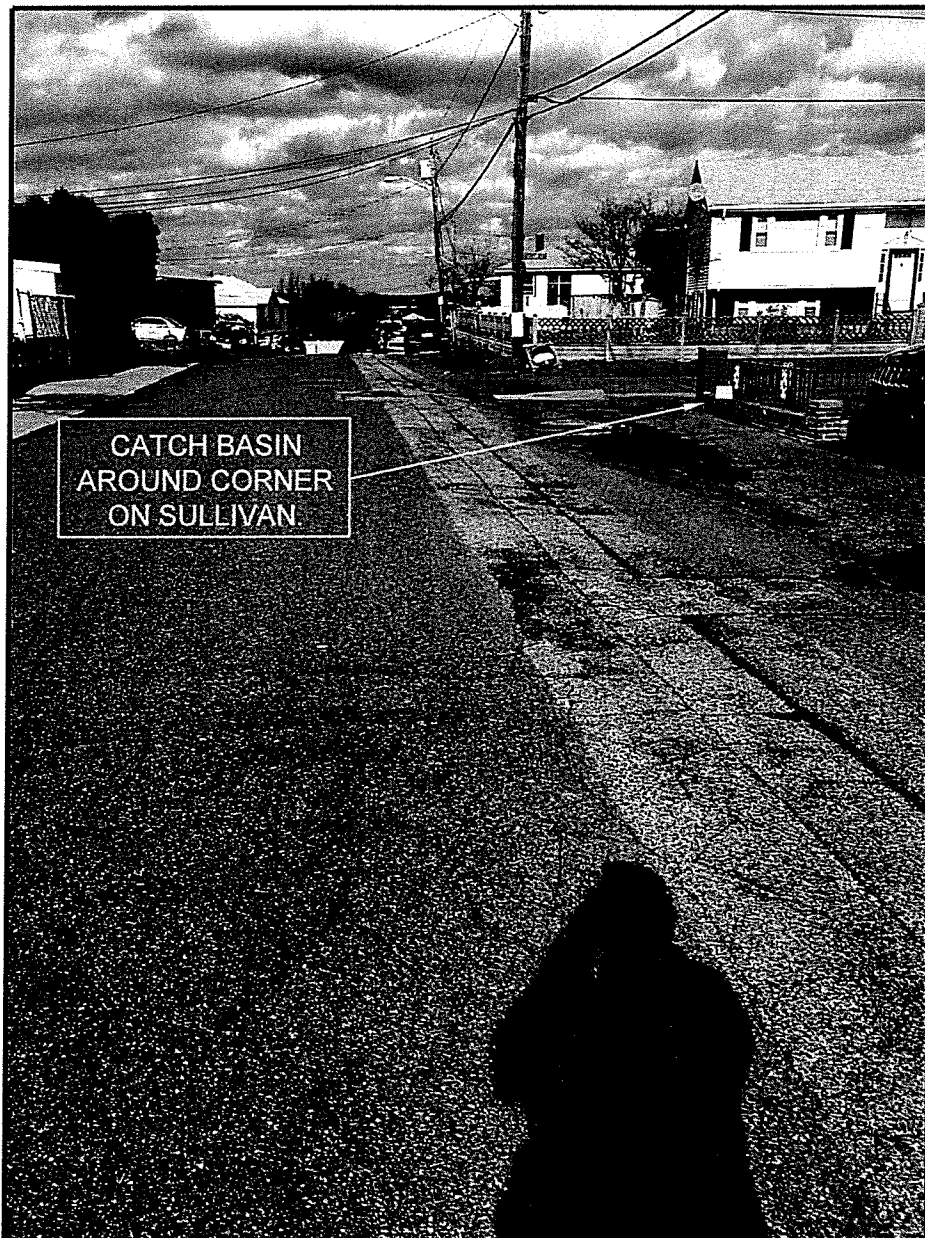
Conant Street
(Between Fenley and Malden)

Photo highlighting alligator cracking of the roadway and the very poor condition of the gas trench. Standing water shown just south of Sullivan Street.

It may be possible to regrade road to get water to the catchbasin on Sullivan. Grades should be investigated.

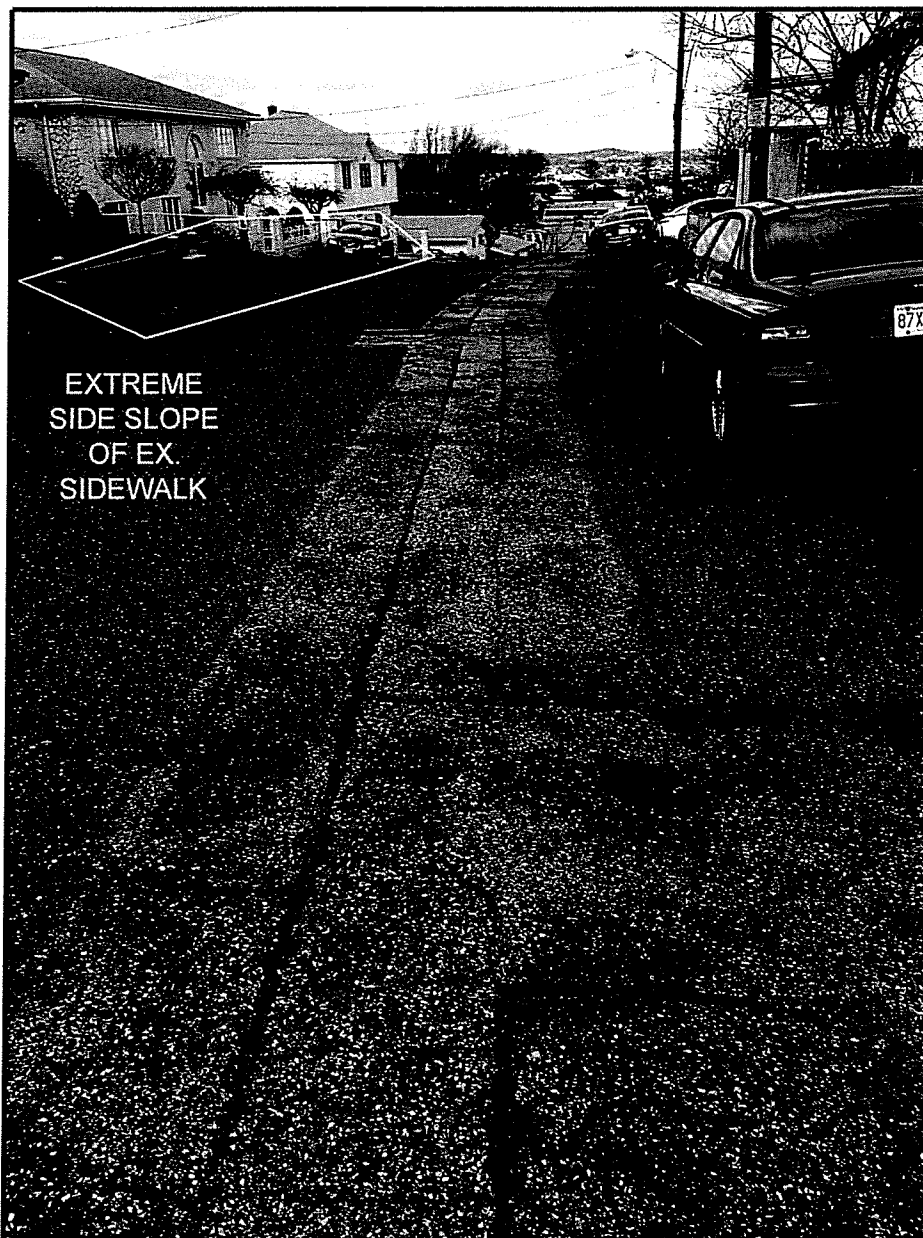
Conant Street
(Between Fenley and Malden)

- The shoulders at both 54 and 60 Conant Street are extremely high and creates a severe side slope towards the roadway. The Americans Disability Act (ADA) mandates that a shoulder or a sidewalk has a four foot right of travel passage for wheelchair accessibility and 2% max. cross slope. To conform to this mandate, major reconstruction of both shoulders would be necessary . It is possible that the retaining walls at both 54 and 60 would have to be rebuilt and additional steps up to the walkways would be required.

Typical condition of the roadway continues.

Note the extreme side slope of the asphalt shoulders / sidewalks. Lowering the back of sidewalk at the wall shown will create issues related to exposing the portion wall which is now below grade. Could possibly expose the footing thus requiring reconstruction of the wall itself.

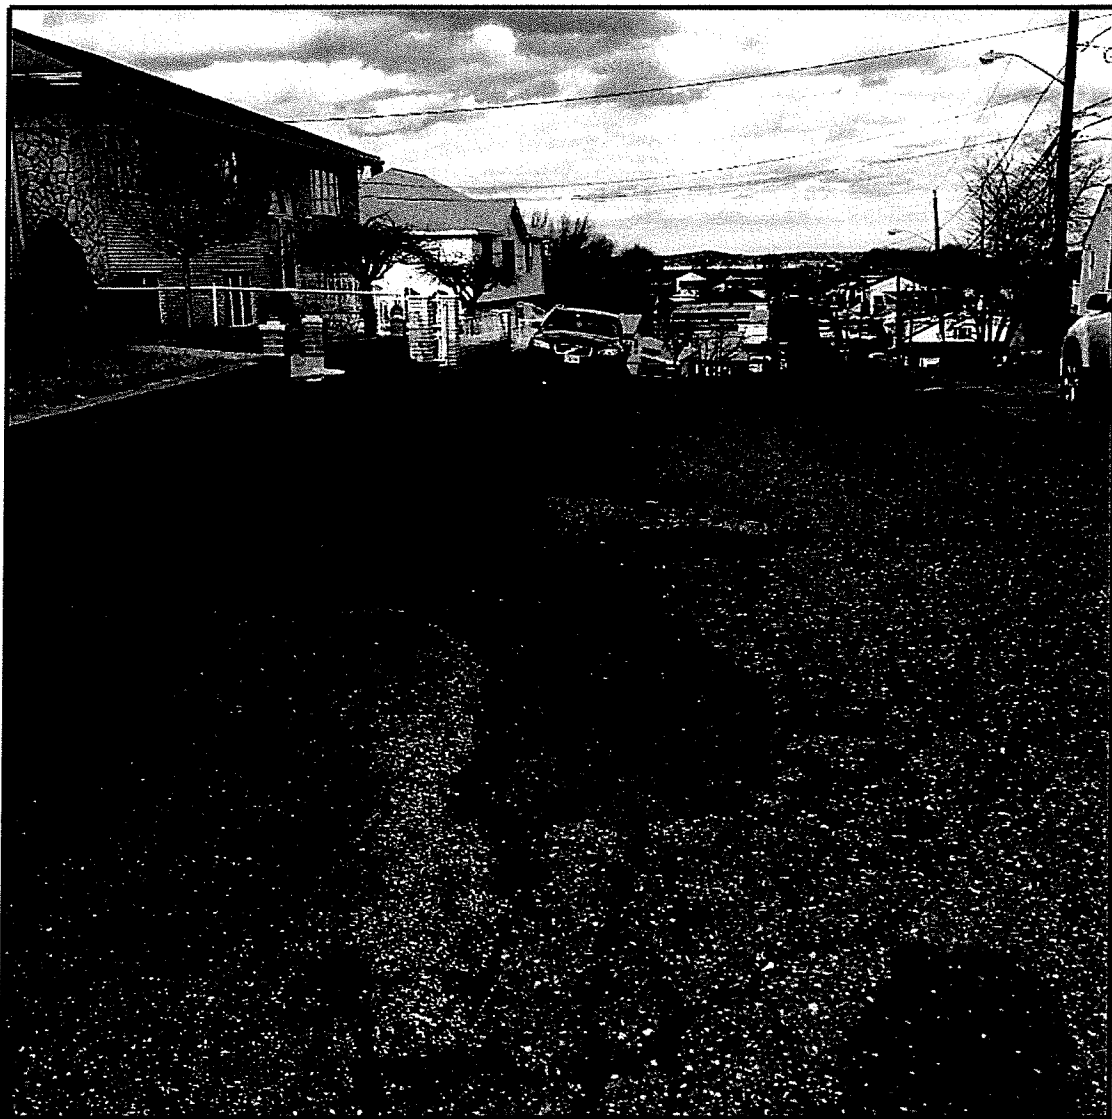
Conant Street
(Between Fenley and Malden)

Photo highlighting the extreme side slope of the shoulder / sidewalk. Extensive alligator cracking shown near the gutter.

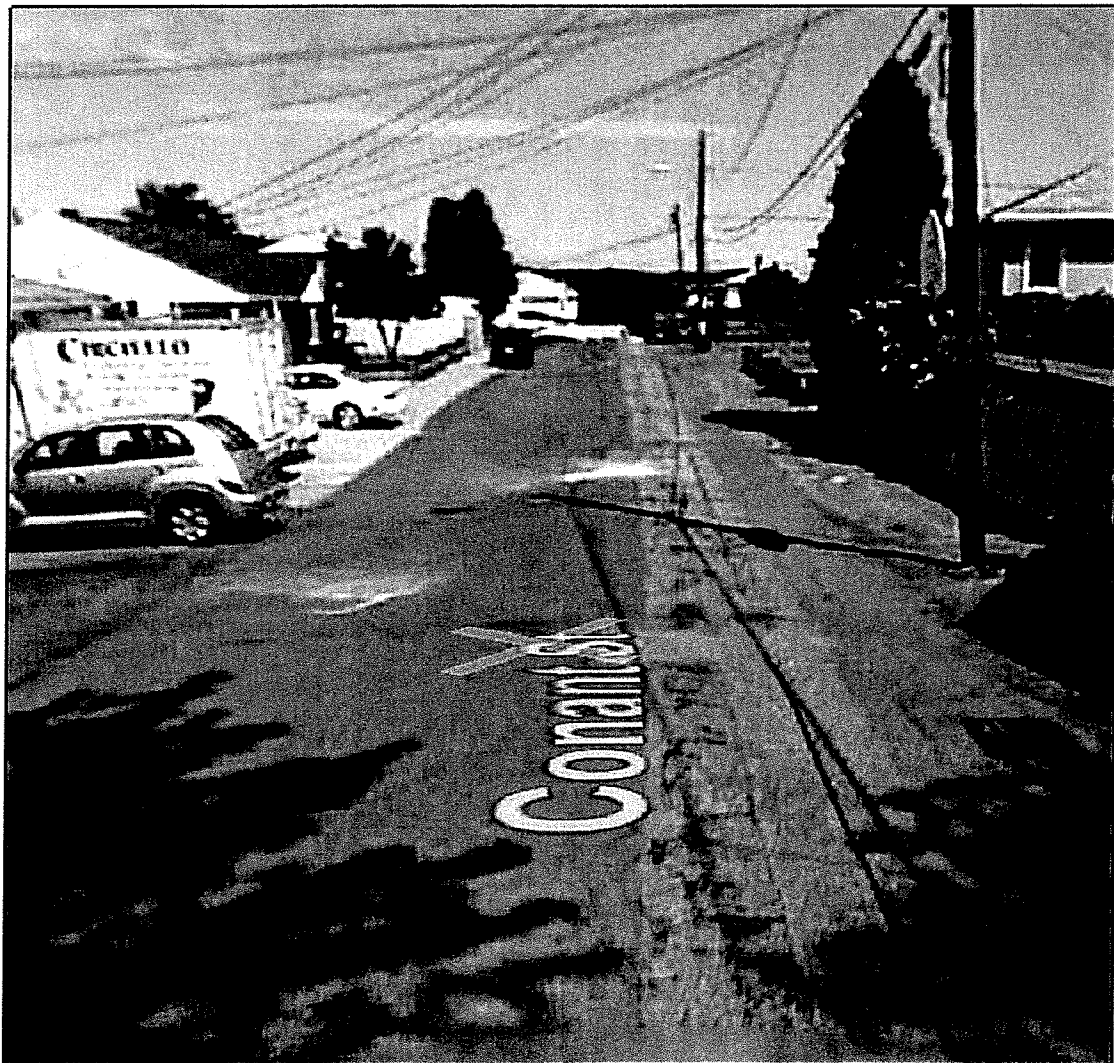
Conant Street
(Between Fenley and Malden)

Google street view image from 2007.
Gas trench installed prior to 2007.
