## **PHASE 2 – FEASIBILITY ANALYSIS**

### **PEARL AVENUE**

#### **West of Summer Street**

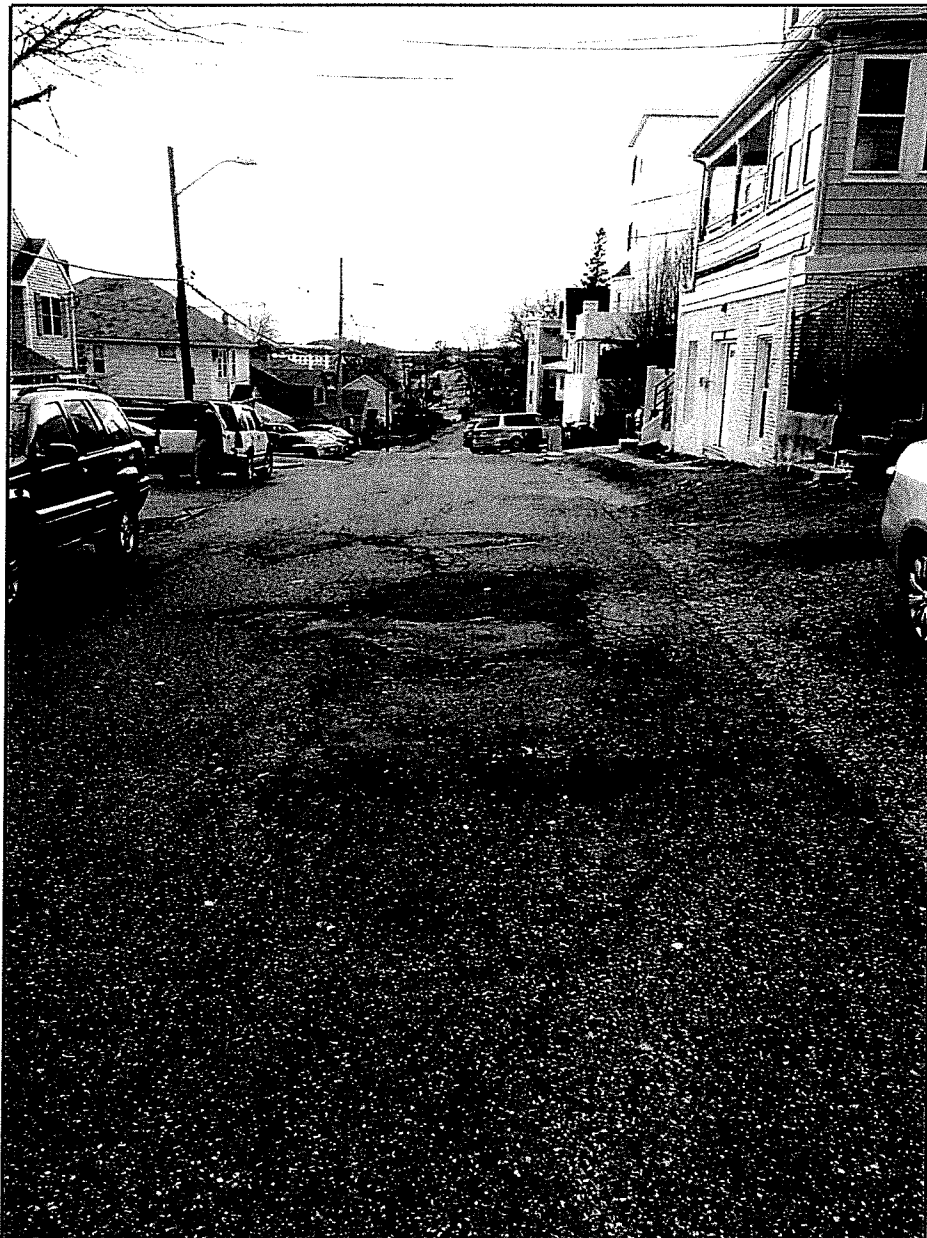
Near Summer St. looking west

Alligator cracking turning to potholes. Multiple pothole repairs seen, roadway failing.

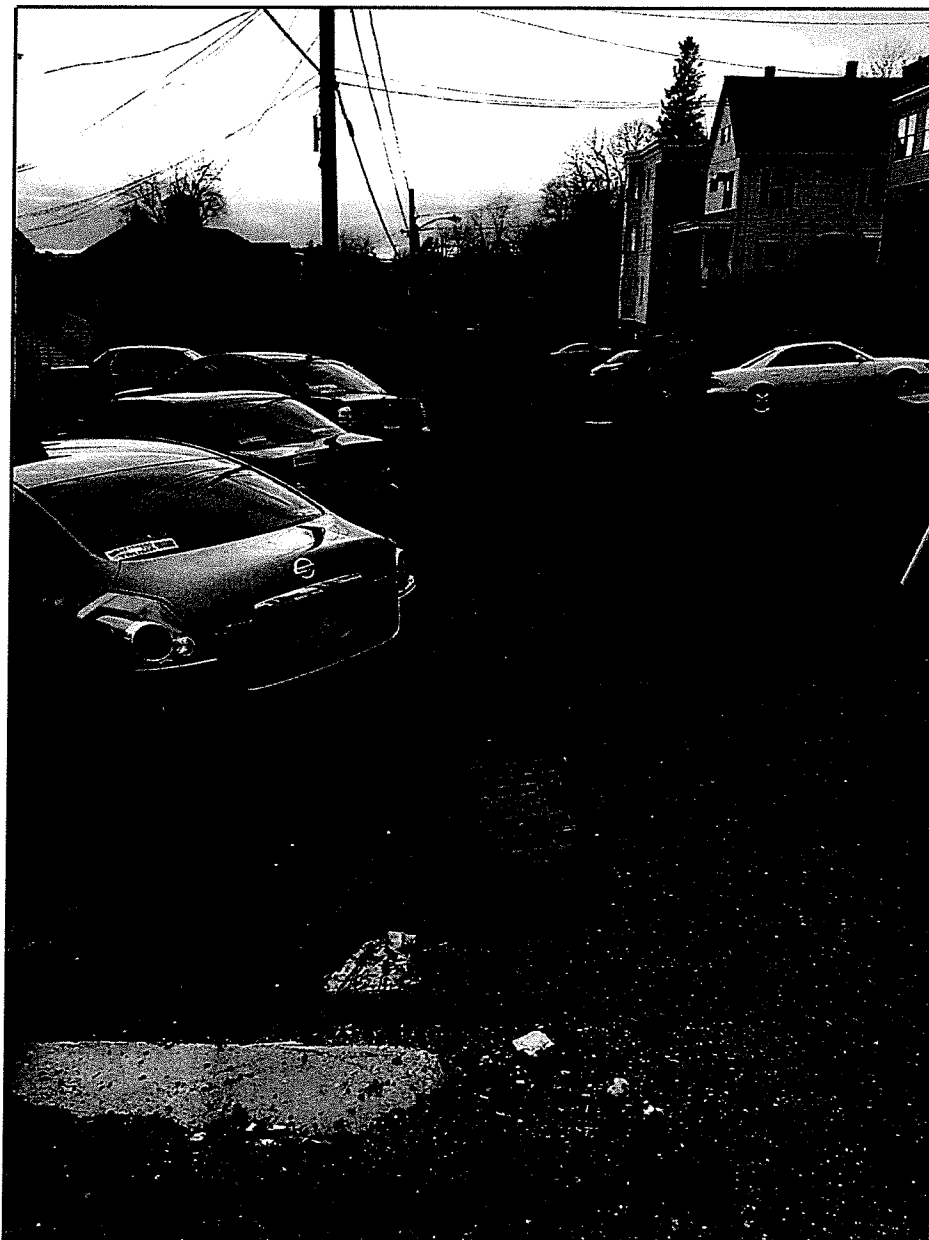
Multiple catch basins on the south side of Pearl Ave are not capturing storm water. Street has major issues that need to be investigated in detail.

Curbing to control water can not be installed consistently on the south side of the street due to the driveways.

No gutter exists, water from the road flows down driveways in multiple locations.

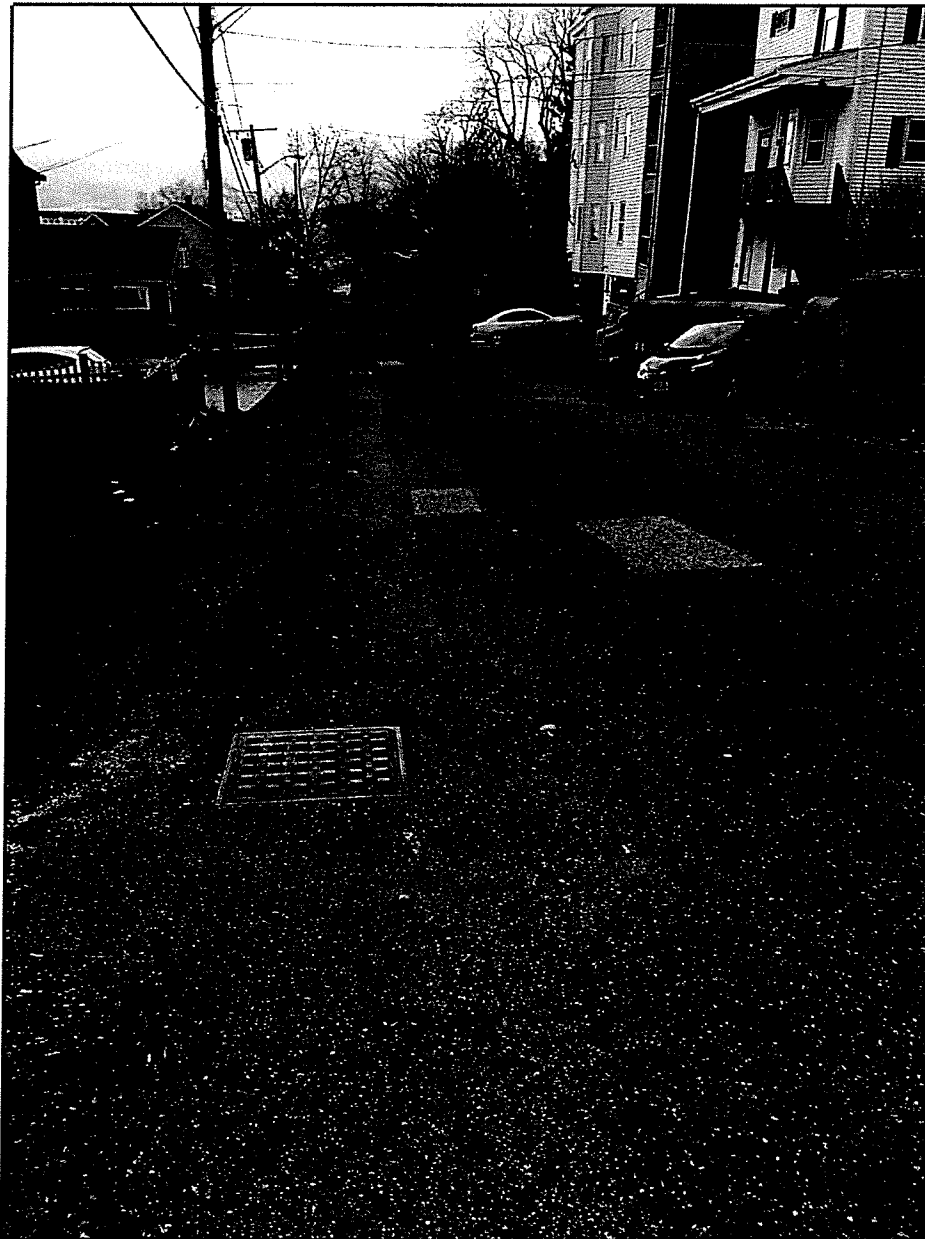
Looking west.

Another catch basin on the south side of the street that is not capturing storm water

Super elevating the road so storm water drains to the north side and installing drainage on that side of the road is a possible solution. Otherwise a formal gutter needs to be created on the south side.

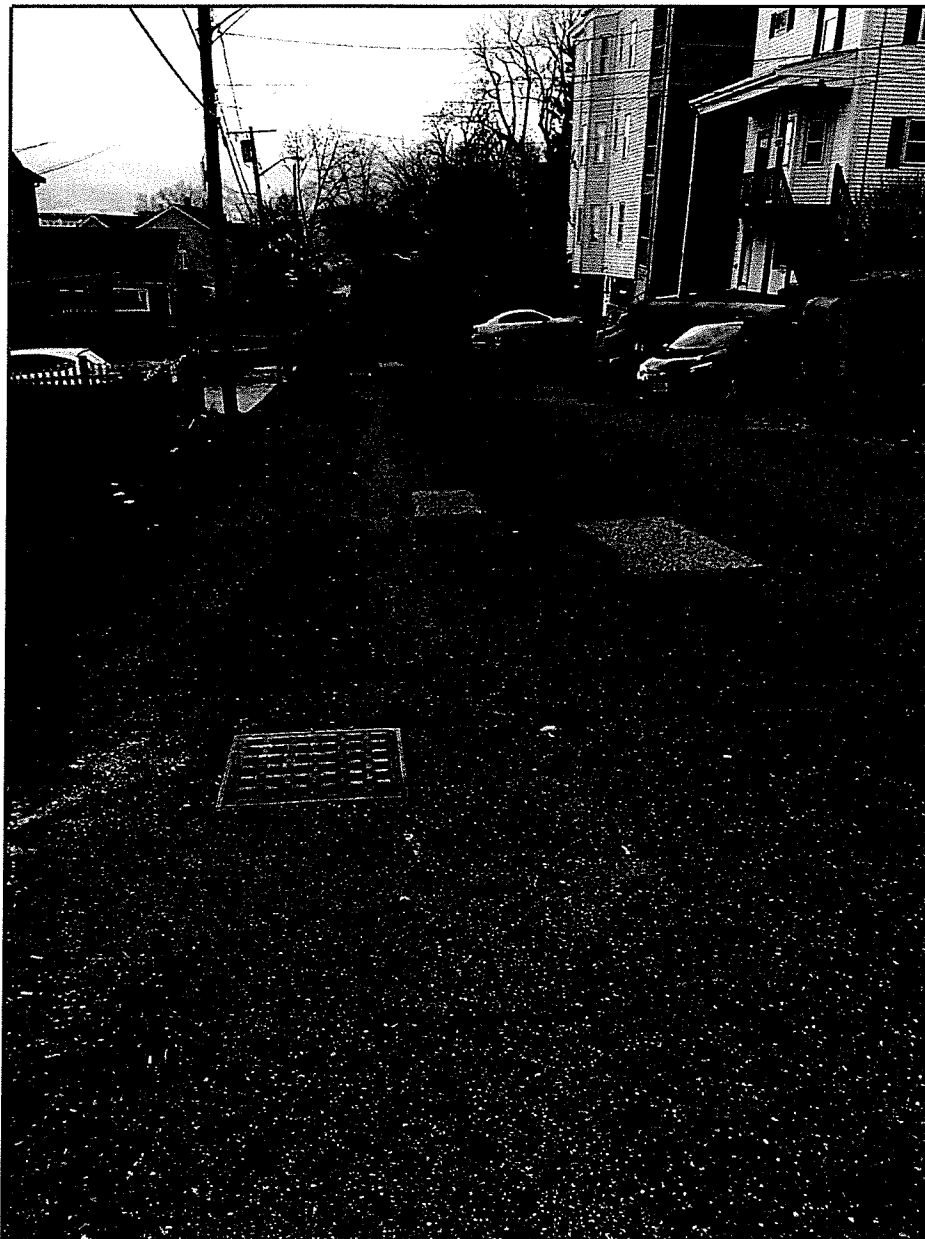
Looking west.

Another catch basin on the south side of the street that is not capturing storm water

Super elevating the road so storm water drains to the north side and installing drainage on that side of the road is a possible solution. Otherwise a formal gutter needs to be created on the south side.

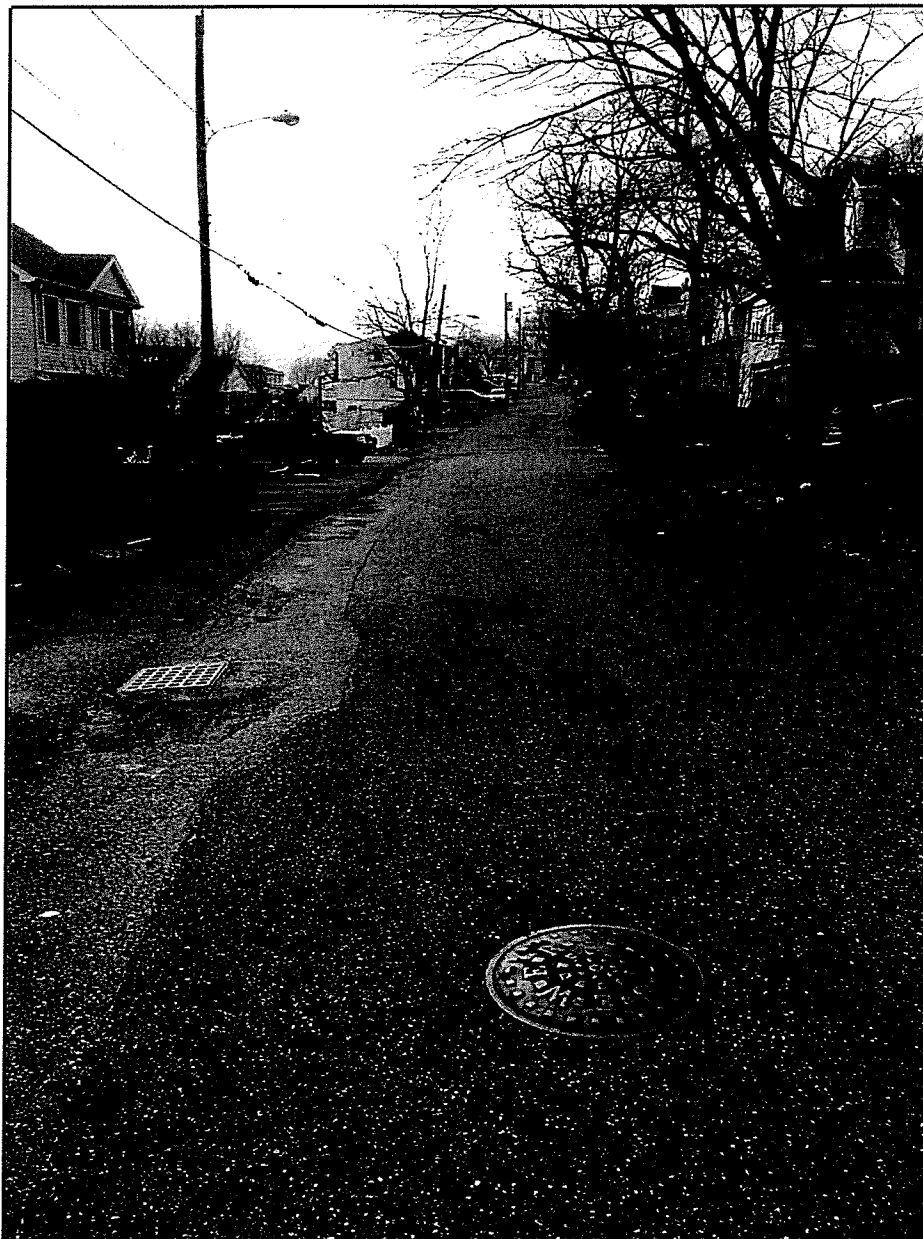
Continuing west on Pearl Ave.

Note the sediment in the gutter of the south side of the road. This is evidence of the amount of puddling that occurs and is a symptom of poor drainage function.

Visual inspection shows drain castings directly atop drain structures, thus castings can't be lowered, which is an issue.

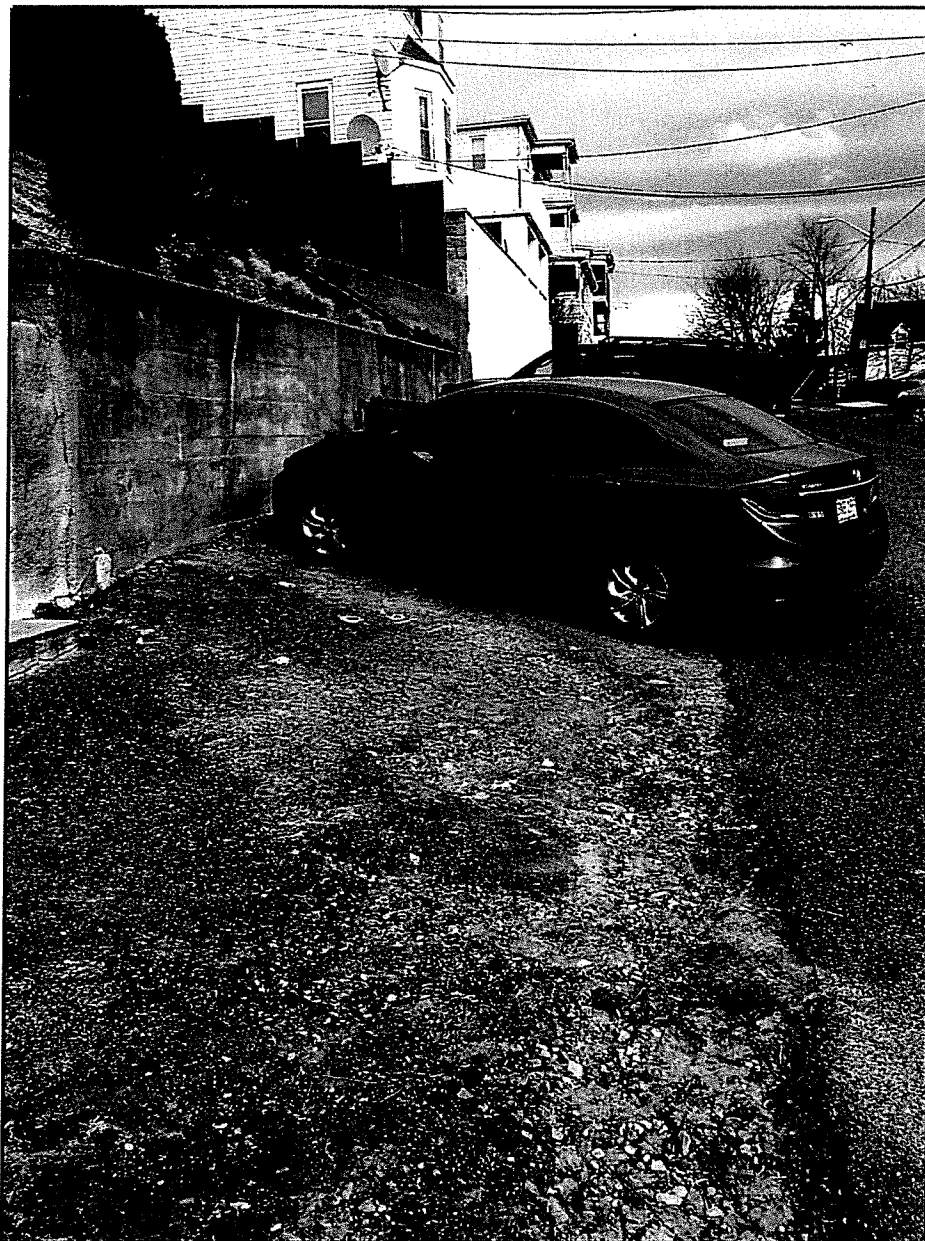
Looking back towards Summer St.

North side of the road is used as a parking area for several houses who have large retaining walls abutting the road. Location of property line is unclear. Vehicles appear to be parking such that they impede on the public right of way.

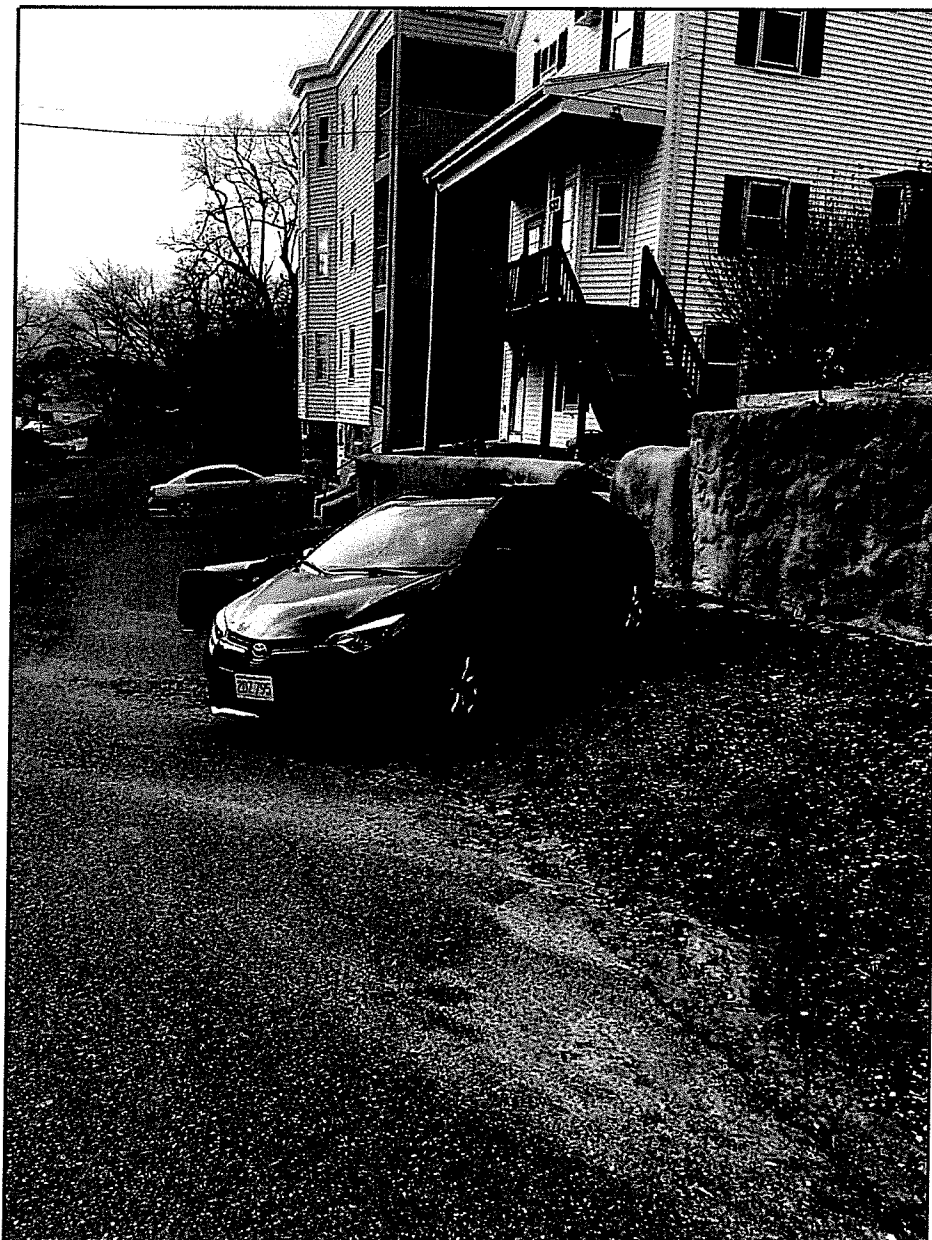
Looking west at the same walls. Note the vehicles parked here are protruding into the roadways, pedestrian access on the north side of the street in these locations is unsafe as is the general nature of how these vehicles are parked on a regular basis.

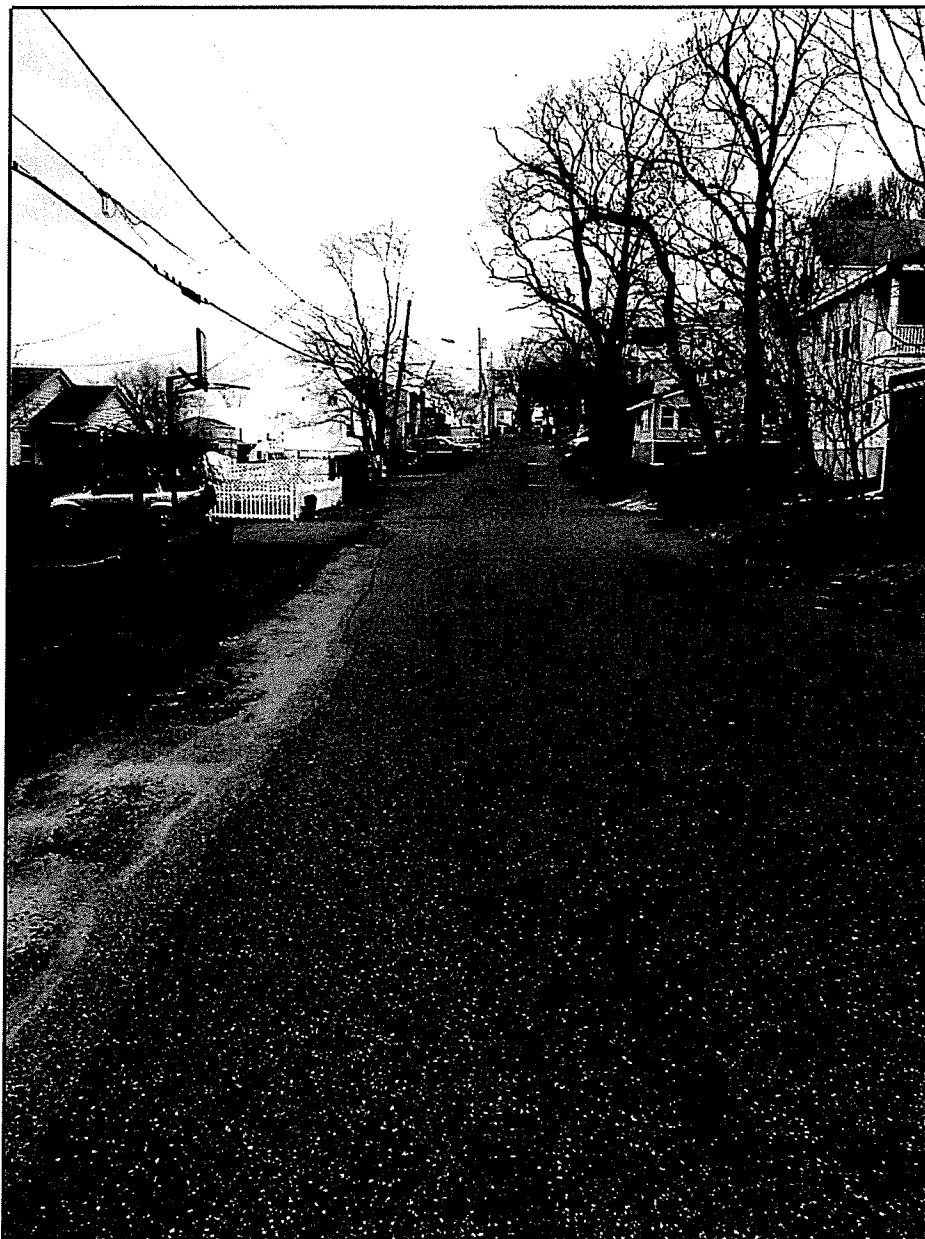
Continuing west on Pearl Ave.

Note the large extent of sediment in the south gutter. Storm water management on this portion of Pearl Ave. needs to be addressed.

Poor drainage design and the settlement of the roadway over time is an issue on this section of the street.

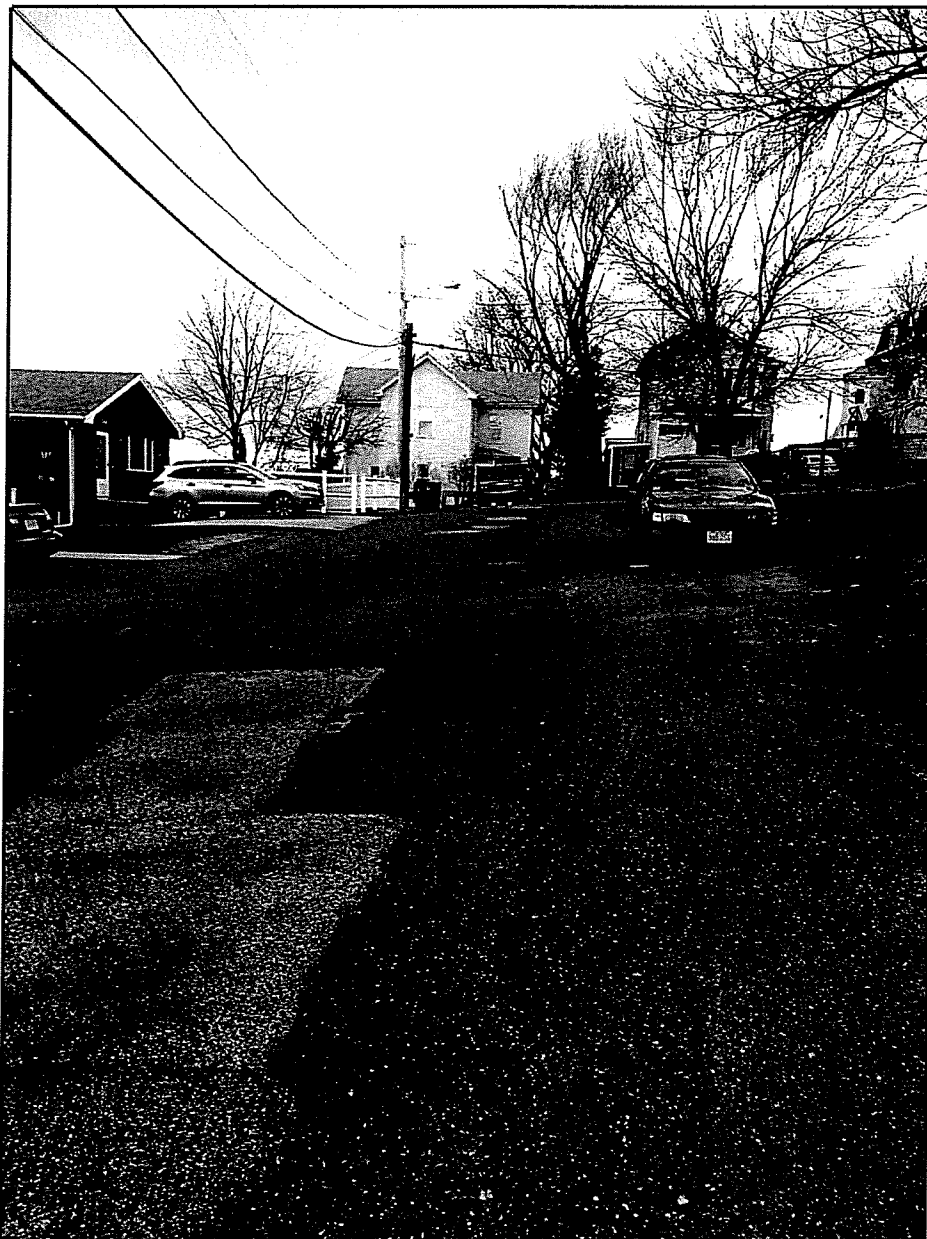
Continuing west on Pearl Ave.

Alligator cracking turning into potholes.  
Roadway in poor condition.

Entire stretch of road needs to be redesigned for  
proper storm water management.
