PHASE 2 – FEASIBILITY ANALYSIS BAYVIEW ROAD

Bay View Street

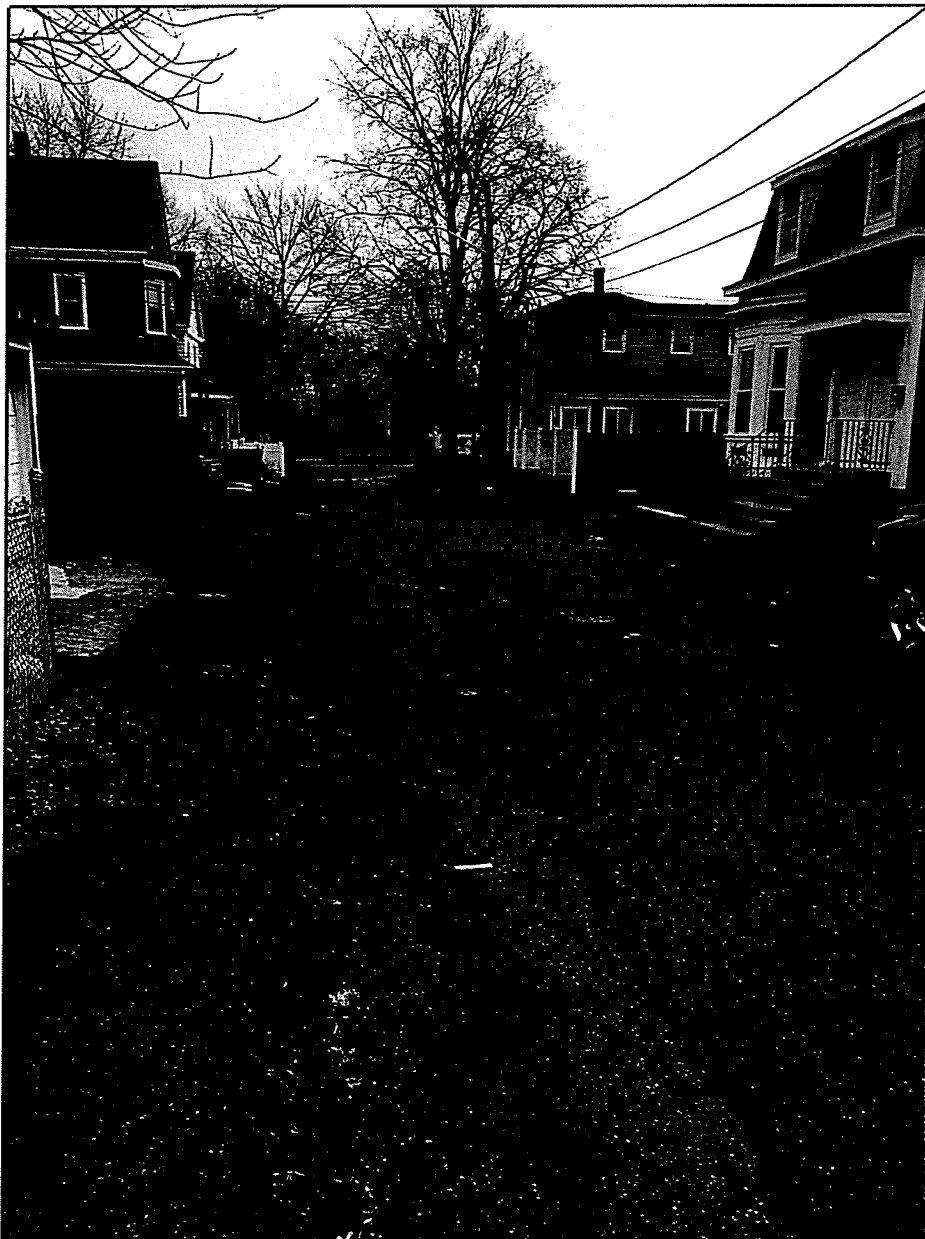
Looking towards Revere Beach Parkway

Gas trench beginning to fail.
Multiple pothole repairs shown.
Sidewalks in poor condition with no curbing.

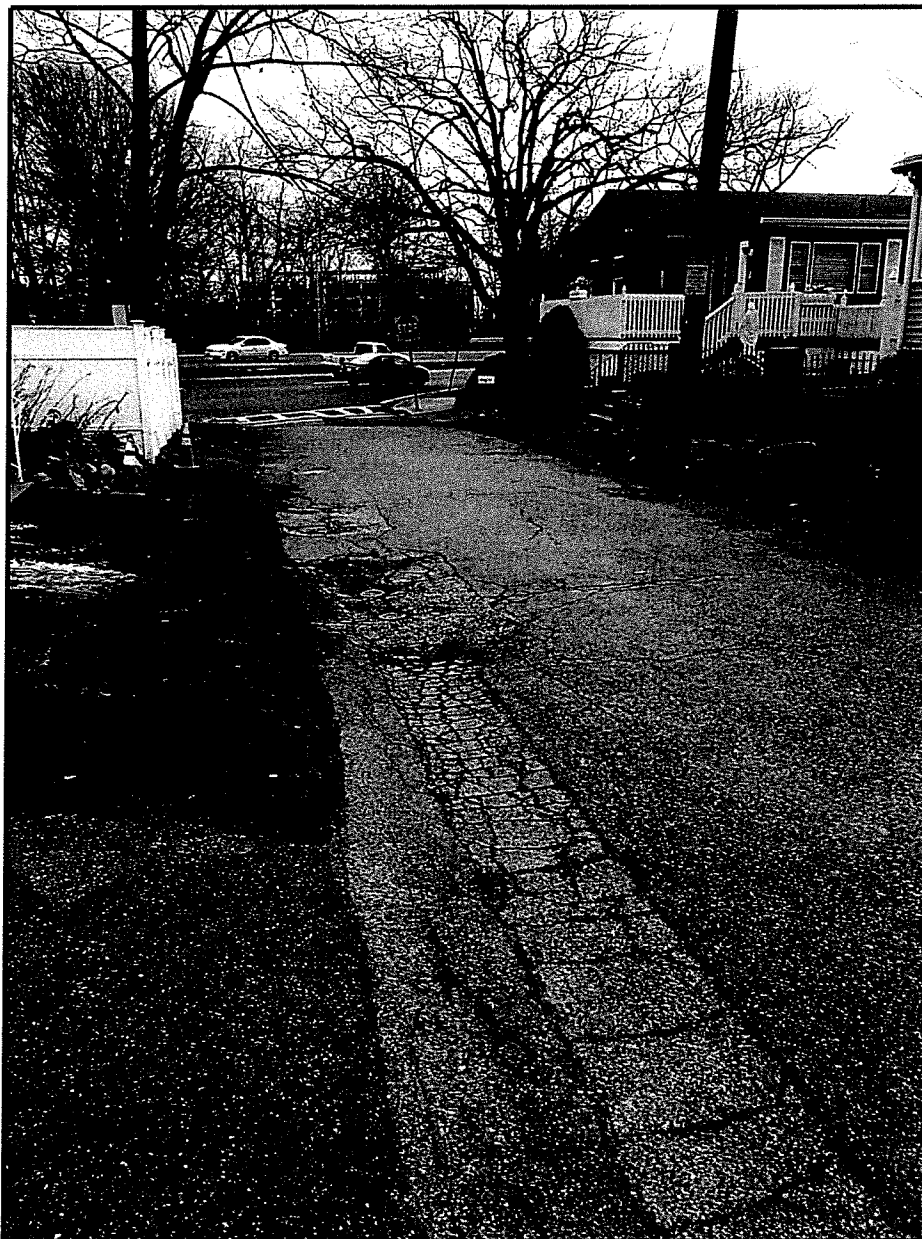
Looking towards Revere Beach Parkway.

Photo shows failing gas trench & longitudinal and transverse cracking.

Sidewalks in poor condition.

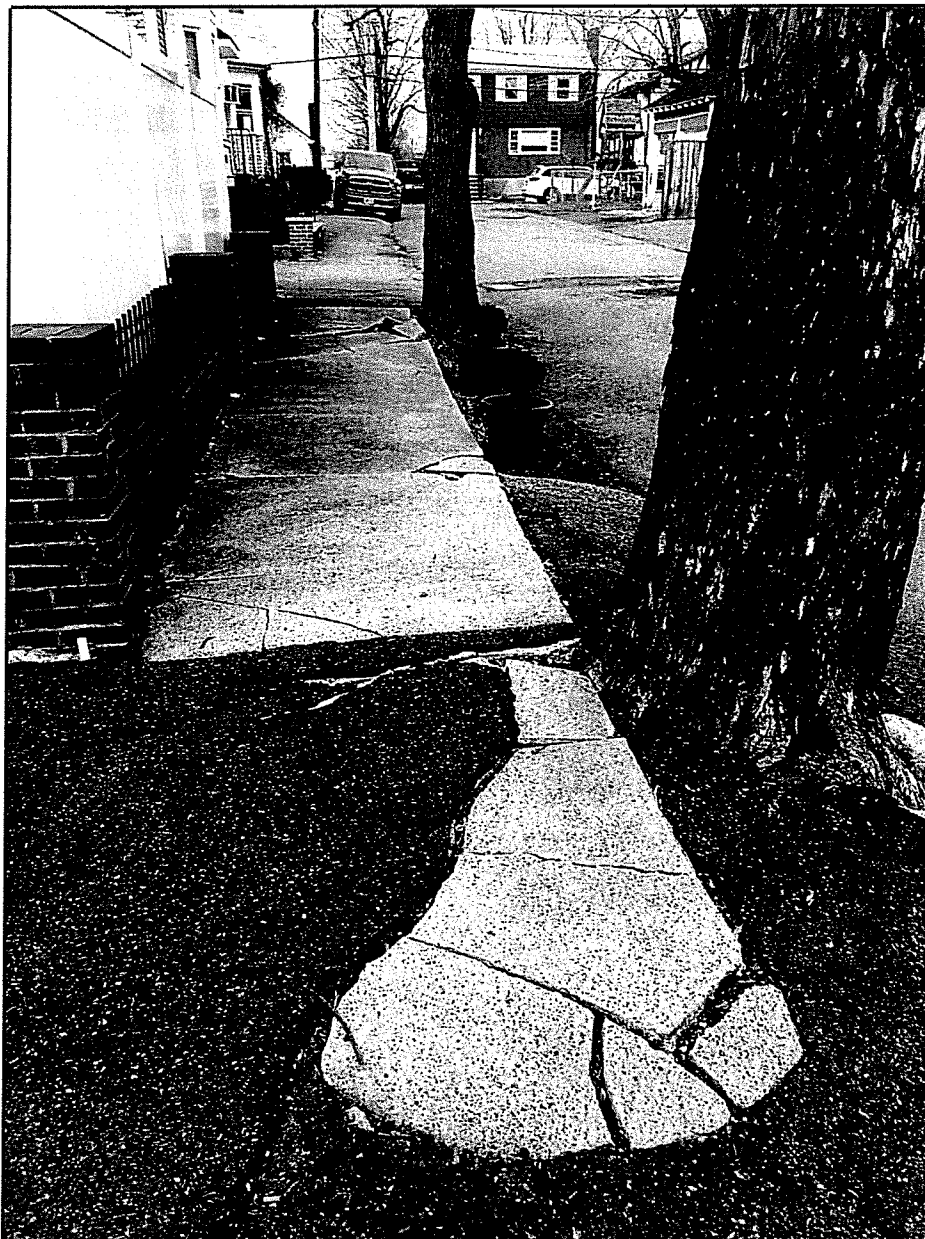
Looking towards Vinal Street

One section of broken up concrete sidewalk exists,
remaining sidewalks are asphalt, all sidewalks
need reconstruction.

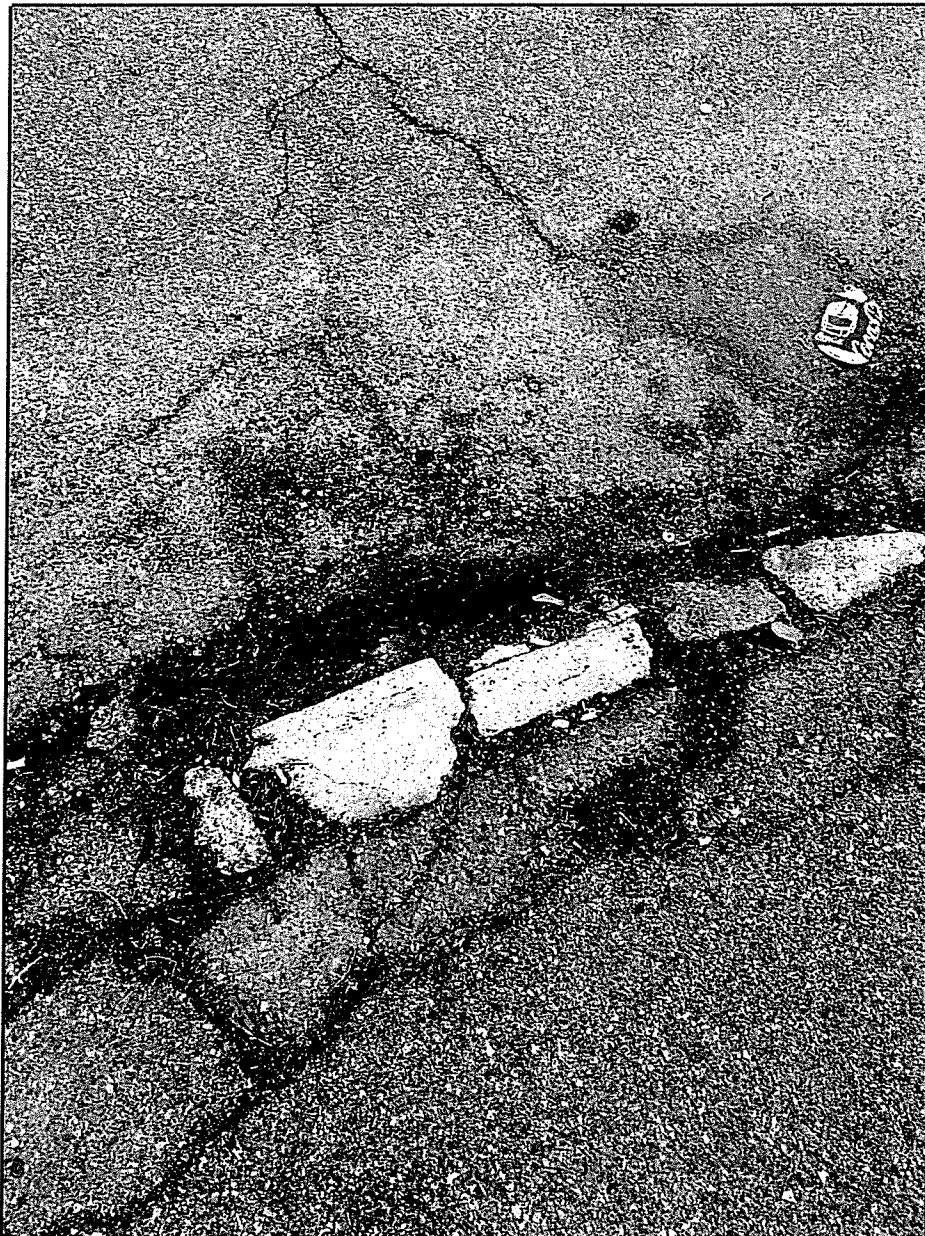
Photo highlighting cobbles at the road edge.

Extent of cobbles unknown, could come into play when resurfacing the roadway.

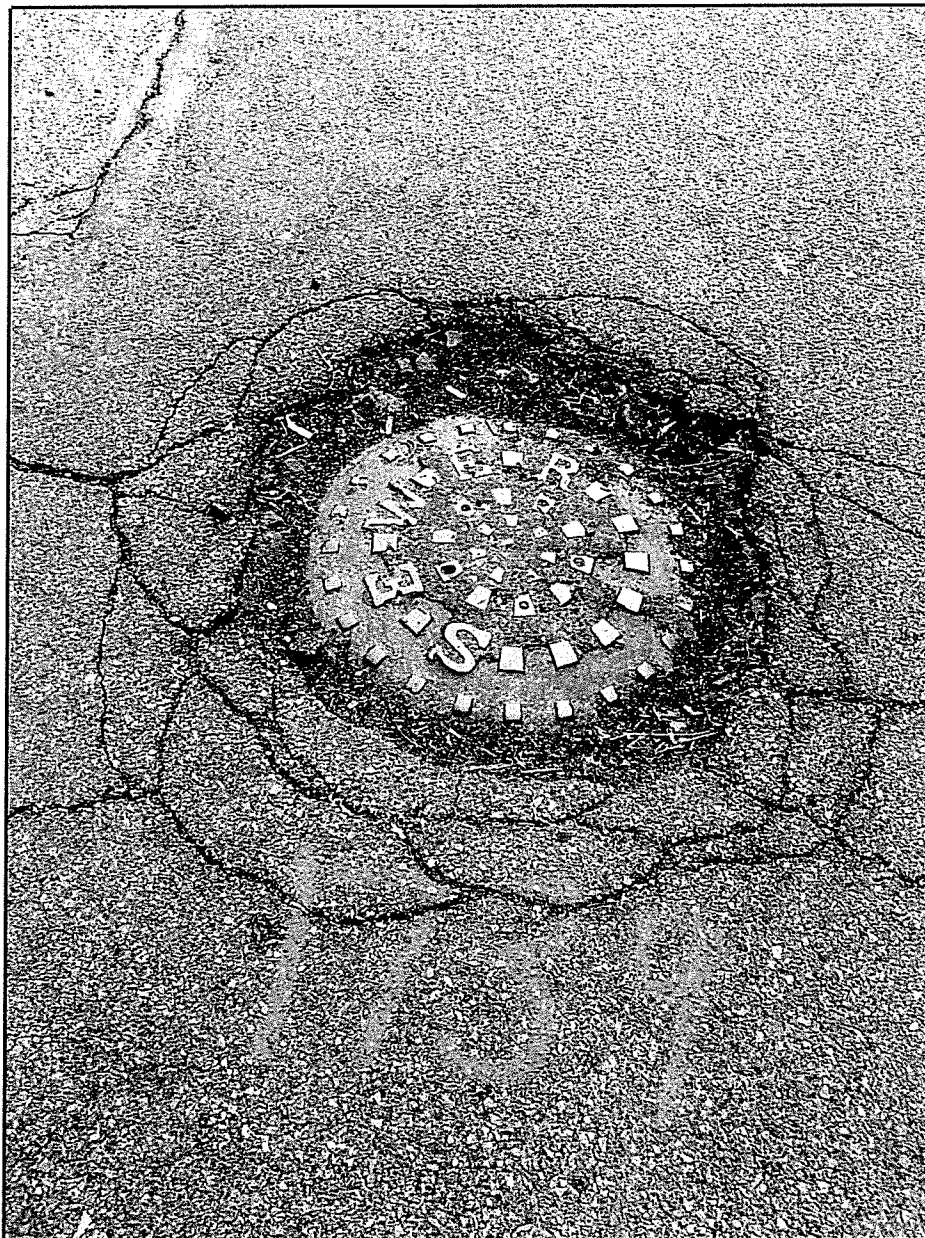
Macadam seen surround manhole cover.

Considering the visible macadam and the visible cobbles, the extent and types of materials used to construct this road are unclear.

Reclamation might not be an option depending on the extent of the cobbles.

1. Mill the roadway, put down a binder course* and apply new top.
 2. Remove existing roadway asphalt shoulders, install new asphalt shoulders
 3. Installing granite curbing is not feasible because the street is narrow and curbing would cause parking problems.
- Because macadam is evident through the roadway surface; a binder course would be required to stabilize the base of the road before putting down the top coat.
