PHASE 2 – FEASIBILITY ANALYSIS

DELANO AVENUE

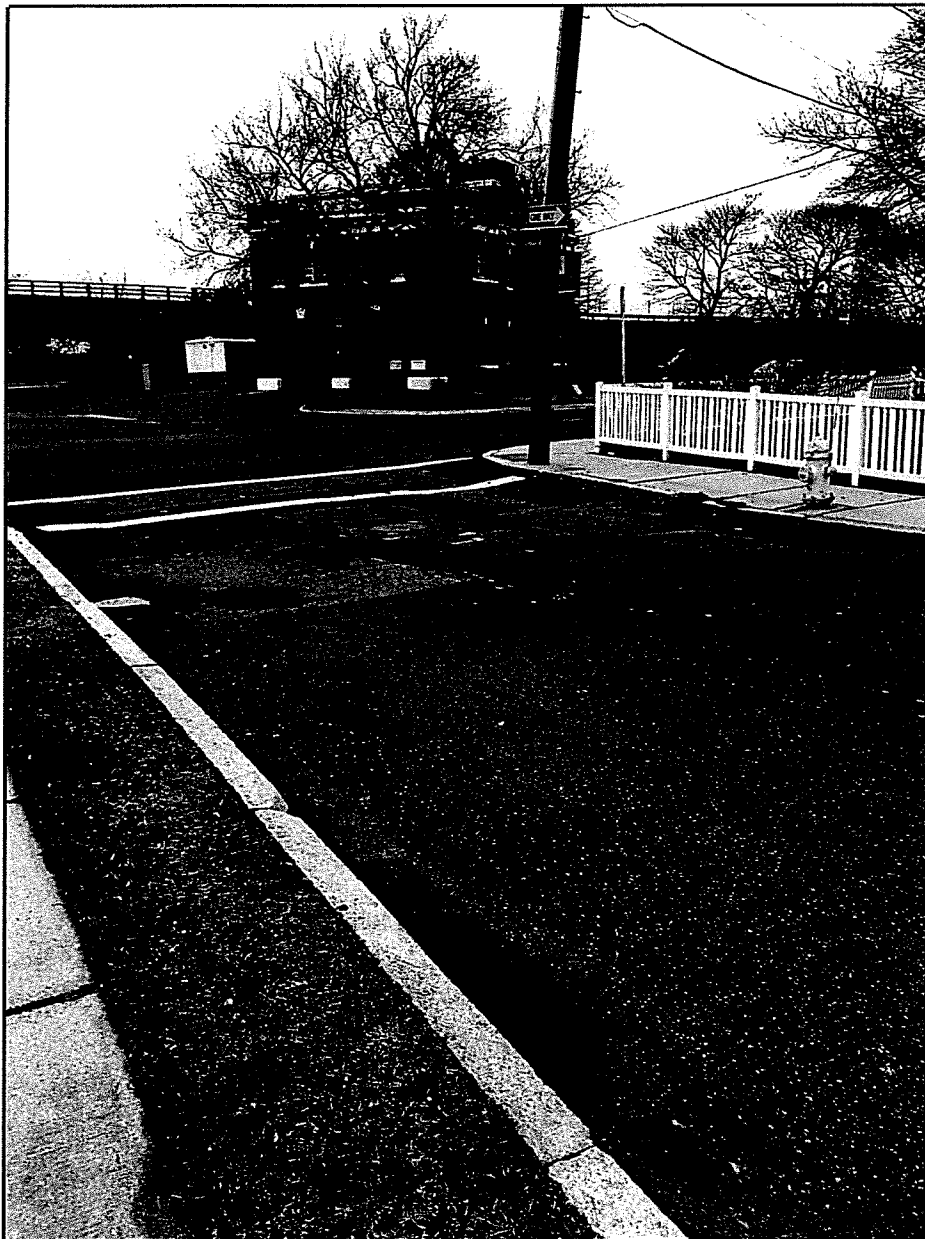
Looking towards The Lynnway

Intersection in poor condition, alligator cracking, settlement and potholes observed.

Street has granite curb and concrete sidewalks.

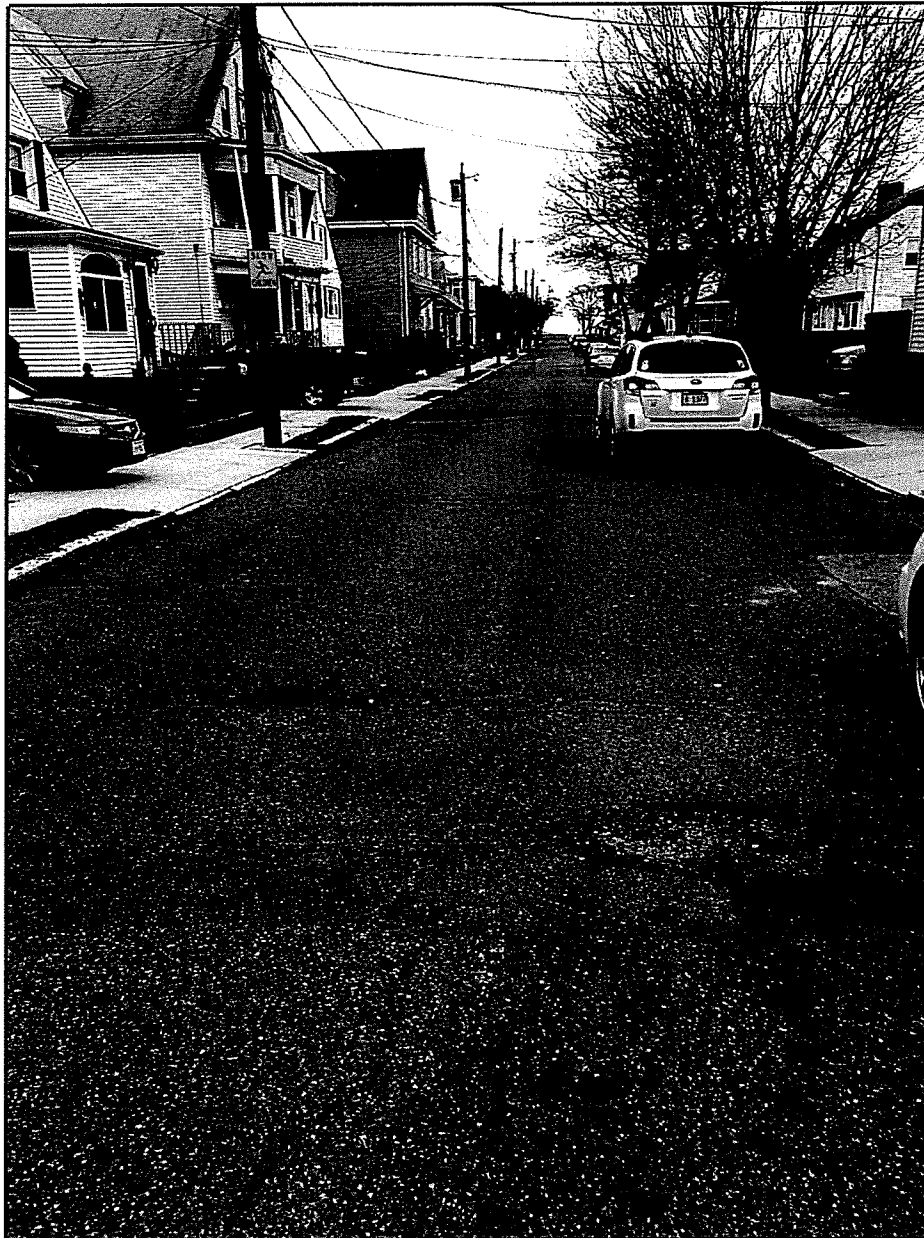
Heading southeast towards Rice Ave.

Curbing showing rolling and settlement, but concrete sidewalks are in good overall condition.

Roadway is not as bad as The Lynnway intersection, but does show alligator cracking and potholes / pothole repairs.

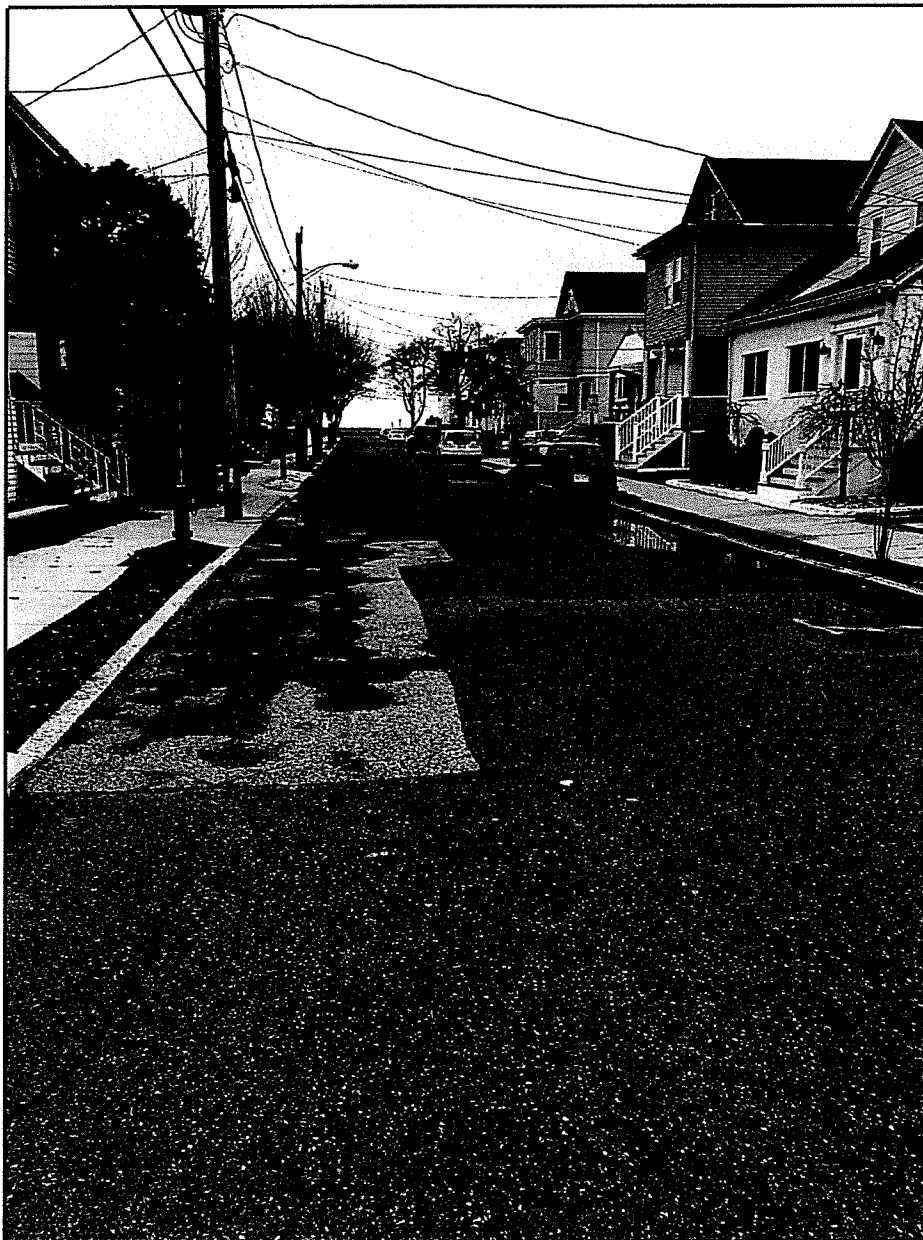
Continuing towards Rice Ave.

Large patch shown in good condition.
Moderate cracking, but failure of road not imminent.

Puddle shown likely due to settlement.

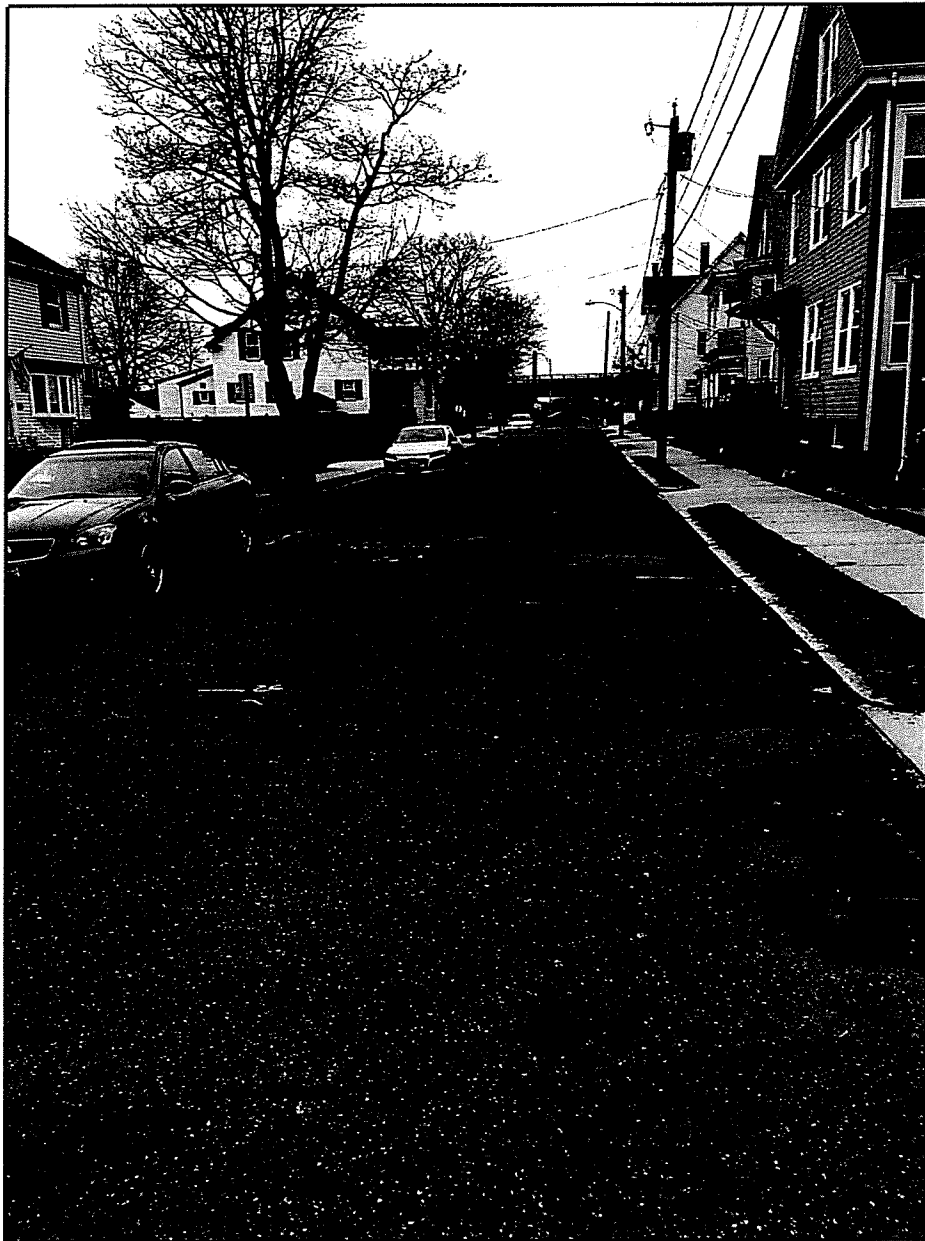
Closer to Rice Ave, looking back towards The Lynnway.
Alligator cracking and settlement turning into potholes.

Pothole repairs present in several locations.

Curb and sidewalk in good condition.

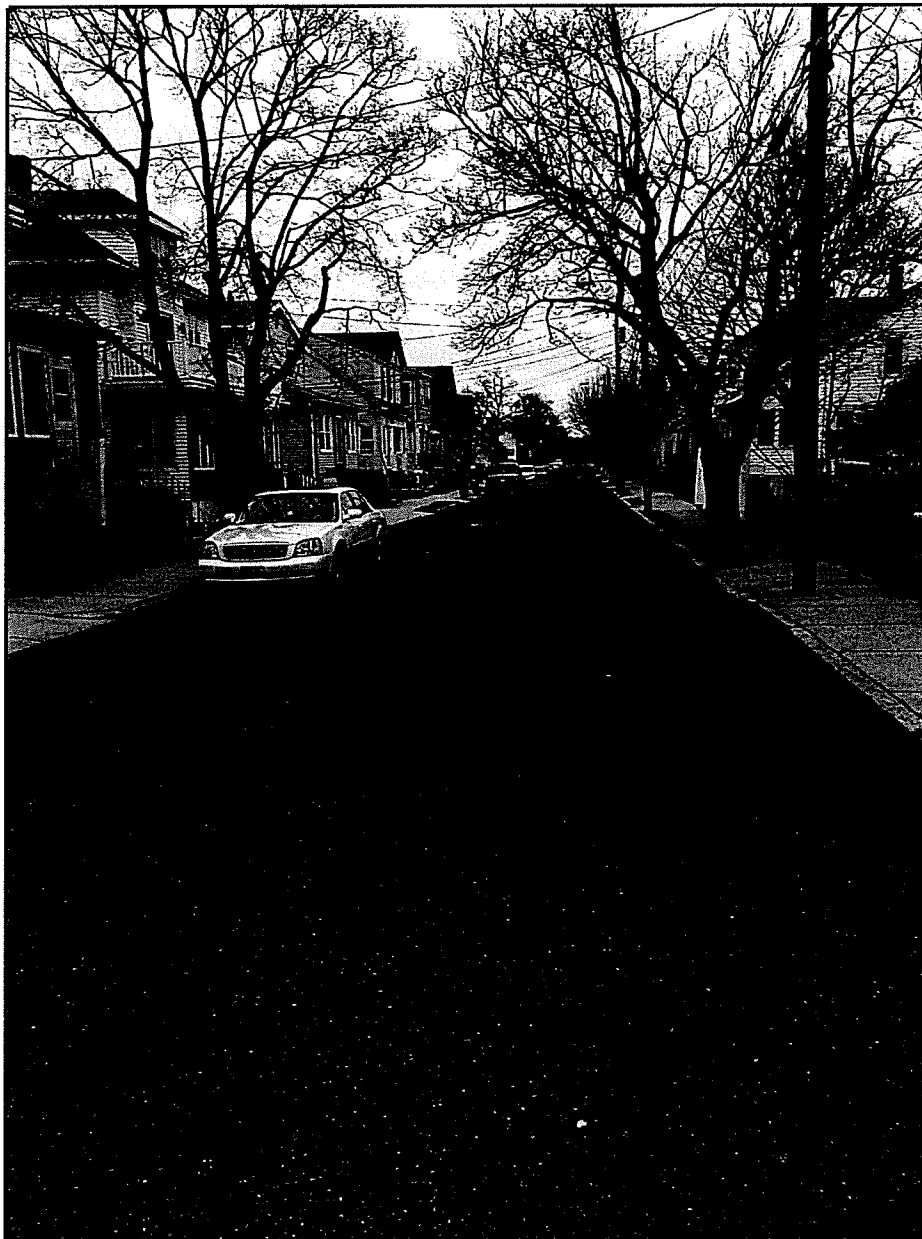
Closer to Rice Ave, looking back towards The Lynnway.
Longitudinal and transverse cracks are beginning to turn
to alligator cracks.

Pothole repairs present in several locations.

Curb and sidewalk in good condition.

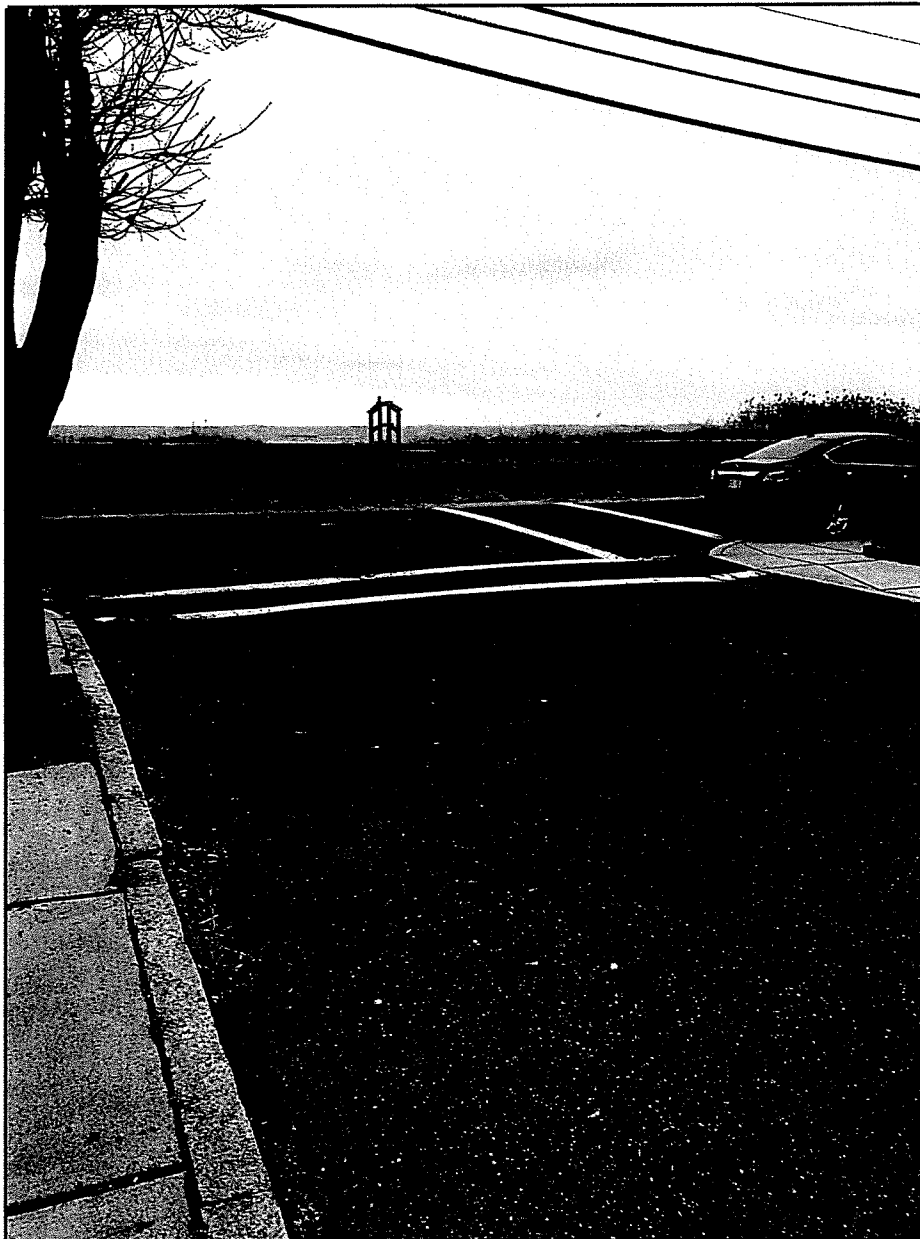
Rice Ave. Intersection

Longitudinal and transverse cracks are beginning to turn to alligator cracks.

Curb and sidewalk in good condition.
