PHASE 1 - FEASIBILITY ANALYSIS

Dedham Street

(Park Ave. to Mountain Ave.)

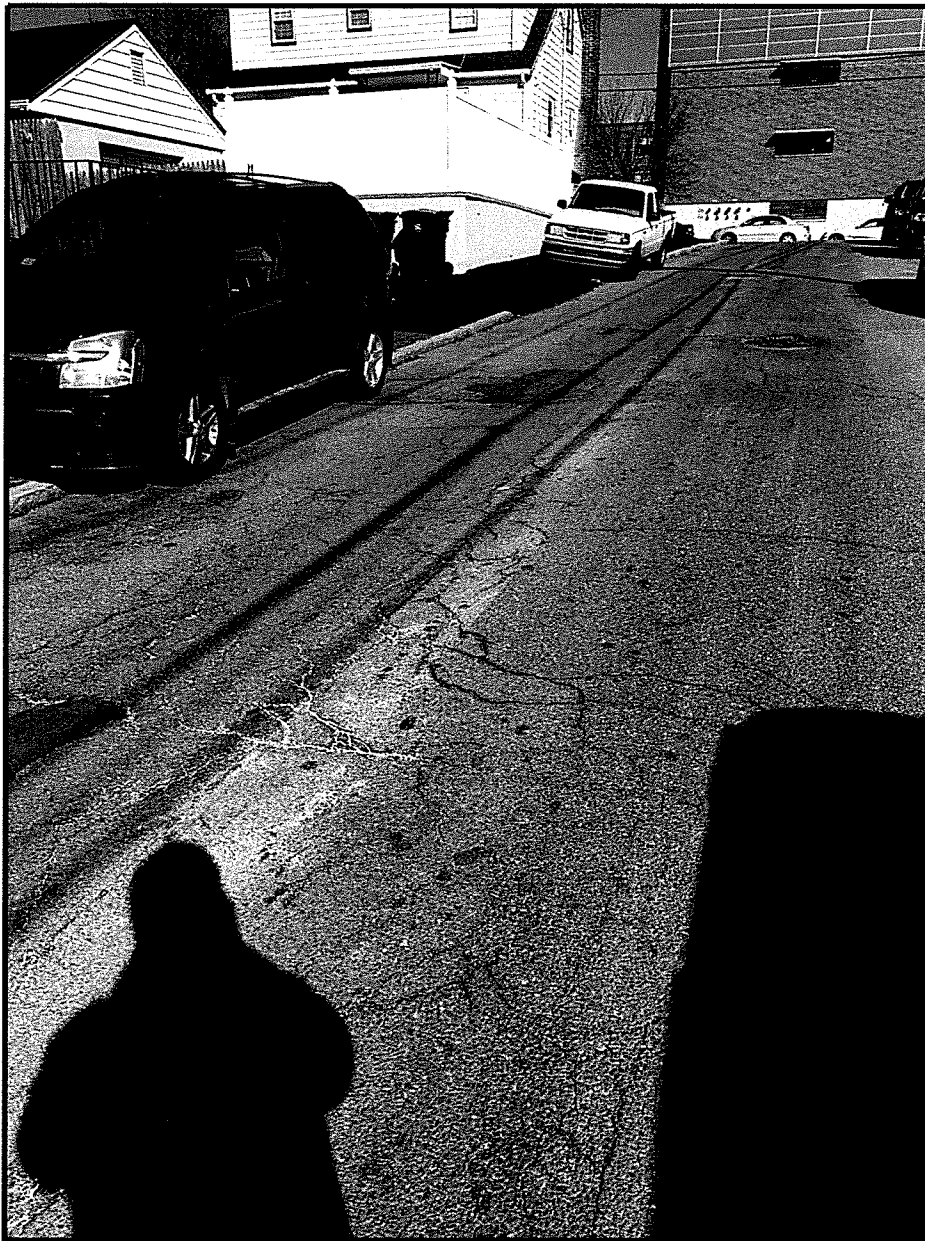
Mid-Block looking north towards Mountain Ave.

Photo shows alligator cracking of street
and vehicles parked on sidewalk

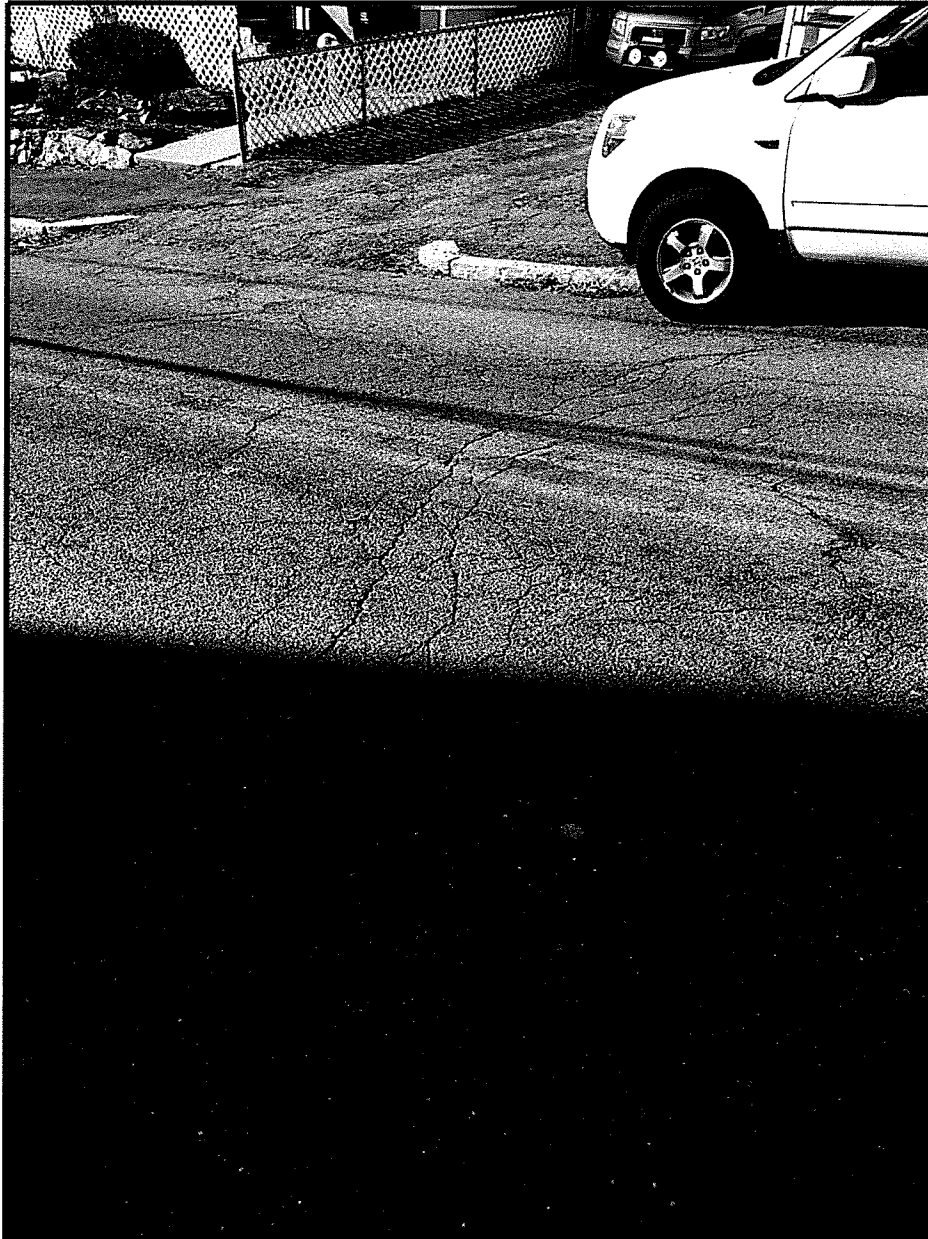
Extensive alligator cracking and differential settlement is observed on the street, note photos 2, 3 and 5, all showing alligator cracking and settlement within different areas. Photo 4 shows multiple pothole repairs where the alligator cracking has broken up. Differential settlement is observed along the majority of the road which questions the condition of the road base as a whole. Exposed macadam road base was observed in one location, see photo 7, in other locations pothole repairs have capped the macadam in place.

Photo shows typical alligator cracking of roadway and mediocre condition of sidewalks, curb and driveway aprons

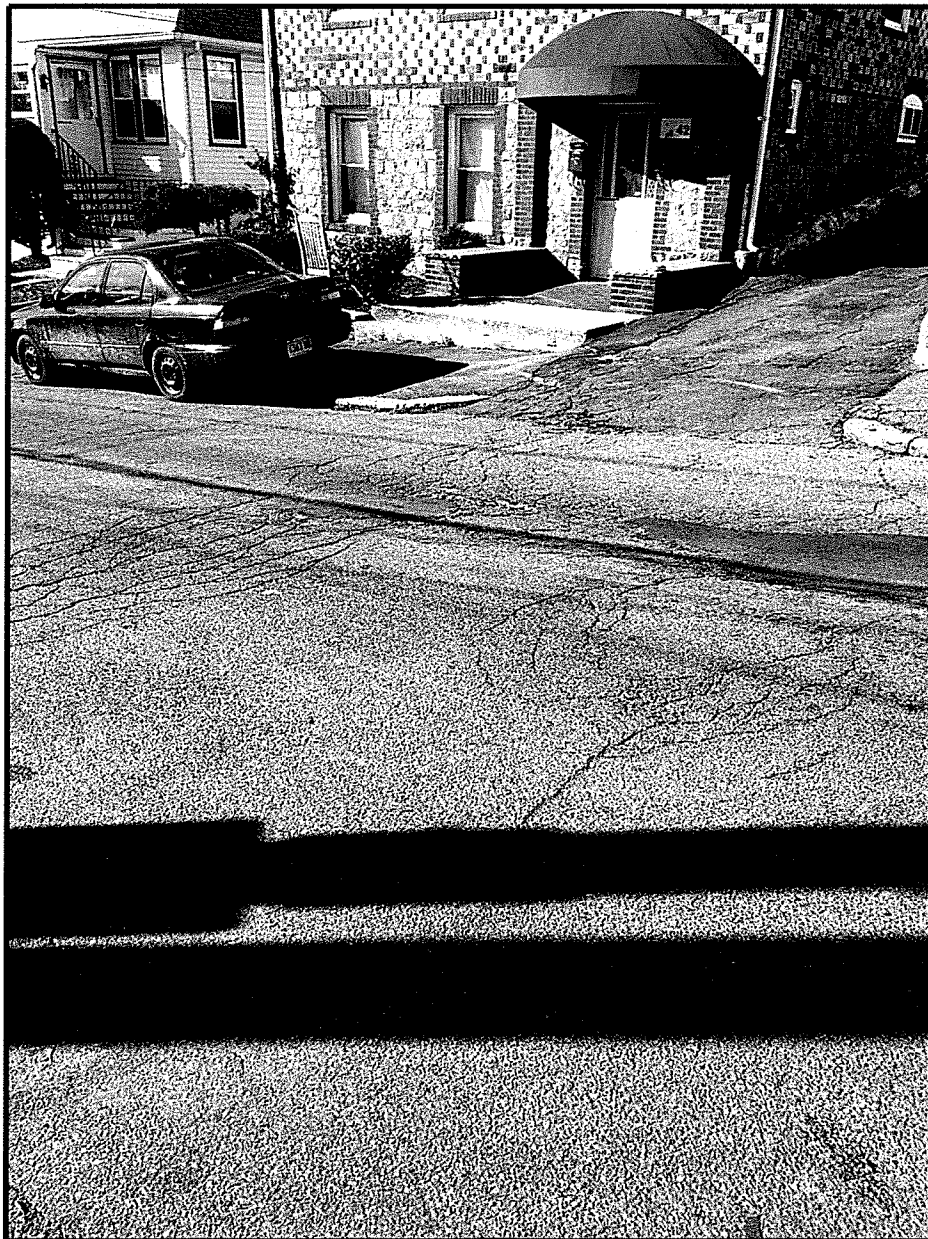
Photo showing typical alligator cracking and differential settlement, evidence of a failed road base is apparent.

Driveway aprons breaking up and in poor condition.

Curbing has settled and has minimal reveal.

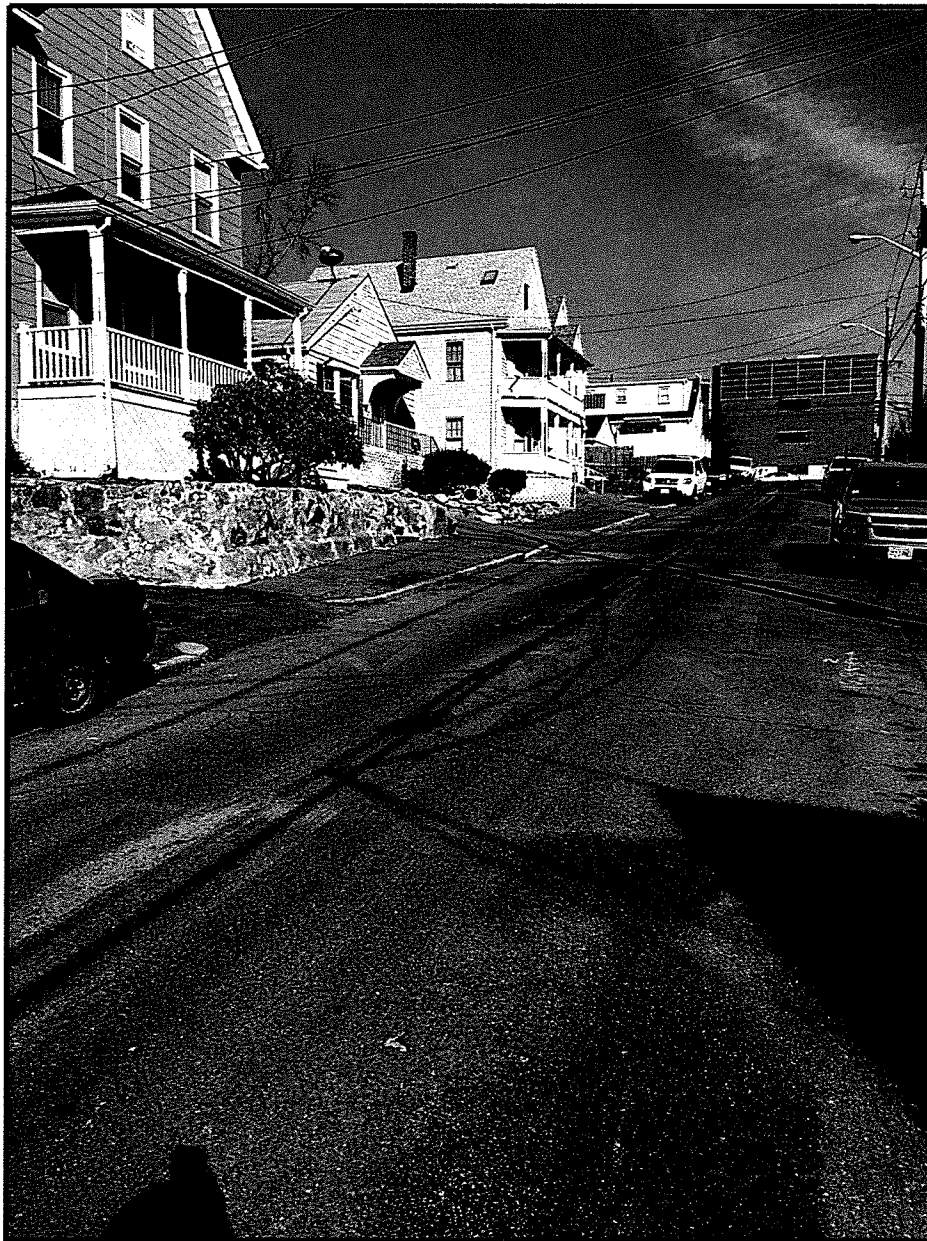
Mid-Block looking north towards Mountain Ave.

Photo shows settlement of sections of curbing and pothole repairs of roadway surface.

Typical cracking of roadway shown.

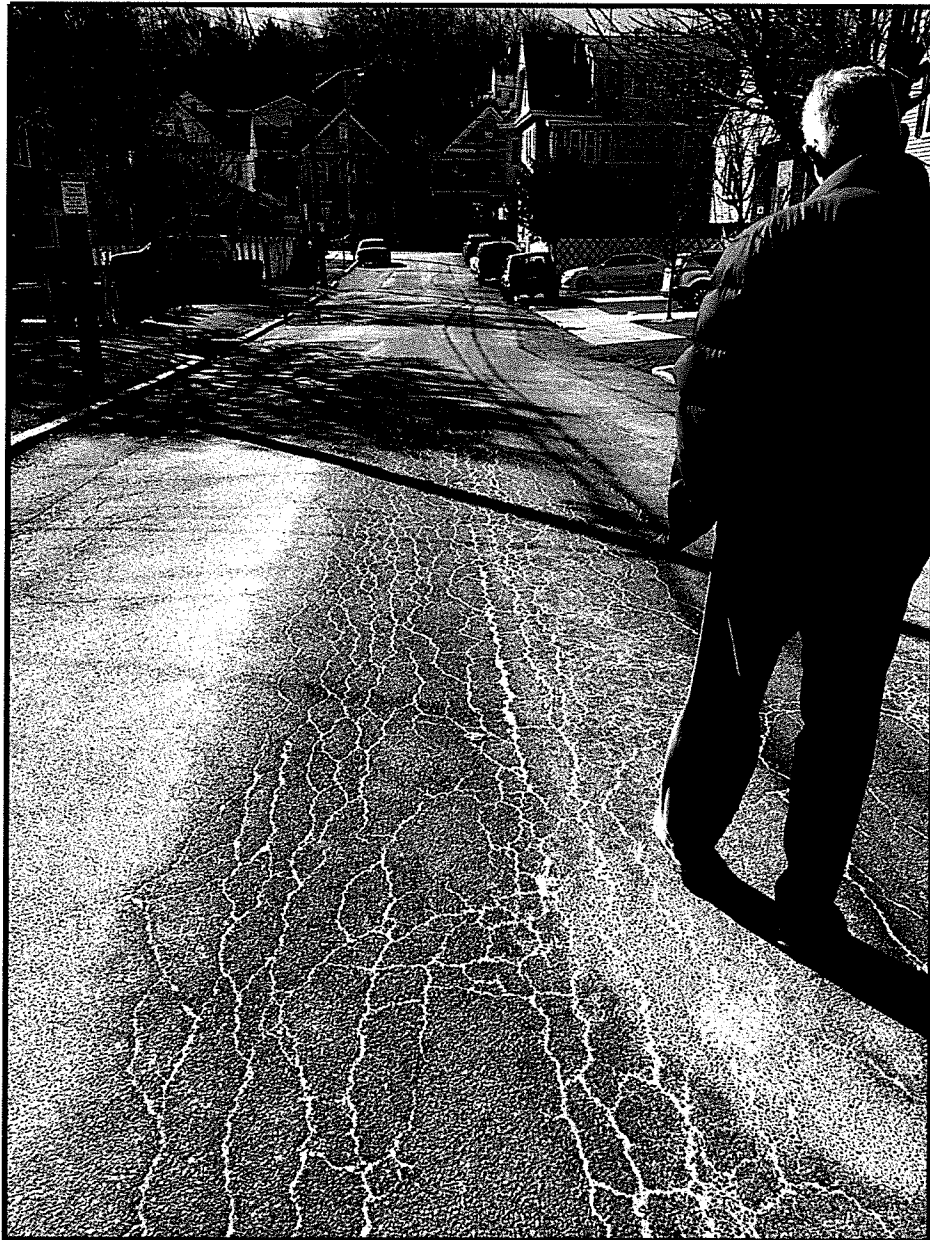
Mid-Block looking south towards Park Ave.

Photo shows extensive alligator cracking
(highlighted by salt within cracks)

Pavement failing and will begin to fall apart
in coming years. Failures beyond preservation
methods. Condition of base questioned.

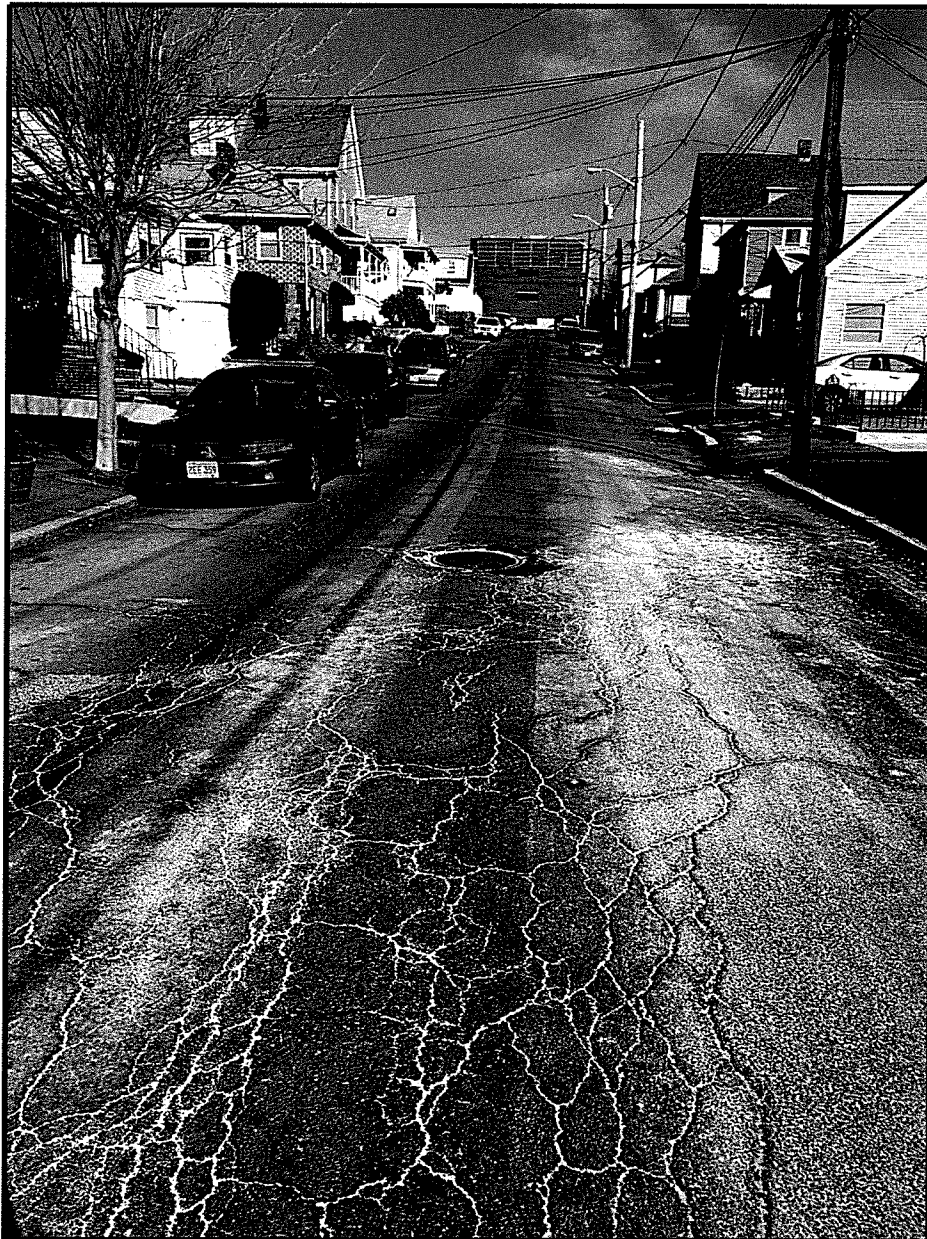
Looking north towards Mountain Ave.

Extensive alligator cracking and settlement observed.

Alligator cracking will continue and pothole repairs will become necessary in the near future.

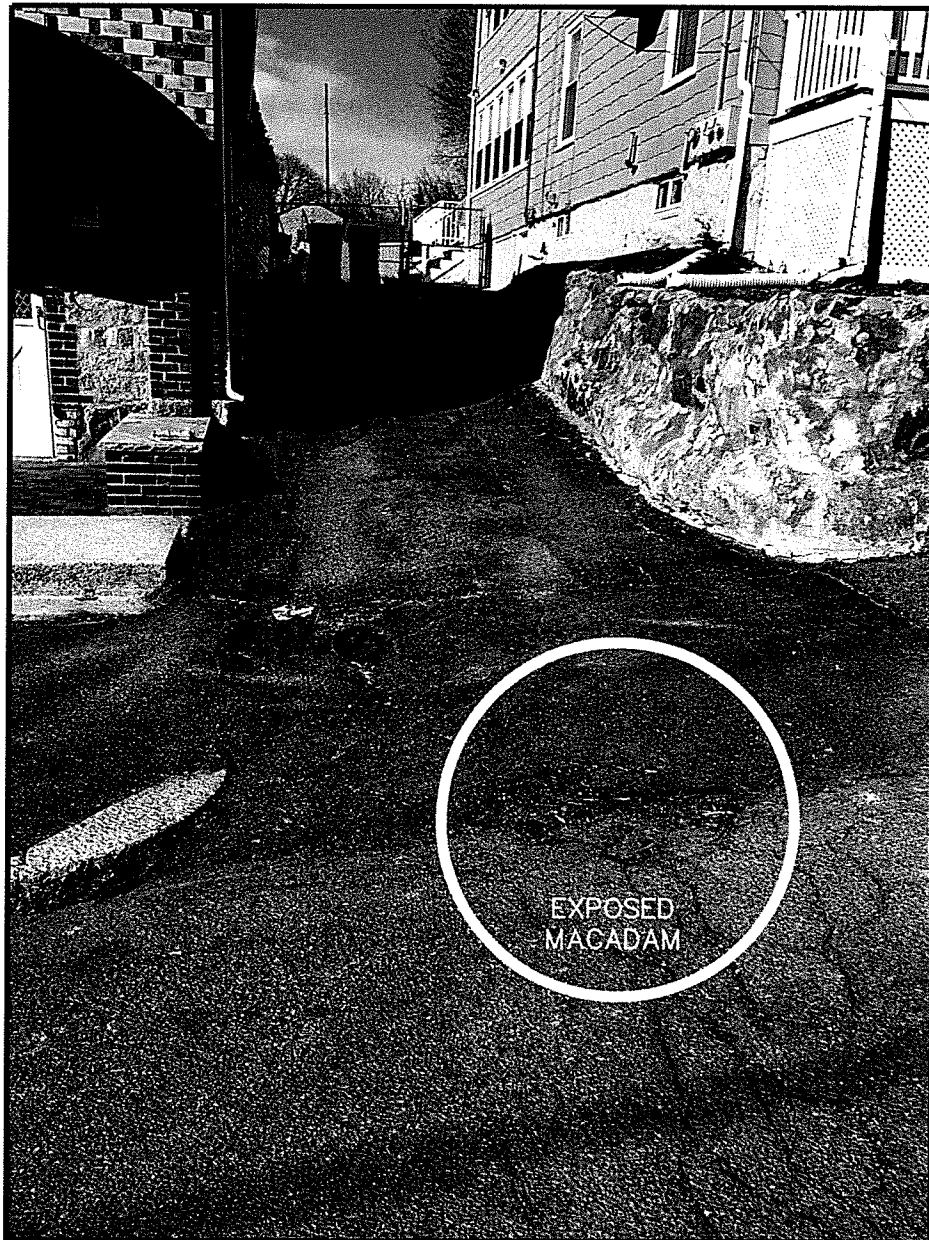
Photo shows condition of road and driveway.

Note exposed macadam (road base).
Milling of road will take road surface
down to the macadam base.
If road is milled, binder and wearing
course should be applied.

Extensive evidence of this condition indicates
roadway reclamation is warranted.

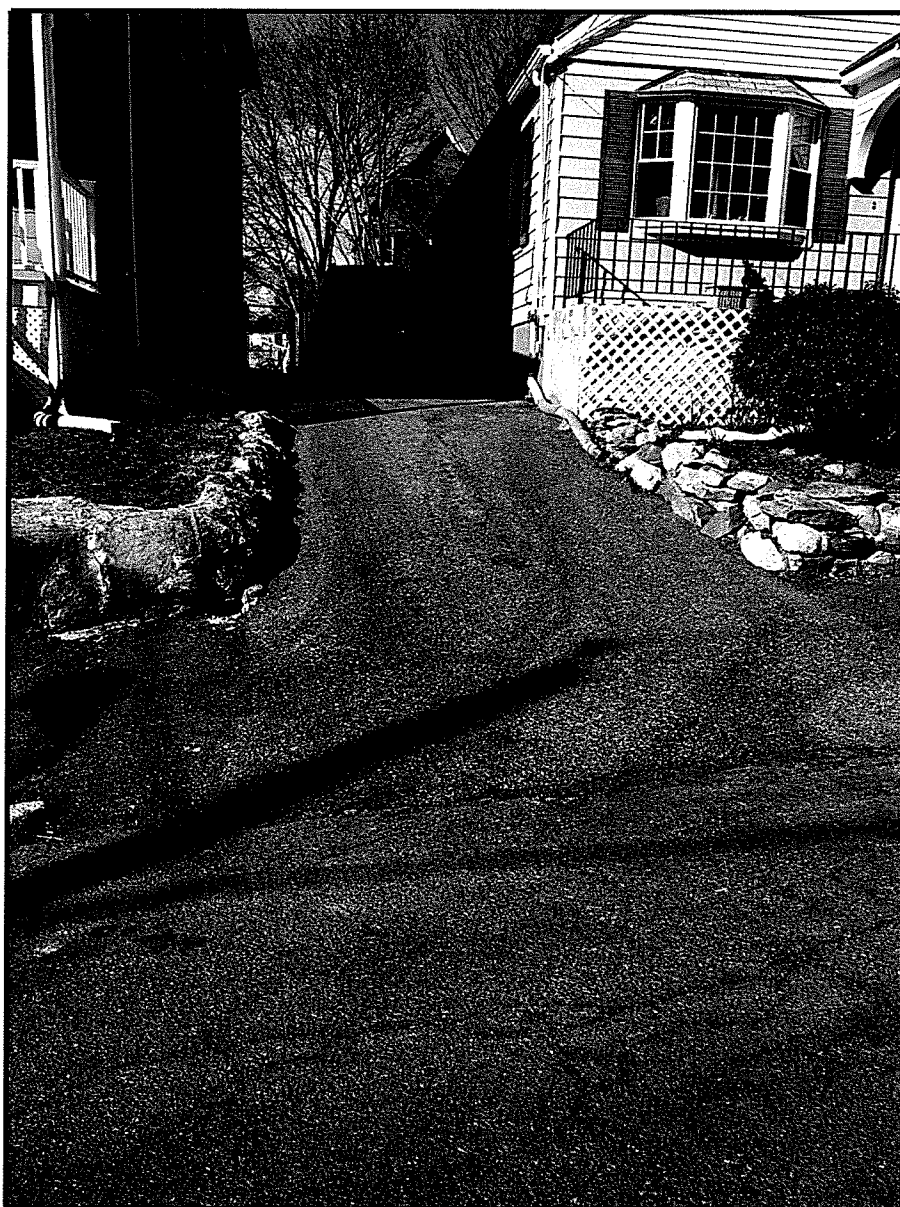
Photo showing slope of driveway continuing to roadway surface. Cross slopes of existing sidewalks in areas such as this do not meet ADA cross slope requirements.

Bringing walks into ADA compliance may required dropping grade at the backs of effected sidewalks thus exposing the bottoms of retaining walls shown. Raising curb to full 6" reveal alleviates this, but does not eliminate the issue.

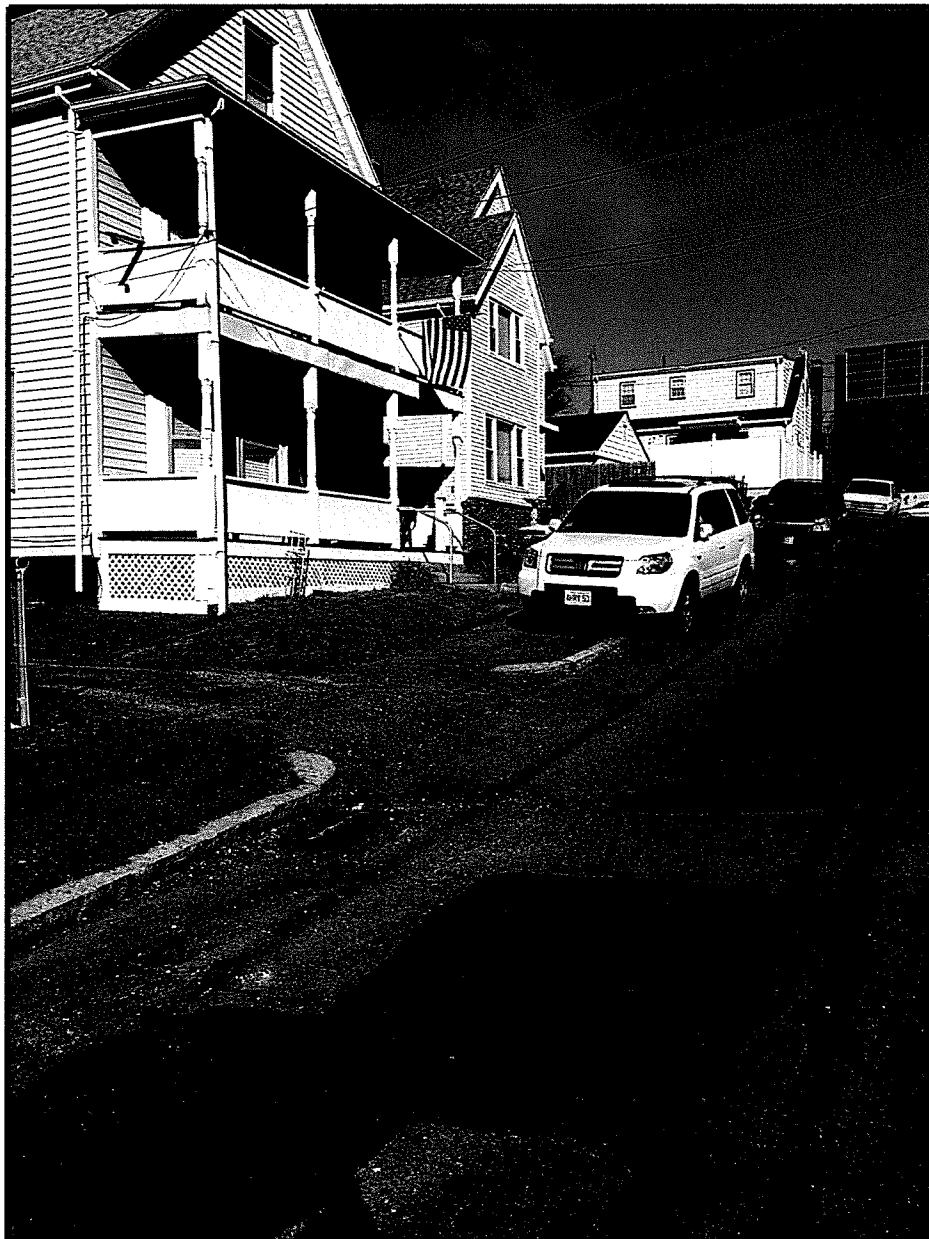
Photo looking north towards Mountain Ave.

Shows vehicles parked on sidewalks and poor condition of driveway apron & unpaved driveway on private property.

Pothole repairs shown, catch basin shown requires adjustment, possibly needs to be re-built.
