PHASE 2 – FEASIBILITY ANALYSIS

BARRETT STREET

(PARK AVENUE TO MOUNTAIN AVENUE)

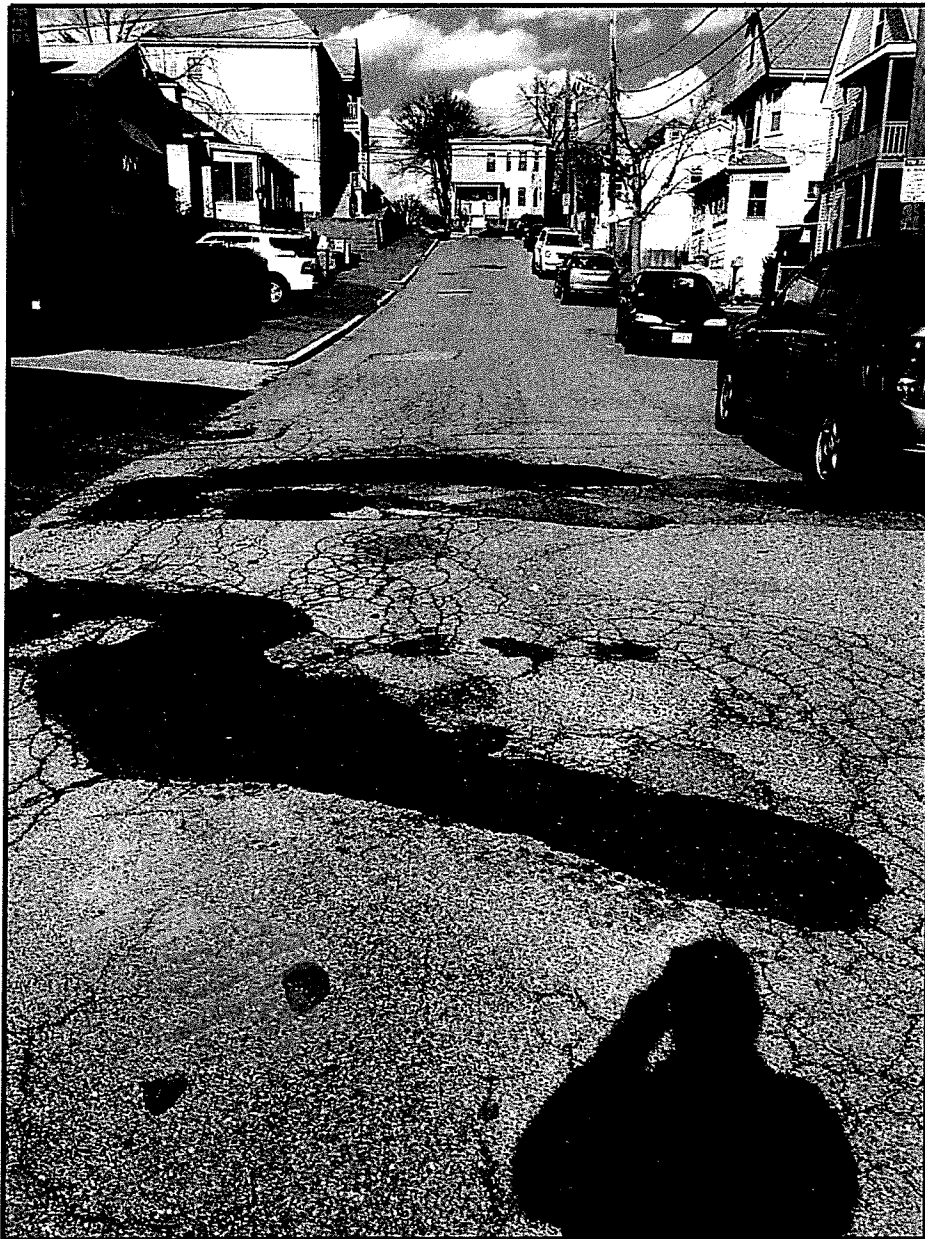
Barrett Street

The pavement suffers from extensive alligator cracking as seen in attached photos. The sub surface condition of the roadway is questionable as macadam is exposed at potholes and must be addressed.

Typical condition of roadway, similar to other side streets between Park Ave. and Mountain Ave.

Extensive cracking, settlement and pothole repairs.

1. Mill roadway, put down a binder course, apply new top coat.
2. Remove and re-set curbing.
3. Remove existing asphalt sidewalks.
4. Install new concrete sidewalks.

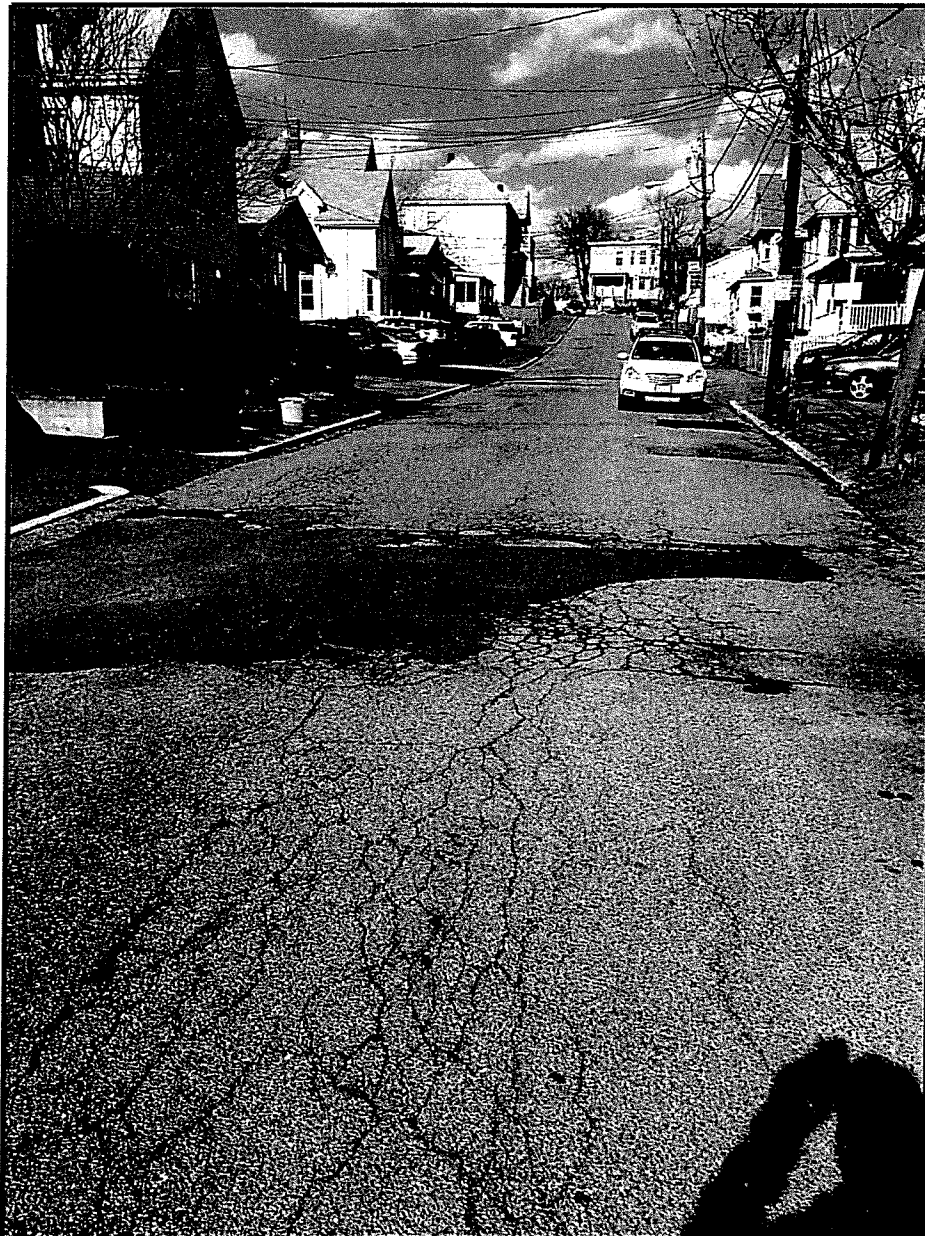
Barrett Street

Typical condition of roadway, similar to other side streets between Park Ave. and Mountain Ave.

Extensive cracking, settlement and pothole repairs.

Hydrant installed 12/2015

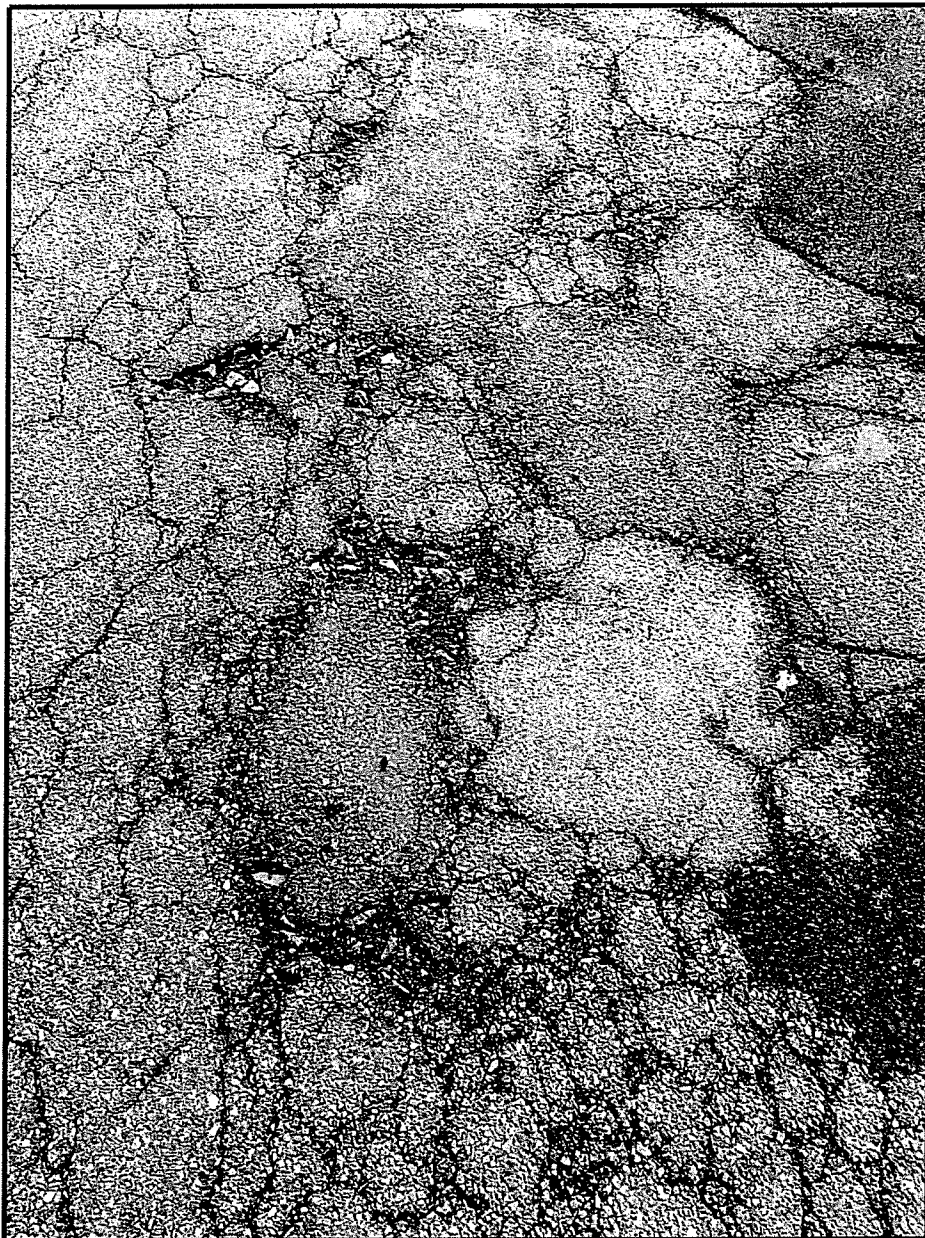
Barrett Street

Photo highlighting exposed macadam road base at potholes.

If road is milled, binder and top course should be applied. More information necessary to determine if this and similar streets, are suitable for reclamation over milling and paving.

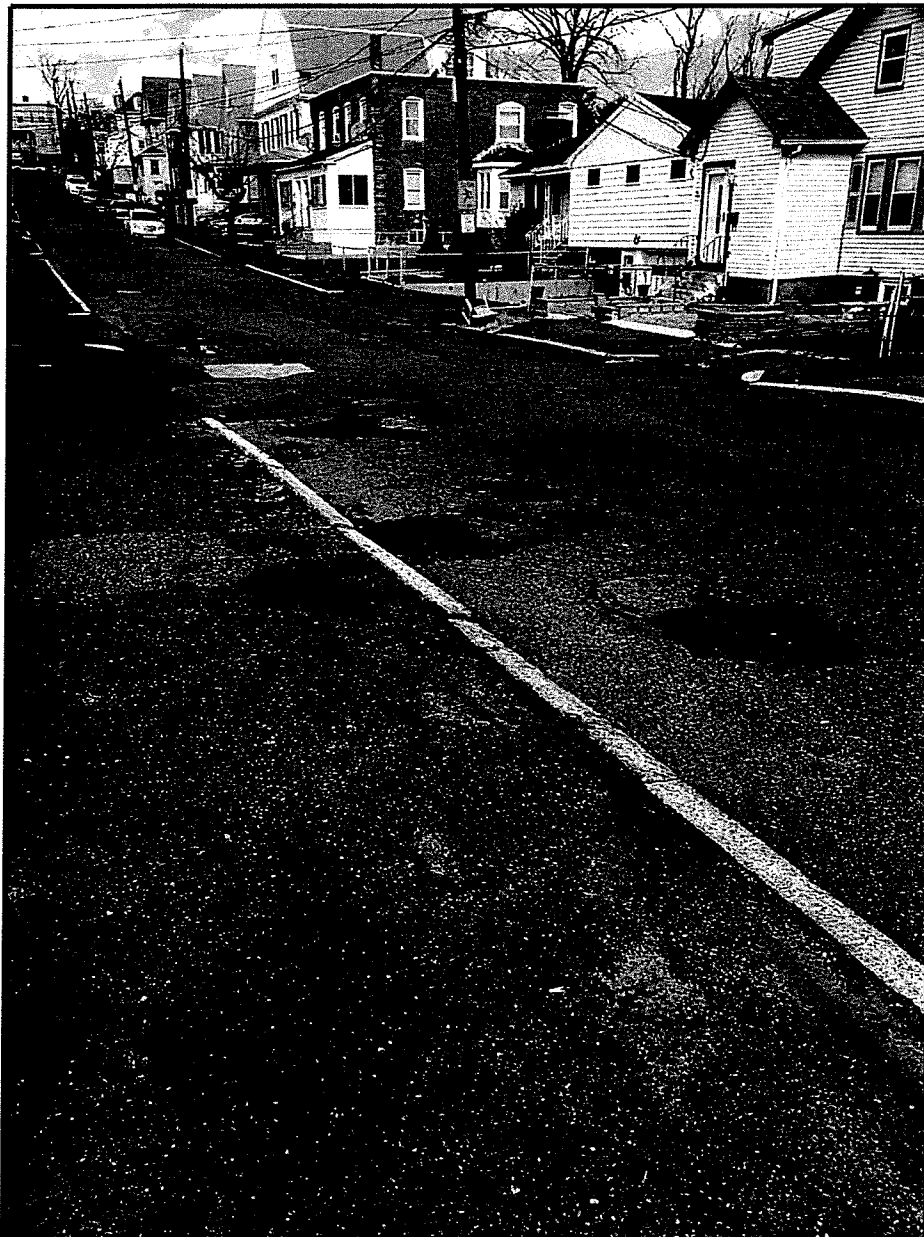
Barrett Street

The roadway does have granite curbing throughout but is rolled and sunken in most areas (see photos) and must be corrected to control storm water flow. The condition of the asphalt sidewalks are poor.

Photo highlighting very poor section of sidewalk and curb which is rolling over. **Curling** should be removed and reset and sidewalks reconstructed in concrete.

Typical condition of roadway continues.
