## **PHASE 2- FEASIBILITY ANALYSIS TAPLEY AVENUE**

## Tapley Ave.

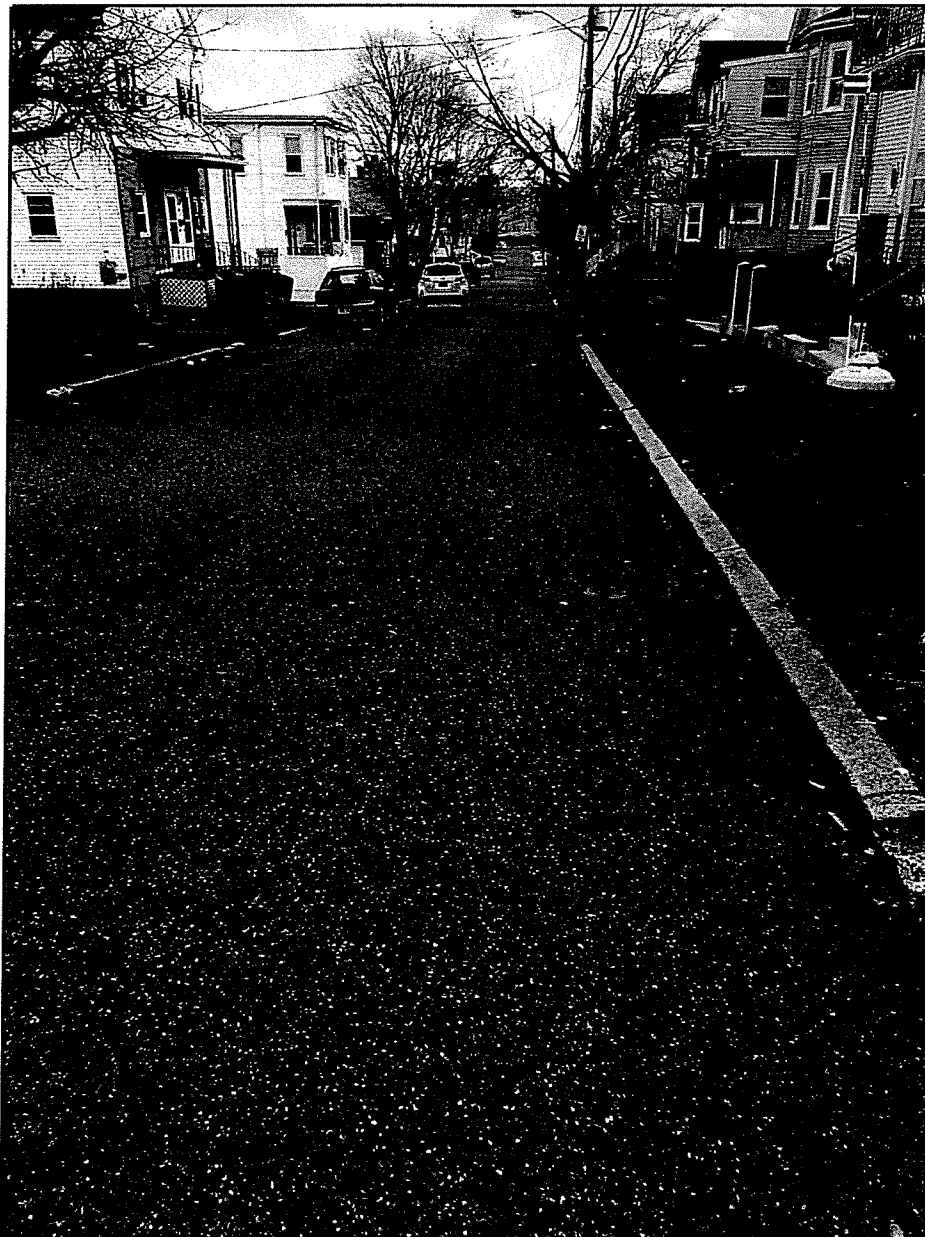
Near Broadway looking east.

Fire Hydrant needs to be replaced ahead of paving.

Concrete curb should be replaced with granite curb.  
Recommend reconstructing sidewalks in Concrete.

Roadway cracking is becoming extensive, worse on the  
Broadway end of the street.

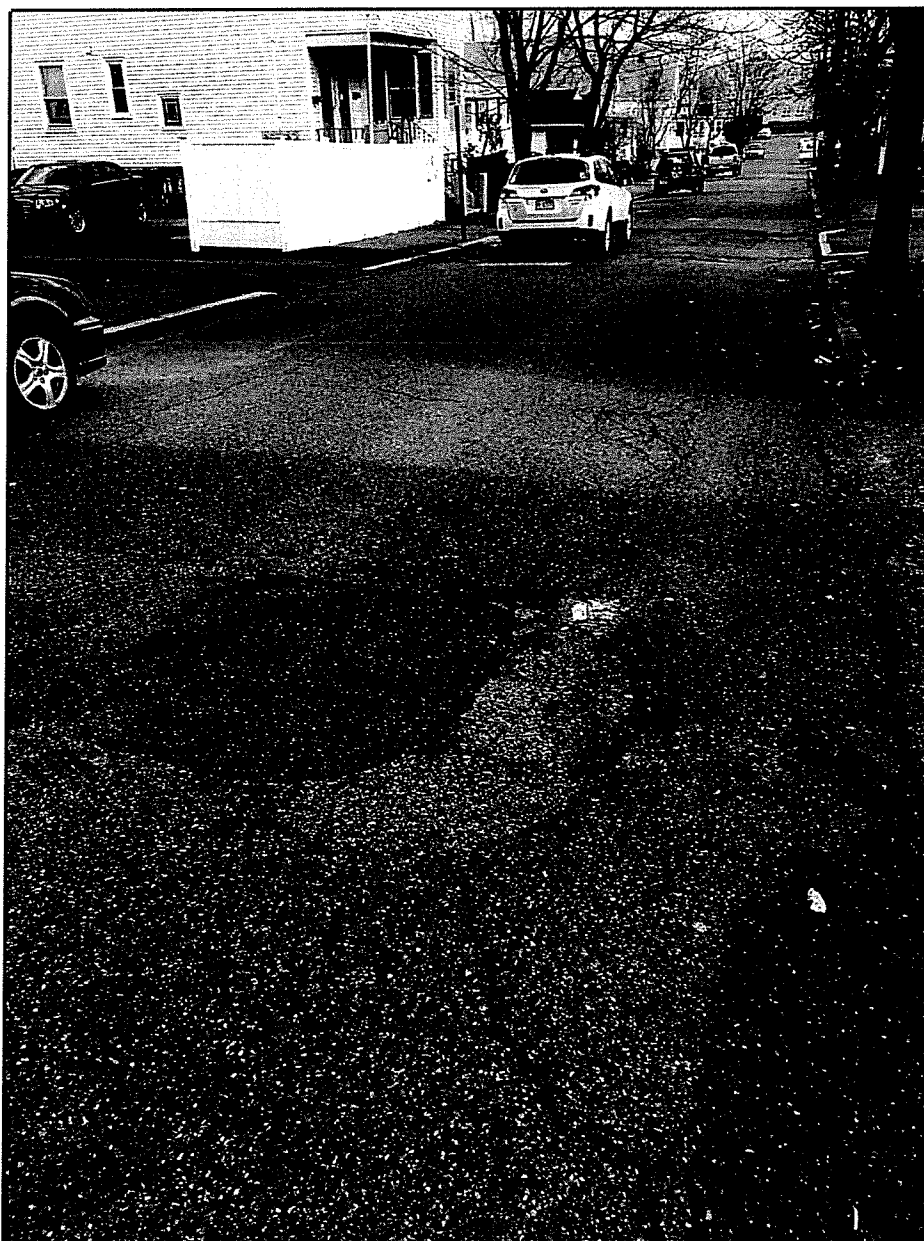
Failed utility trench shown.  
2006 to 2014 water main break map shown on breaks  
on  
Tapley, reason for trench is unclear.

Alligator cracking at edges seen, edges will begin to  
break apart in the coming years.

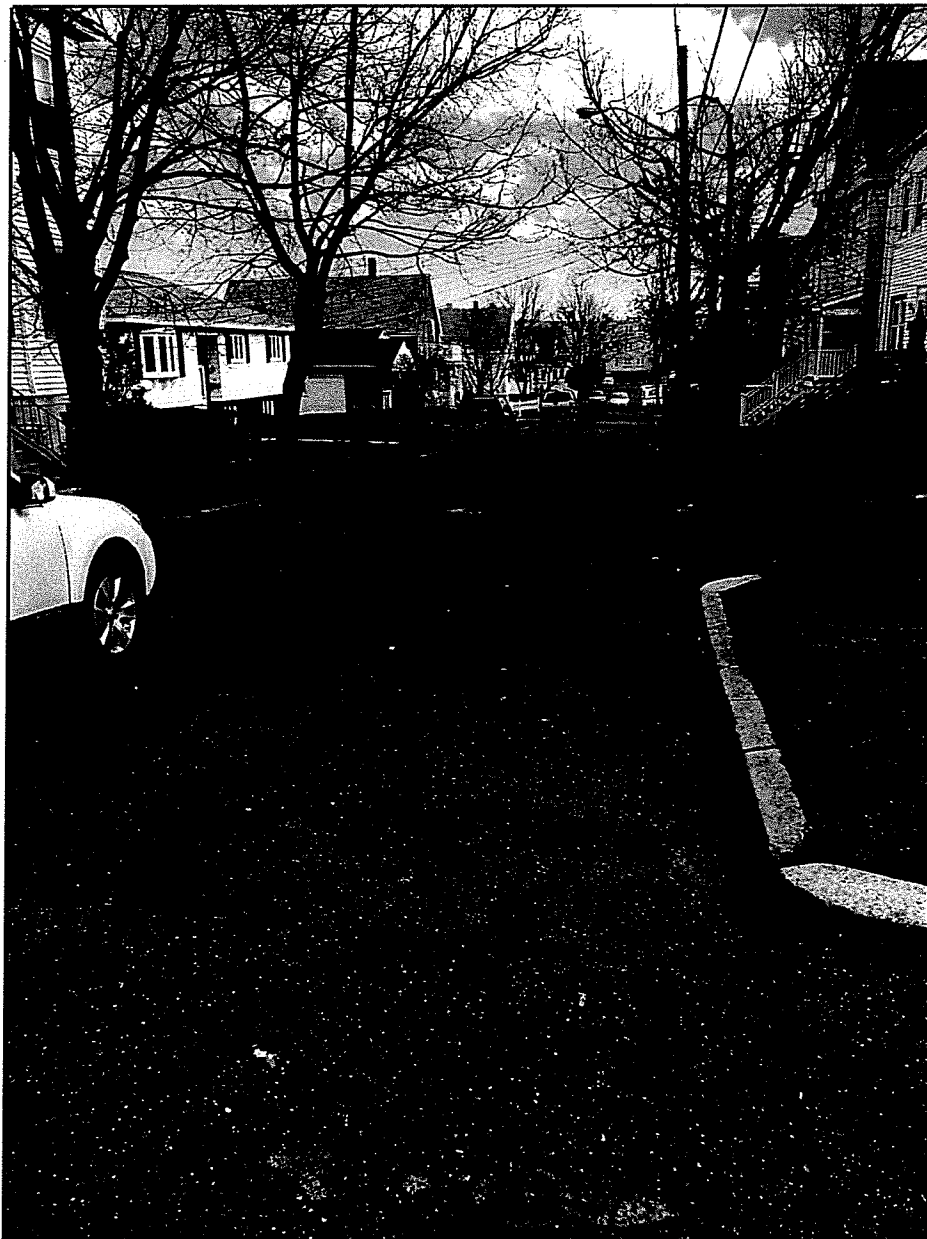
Multiple utility trenches shown.  
Mismatched curbing materials exist on the street.  
Concrete curb is beginning to deteriorate in  
several locations.

Condition of the roadway improves ahead.

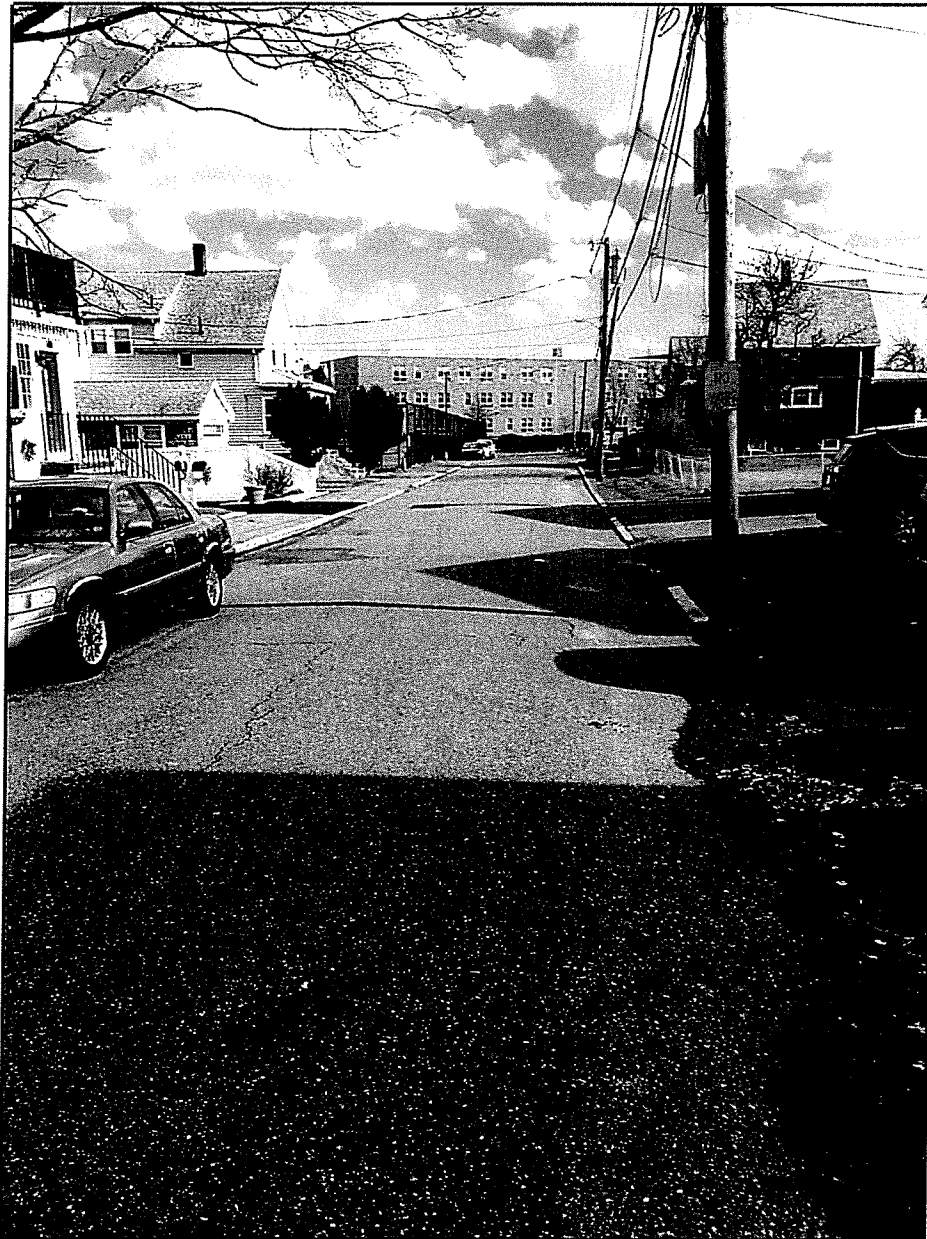
Continuing towards School.

Roadway condition improves as you approach the School.

Roadway beginning to crack, but alligator cracking is not seen yet.

Recommend removing remaining curb adjacent to black fence ahead to increase parking access

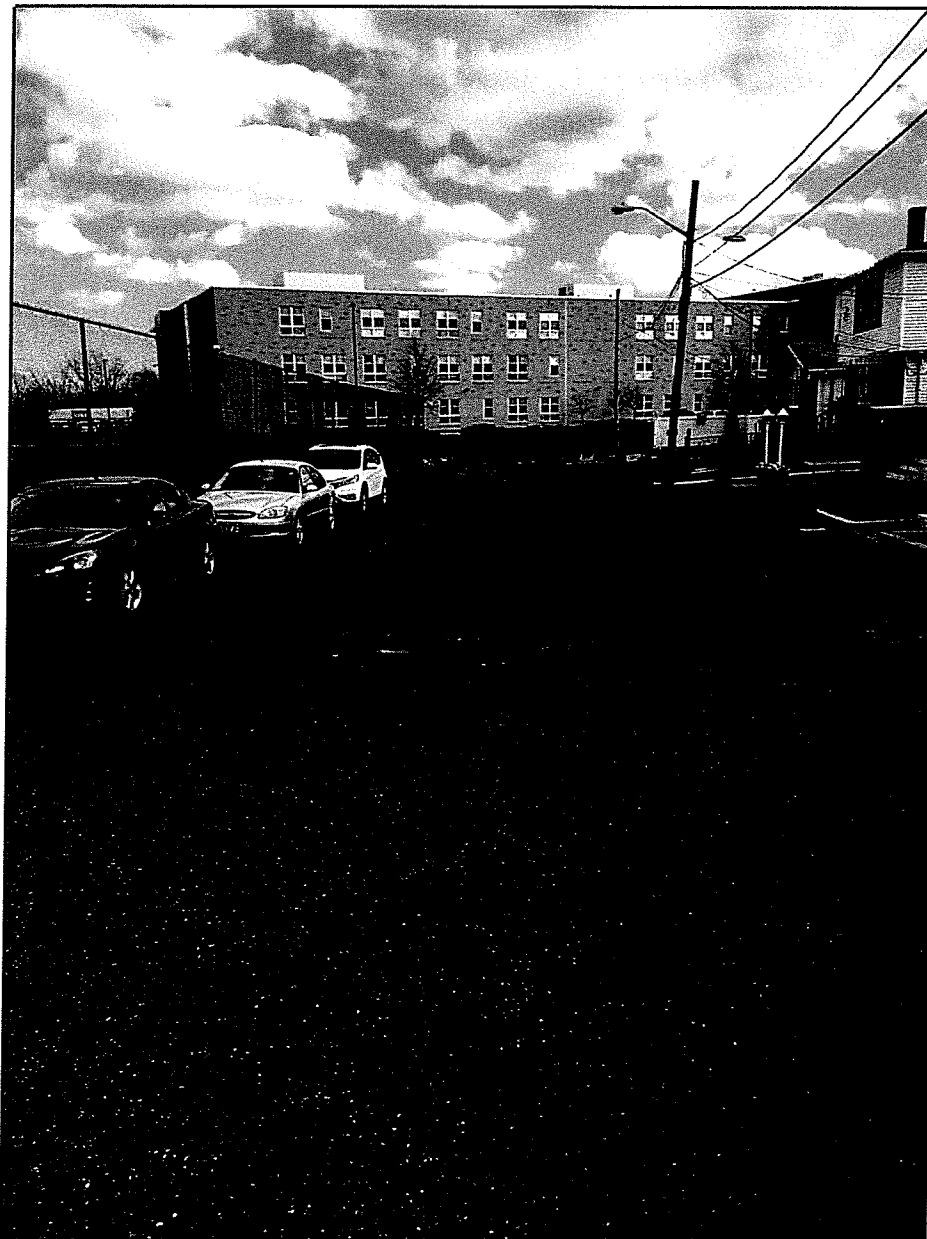
Dead end in good condition except for utility trenches. Unclear why trenches exists, possible water main breaks.

Recommend leaving this section with out curbing for ease of parking and turn around.
