PHASE 2 – FEASIBILITY ANALYSIS

CUMMINGS AVENUE

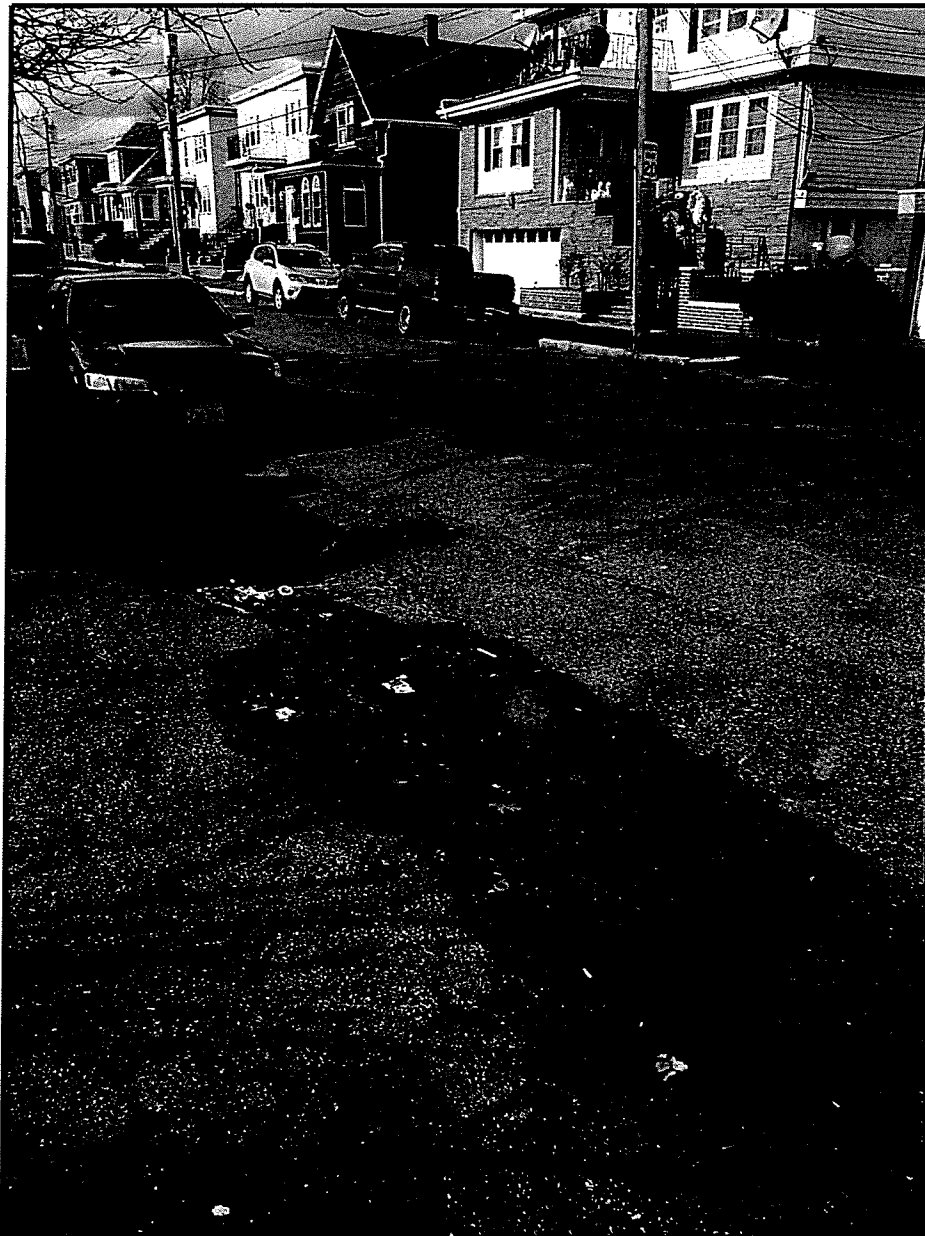
Cummings Ave.

Alligator cracking turning into pothole repairs in several locations. Driveway apron shown is also breaking up.

Condition of roadway is poor.
Sidewalks are also in poor condition.

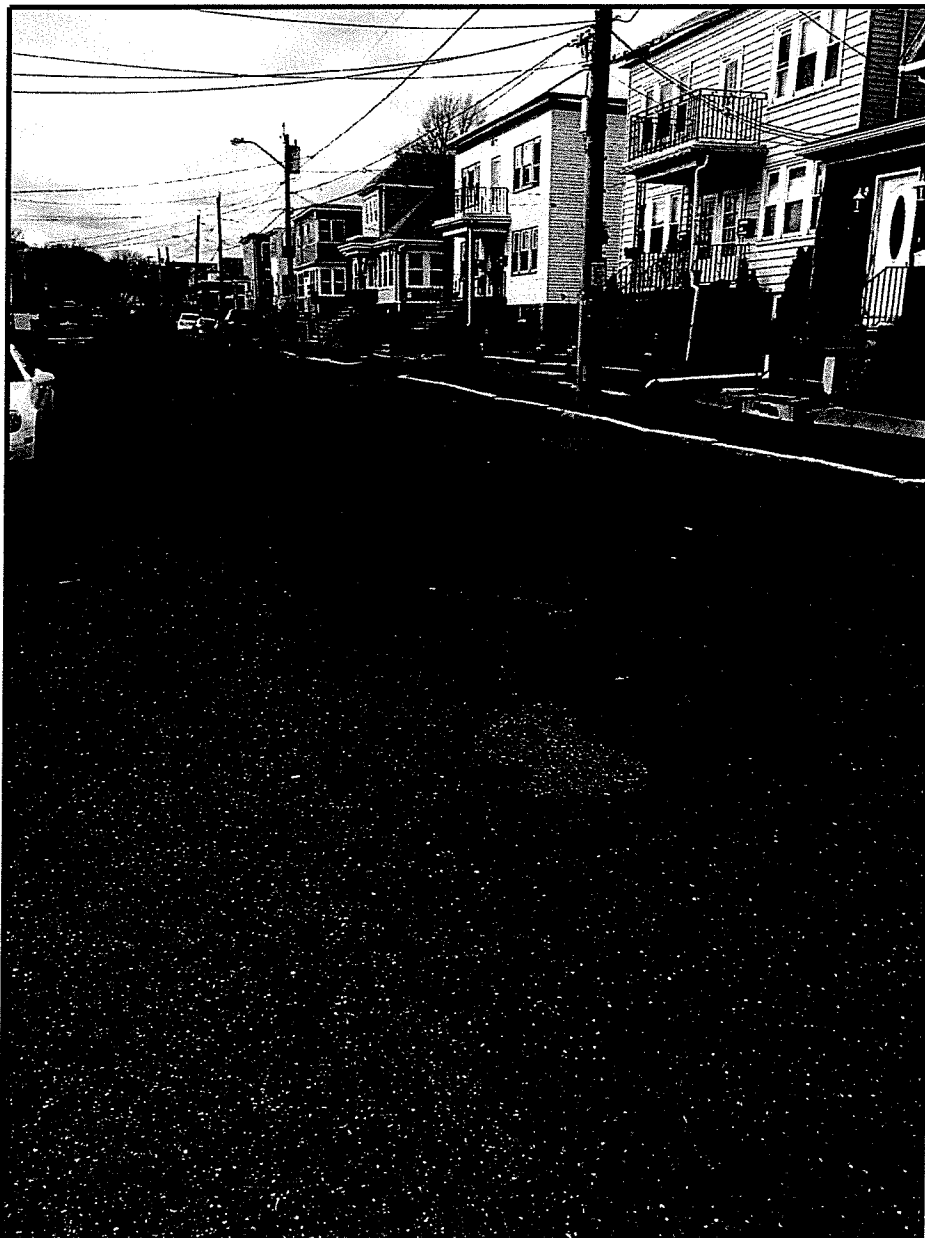
Cummings Ave.

Photo shows multiple pothole repairs.

Granite curbing is settling and rolling over.

Granite curb should be removed and reset and sidewalks reconstructed in concrete.

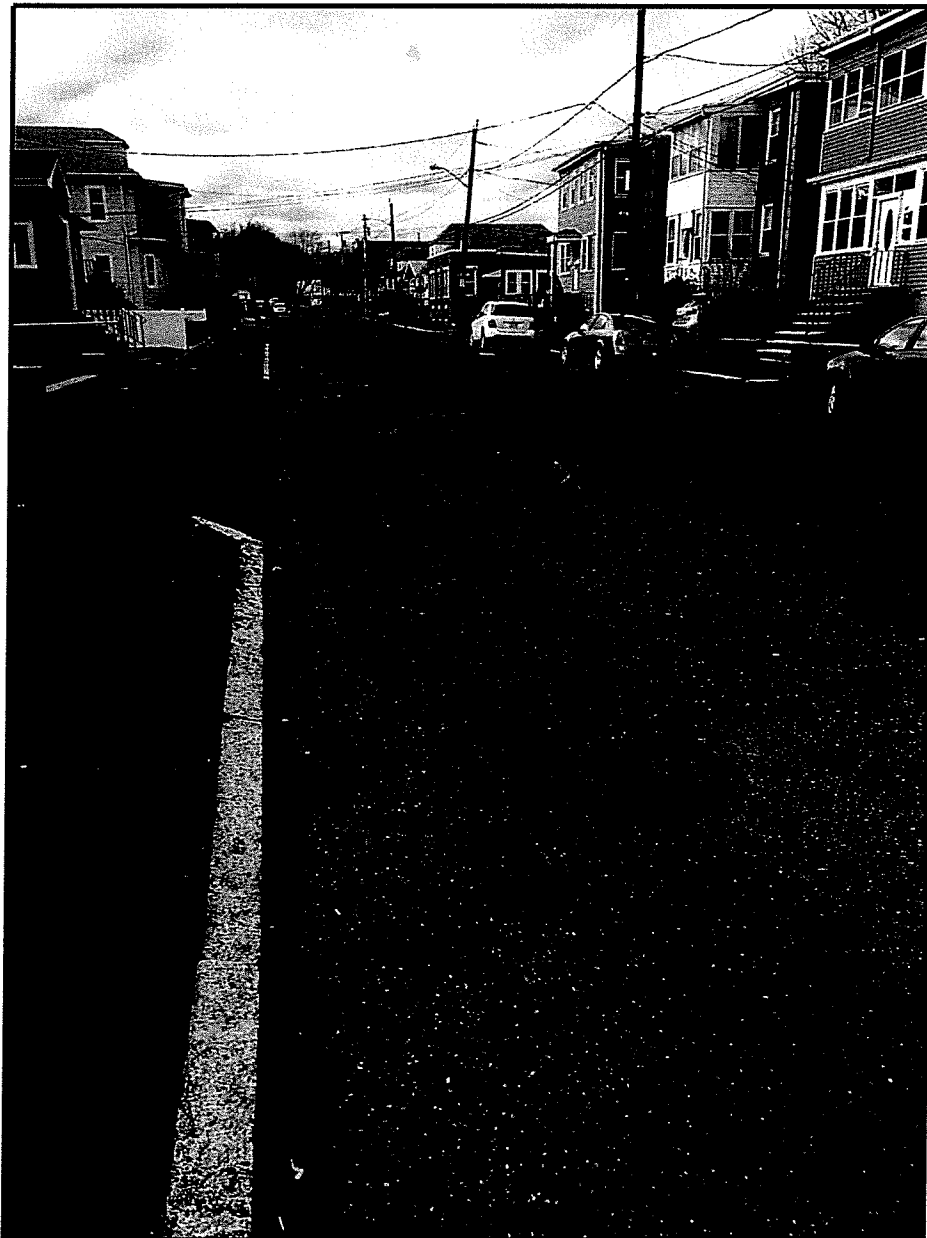
Cummings Ave.

Photo showing poor condition of sidewalk. Sidewalk cracking and sidewalk repairs shown. Alligator cracking of roadway shown along with utility trench and pothole repairs.

Note rolling of curb as curb line extends.

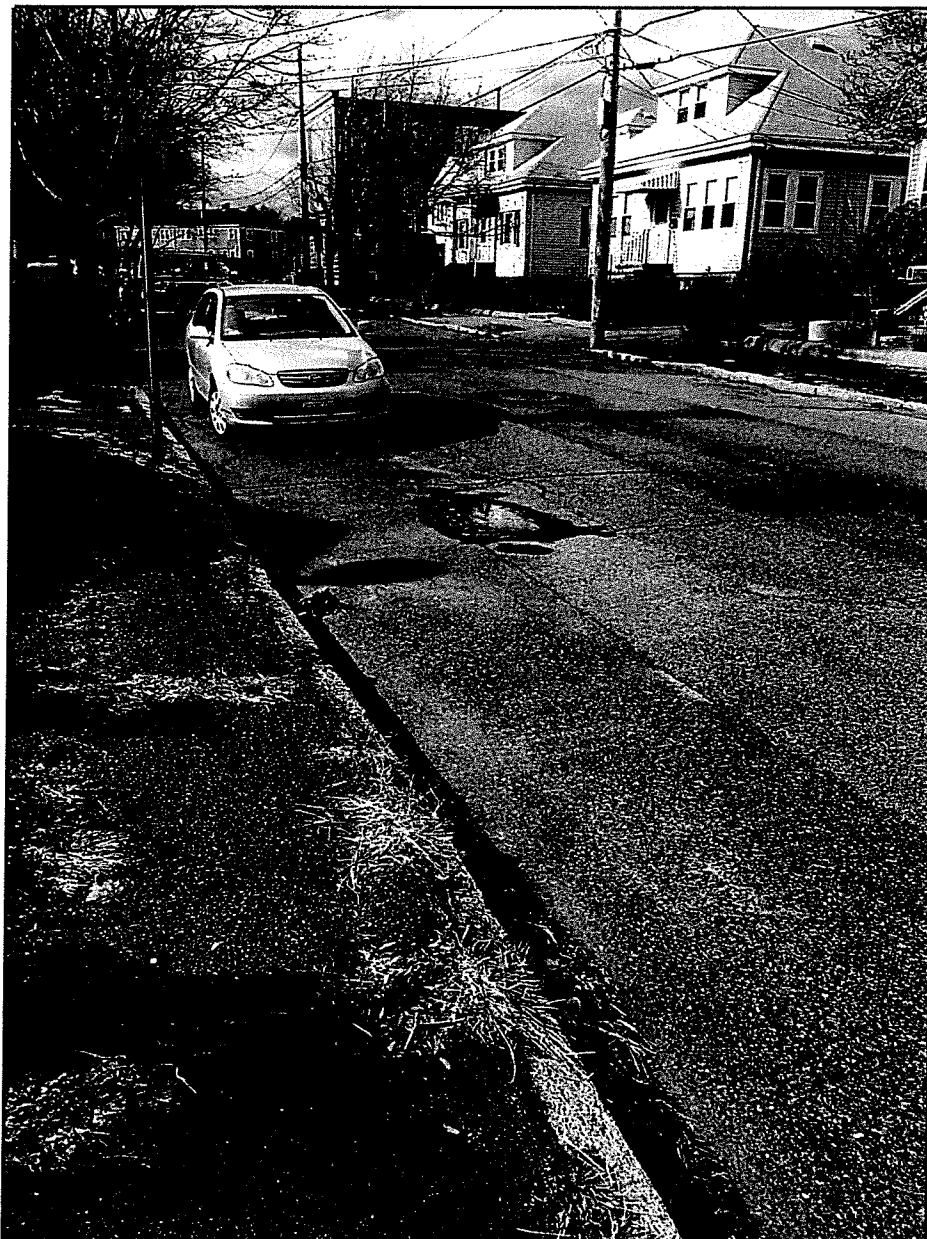
Cummings Ave.

Photo shows section of roadway in better condition as you move towards B Street.

Poor condition of curb and sidewalk continues.

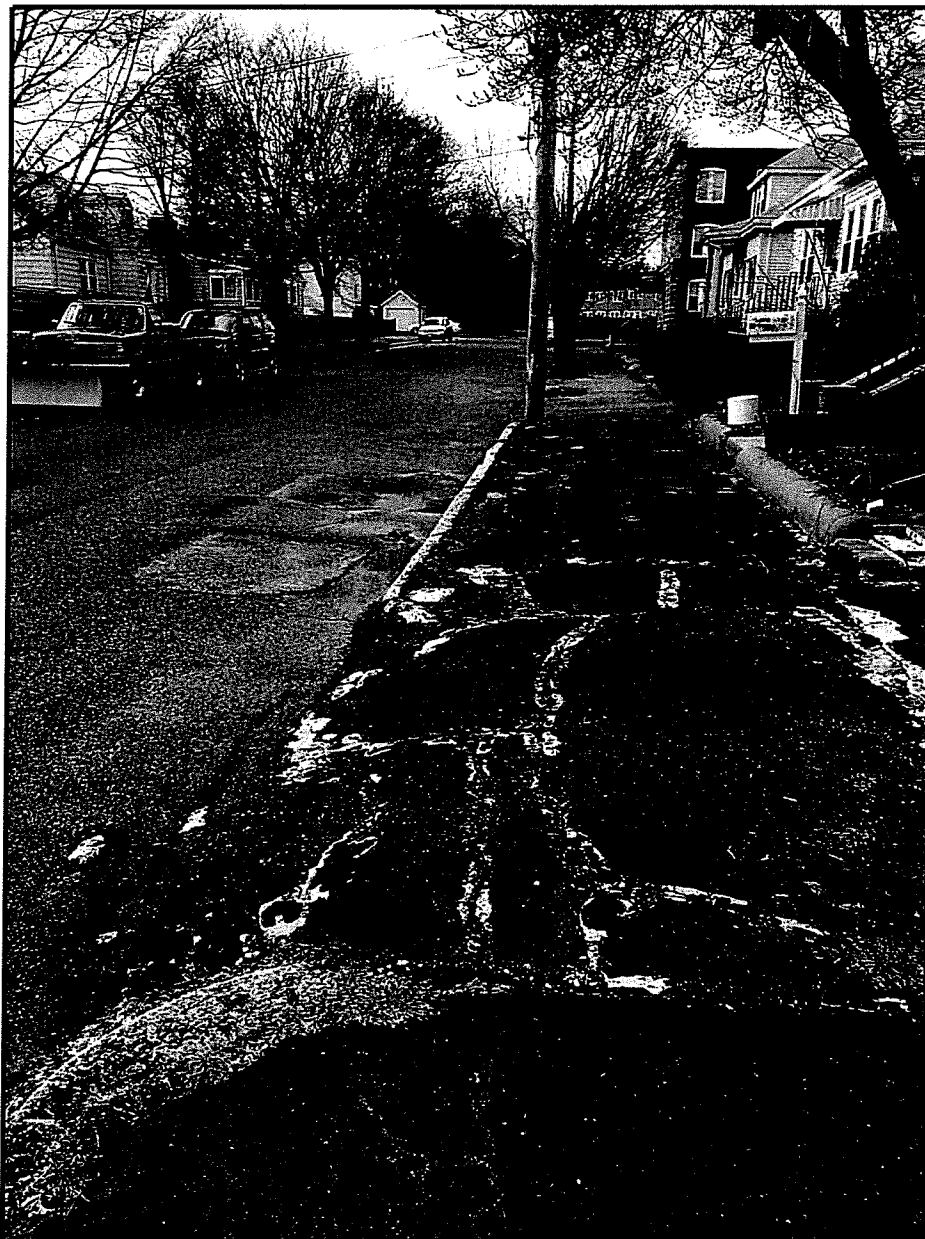
Cummings Ave.

Photo highlighting poor condition of sidewalk and driveway apron.

Roadway cracking and utility trenches shown.
