PHASE 2-FEASIBILITY ANALYSIS

CURTIS ROAD

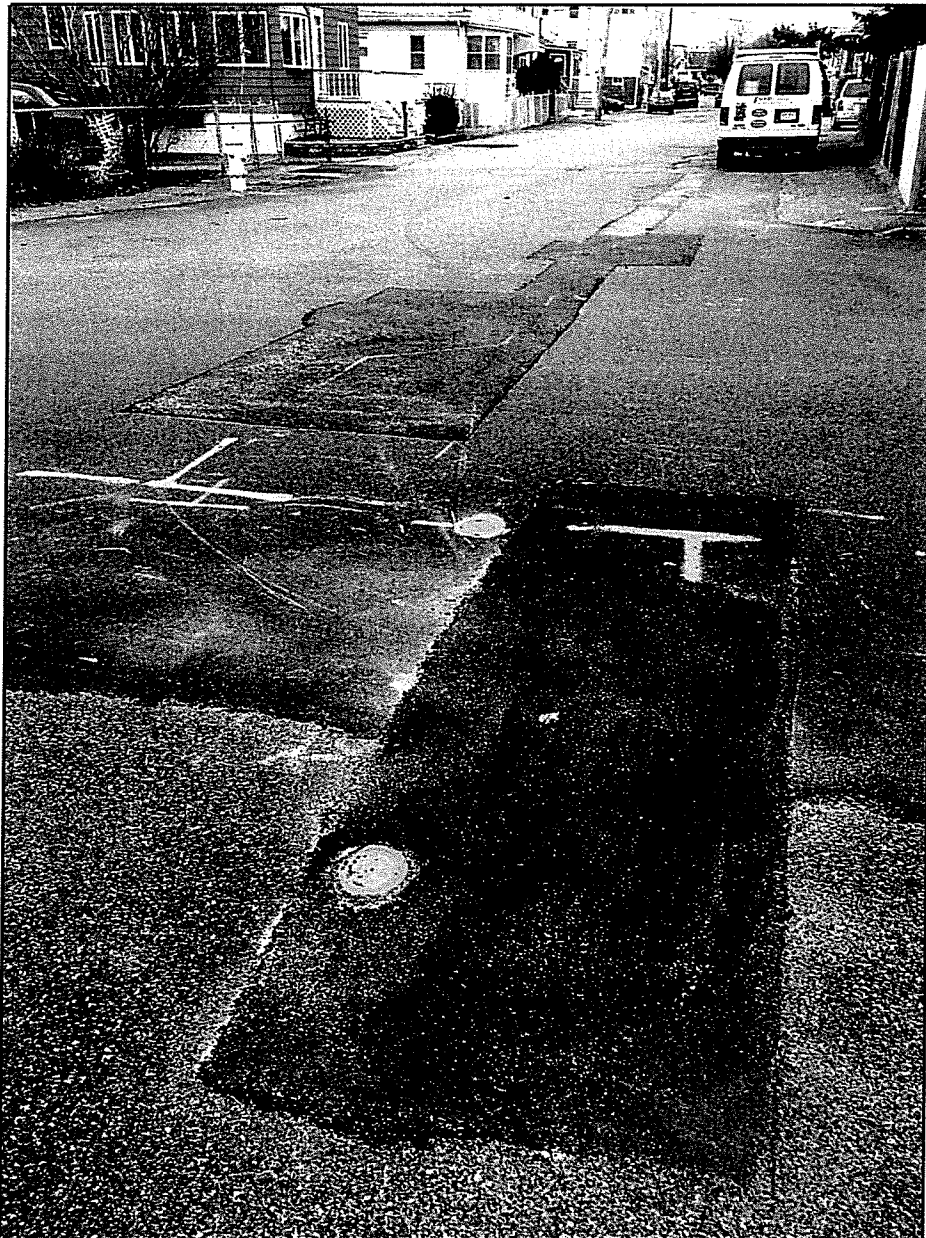
Curtis Road

At Standish looking north.

Gas trench installed after Standish was paved.
Chase after gas company to complete curb to curb mill
and overlay

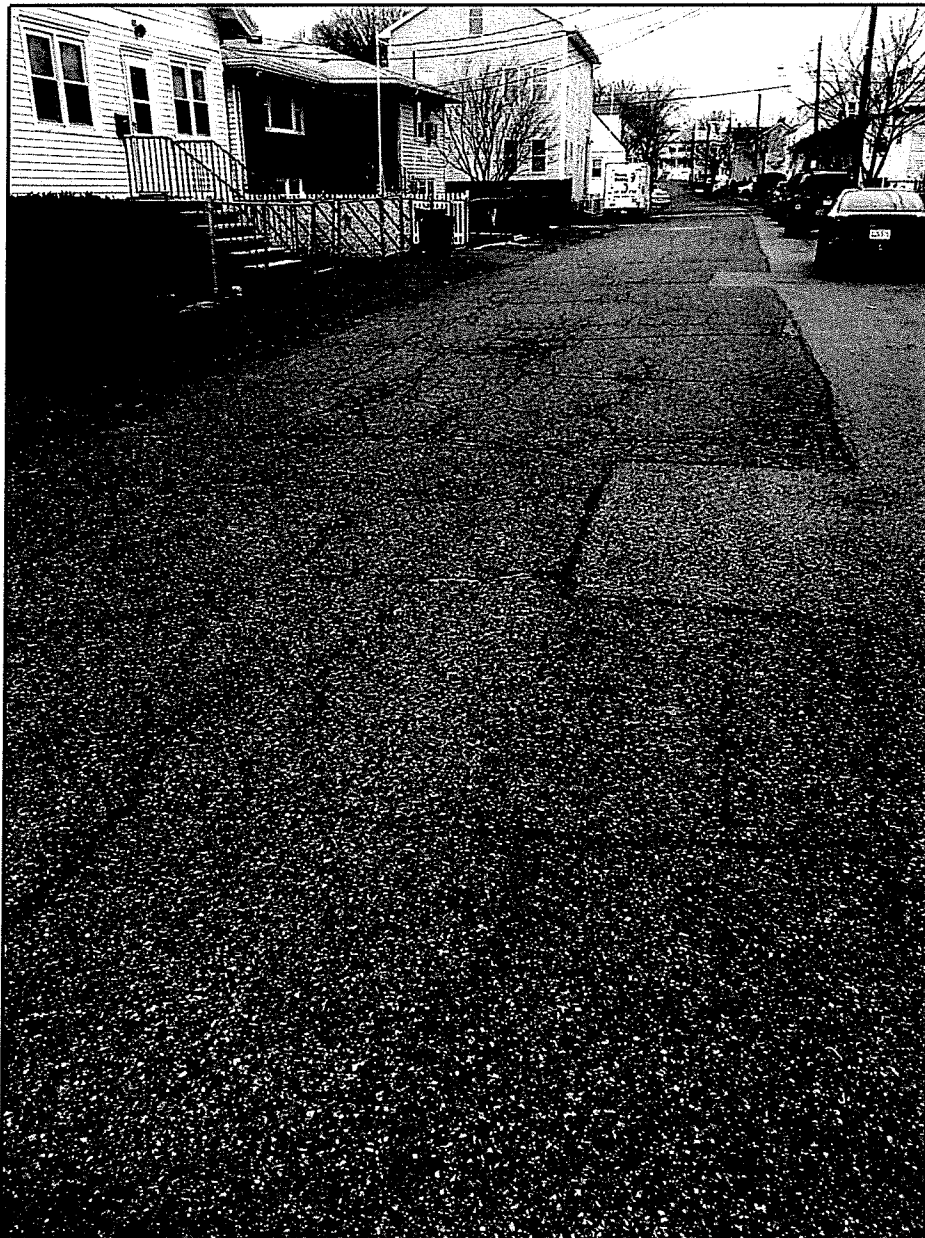
Curtis Road

Roadway in poor condition.

Extensive longitudinal and transverse cracking turning into alligator cracking, roadway will require pothole repairs in coming years.

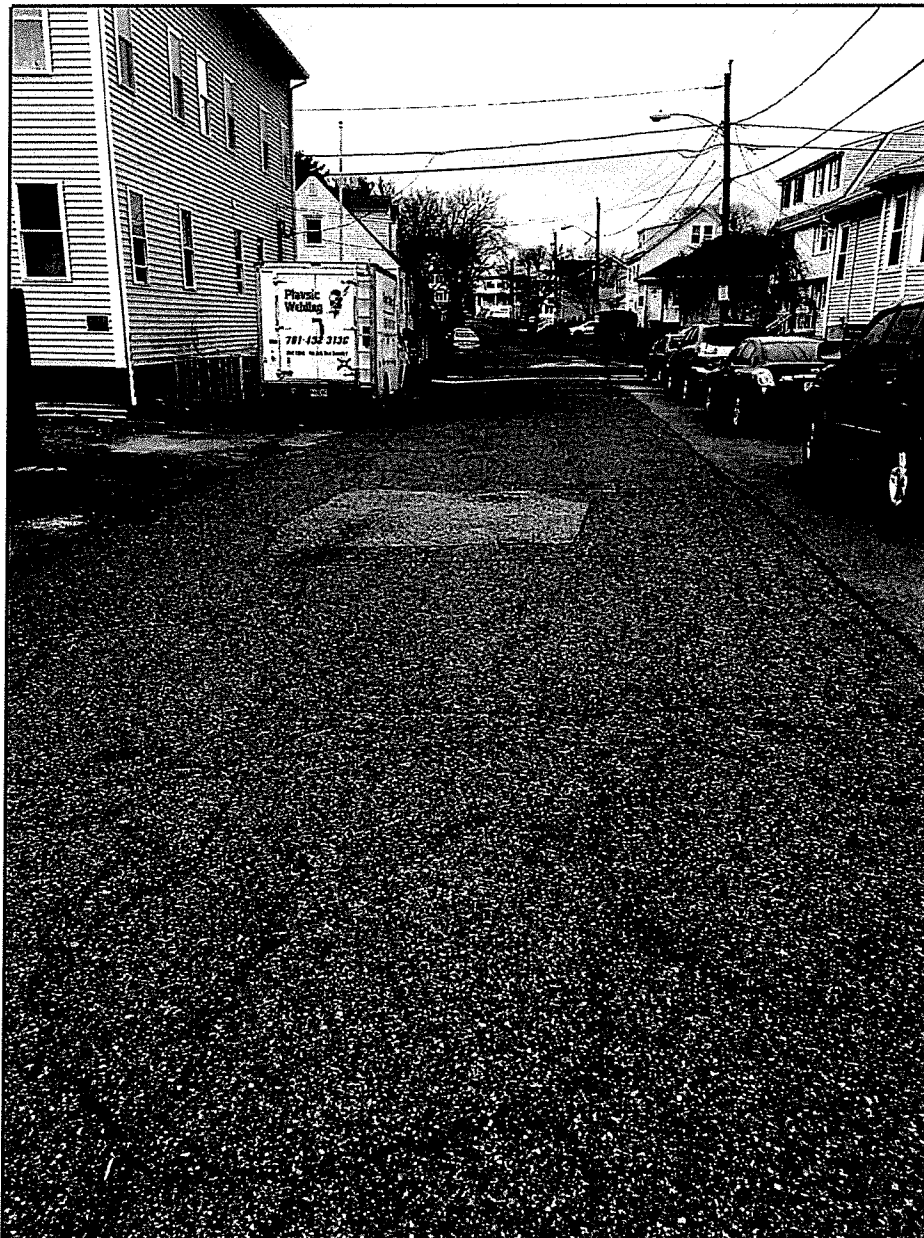
Curtis Road

Poor condition of roadway continues.

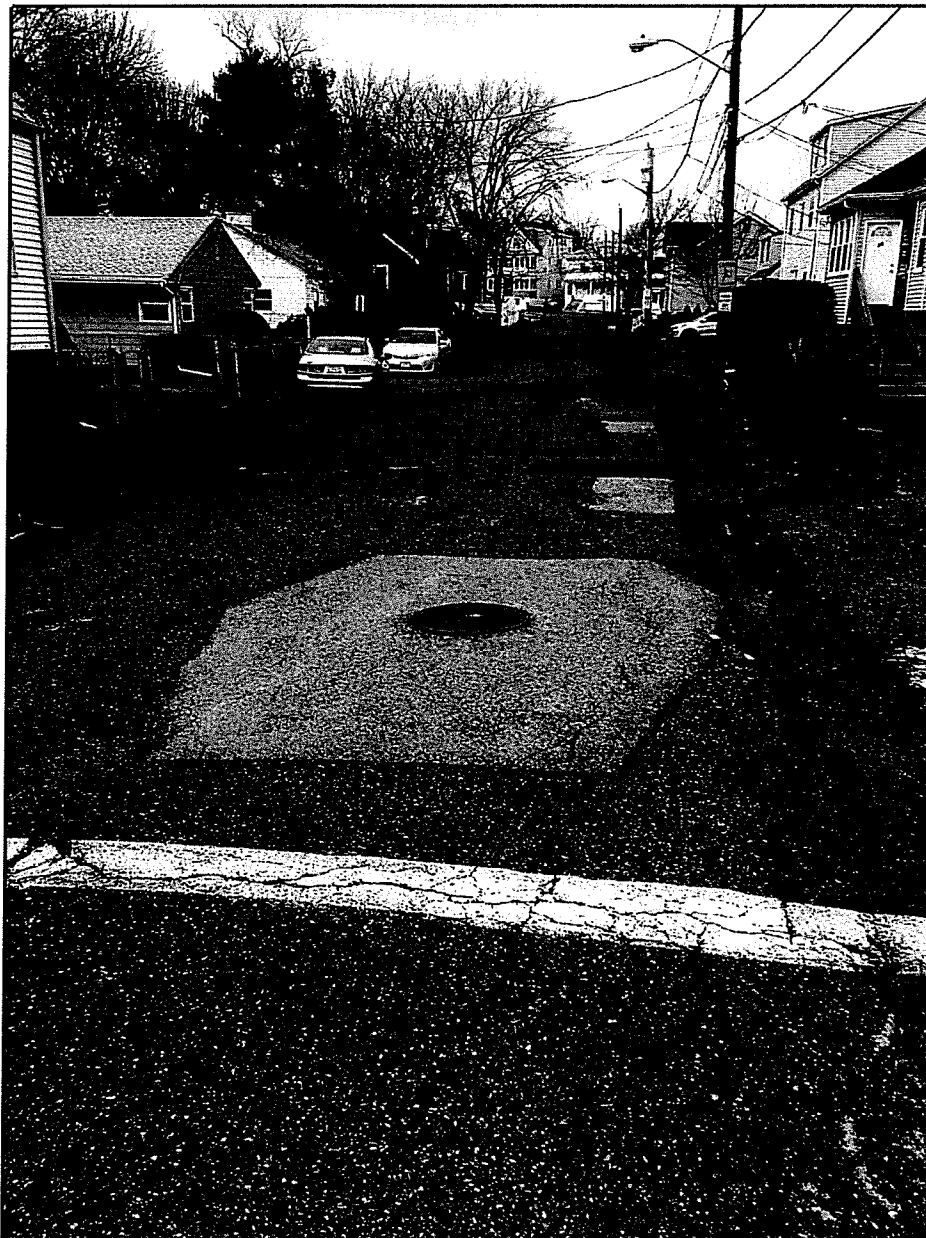
Curtis Road

Roadway consistently very poor.

Pothole repairs completed ahead.

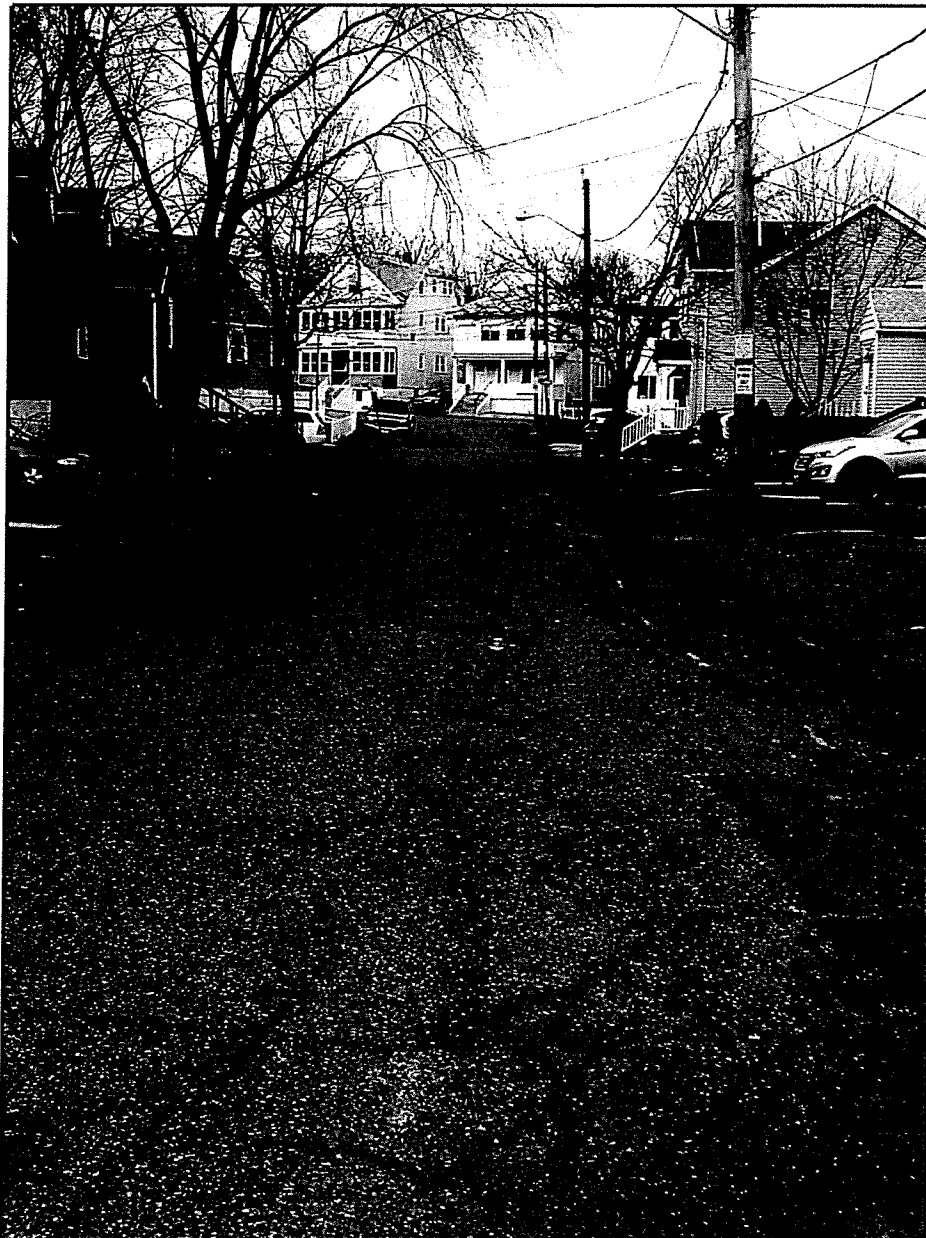
Curtis Road

Roadway and sidewalks both in poor condition.

Recommend reconstructing sidewalks in asphalt no curbing due to the high density of vehicles that park on the sidewalk in this neighborhood.
