Mountain Ave.

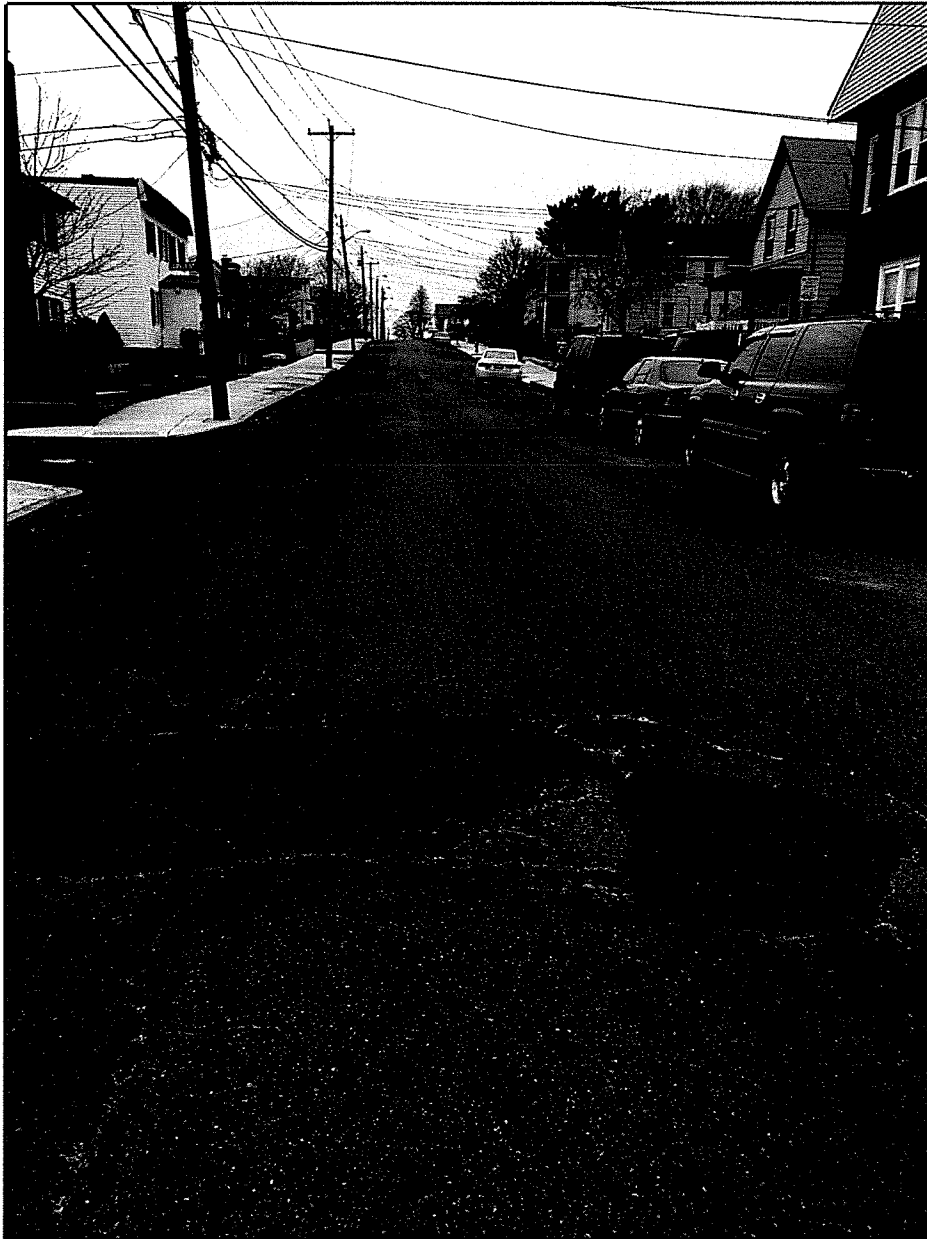
Looking west at Jarvis

Poor condition in the left gutter continues.
Similar overall condition compared to last photo.
Extent of reconstruction will become evident upon
milling of the roadway.

Multiple trenches cause an unpleasant ride.

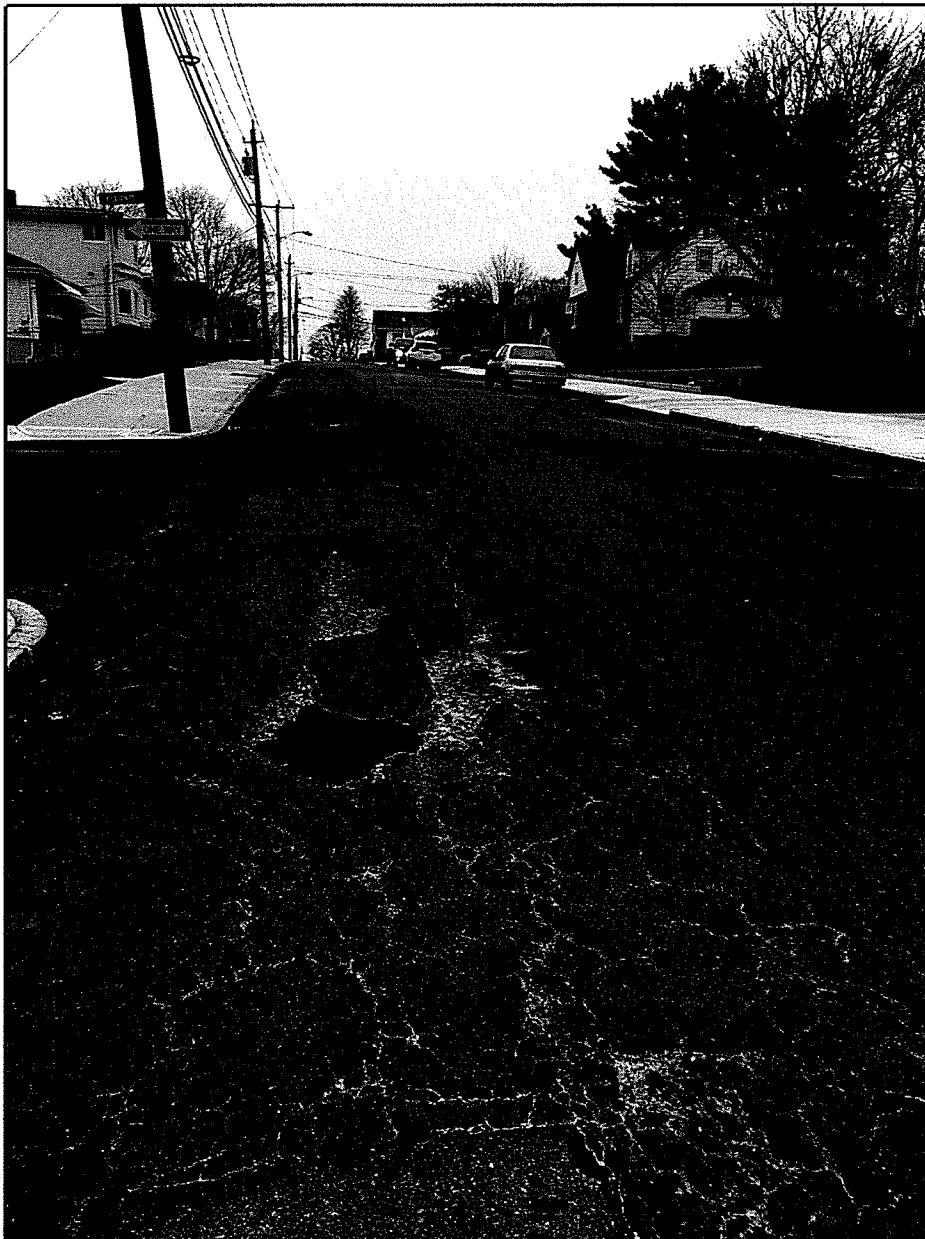
Looking west at Kilburn St.

Poor condition of left gutter continues.

Condition improves west of Kilburn St.

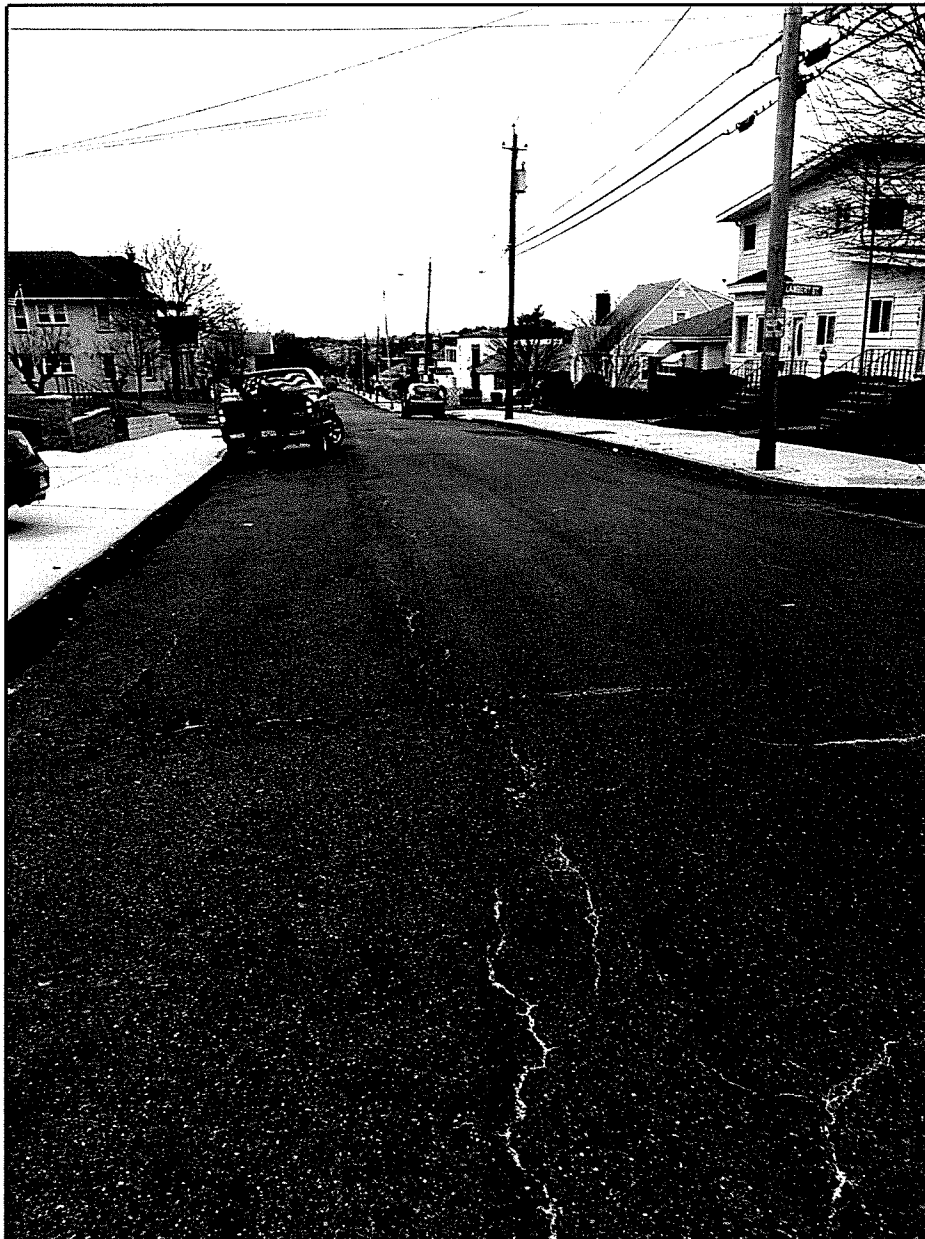
Looking west to Lambert St.

Gutter condition improves.

Longitudinal cracks are visible but lack extensive settlement, therefore majority of road base is assumed to be firm enough to support milling and paving of the roadway.

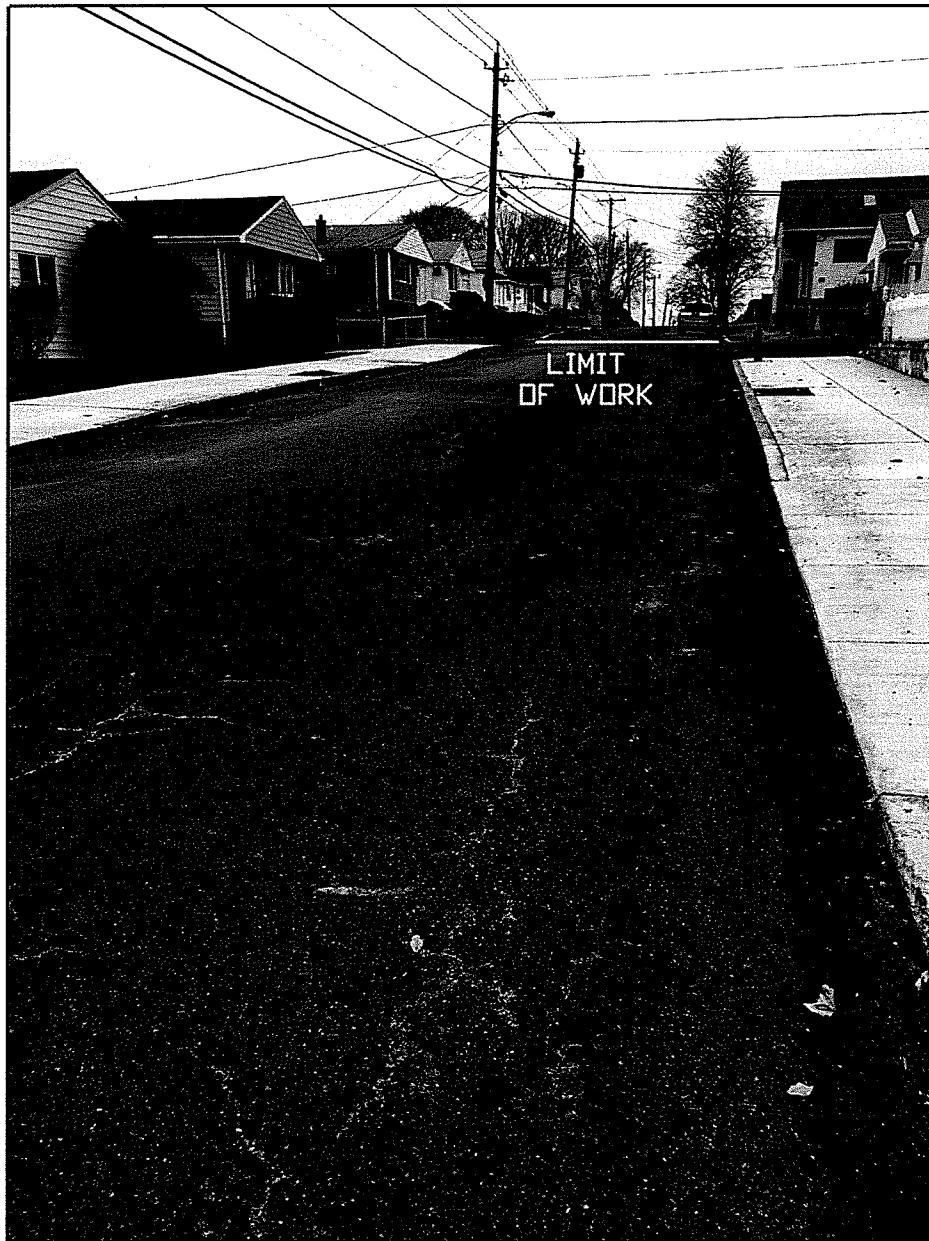
Looking west towards limit of repaving at Seaview

Road in decent condition, shows cracking but settlement is not substantial.
Slight alligator cracking in right gutter shown, but not nearly as severe as the left gutter closer to Broadway.
