## **PHASE 2 – FEASIBILITY ANALYSIS**

### **ENSIGN STREET**

#### **(FENLEY STREET TO MALDEN STREET)**

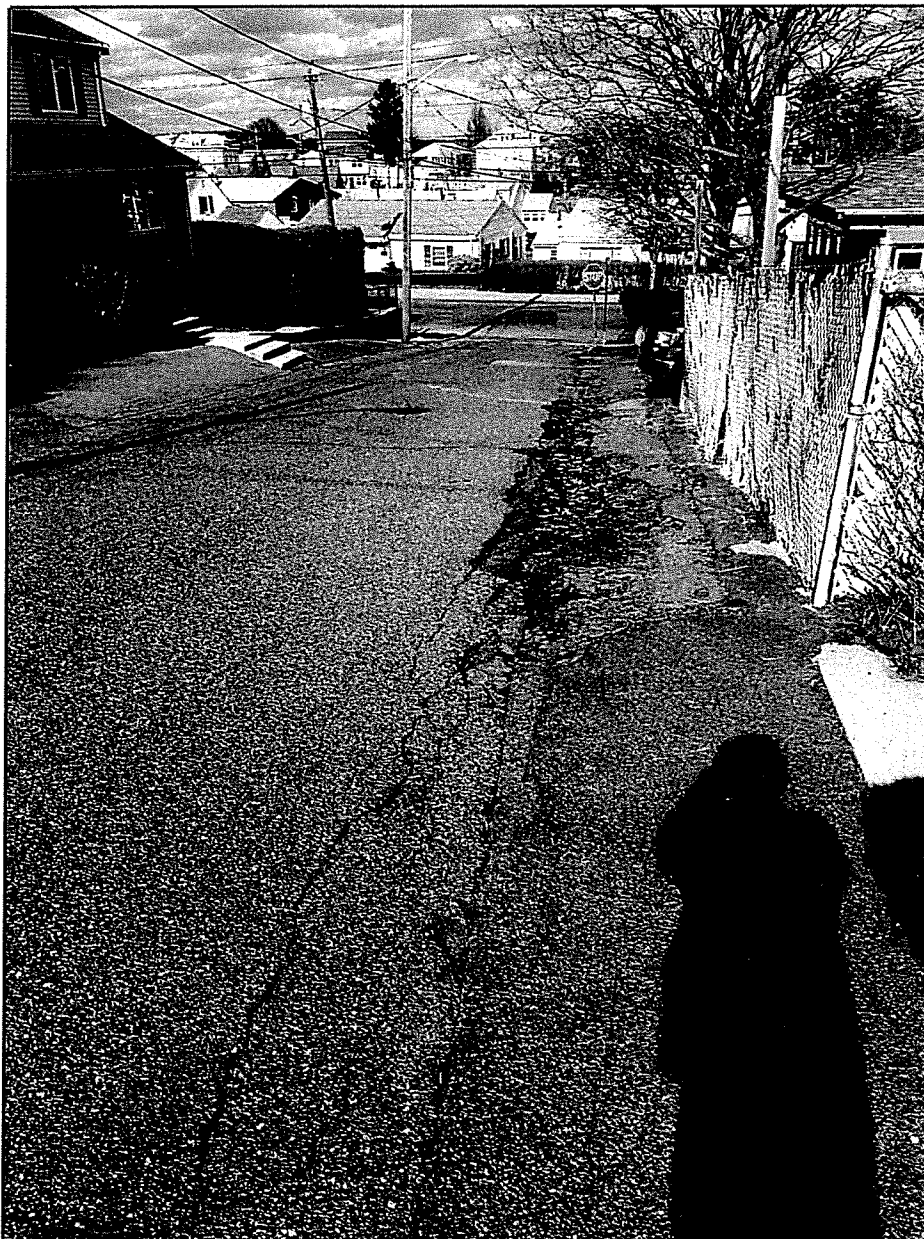
## Ensign Street

Roadway in decent condition. Asphalt shoulders in poor / very poor condition. Refreshing shoulders may improve overall streetscape, pedestrian access and vehicular access at effected residences.

1. Mill and pave roadway
2. Remove and replace bituminous concrete areas.

In the meantime, refreshing the shoulders may be warranted.

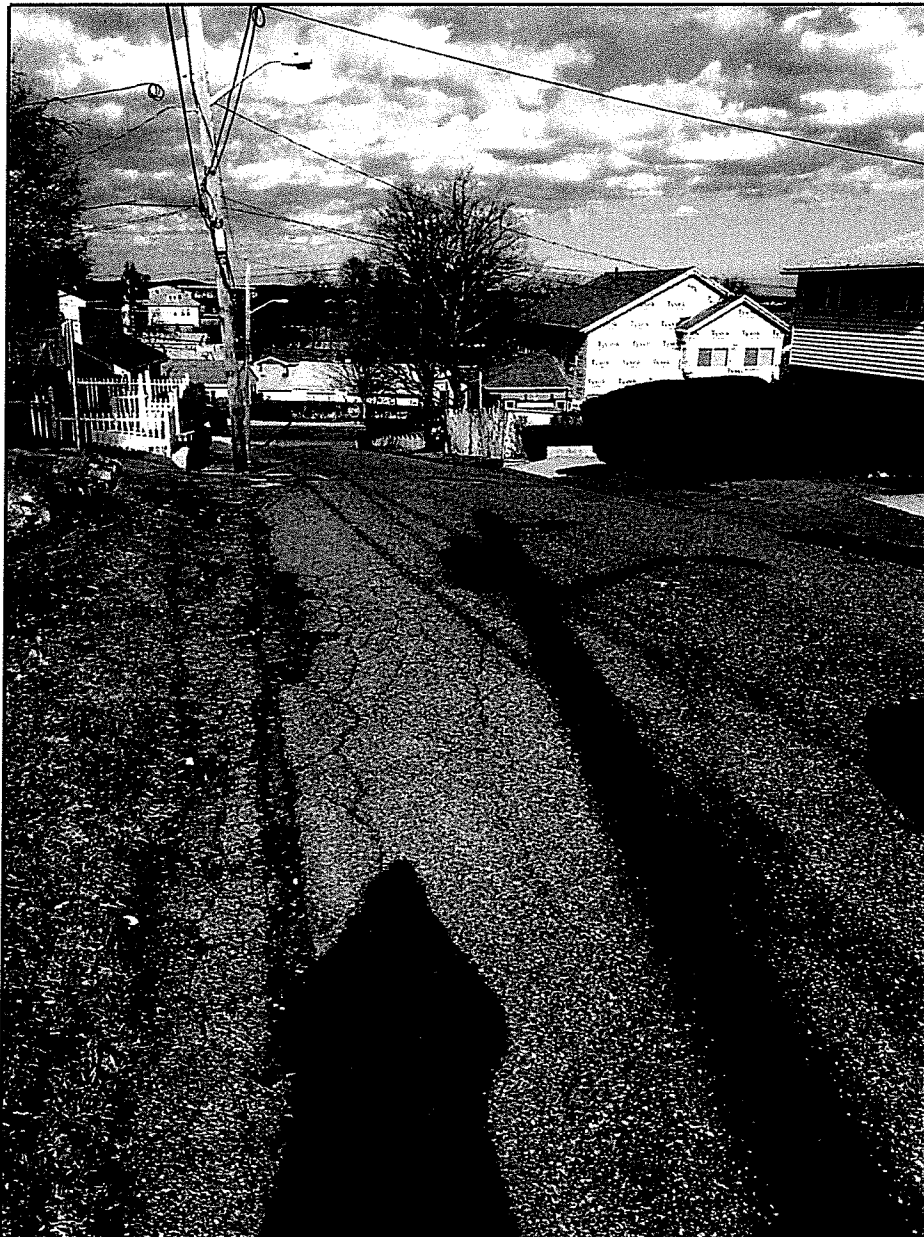
## Ensign Street

Streets in decent condition.

Asphalt shoulder in poor condition.

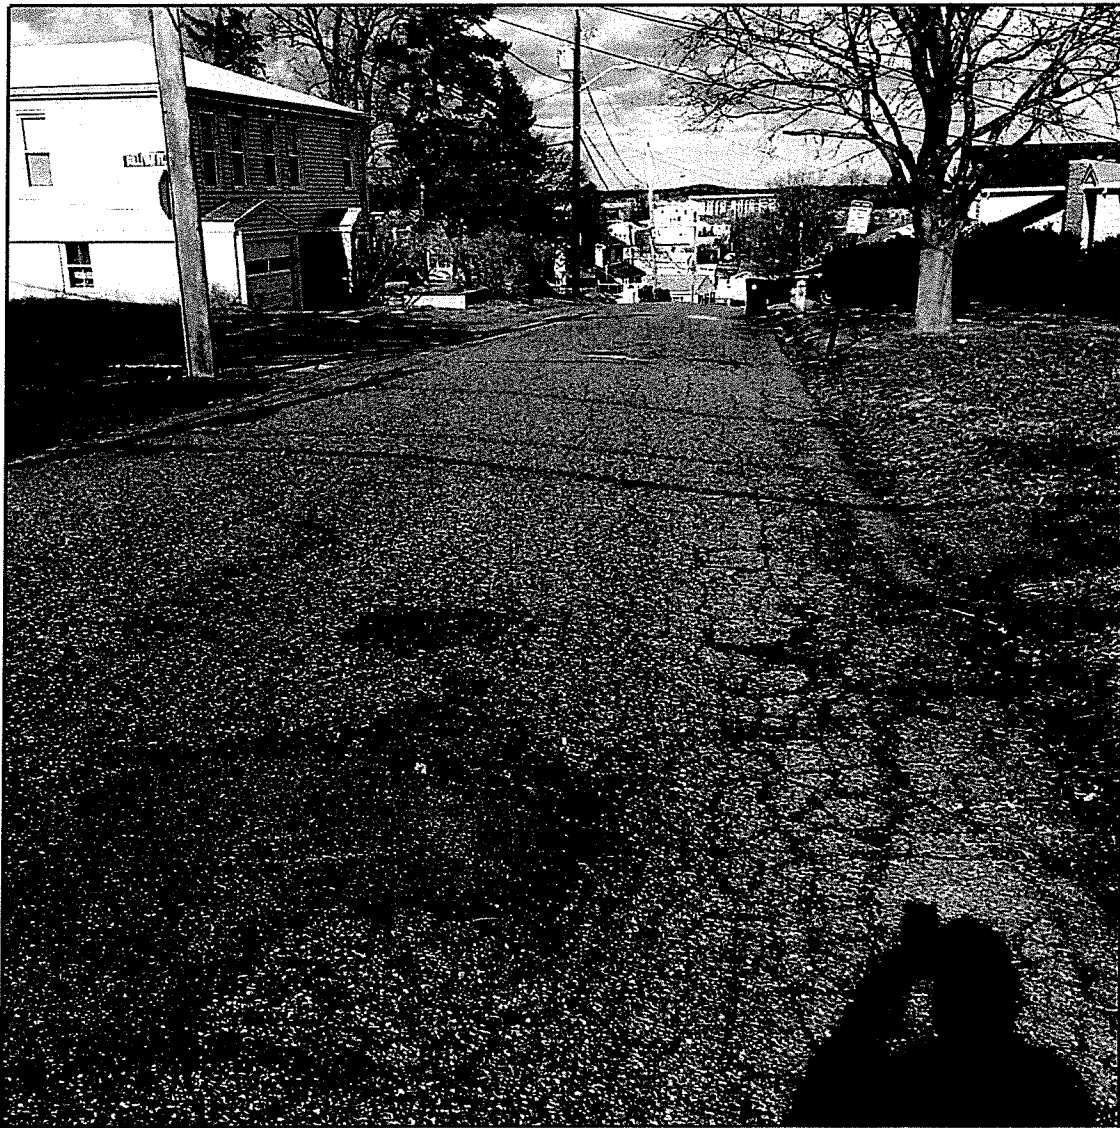
## Ensign Street

The roadway suffers from moderate alligator cracking in sections (see attached photos) and is worst close to the Fenley Street intersection.

Extensive alligator cracking shown, roadway breaking up and potholes have begun to form.

This condition is limited to the most southerly section of the roadway at the Fenley Street intersection
