## PHASE 1 - FEASIBILITY ANALYSIS

### Adams Street

(Mountain Ave. to Cushman Ave.)

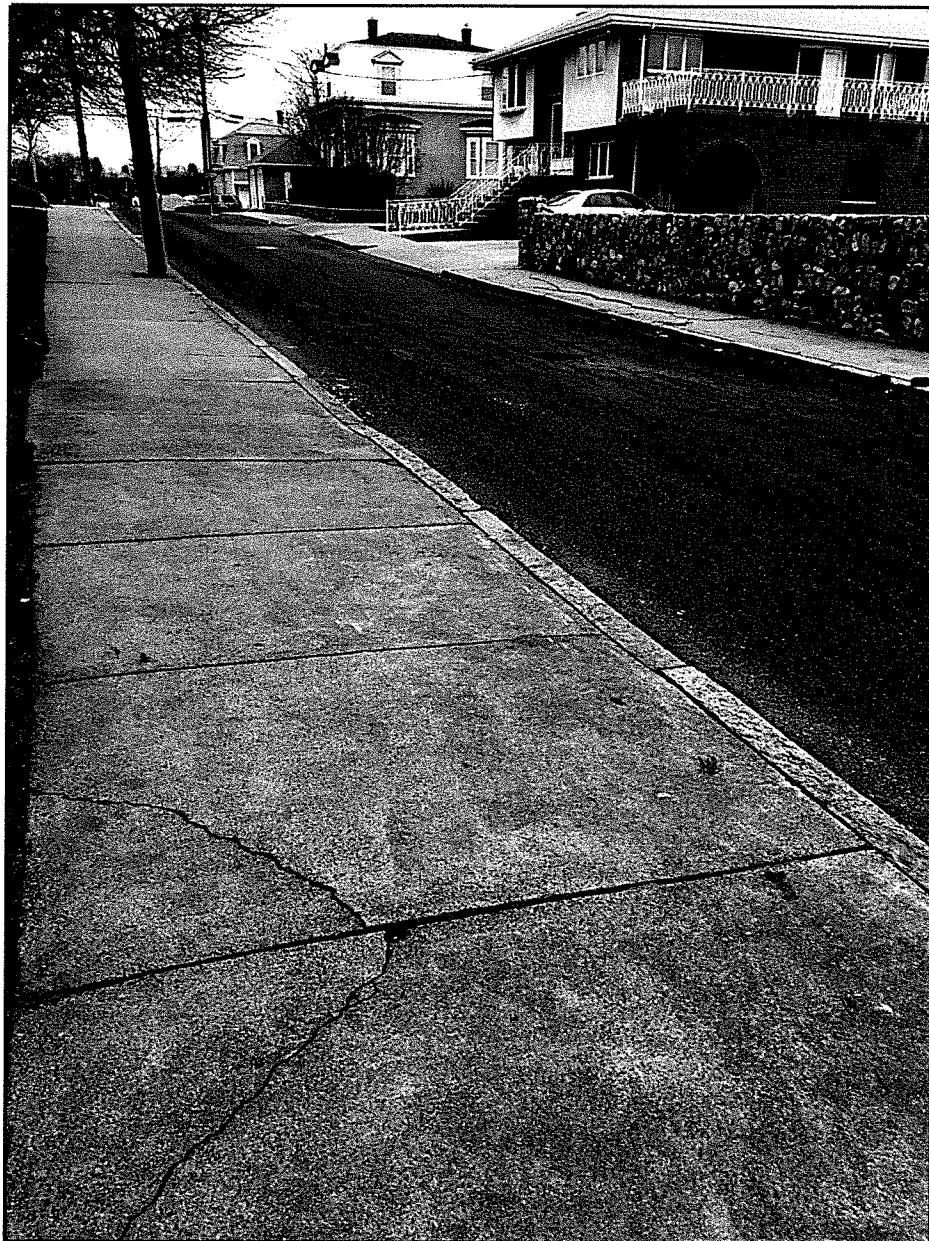
At Mountain Ave. looking north

Extreme alligator cracking of roadway shown.  
Pothole shown. Broken sidewalk panels shown.

Broken sidewalk panels should be replaced between  
Mountain Ave. & Proctor.  
Curb and sidewalk north of proctor are in good  
condition.

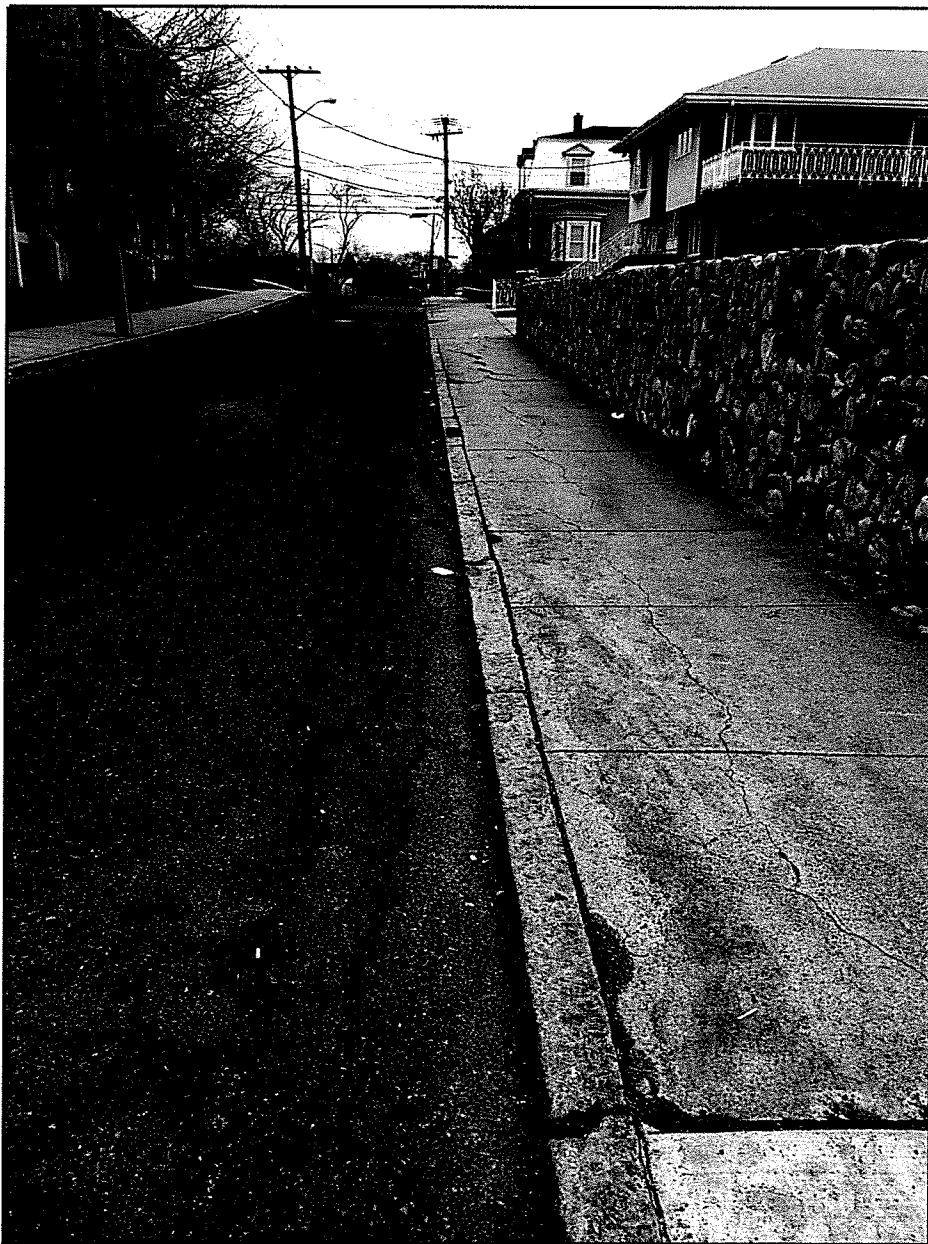
At Mountain Ave. looking north

Highlighting broken sidewalk panels on the east side of Adams between Proctor and Mountain.

All broken sidewalk panels should be replaced.

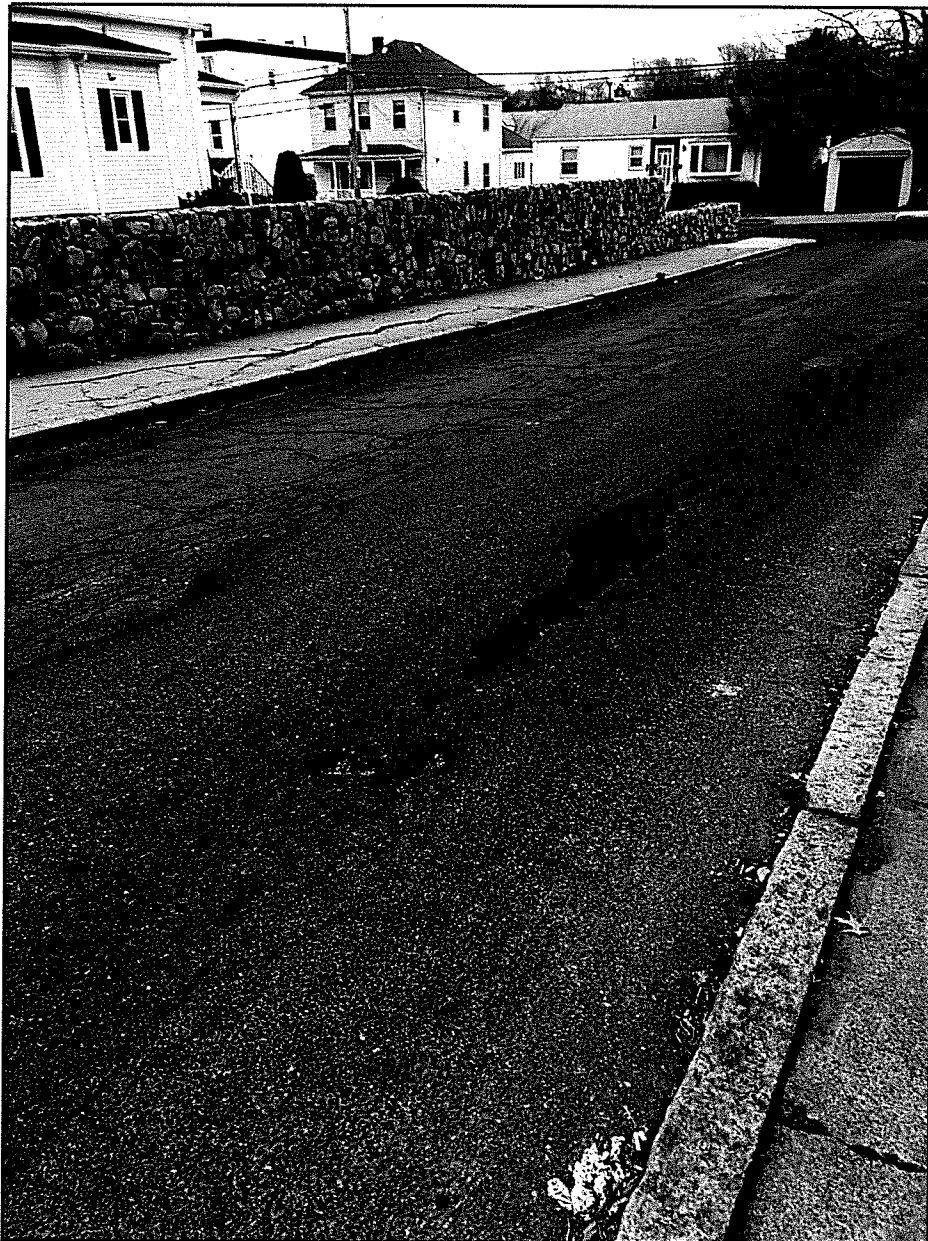
Looking south towards Mountain Ave.

Alligator cracking is breaking up.  
Pothole repairs shown.

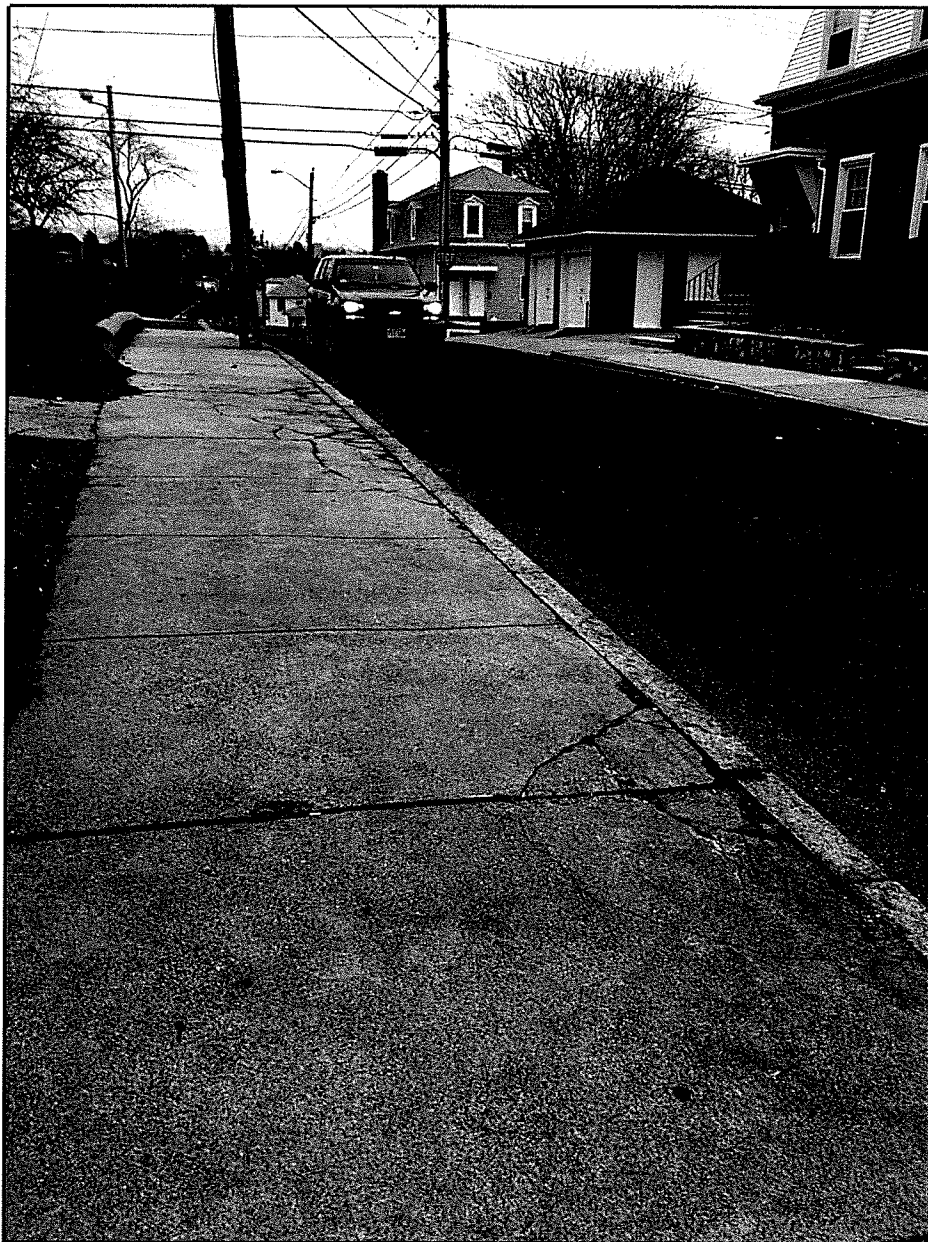
Looking north towards Proctor

Photo shows more broken sidewalk panels on the west side of Adams between Mountain Ave. and Proctor

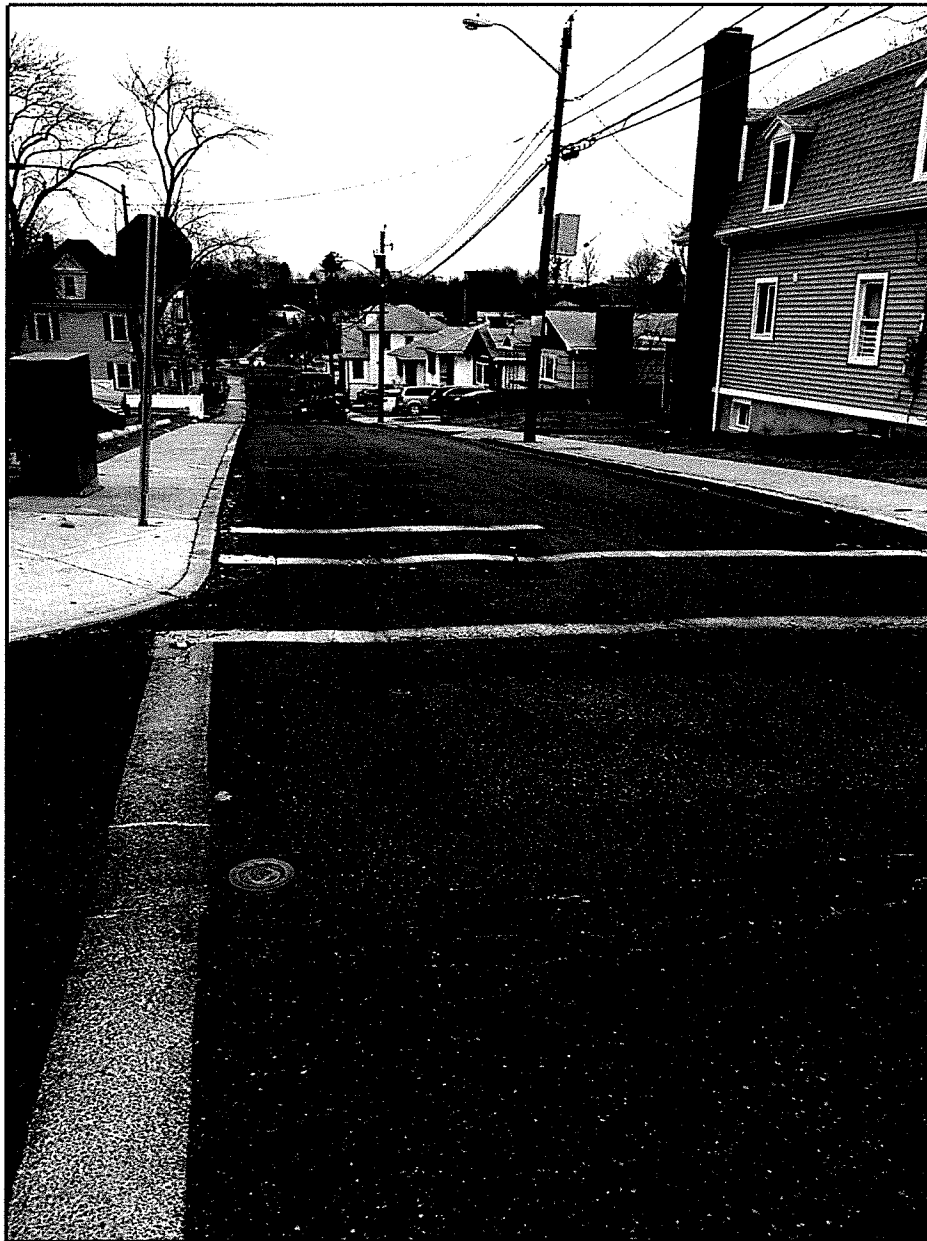
At Proctor looking north

Curb and sidewalk in good condition.

Road has various patches, utility trenches and potholes along this stretch

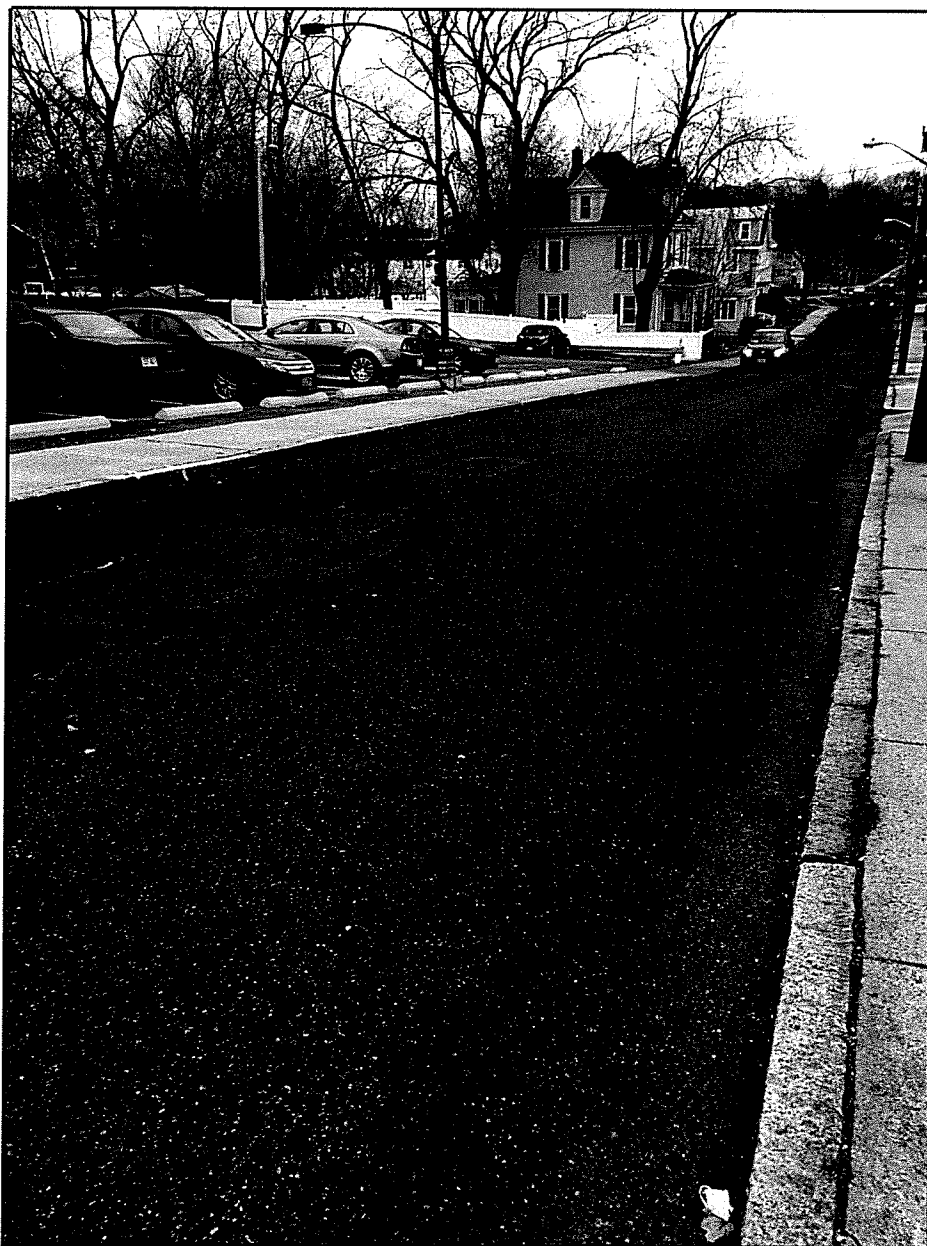
Continuing north towards Constitution Ave.  
Curb and sidewalk remains in good condition.  
Road shows cracking and settlement at utility  
trenches.

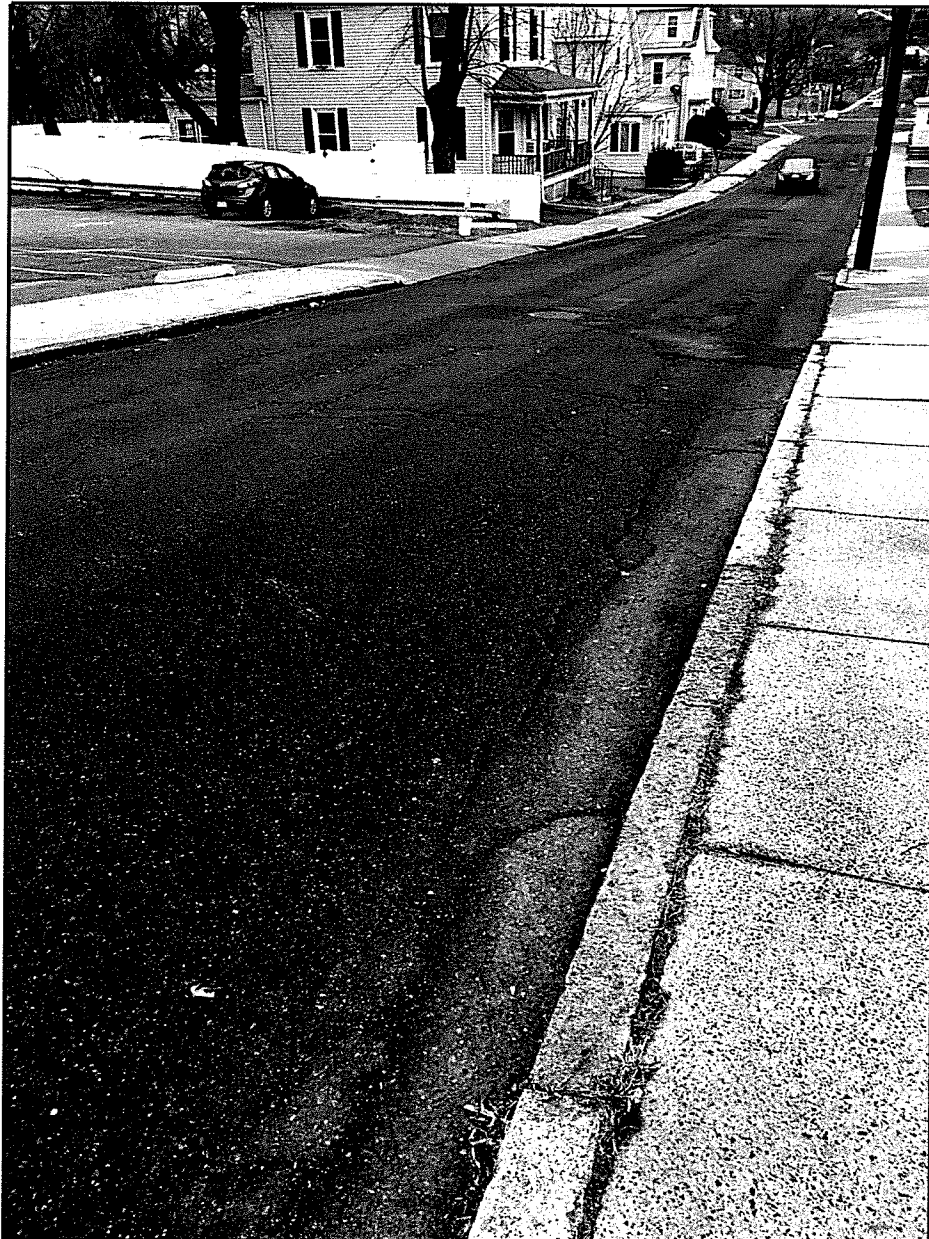
Continuing north towards Constitution Ave.

Curb and sidewalk remains in good condition.

Cracked condition of roadway continues.  
Worsens toward gutter. Extreme settlement of  
the roadway not observed.

Milling and paving recommended

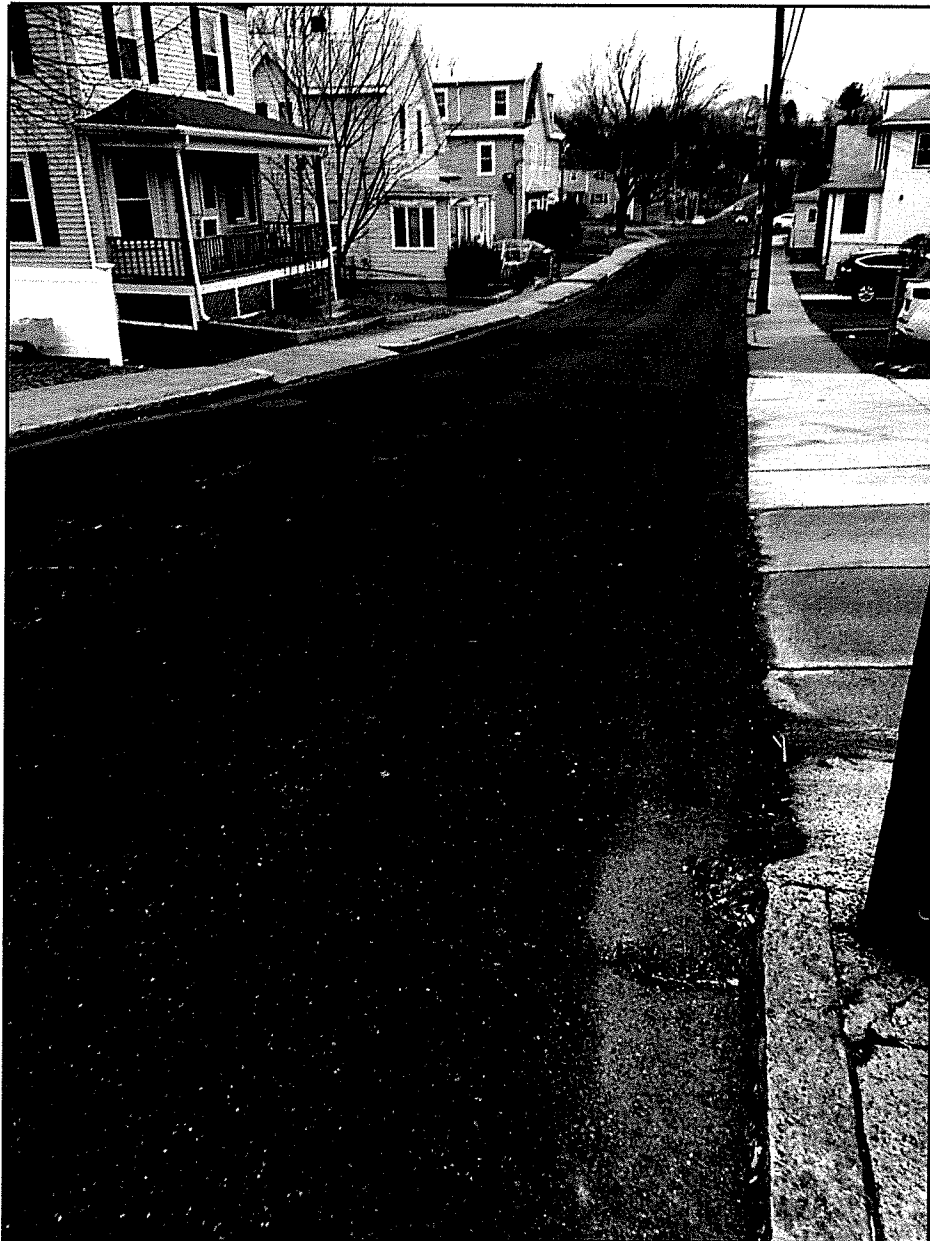
Continuing north towards Constitution Ave.

Curb and sidewalk remains in good condition.

Cracked condition of roadway continues.  
Worsens toward gutter. Extreme settlement of  
the roadway not observed.

Milling and paving recommended

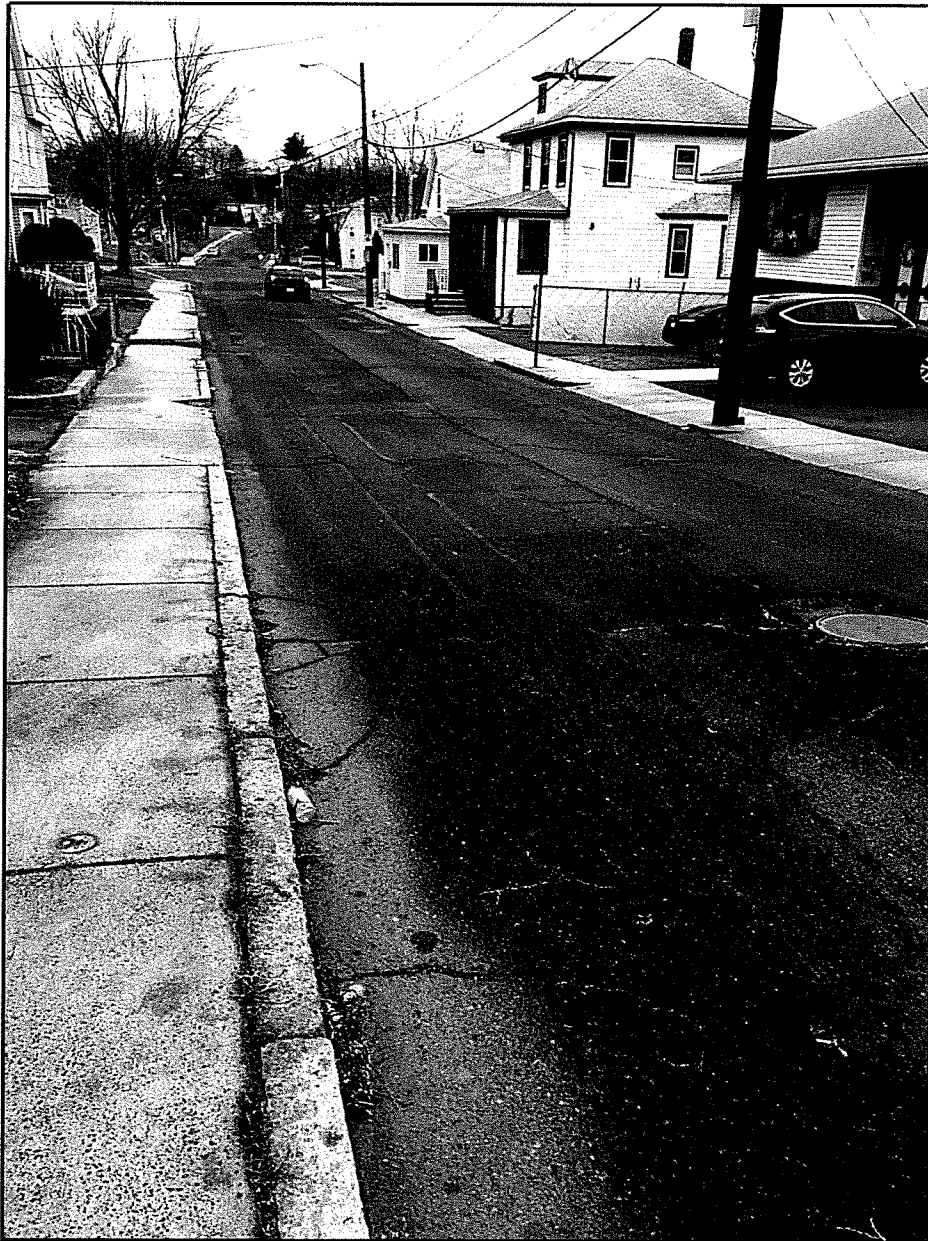
Continuing north towards Constitution Ave.

Curb and sidewalk remains in good condition.

Cracked condition of roadway continues.  
Worsens toward gutter. Extreme settlement of  
the roadway not observed.

Milling and paving recommended

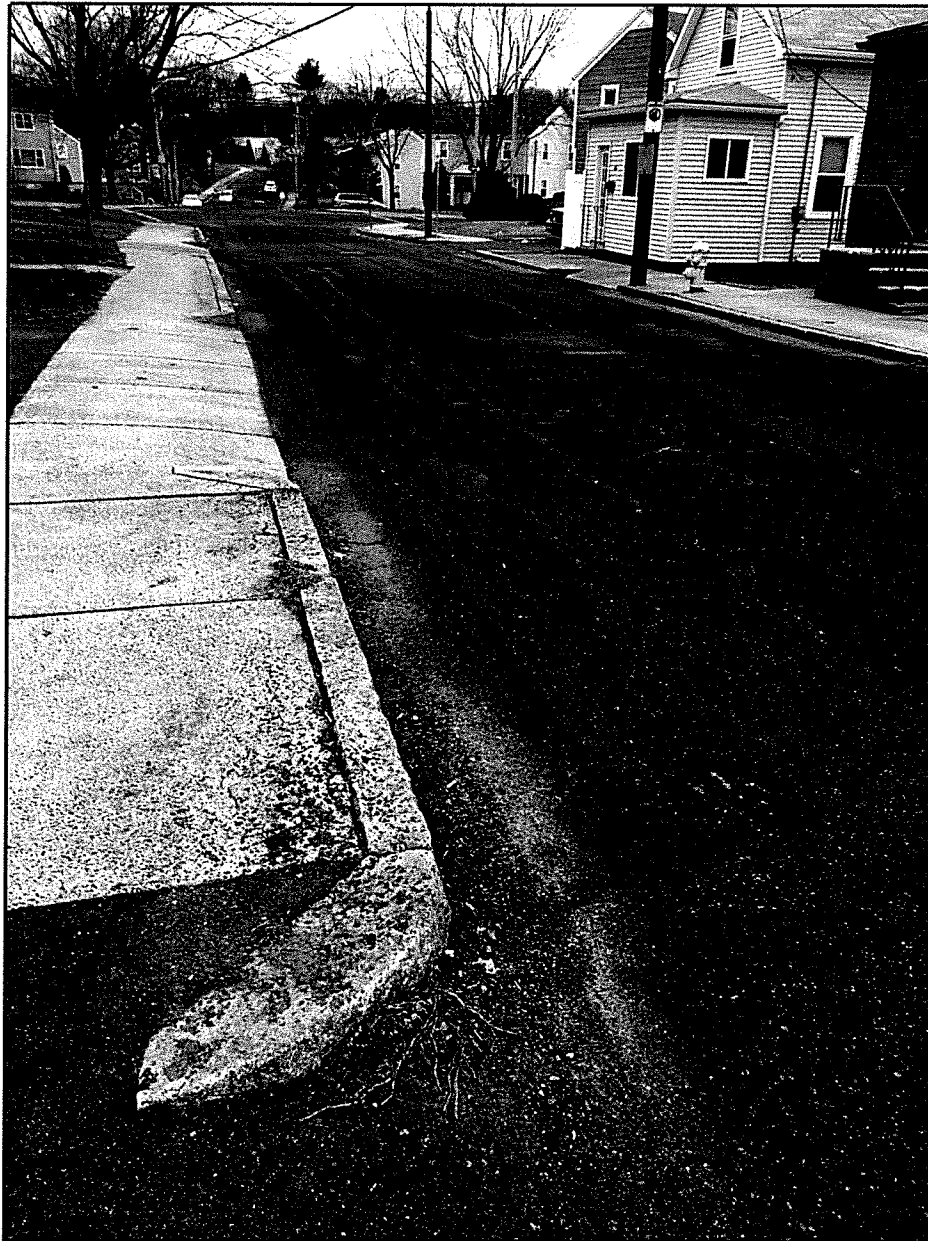
Continuing north towards Constitution Ave.

Curb and sidewalk remains in good condition.

Pothole and pothole repairs shown where alligator cracking has broken away from the road.

No extreme settlement at utility trenches shown.

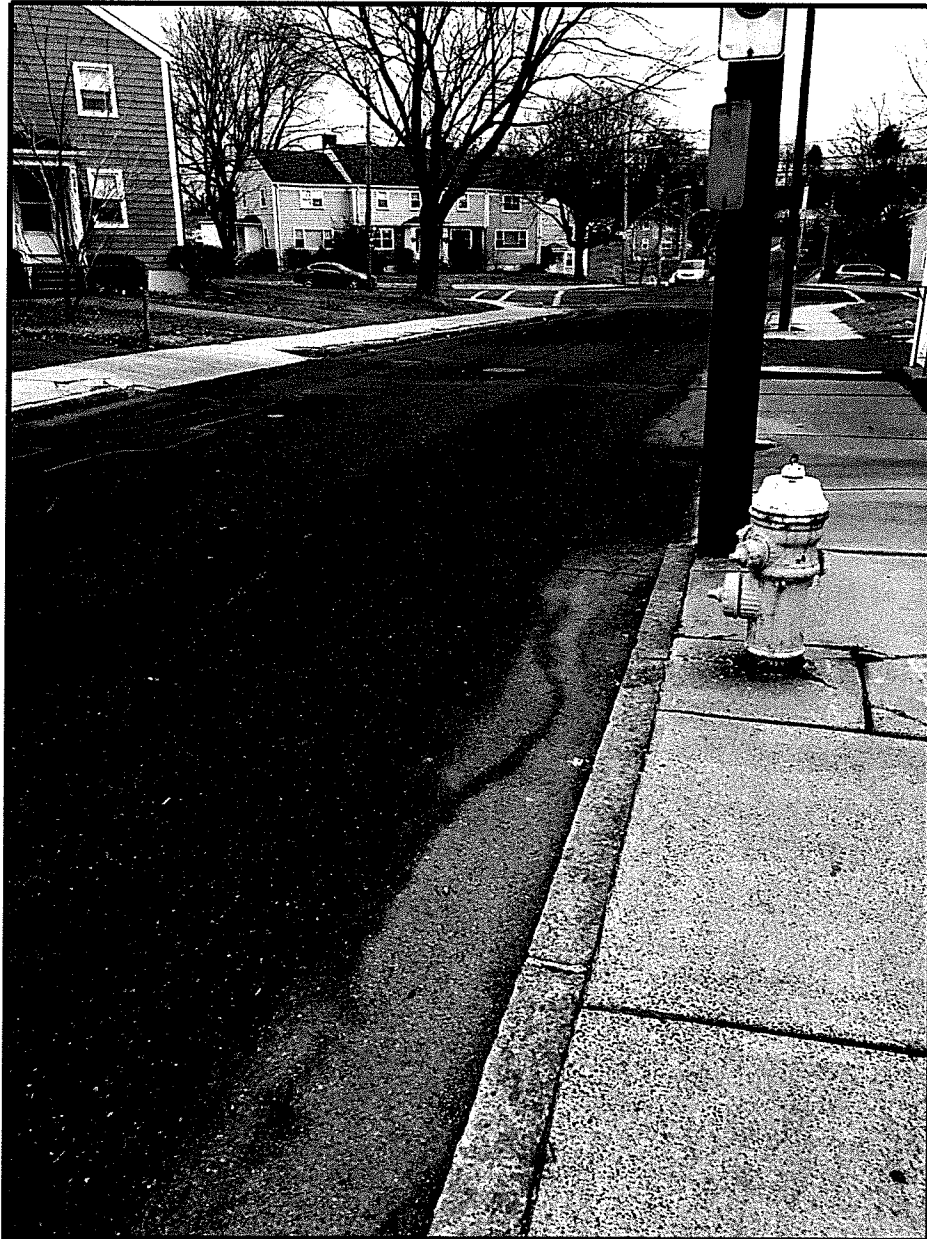
Continuing north towards Constitution Ave.

Typical condition of curb, sidewalk and roadway shown. Alligator cracking will begin to break away from roadway soon.

In addition to the sidewalk spot repairs, the fire hydrant shown in photo 12 should also be replaced ahead of the paving operation. The hydrant can be replaced under DPCD-2015-1014 - Fire Hydrant Replacement Contract. Under that contract, the hydrant items themselves have been exhausted, but sufficient funds under the contract are available and the replacement can be completed under a change order. The Contractor R&D Site Development has been made aware of the fire hydrant and has verbally agreed to complete the work asap come spring.

Fire hydrant requires replacement prior to paving the roadway. Can be completed under Hydrant Contract DPCD-2015-1014 in early spring. Funding and Contract both in place.

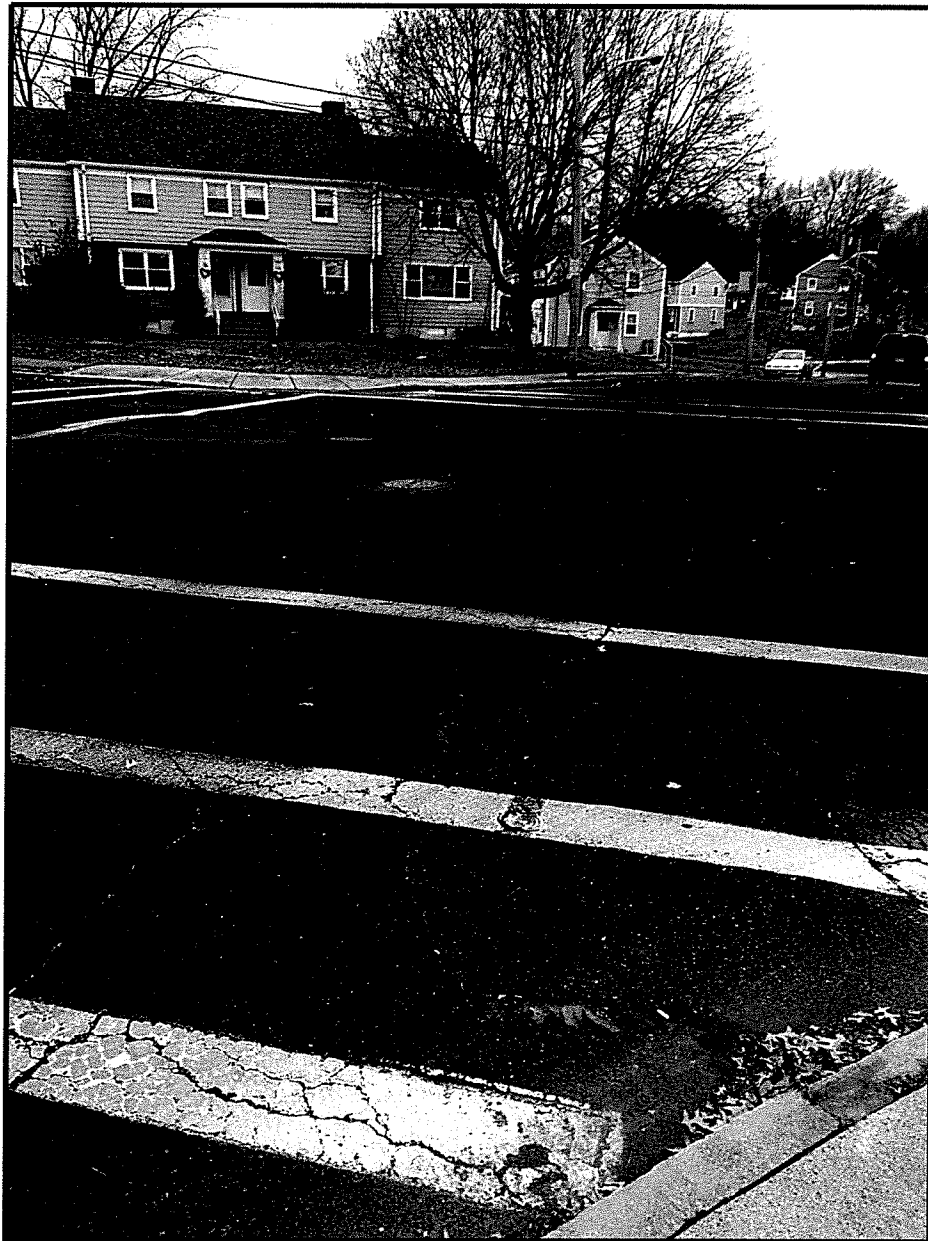
Intersection of Constitution Ave.

Very large intersection as Adams widens at this location.

Many utility castings exist in this intersection

Recommend milling and paving through the intersection.

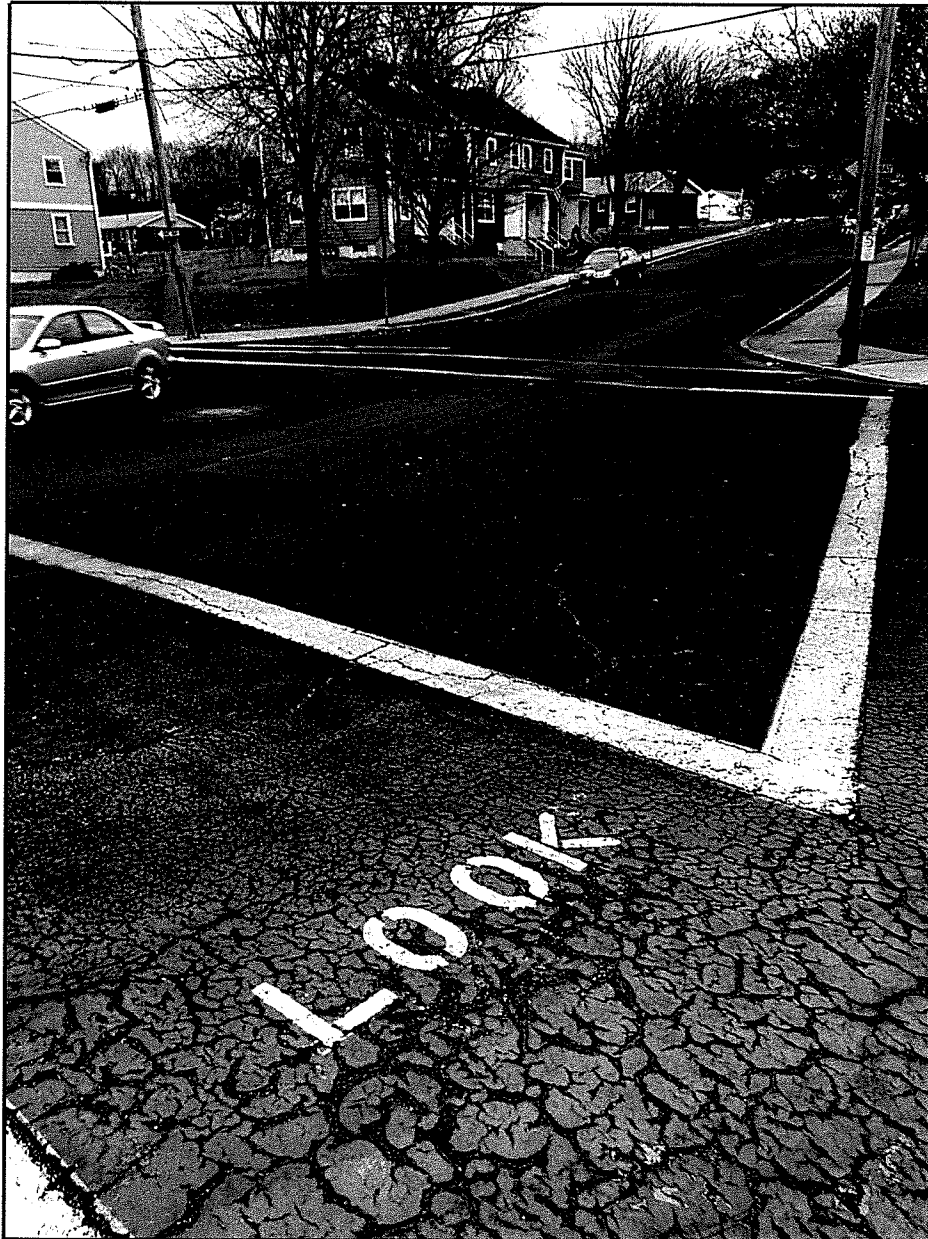
At Constitution Ave. Looking North

Cracking of roadway can be seen in this photo.

Lastly, the crosswalks at Constitution Ave and Cooledge Street must be re-stripped as soon as possible upon final paving. Striping of crosswalks is typically completed under a DPW contract and coordinated by Paul Argenzio and has not been included in the estimate due to a separate striping budget. DPW will be kept in the loop regarding the construction schedule as project approvals are obtained from the Mayor's office and a firm schedule is established.

Painted crosswalks shown. City should consider options for crosswalk striping and have measures in place to stripe crosswalks asap after the street is paved as this is a heavily traveled pedestrian intersection.

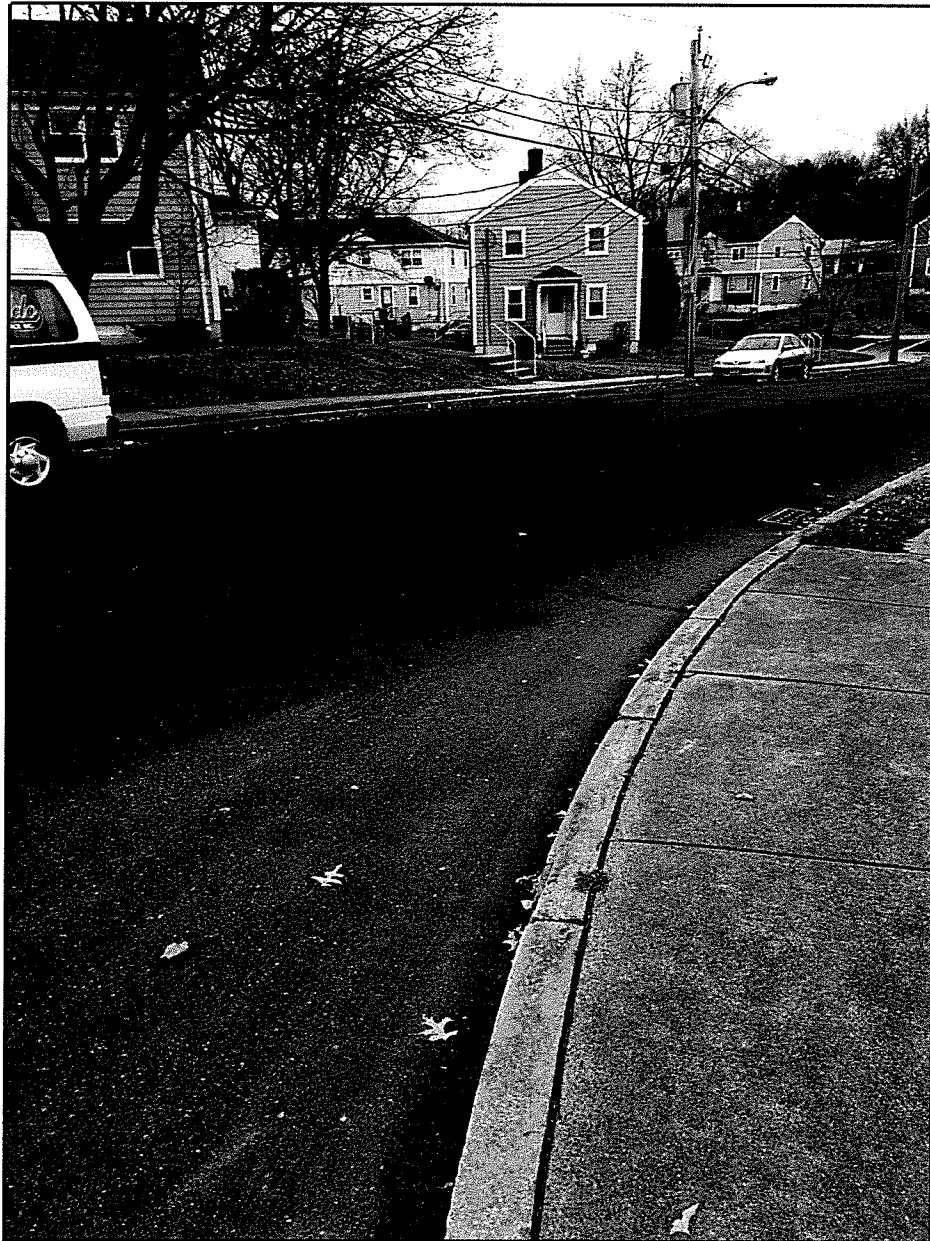
Continuing north on Adams

Condition of the roadway relatively consistent as we travel north.

Curb and sidewalk in good condition.

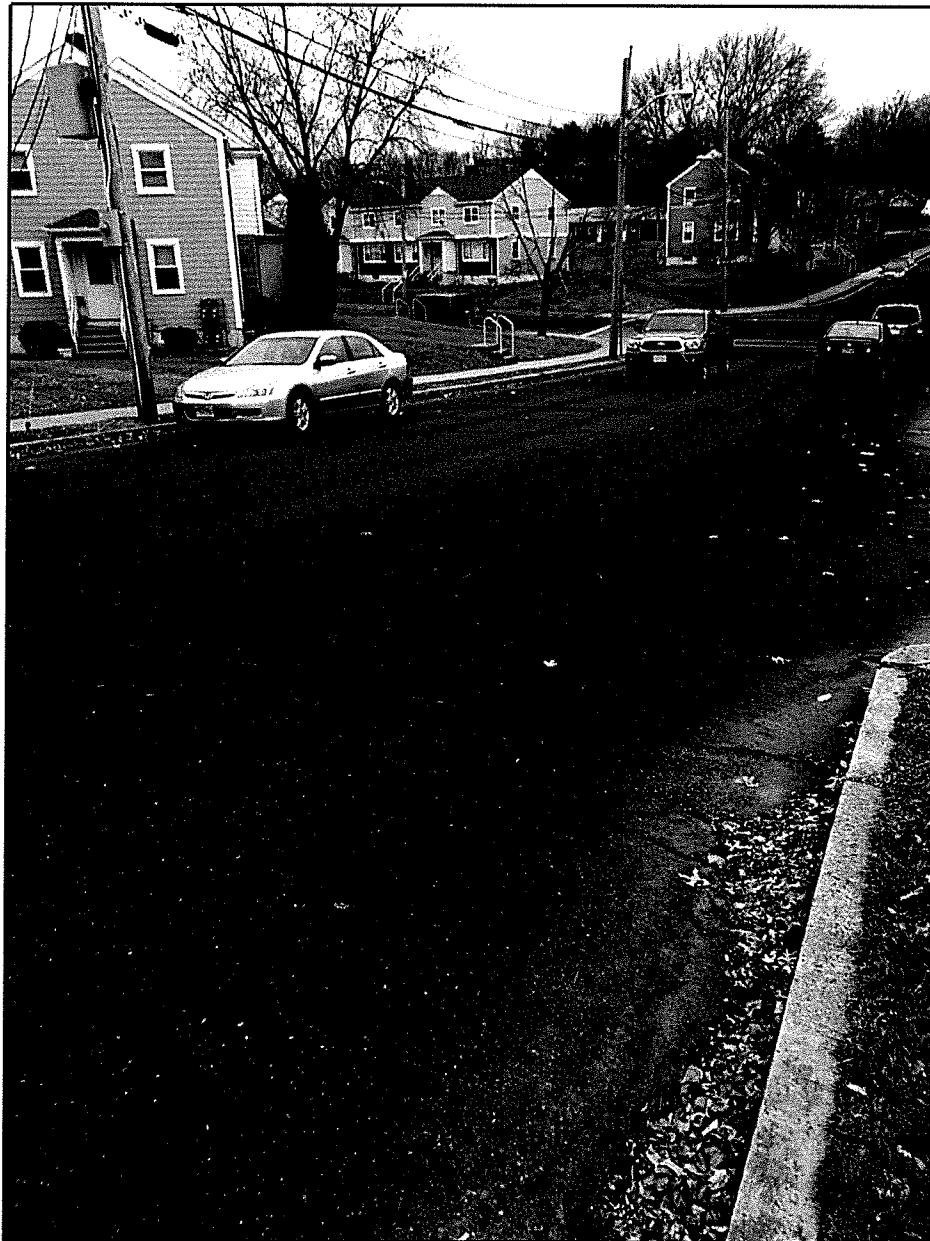
Continuing north on Adams

Condition of the roadway relatively consistent as we travel north.

Curb and sidewalk in good condition.

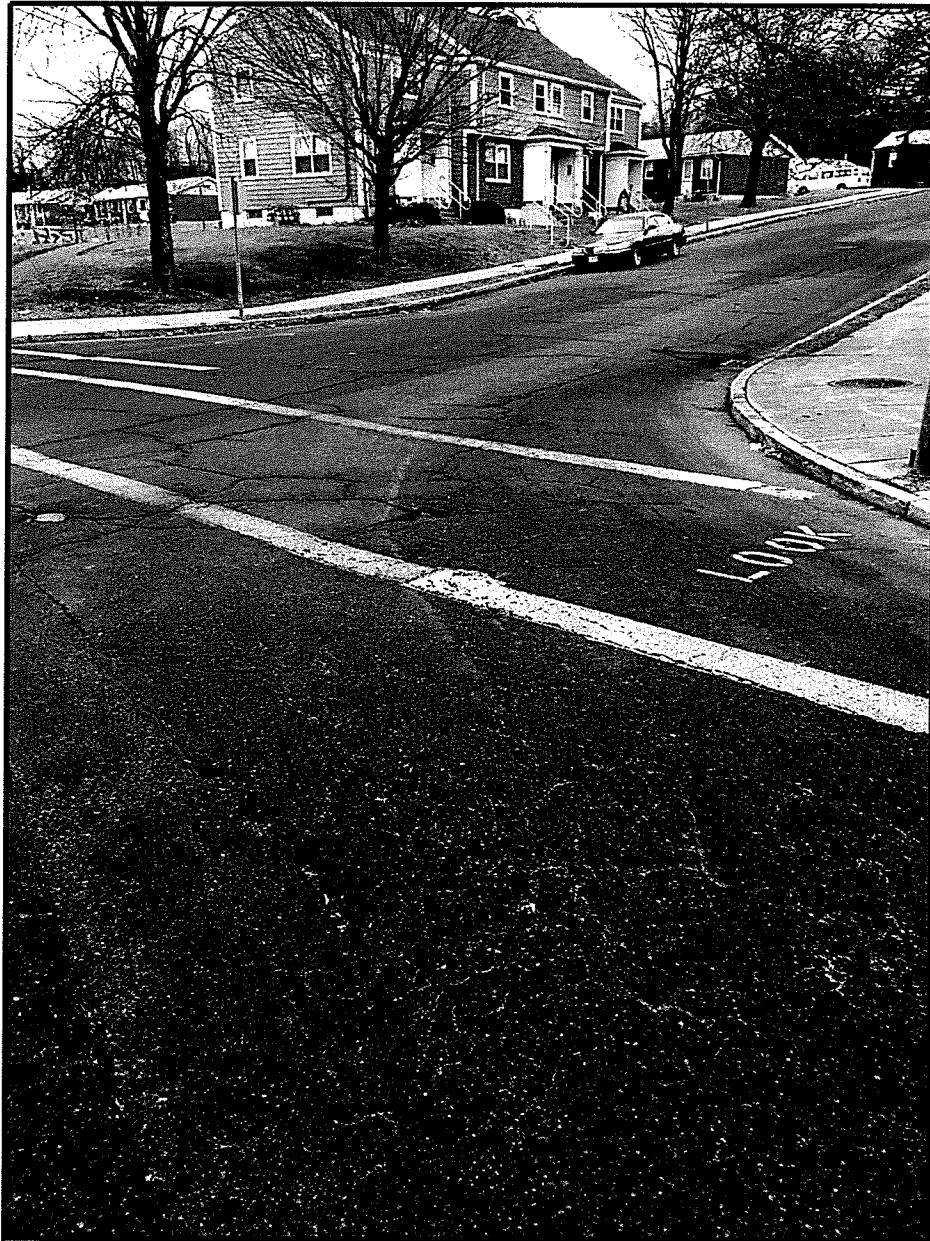
Continuing north on Adams

Condition of the roadway relatively consistent as we travel north.

Curb and sidewalk in good condition.

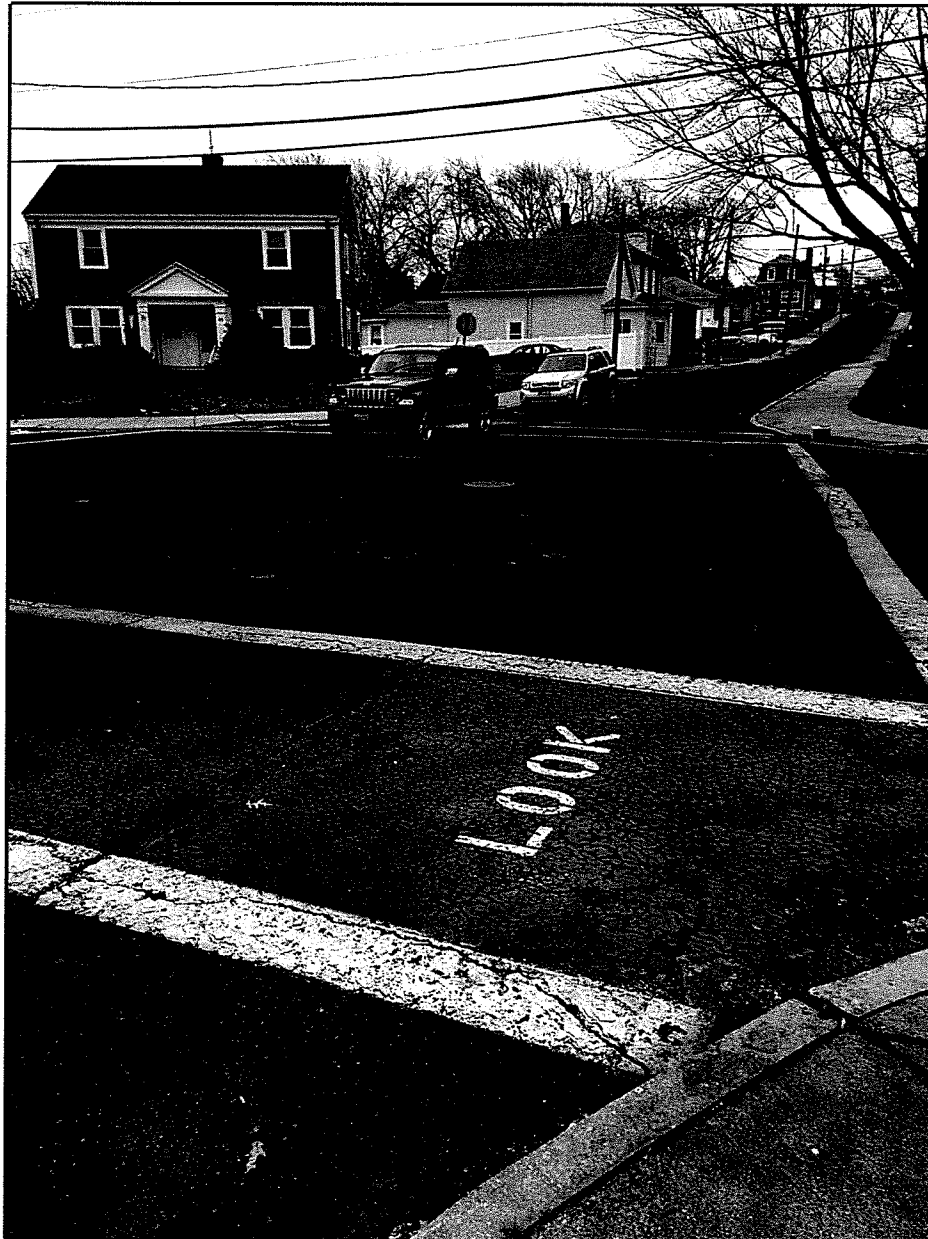
Continuing north on Adams

Condition of the roadway relatively consistent as we travel north.

Curb and sidewalk in good condition.

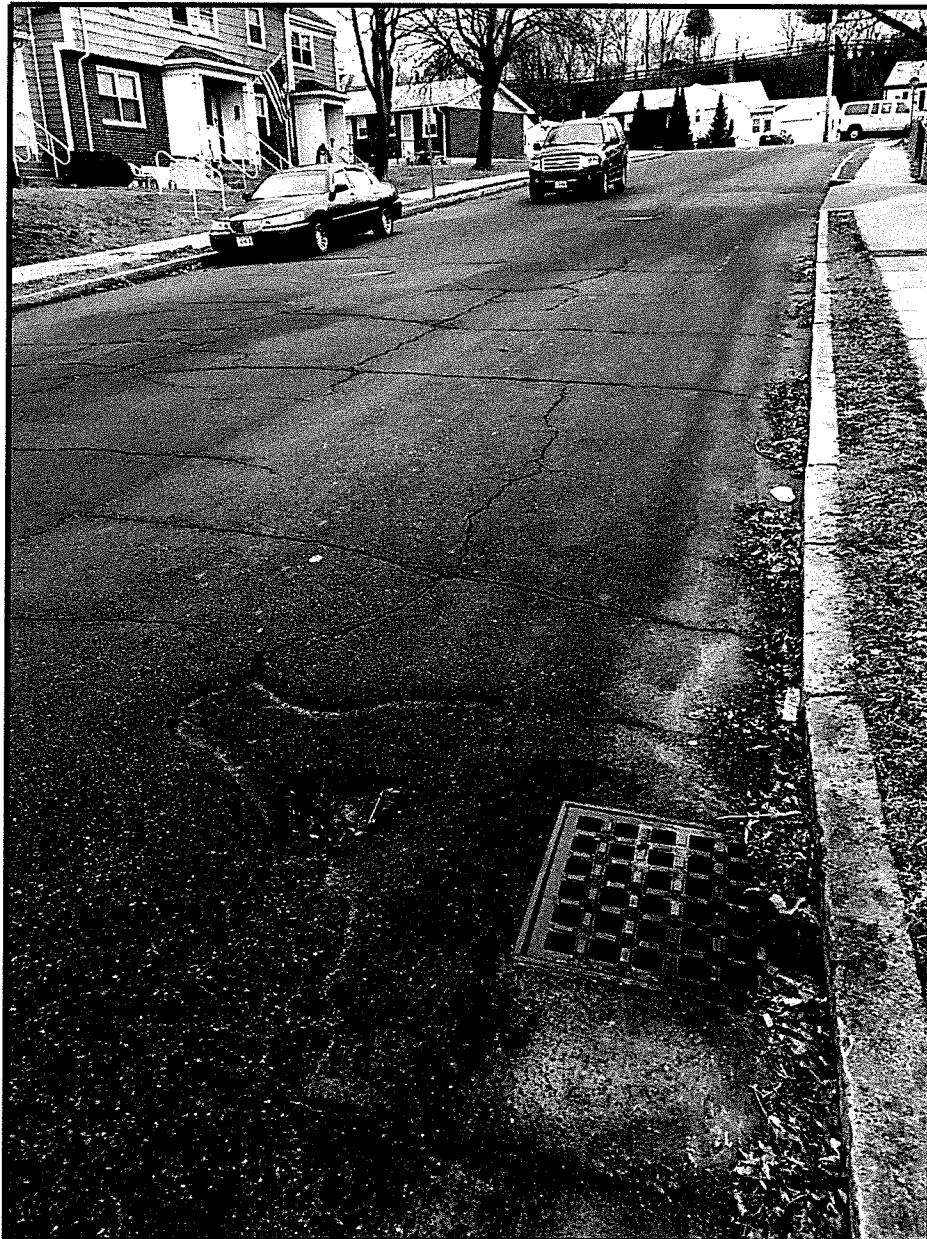
Continuing north on Adams

Condition of the roadway relatively consistent as we travel north.

Curb and sidewalk in good condition

Multiple layers of asphalt seen at pothole.

Milling and paving recommended.

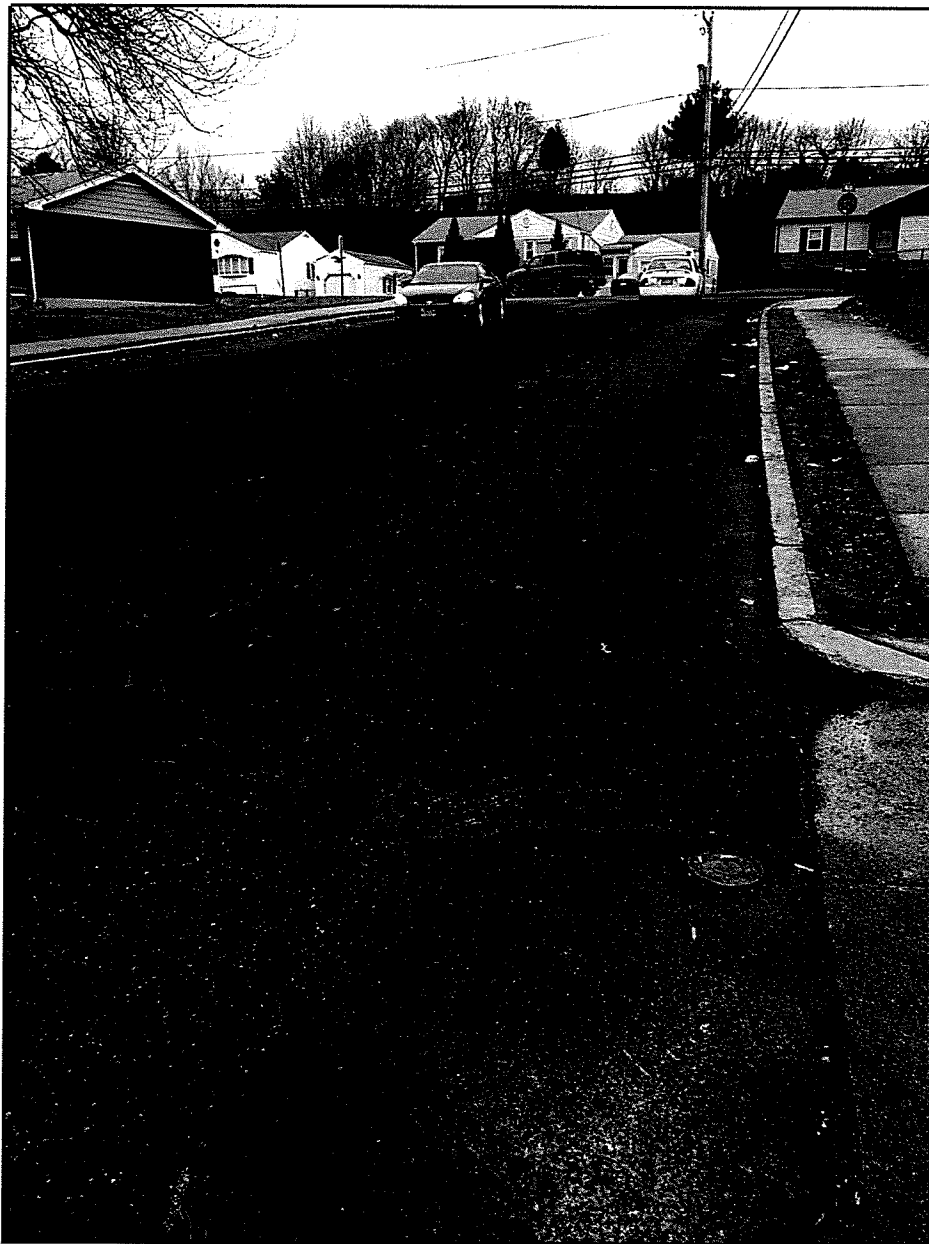
Continuing north on Adams

Condition of the roadway relatively consistent as we travel north.

Curb and sidewalk in good condition
