## PHASE 1 - FEASIBILITY ANALYSIS

### Adams Street

(Mountain Ave. to Cushman Ave.)

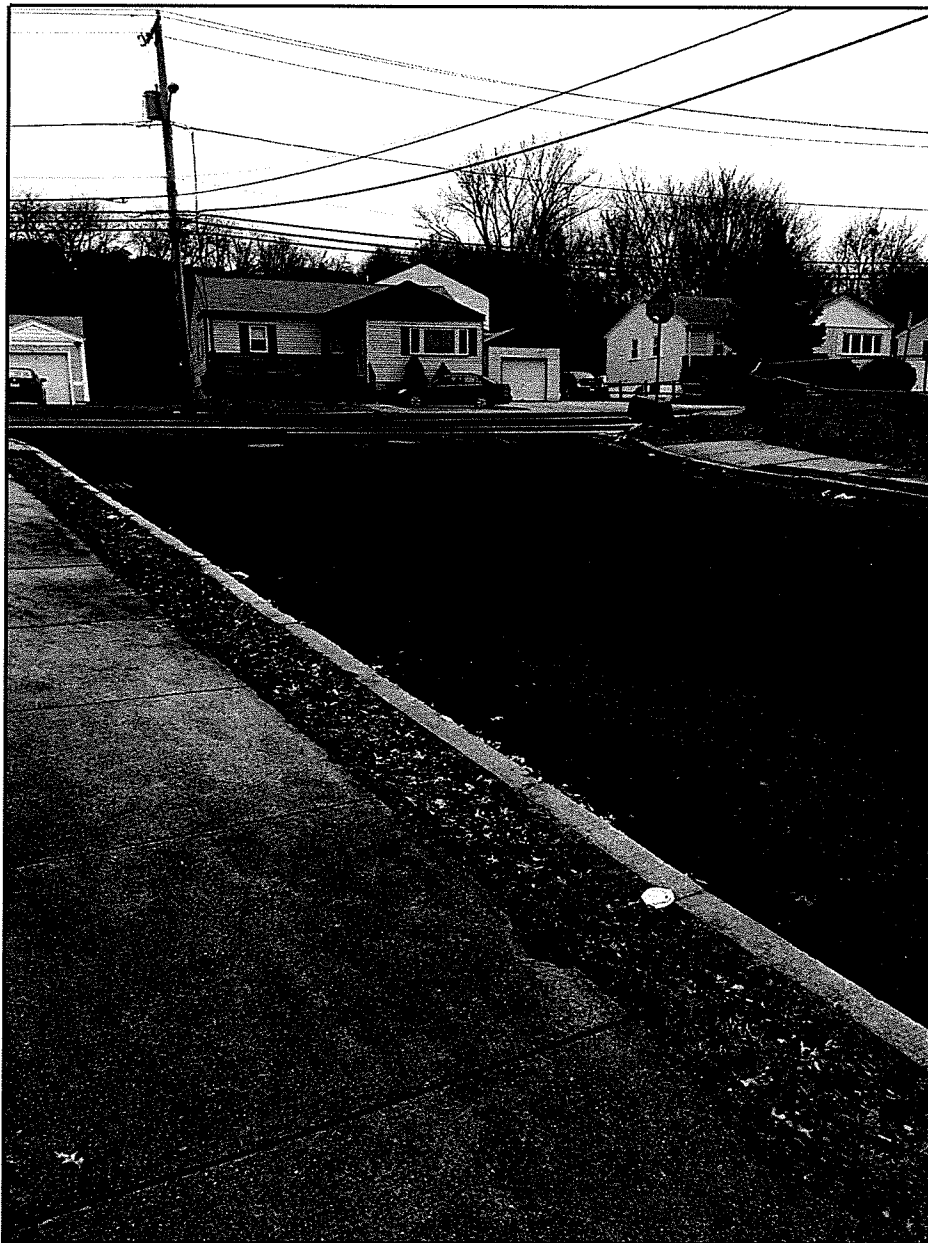
Looking north to Cushman Ave.

Condition of the roadway relatively consistent as we travel north.

Roadway appears suitable to support a milling and paving operation. Proposed operation to connect with Cushman Ave. (paved 2015) and Mountain Ave. (to be paved in 2016).
