## **PHASE 1 - FEASIBILITY ANALYSIS**

### **Essex Street**

(Park Ave. to Mountain Ave.)

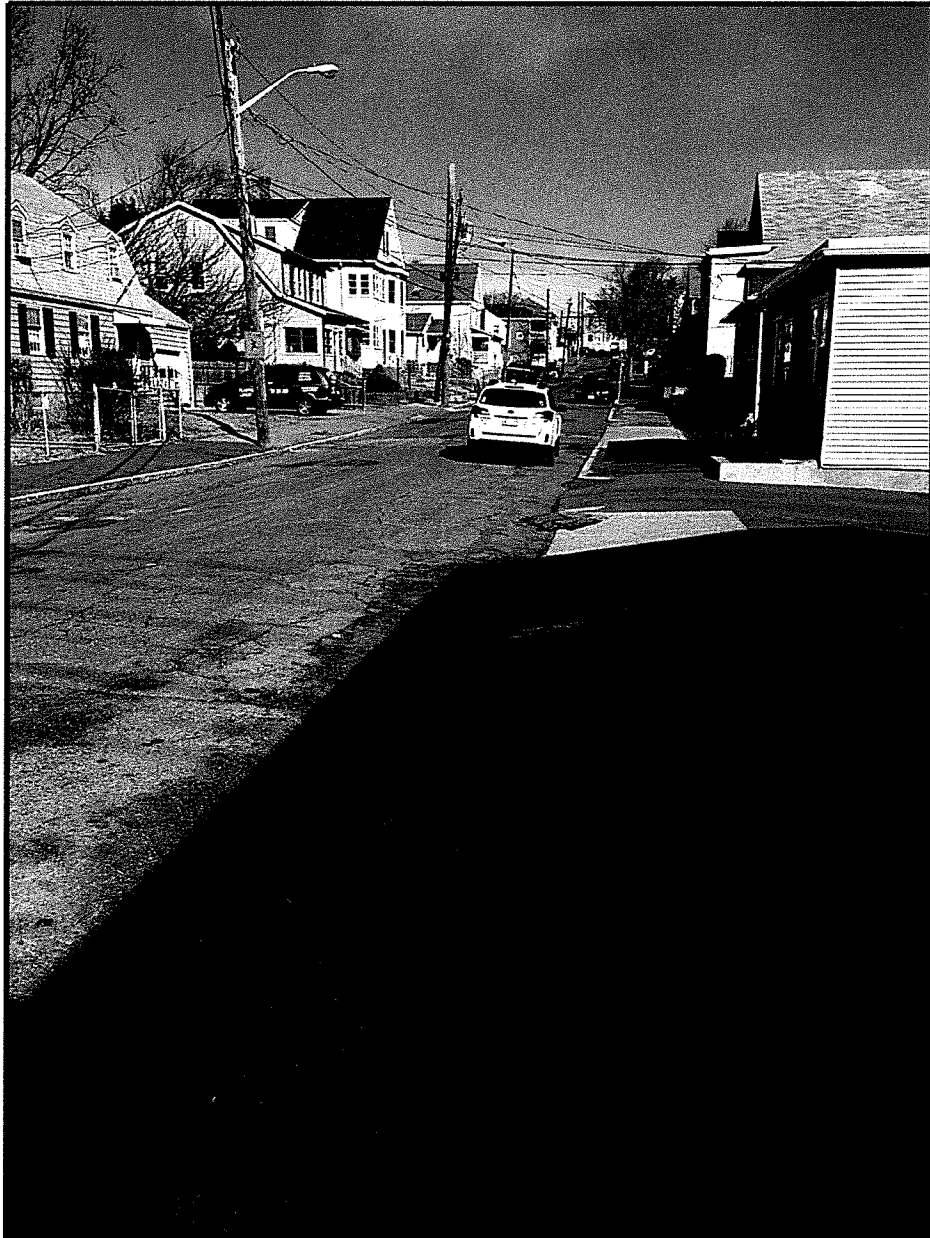
At Park Ave. looking north.

Photo shows concrete sidewalk section  
breaking up and multiple  
pothole repairs over the years.

Road is settling differentially

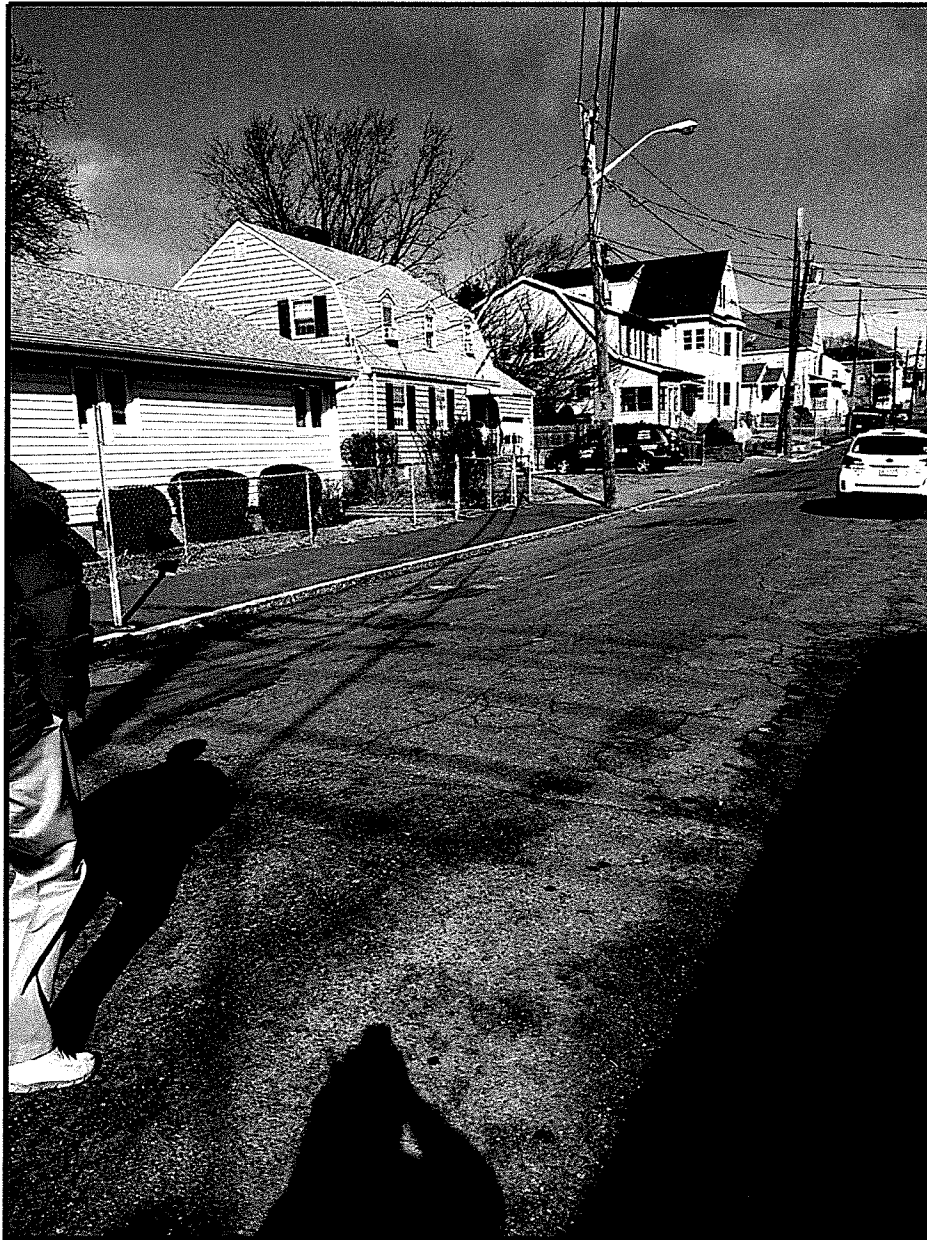
North of Park Ave. looking north.

Photo shows poor condition of pavement  
but decent condition of granite curb  
and asphalt sidewalks.

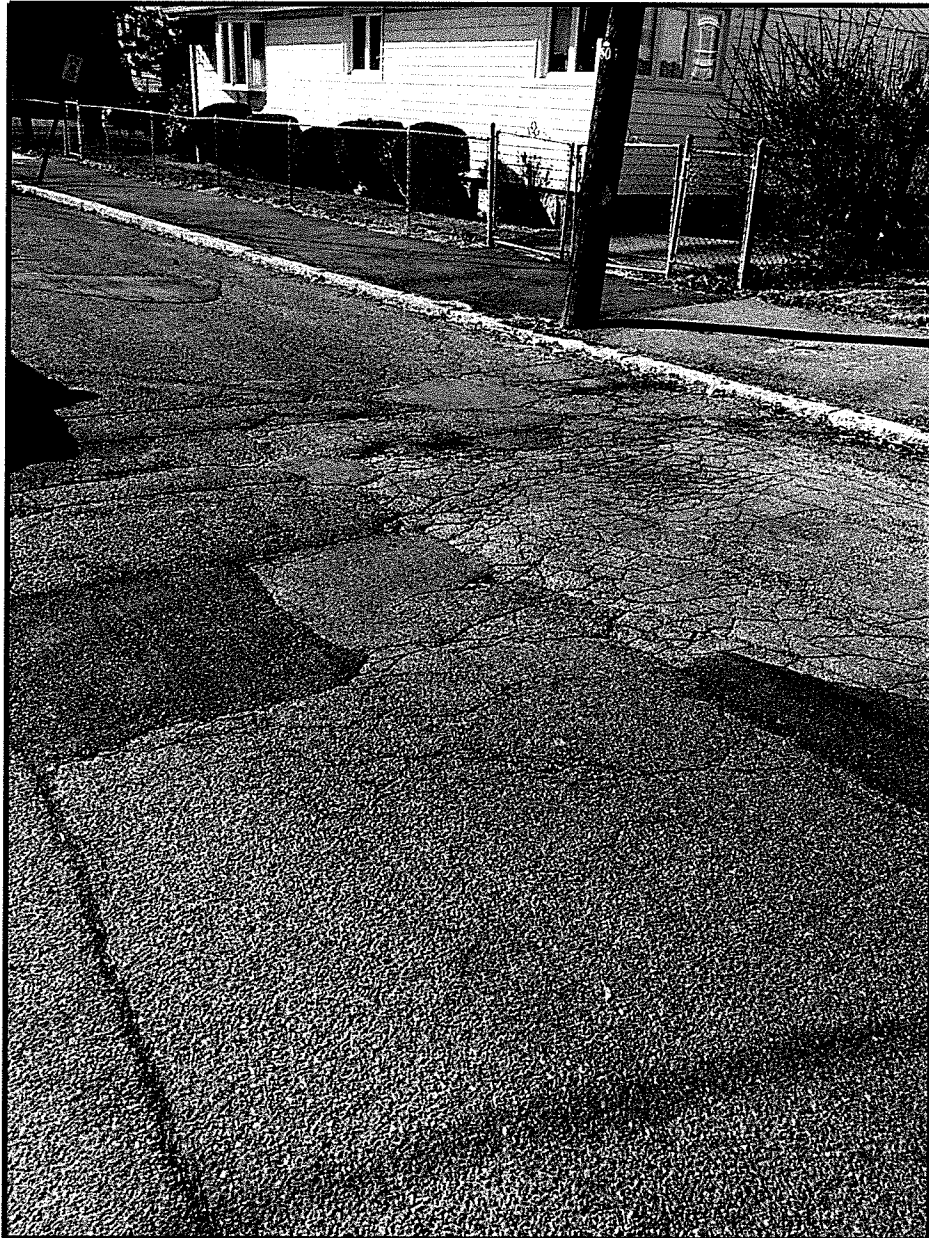
Photo showing structural failure of  
roadway and possible failure of roadway base.  
Extensive settlement and cracking.

Curb and sidewalk in decent condition.

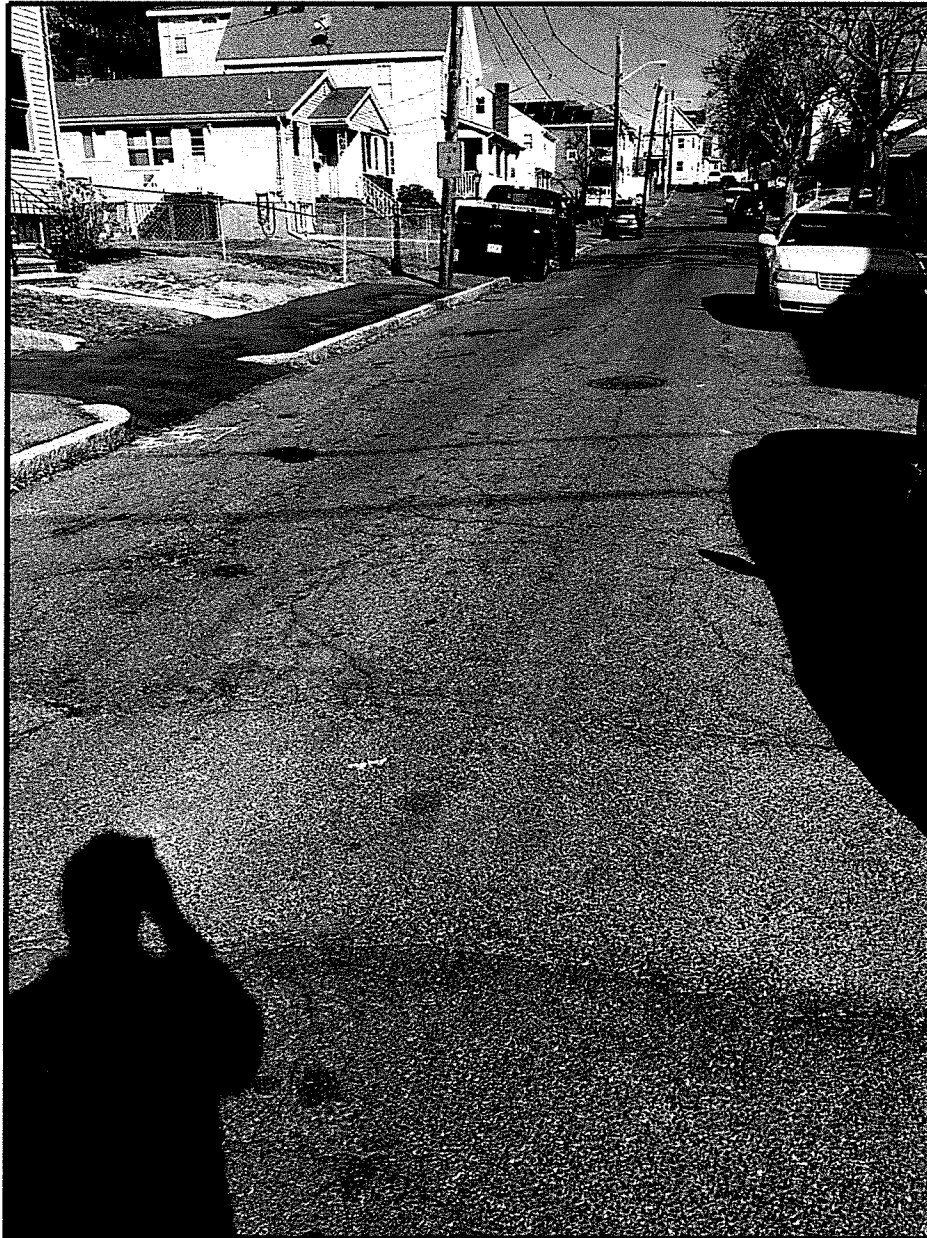
Mid-Block looking north towards Mountain Ave.

Photo shows typical condition of  
roadway, curb and sidewalks

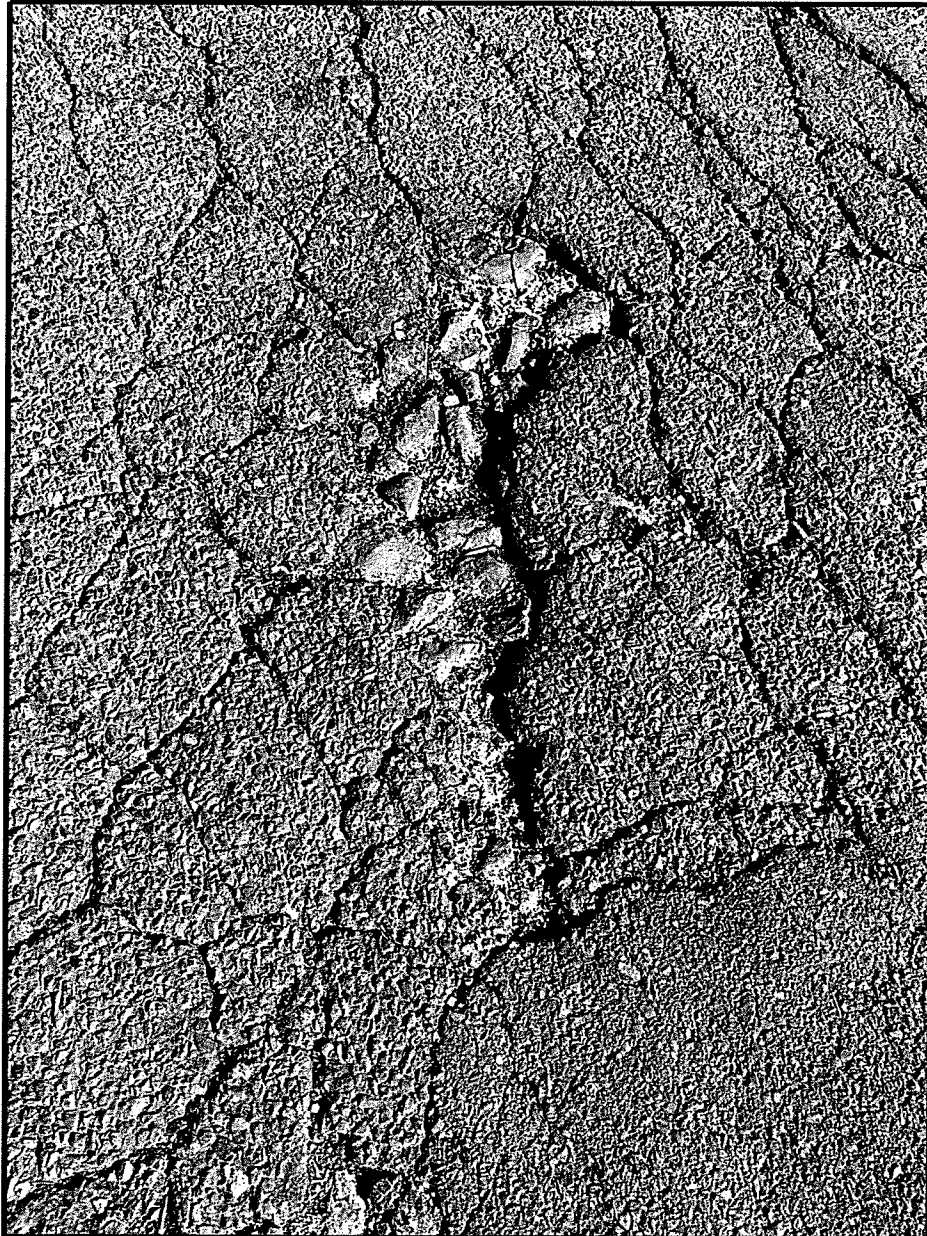
Photo shows exposed macadam.

If milled, the milling operation will take the roadway down to the base layer. Level course, binder and top course of pavement should be applied if milled.

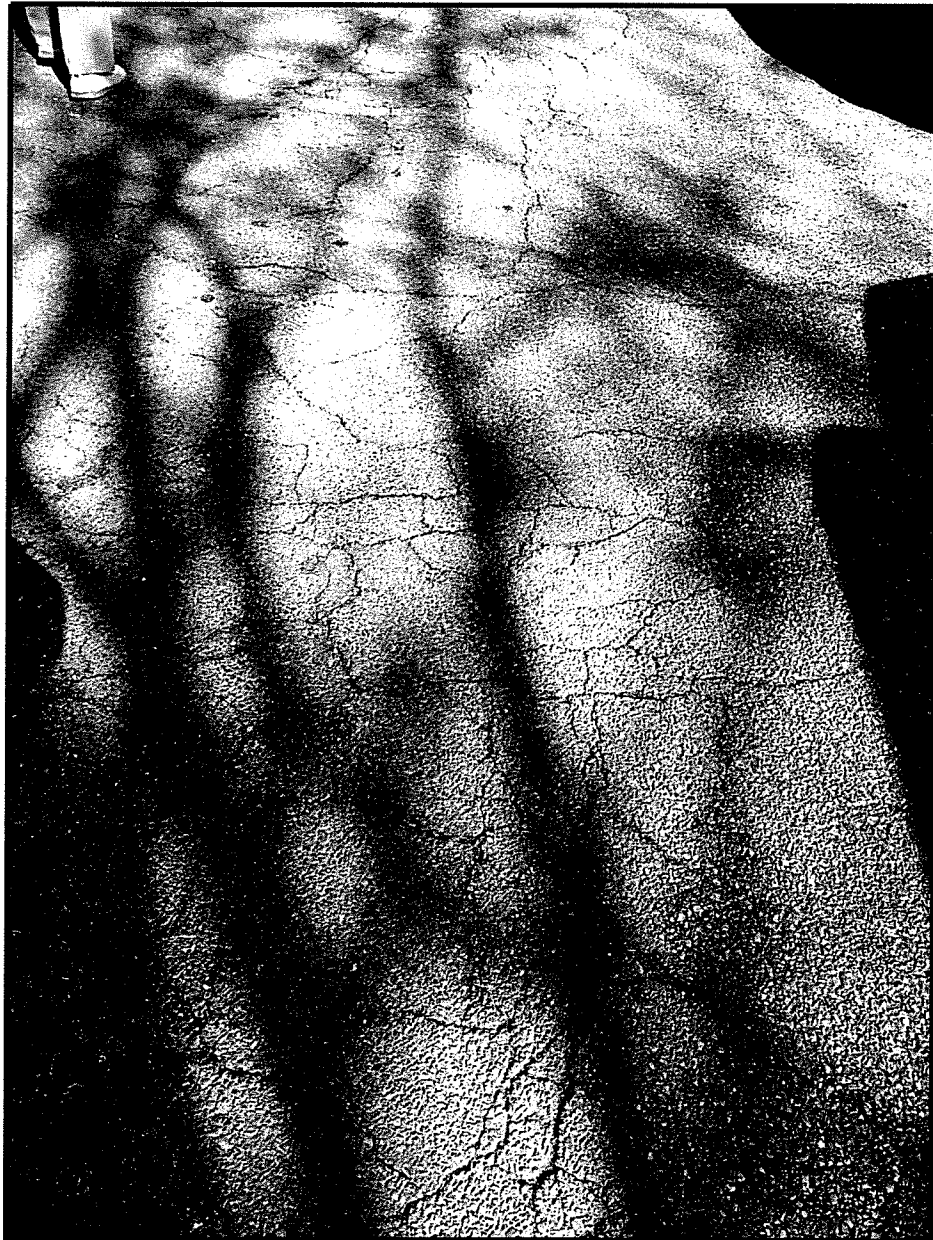
Photo showing typical roadway cracking

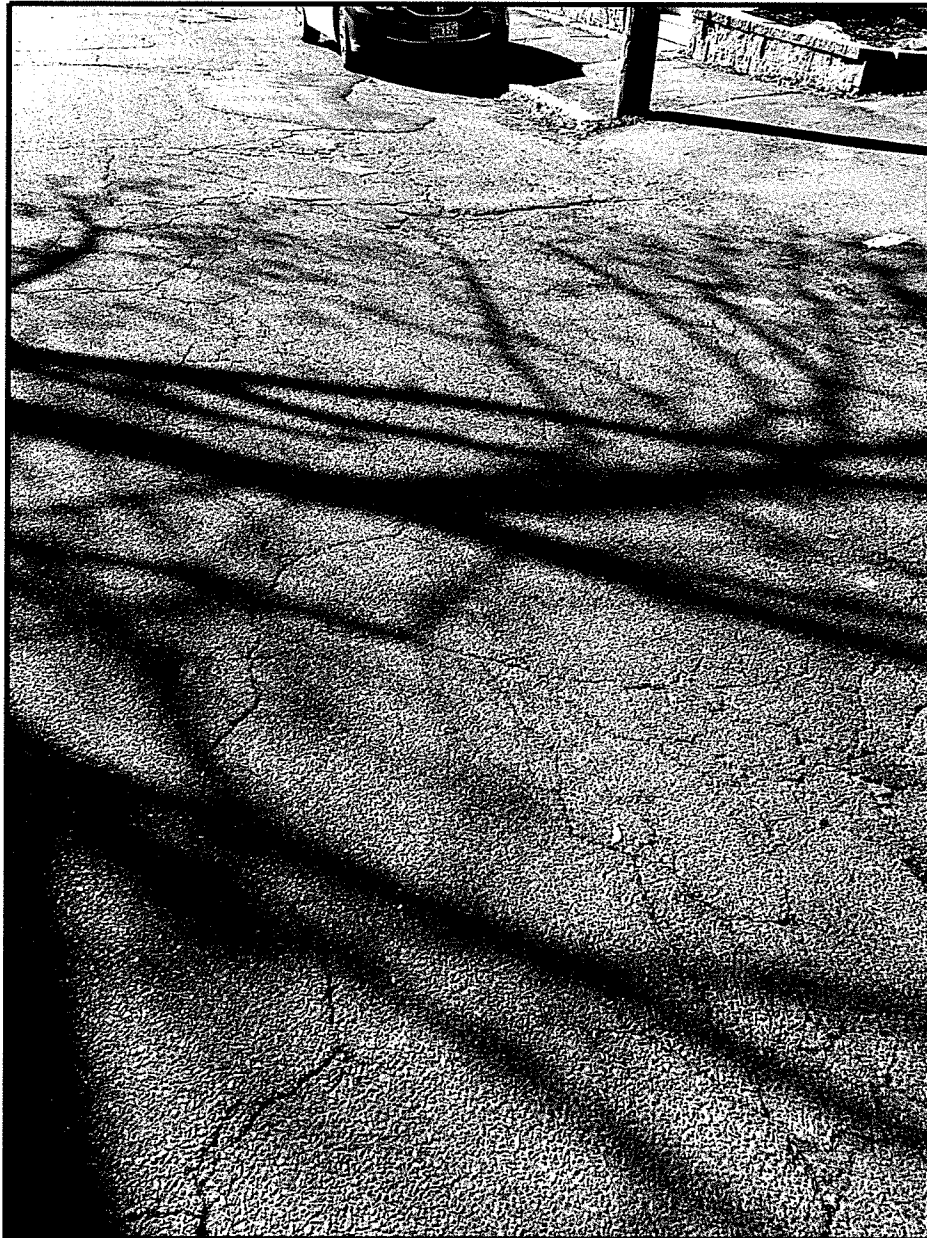
Mid-Block looking north towards Mountain Ave.

Photo shows alligator cracking of street  
and vehicles parked on sidewalk

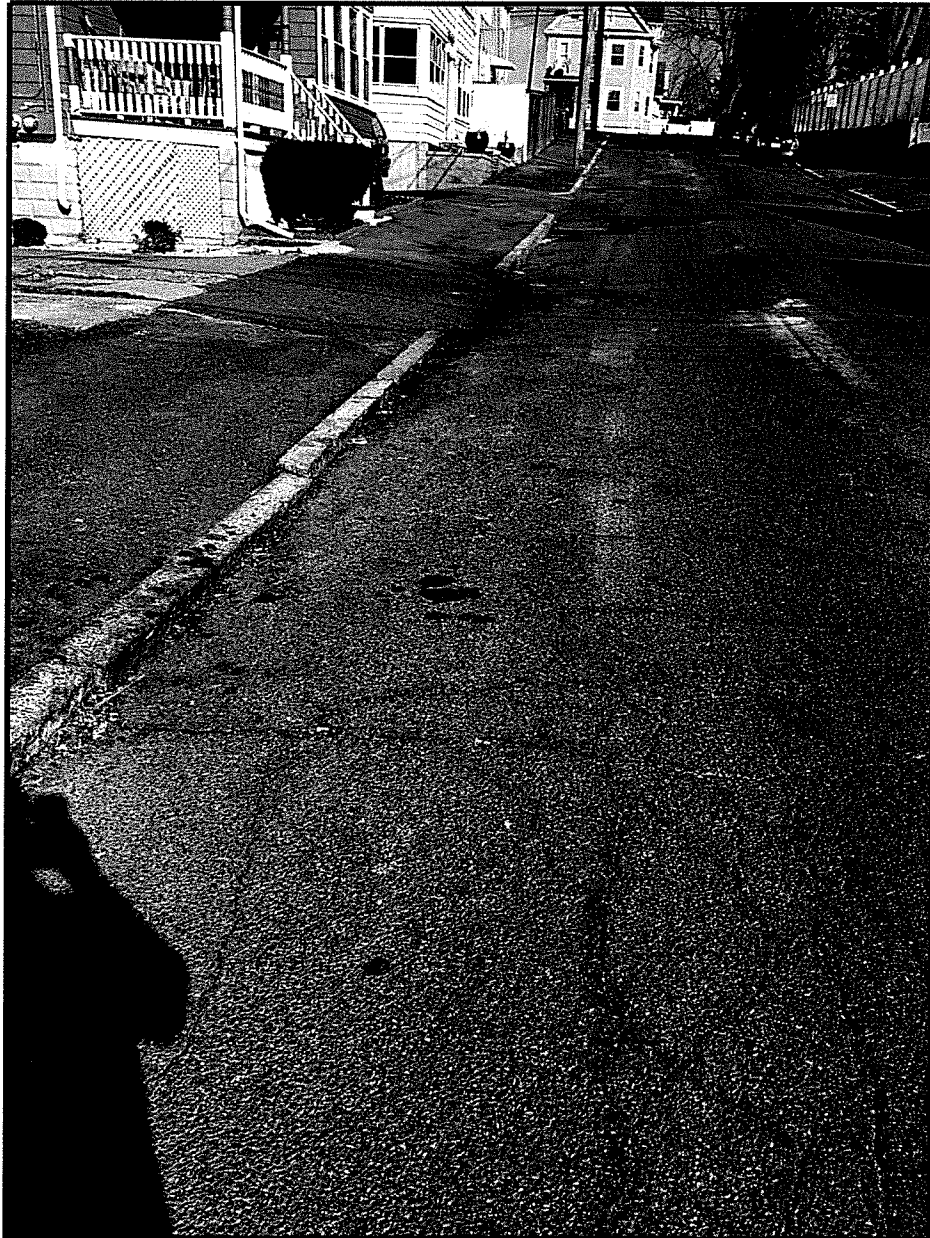
Mid-Block looking north towards Mountain Ave.

Photo shows some curb settlement but curb is mostly in decent condition.

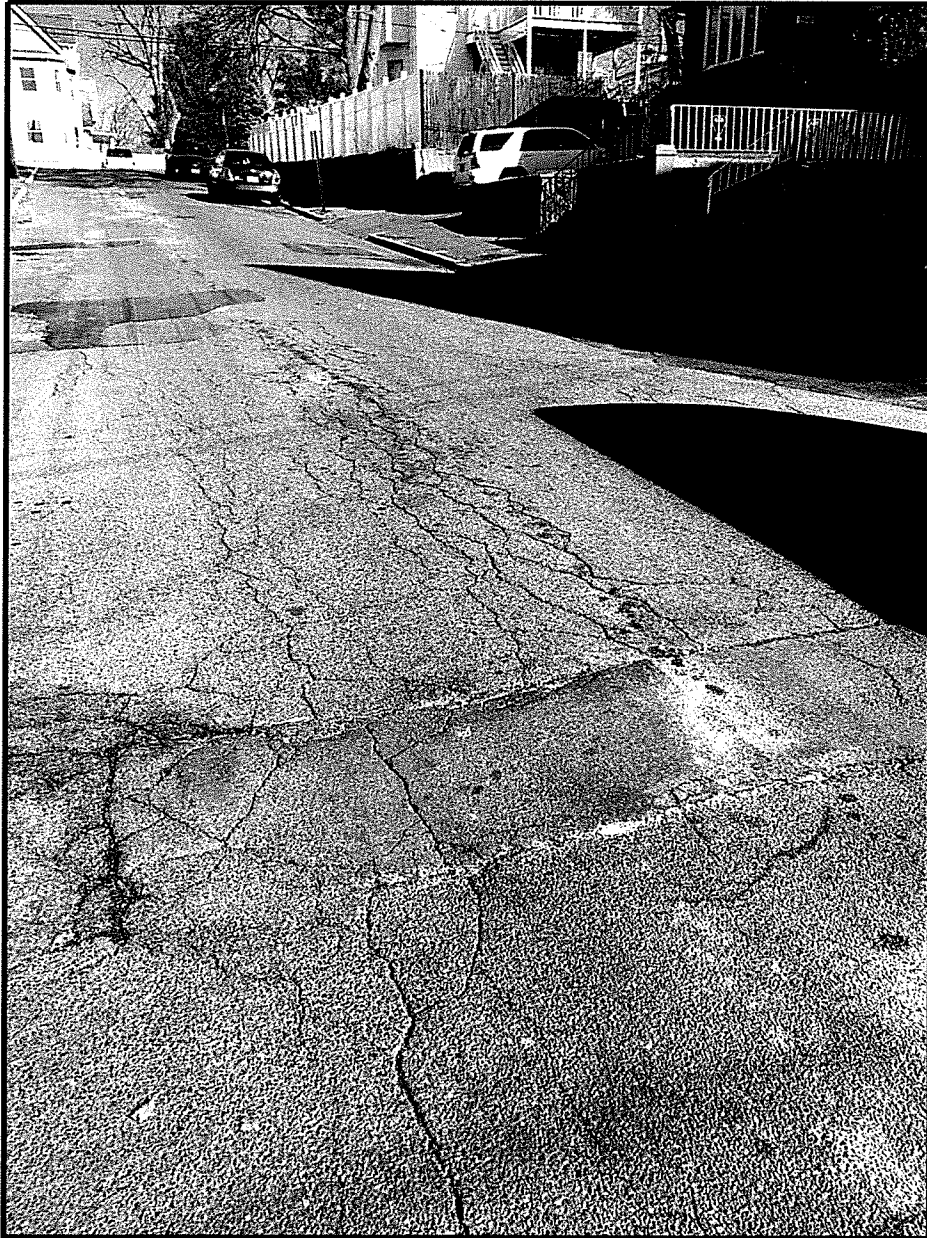
Towards the top of the street looking north  
towards Mountain Ave.

Photo shows existing pavement repairs and  
typical cracking. Some settlement of curbing  
shown as well as a poor section of  
sidewalk.

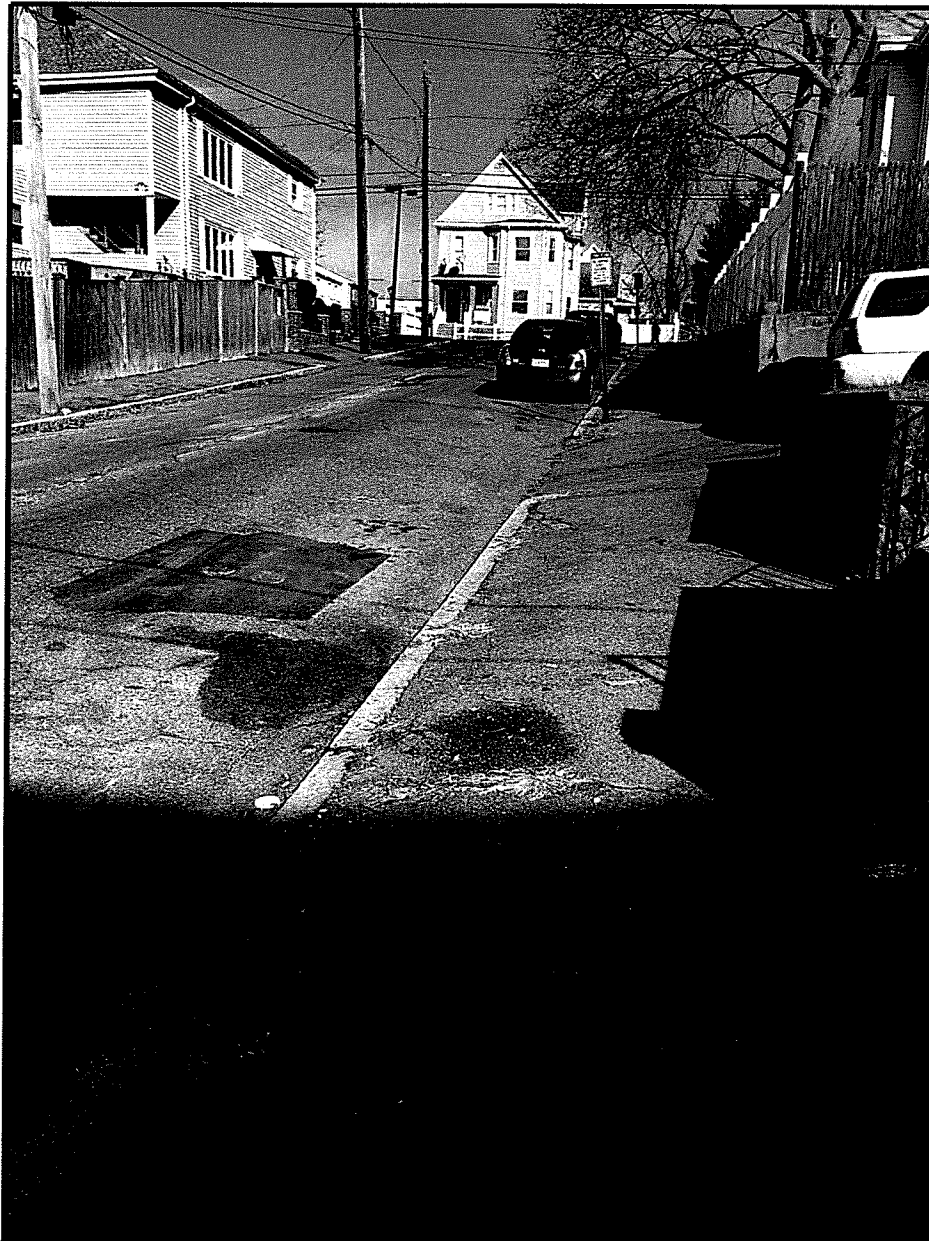
Towards the top of the street looking north  
towards Mountain Ave.

Photo highlighting poor section of  
sidewalk. Curb doesn't have 6" of reveal  
but in decent condition.
