PHASE 1 - FEASIBILITY ANALYSIS

McKinley Street

(Revere Street to Dead End)

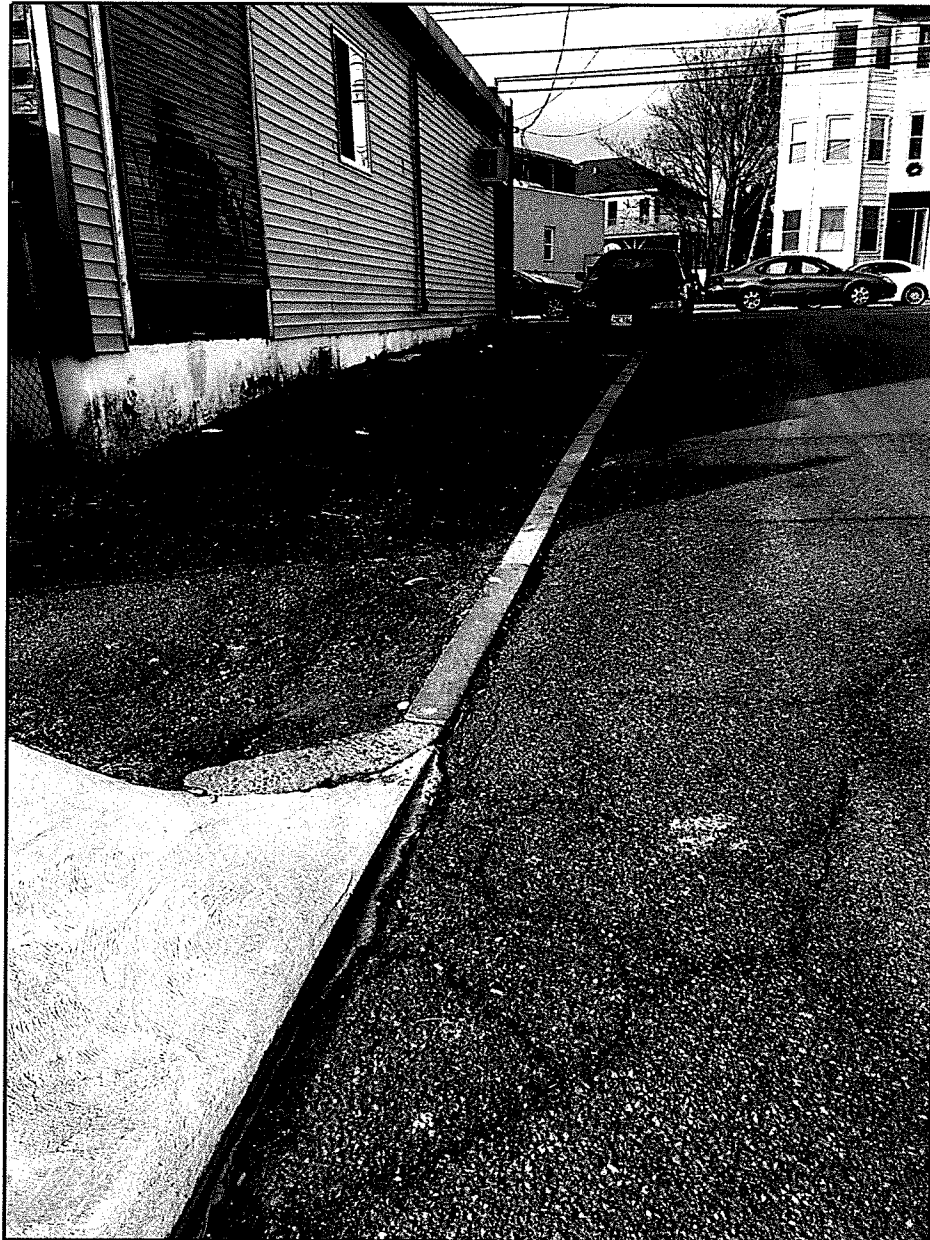
Just south of Revere St. looking north

Photo shows minimal curb reveal and very poor condition of sidewalk, continues to Revere St..

Note, new concrete driveway apron installed to old curb reveal. Curb should be raised before concrete sidewalks are installed.

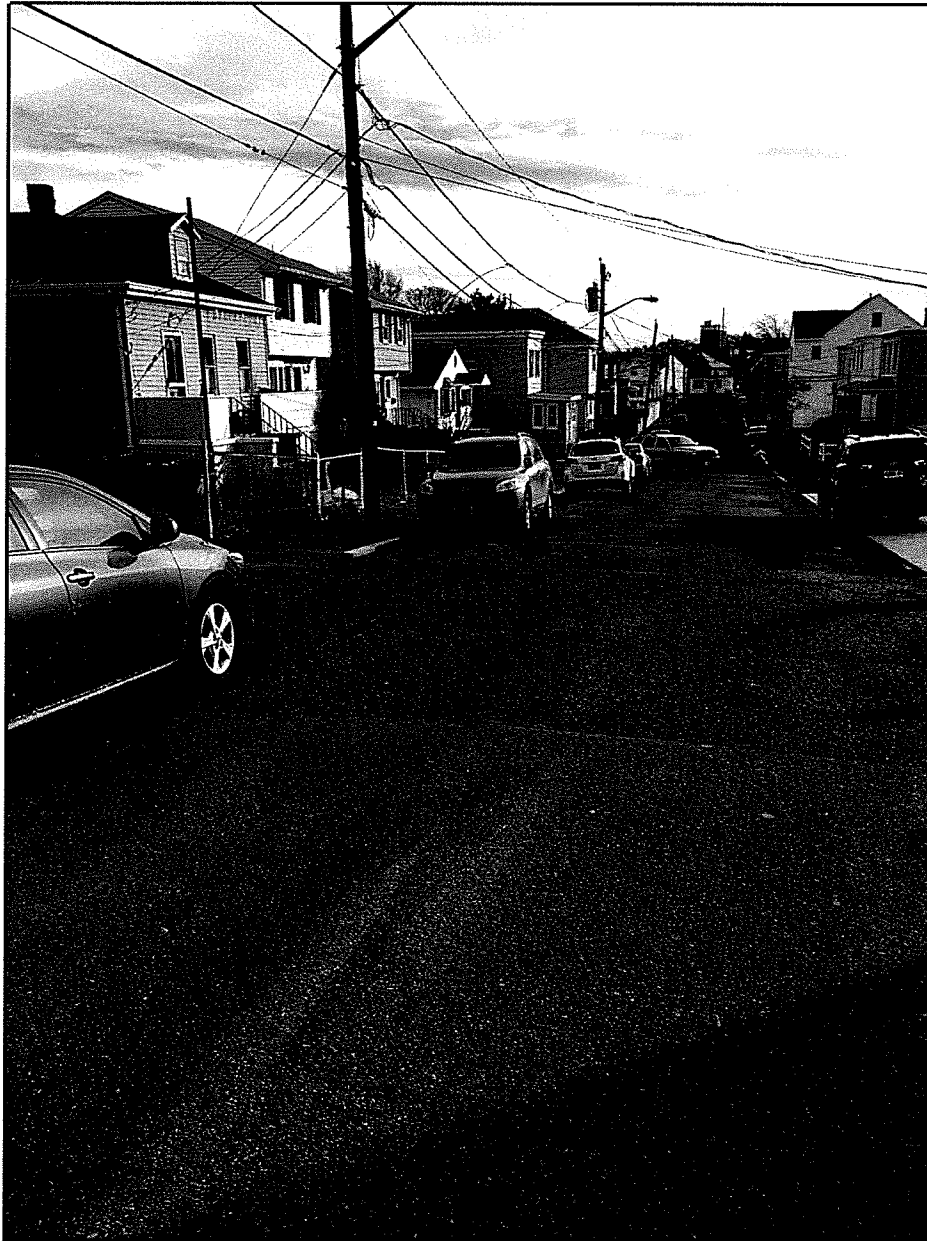
Near Revere St. looking south

Photo fairly extensive cracking of roadway.
Some settle apparent.

Curb reveal is minimal, curb settling and
rolling over towards the street.

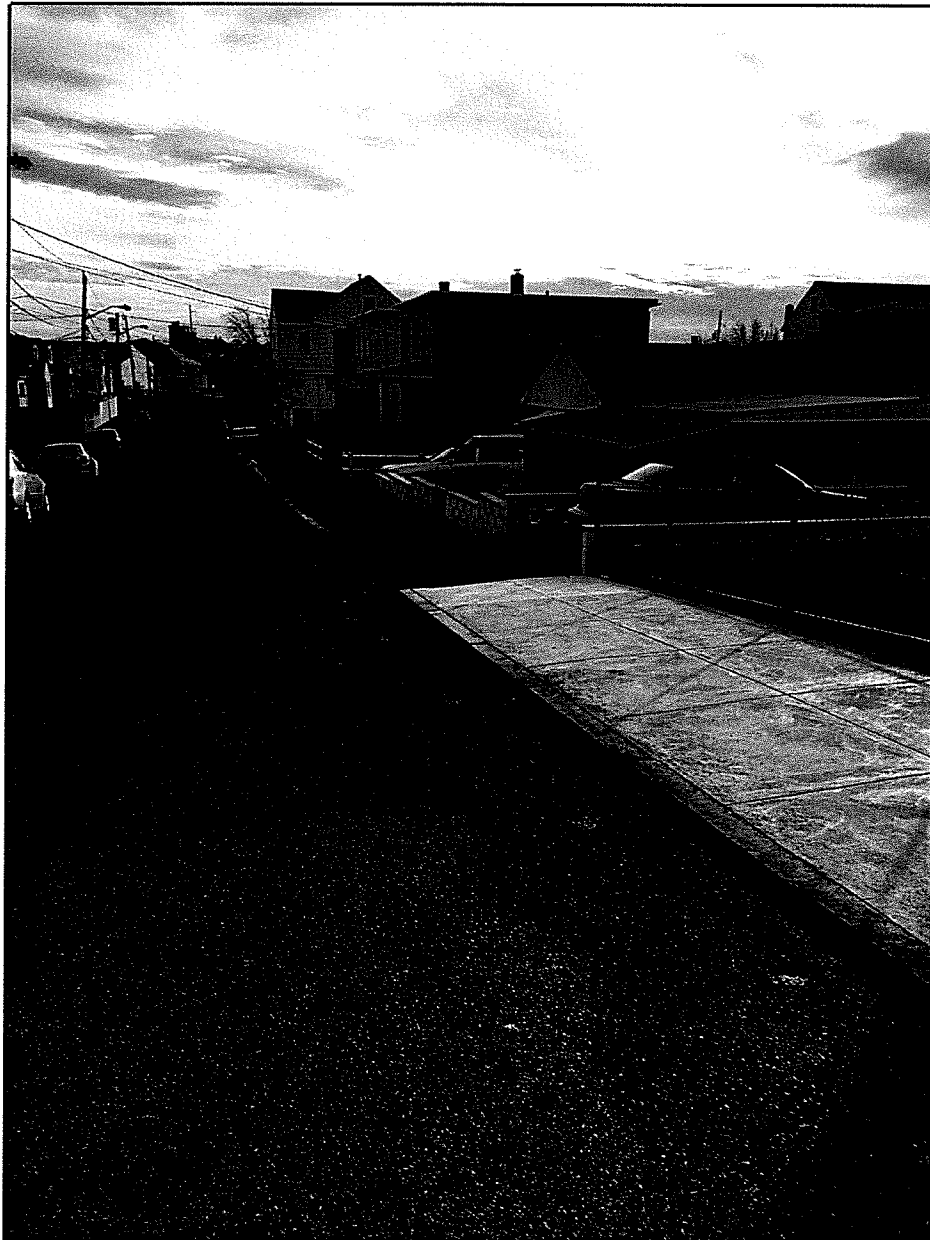
Continuing south on McKinley St.

fairly extensive cracking and settling of roadway continues. Typical for the street.

Note, new concrete sidewalk installed without resetting curb. Curb should be reset before concrete sidewalks are installed.

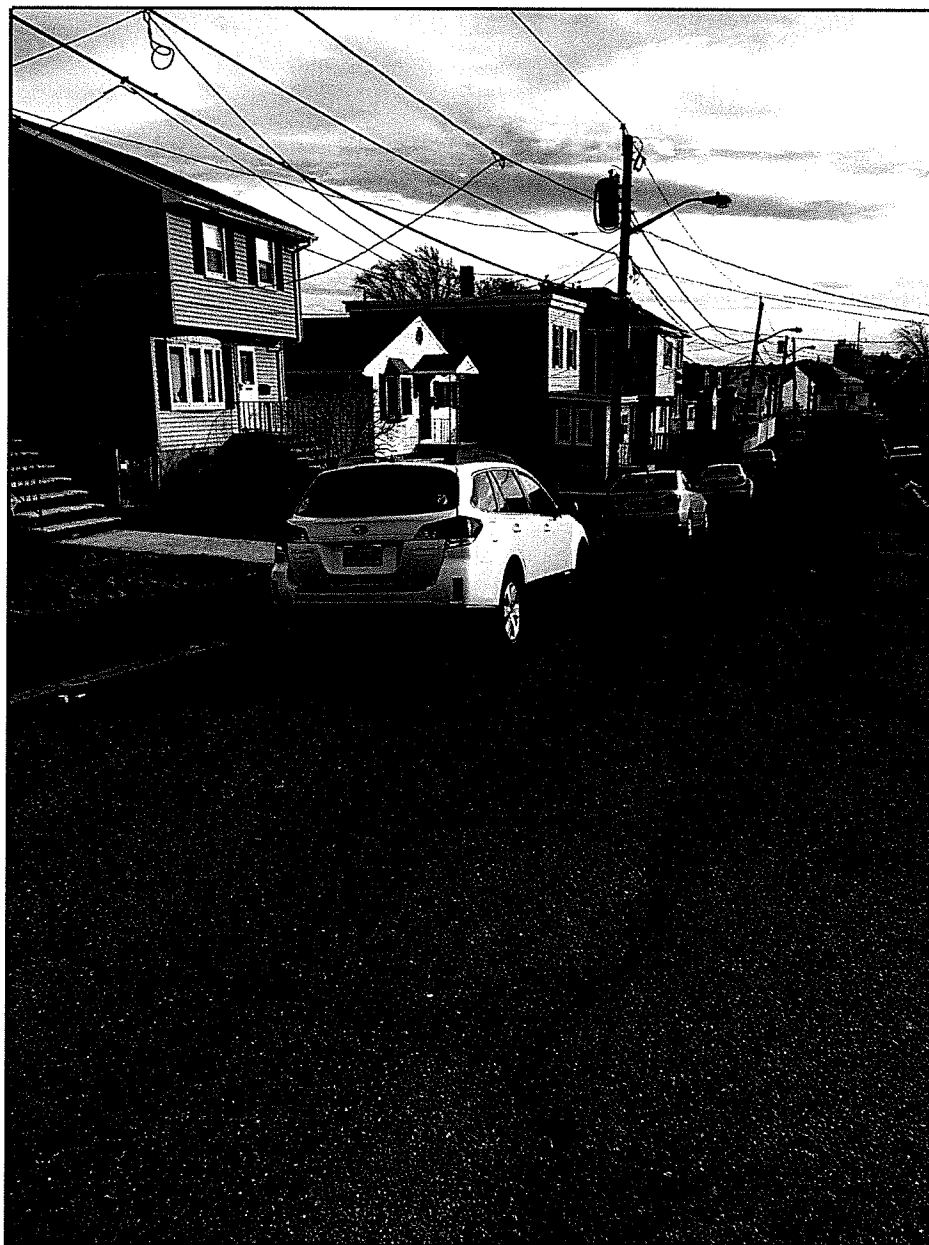
Continuing south on McKinley

Typical condition of roadway continues

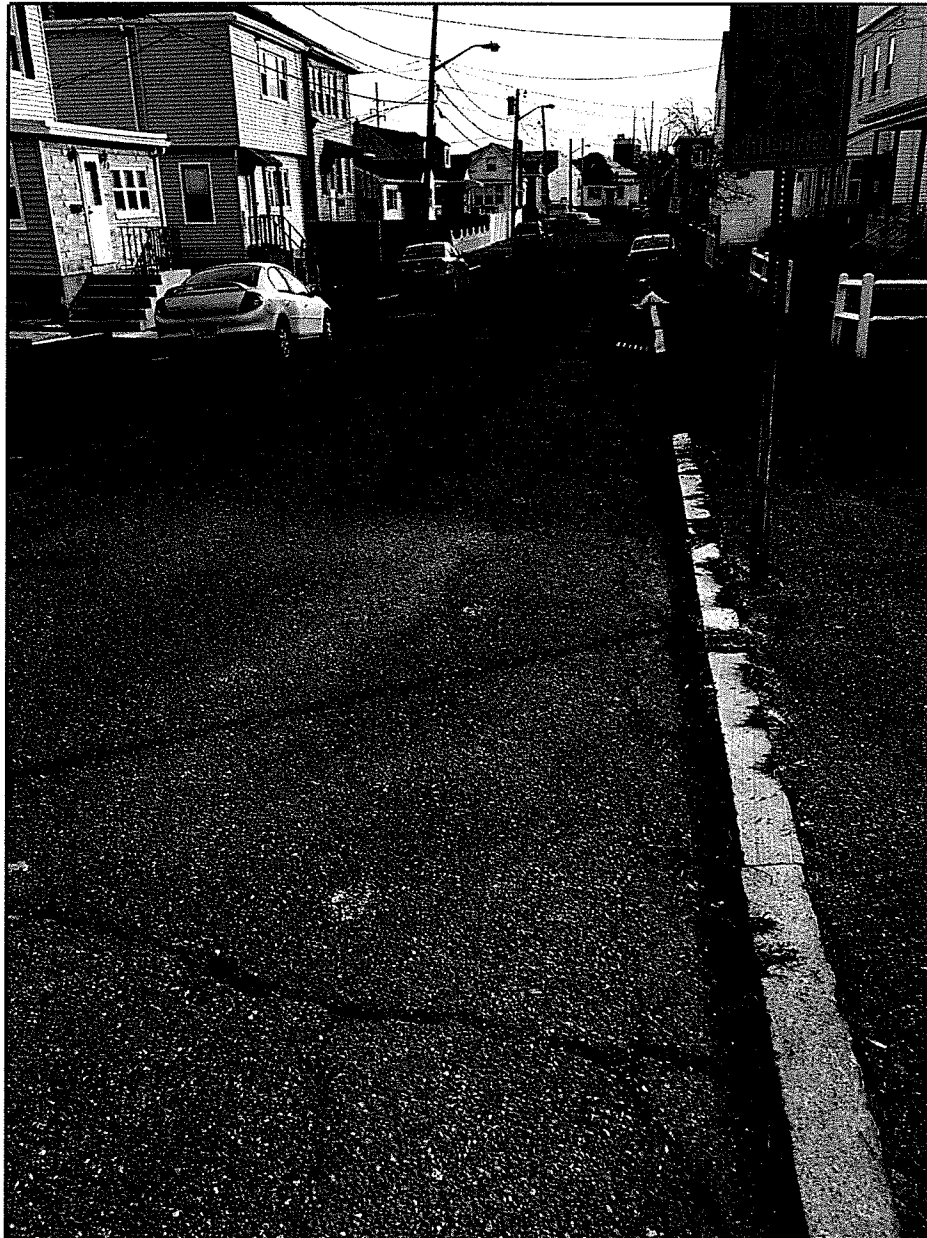
Continuing south on McKinley

Typical condition of McKinley continues. Cracking is consistent as you travel south, alligator cracking in the gutters is likely due to poor compaction around the curbing.

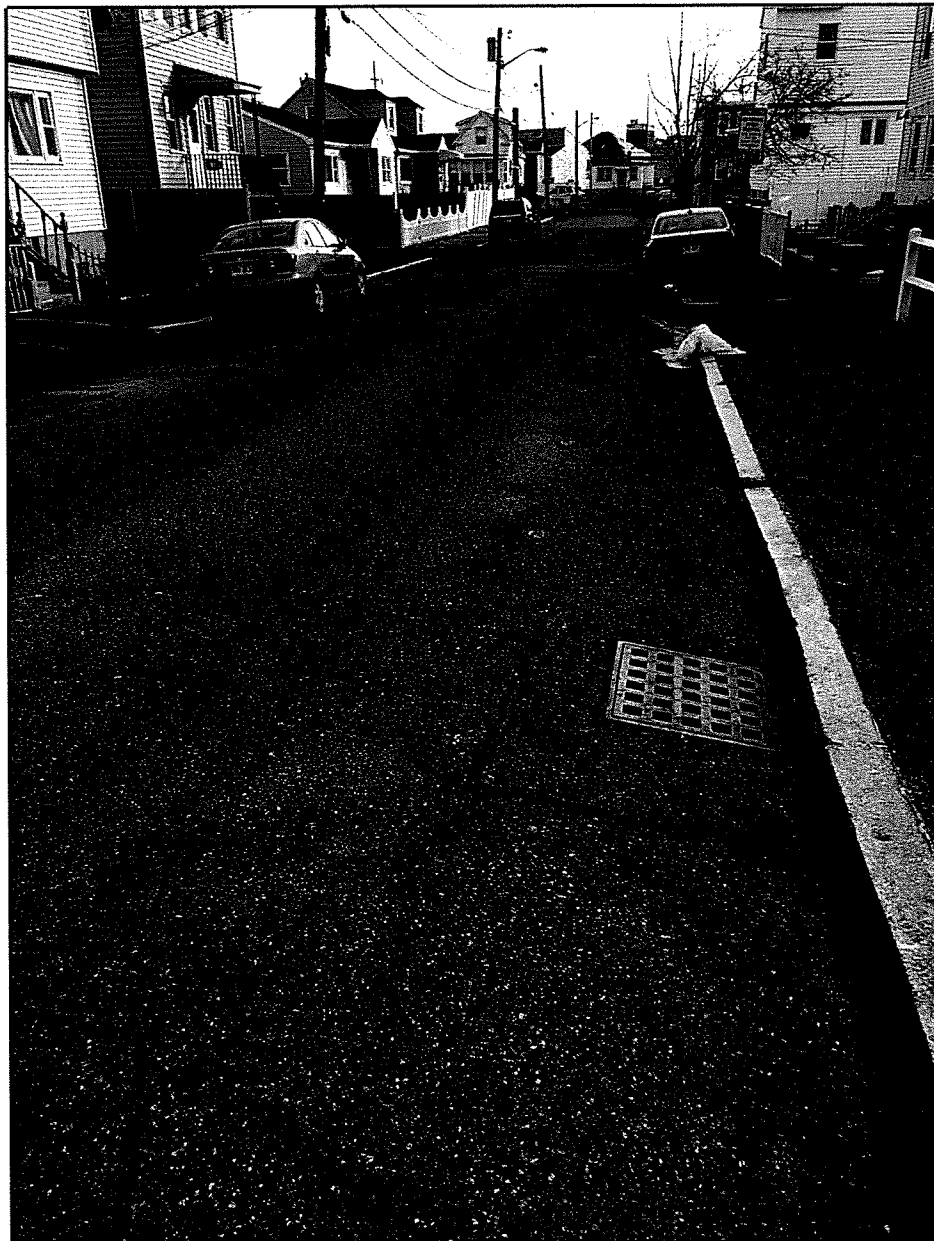
Continuing south on McKinley

Typical condition continues.

Catch basin tipped back, may require rebuilding prior to paving the road.

Asphalt sidewalks beginning to break up.

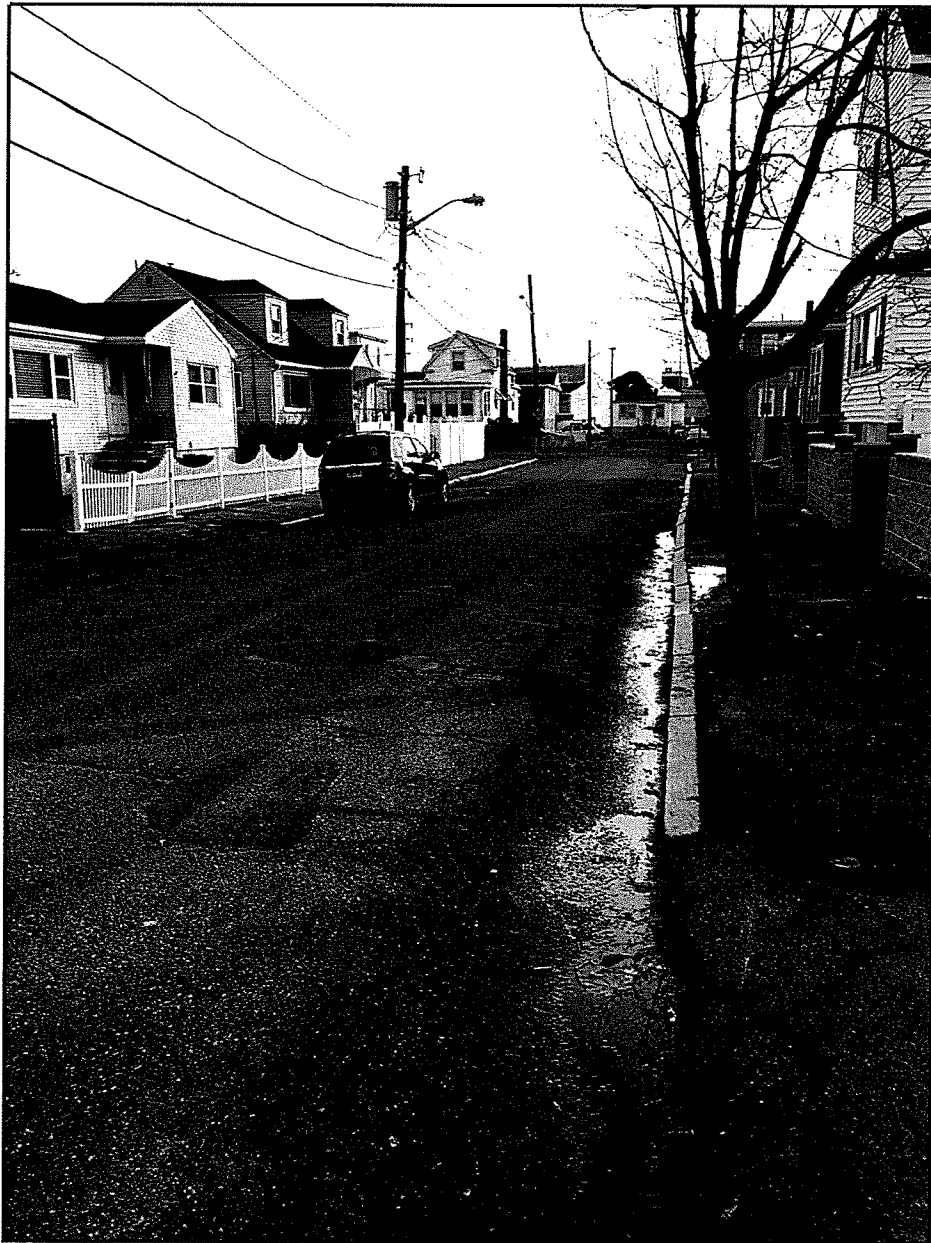
Continuing south on McKinley

Asphalt sidewalks uneven and breaking up.
Water source shown on next picture.

More extensive cracking of roadway shown.
Pothole repairs shown.

Minimal curb reveal and curb is rolling over
towards the street.

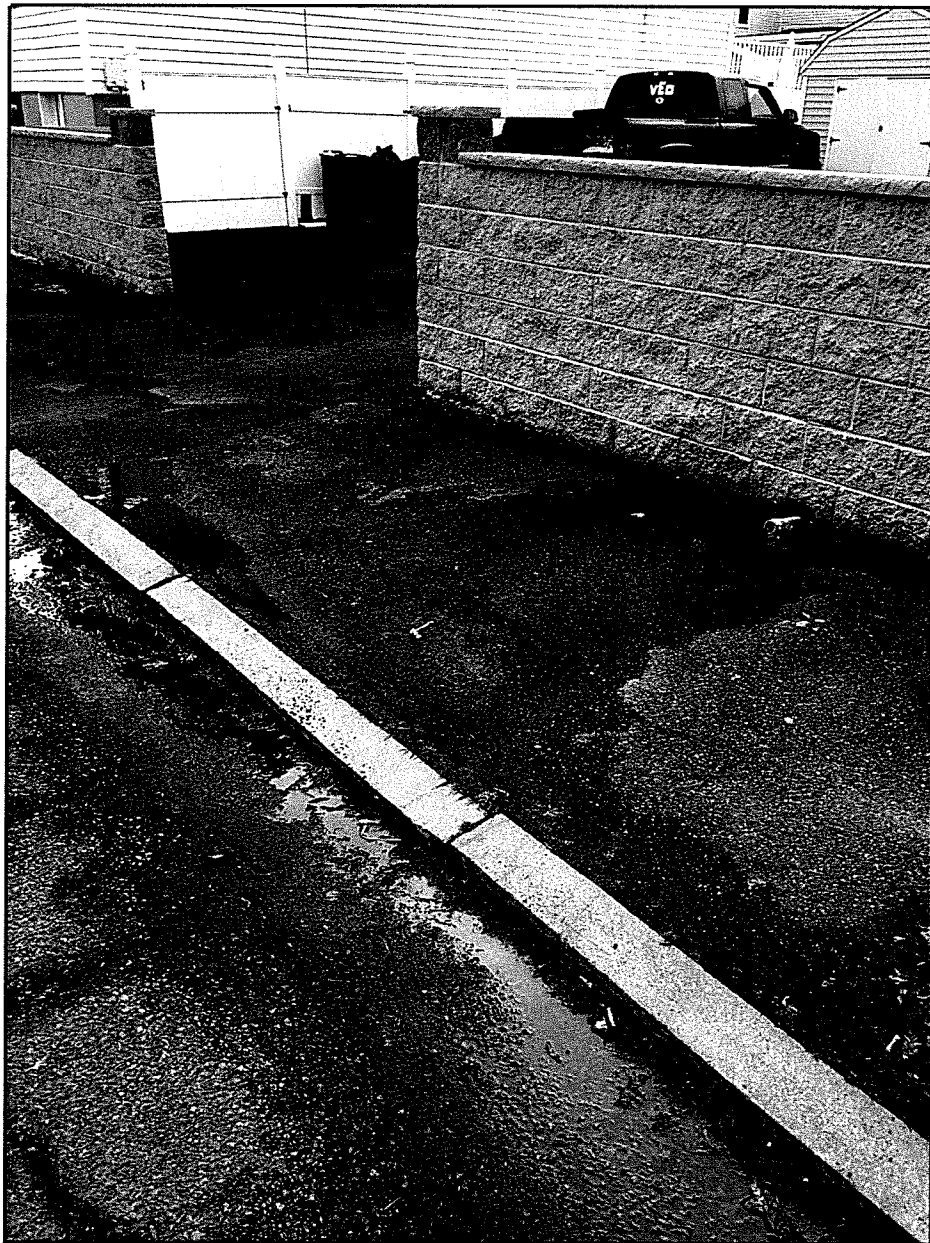
Sump Pump discharge

Water shown originating from sump pump discharge
at the base of the wall.

Discharged water has most likely amplified the
damage to the sidewalk and adjacent roadway
shown.

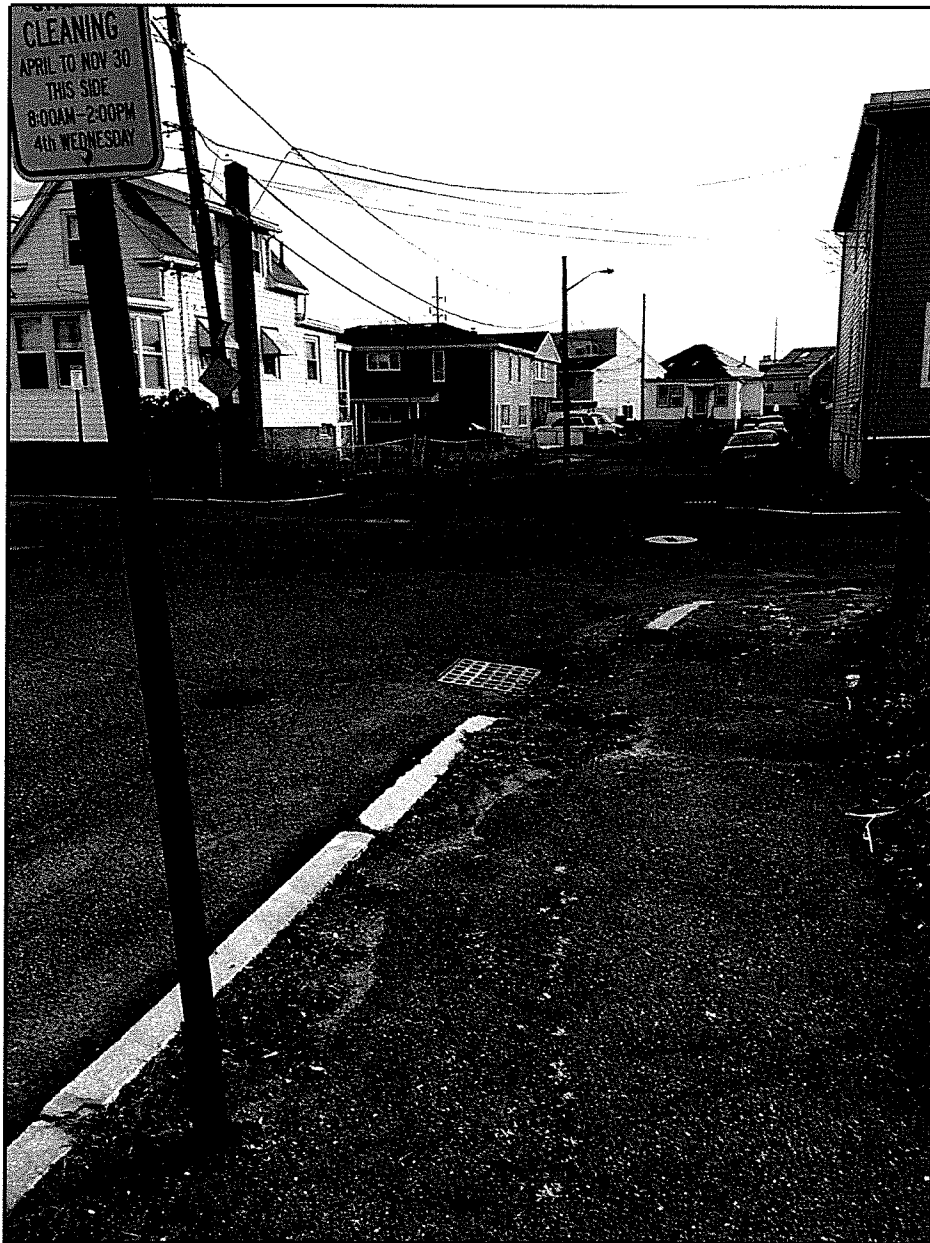
looking south at Washington St.

Extensive failure of sidewalks and roadway shown.
Damage may be accelerated due to standing storm
water.

Intersection lacks accessible ramps.

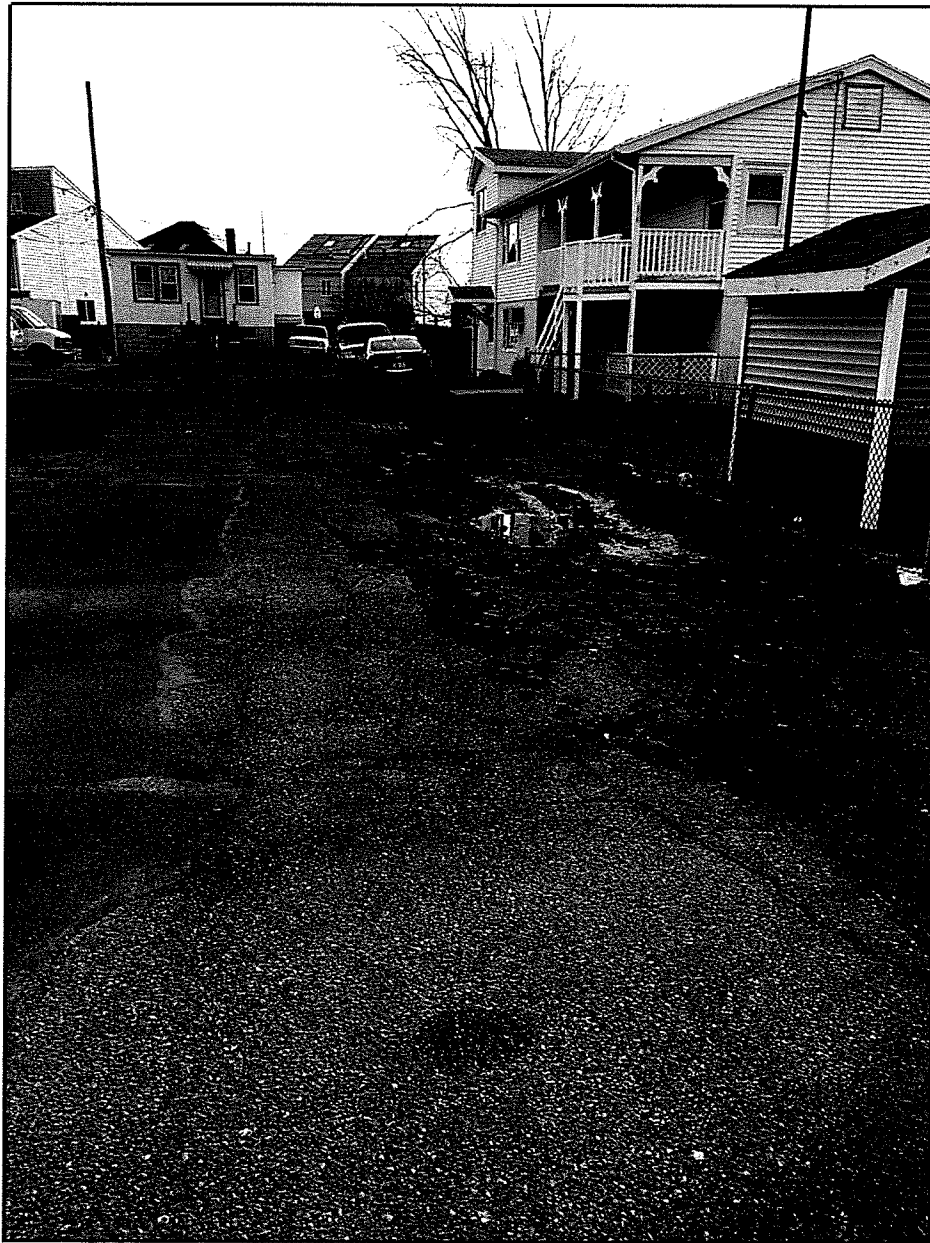
At Washington St. looking south.

Extensive damage to roadway and sidewalk shown. Damage due to standing water evident by puddle shown. Water not traveling overland to catch basin just beyond damaged area.

Source of water is a sump pump discharged from adjacent house shown in next photo.

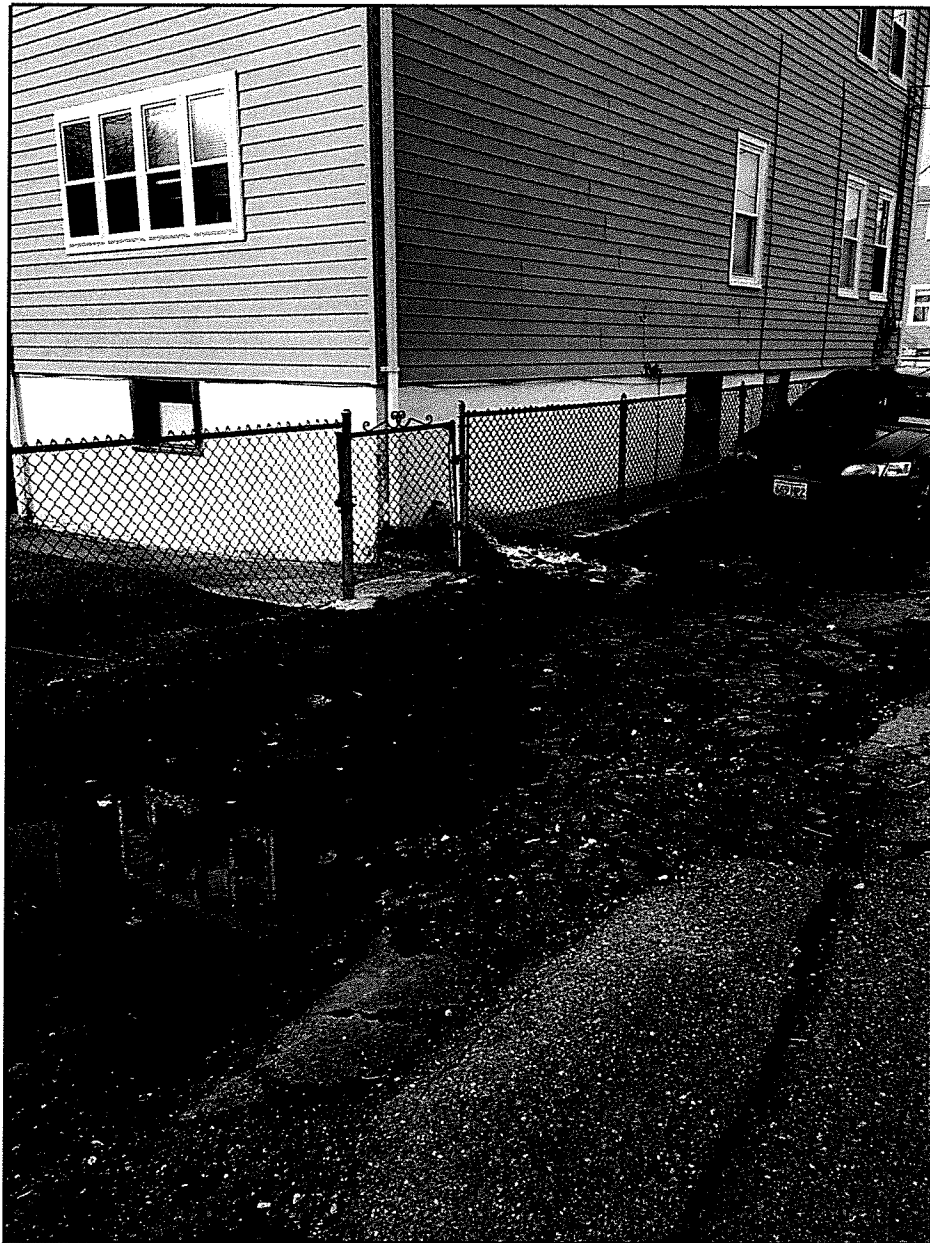
Same location looking north
towards Washington St.

Water discharging from residence. Discharged water does not travel overland to downstream catch basin. Standing water has caused extensive damage to asphalt sidewalk and roadway.

re-grading of gutter to catch basin required at a minimum. Possibly connect sump directly to drain system to eliminate overland flow.

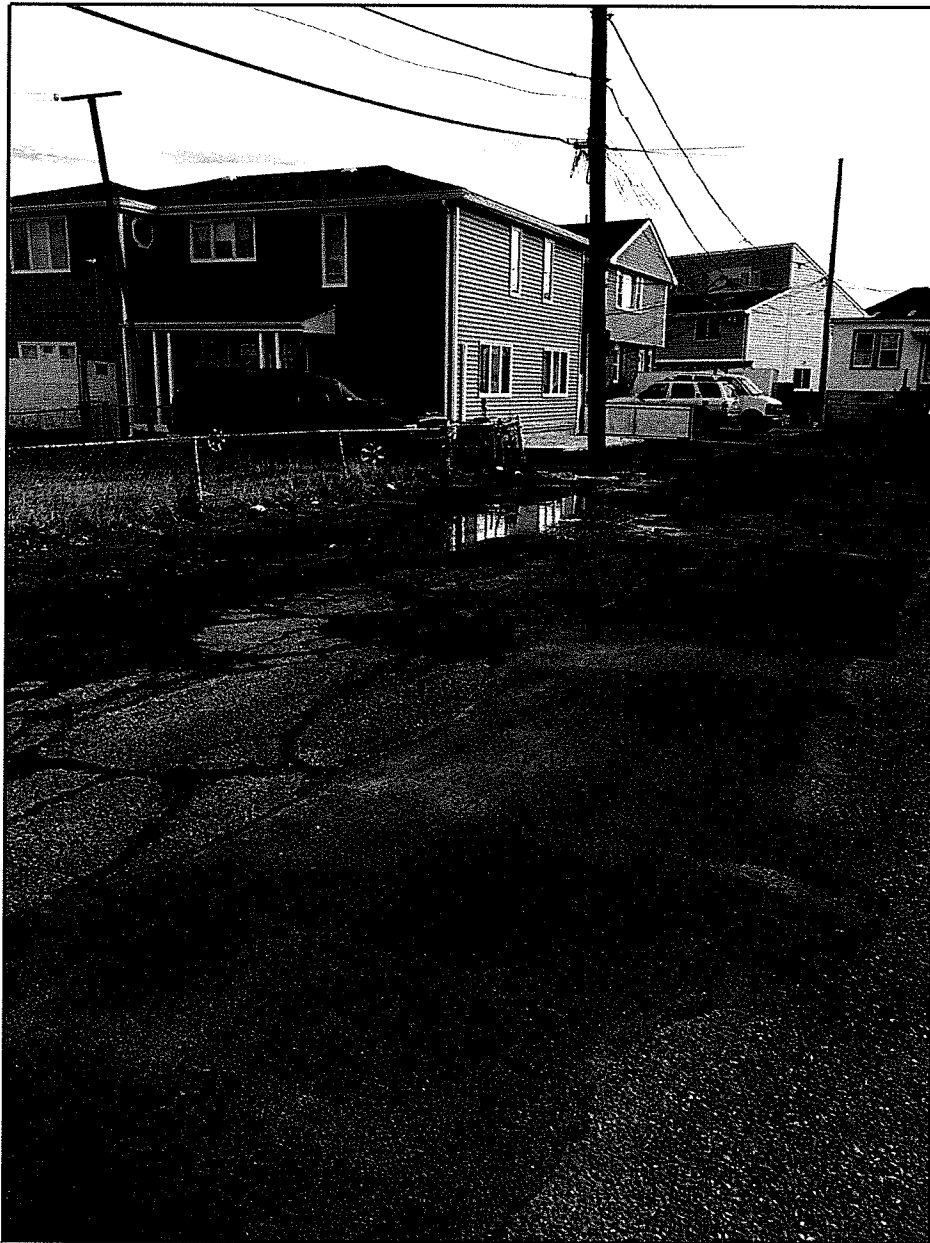
Looking south towards dead end.

Opposite side of road from last photo shown.

Observed standing water, water not flowing to catch basin by grade. Standing water has caused extensive damage in this location as well.

Drainage issues must be addressed prior to paving or condition will continue.

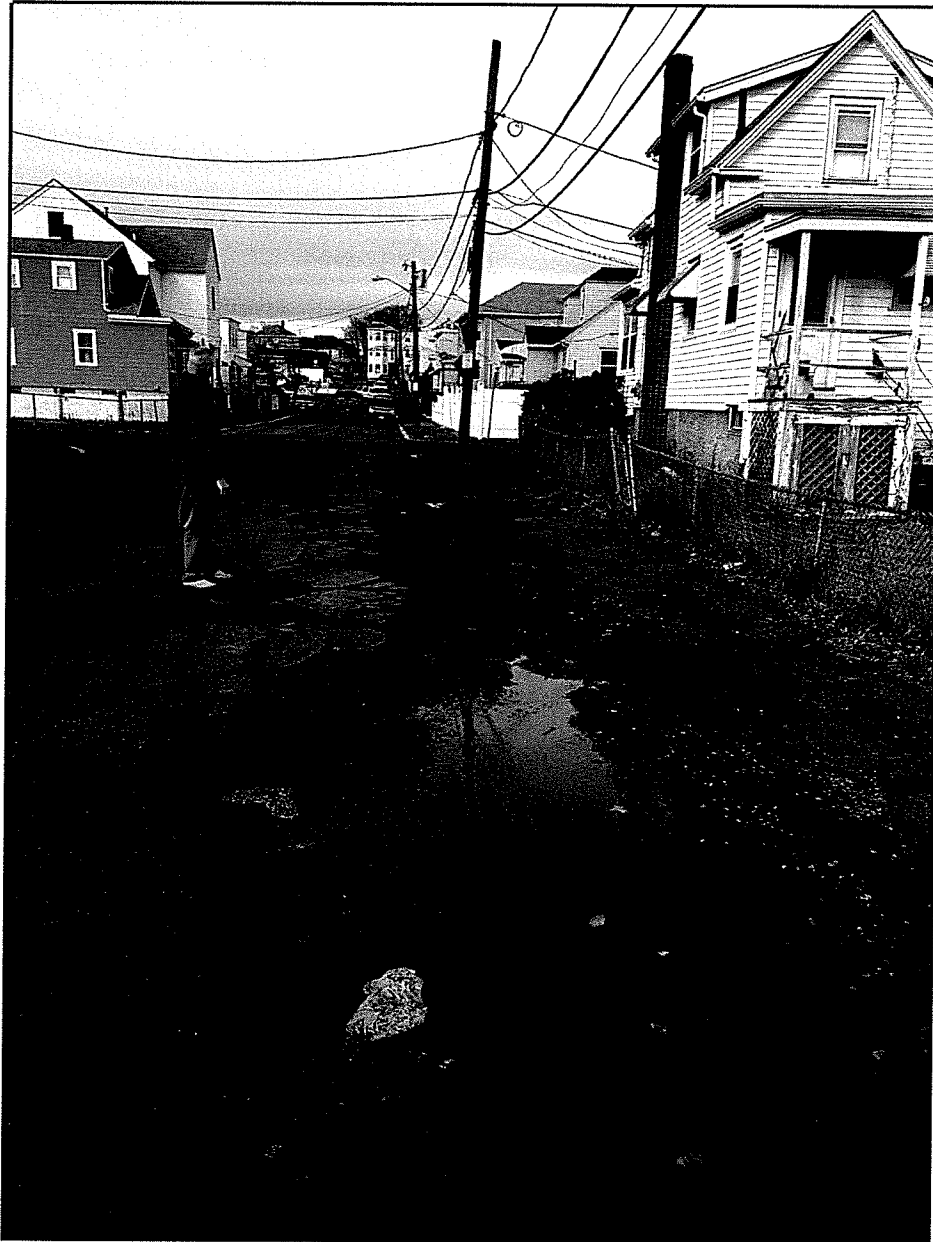
Looking north to Washington St.

View of same condition as previous photo from the south. No catch basin exists on east side of the street. Closest basin on east side at Washington Street. Grade of road prevents water from reaching closest basin.

If drainage issue can not be solved by re-grading the road, a new catch basin needs to be installed at the low spot.

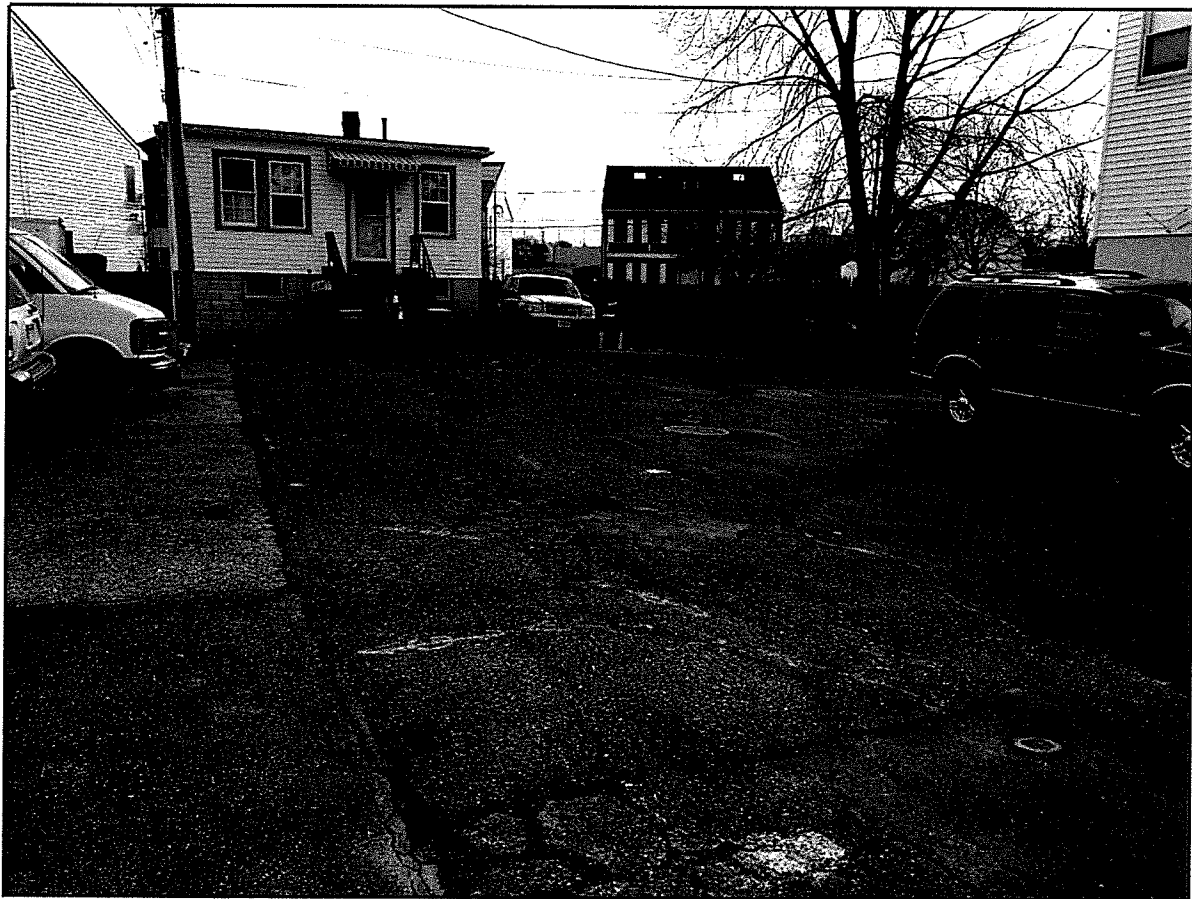
Looking south to dead end.

Extensive cracking / alligator cracking of the roadway observed. Road has settled around the catch basin, water does not appear to be draining into basin.

Pronounced low point at catch basin would direct water into the drain.

Further investigation of grades required, could observe during rain event to better understand flow of storm water.

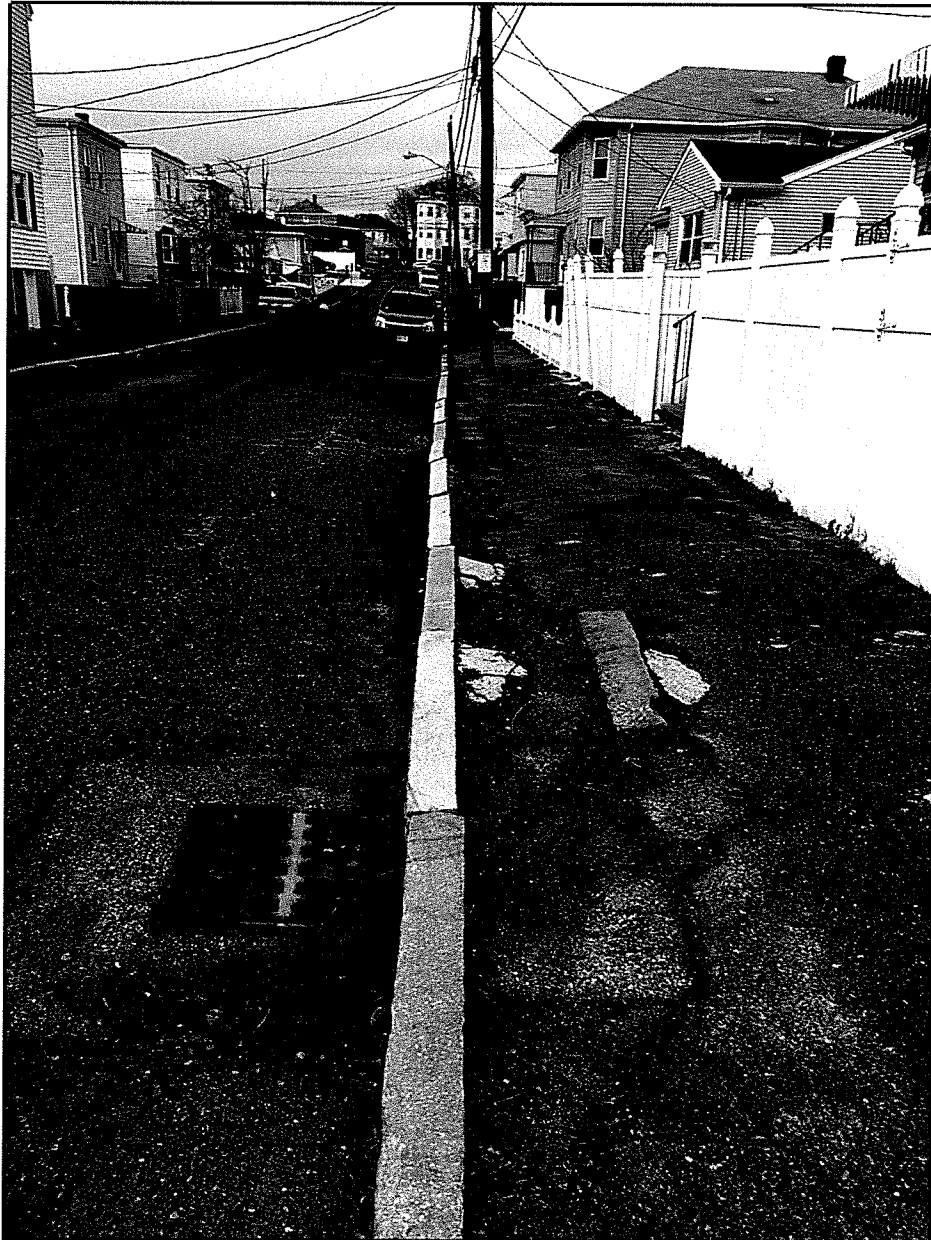
At Washington St. looking north

Very poor condition of sidewalk shown.

Curb settling and rolling over towards road.

Note lip between the sidewalk and the curb,
water likely sits in this location.

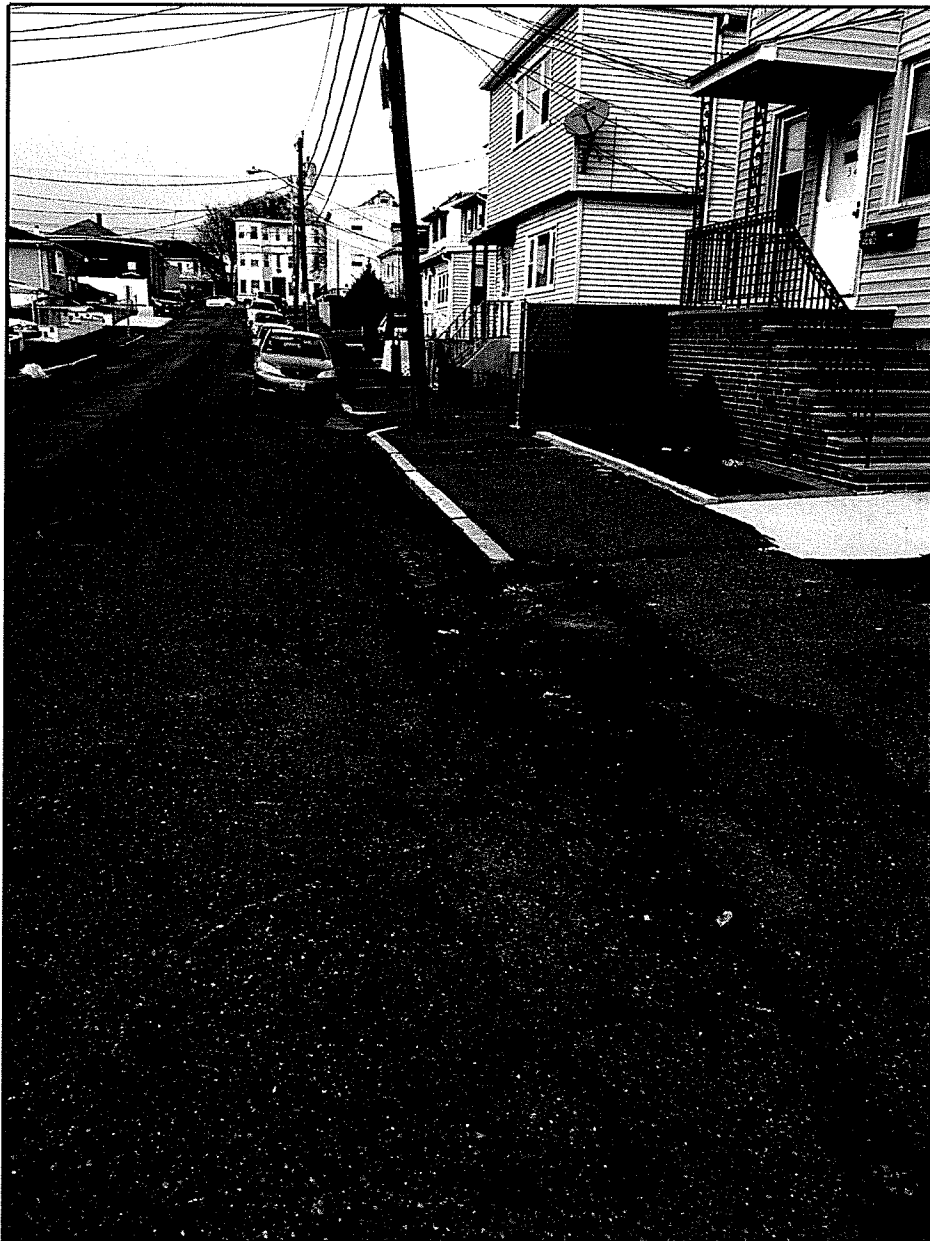
Continuing north towards Revere St.

Poor condition of sidewalk / driveway apron shown.

Typical condition of roadway shown and becoming worse towards the edge of the road.
