PHASE 1 - FEASIBILITY ANALYSIS

Walnut Ave.

(Entire Road)

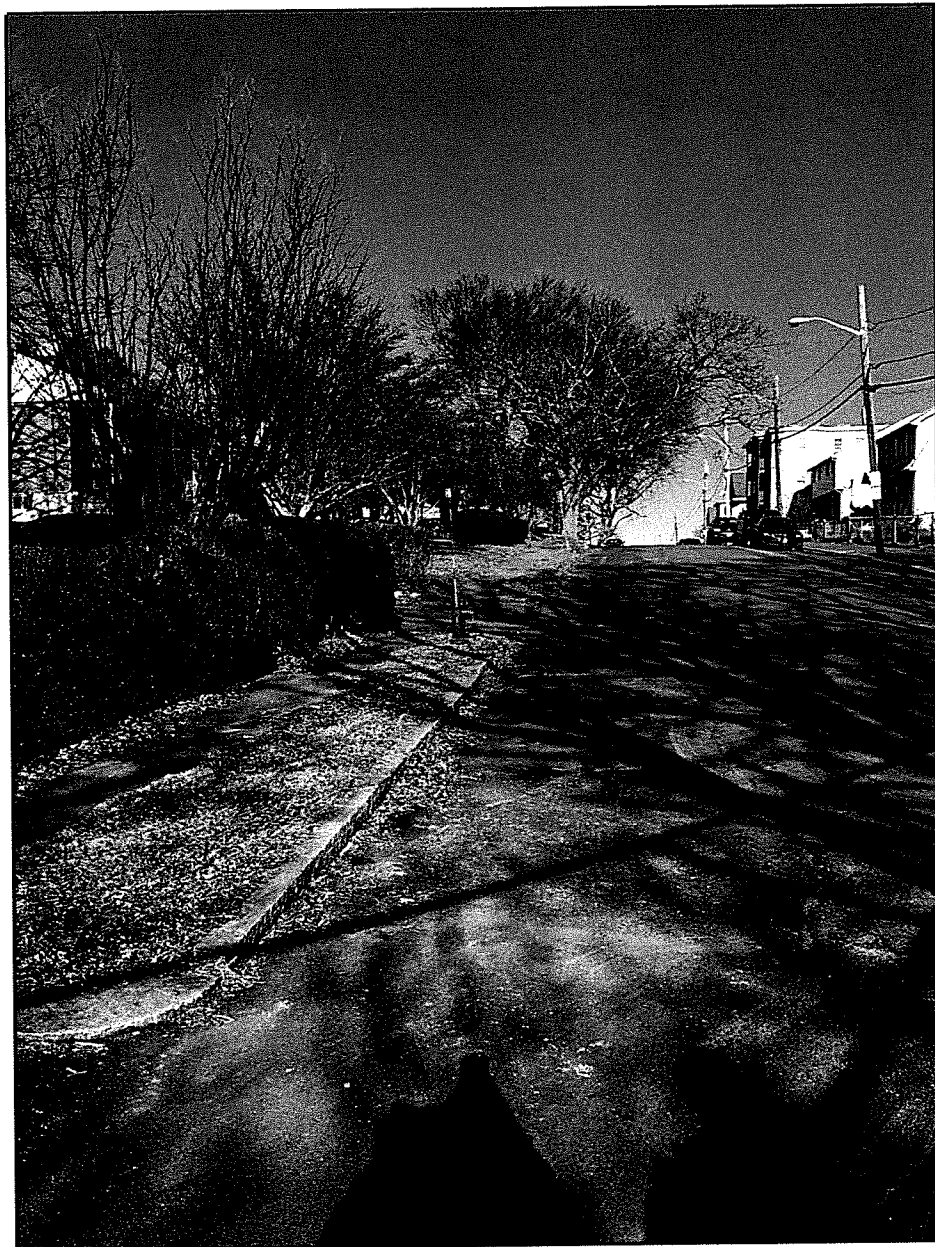
At dead end looking north

Minimal curb reveal. Sidewalks in poor condition.
Water main trench shown. Gas trench on
opposite side of the street. Longitudinal and
transverse cracking apparent, alligator cracking
beginning to form.

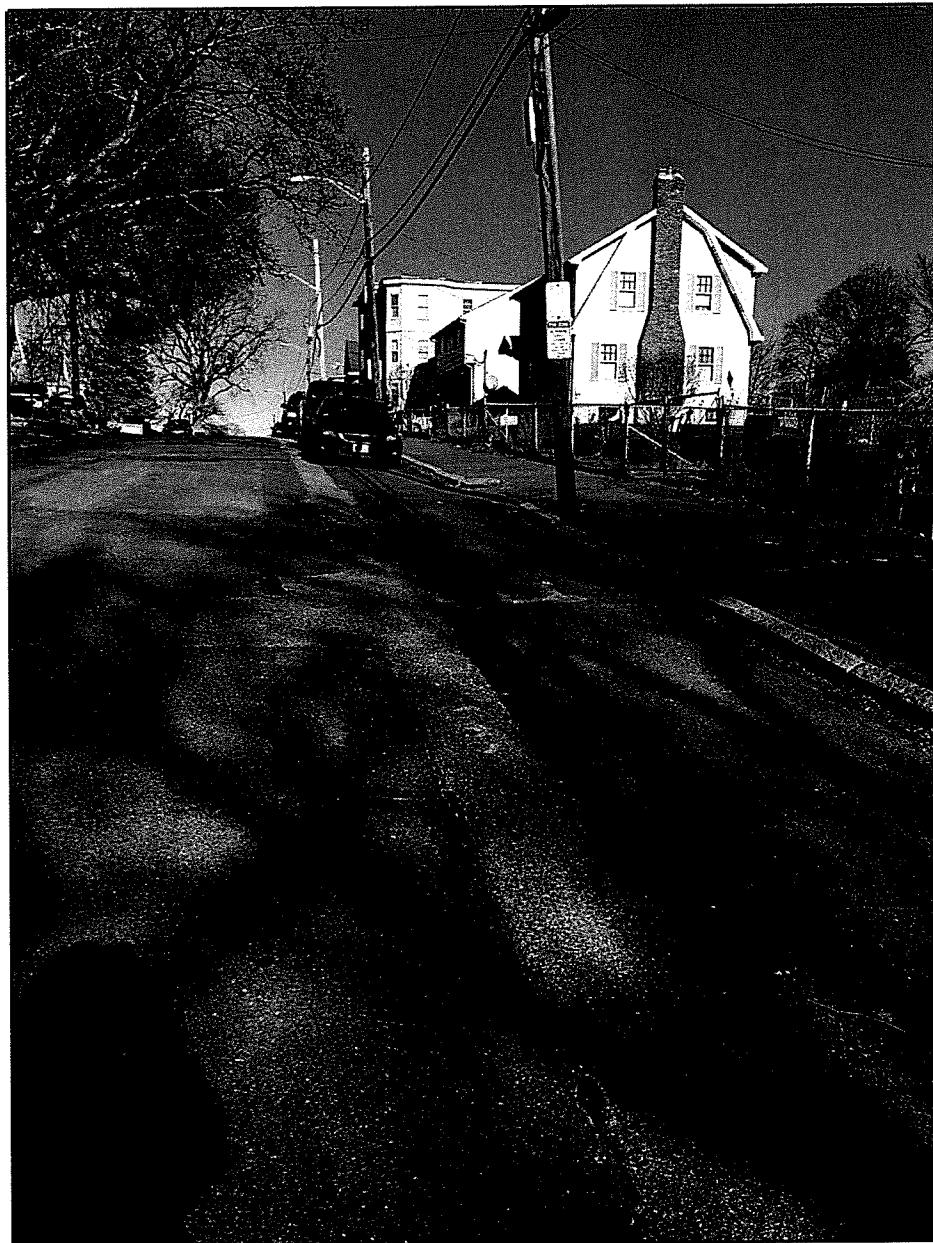
At dead end looking north, east side of road shown.

Curbing failing, rolling over, sidewalks cracking and seperating.

Roadway in poor condition, multiple utility trenches. Trenches not showing settlement. Cracking of roadway continues, alligator cracking in the gutter related to curbing failure.

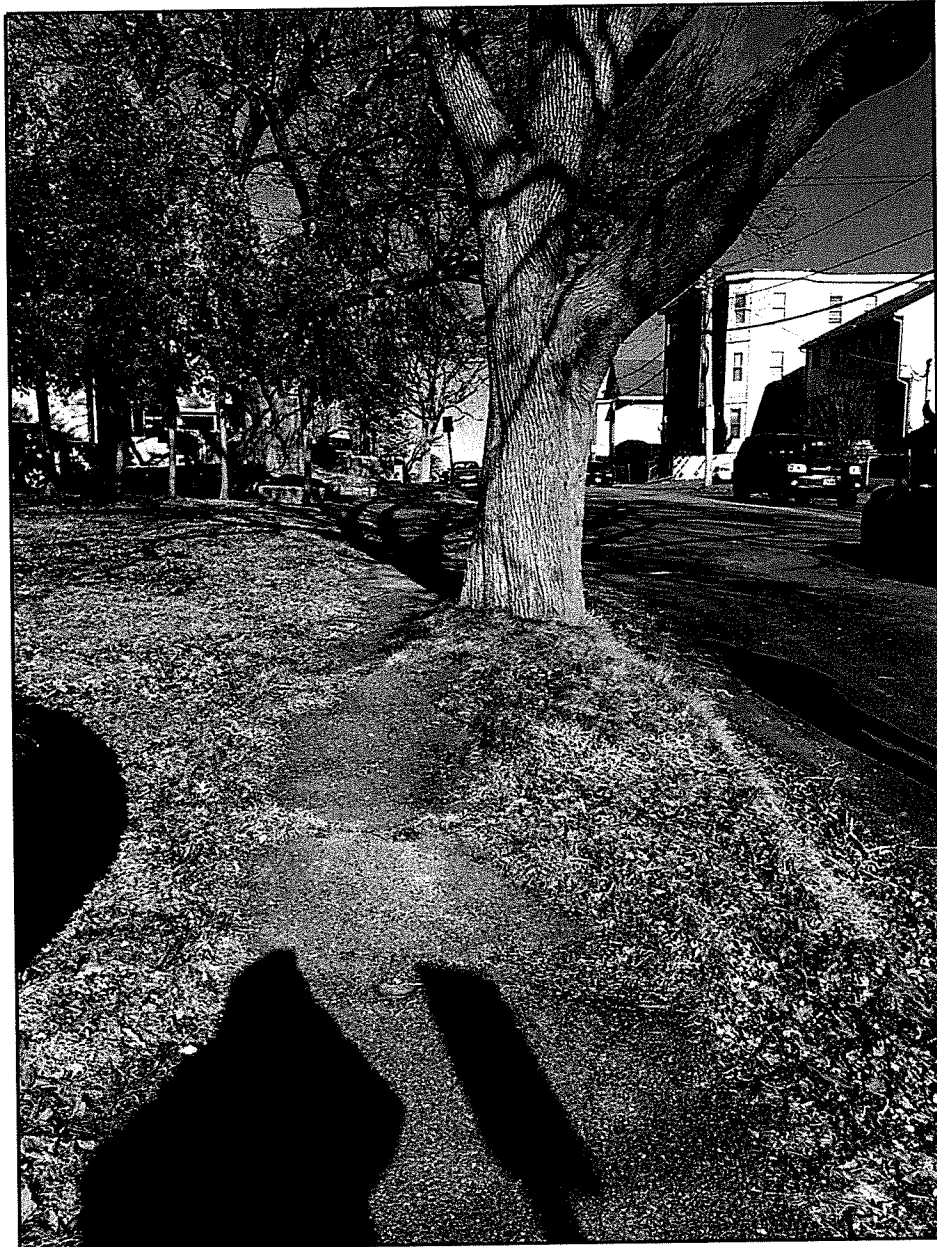
Heading north towards James Street.

Very poor condition of the sidewalks highlighted.
Tree large and in good condition. Efforts to
save the tree should be made, including not
excavating curbing directly in front of the tree.

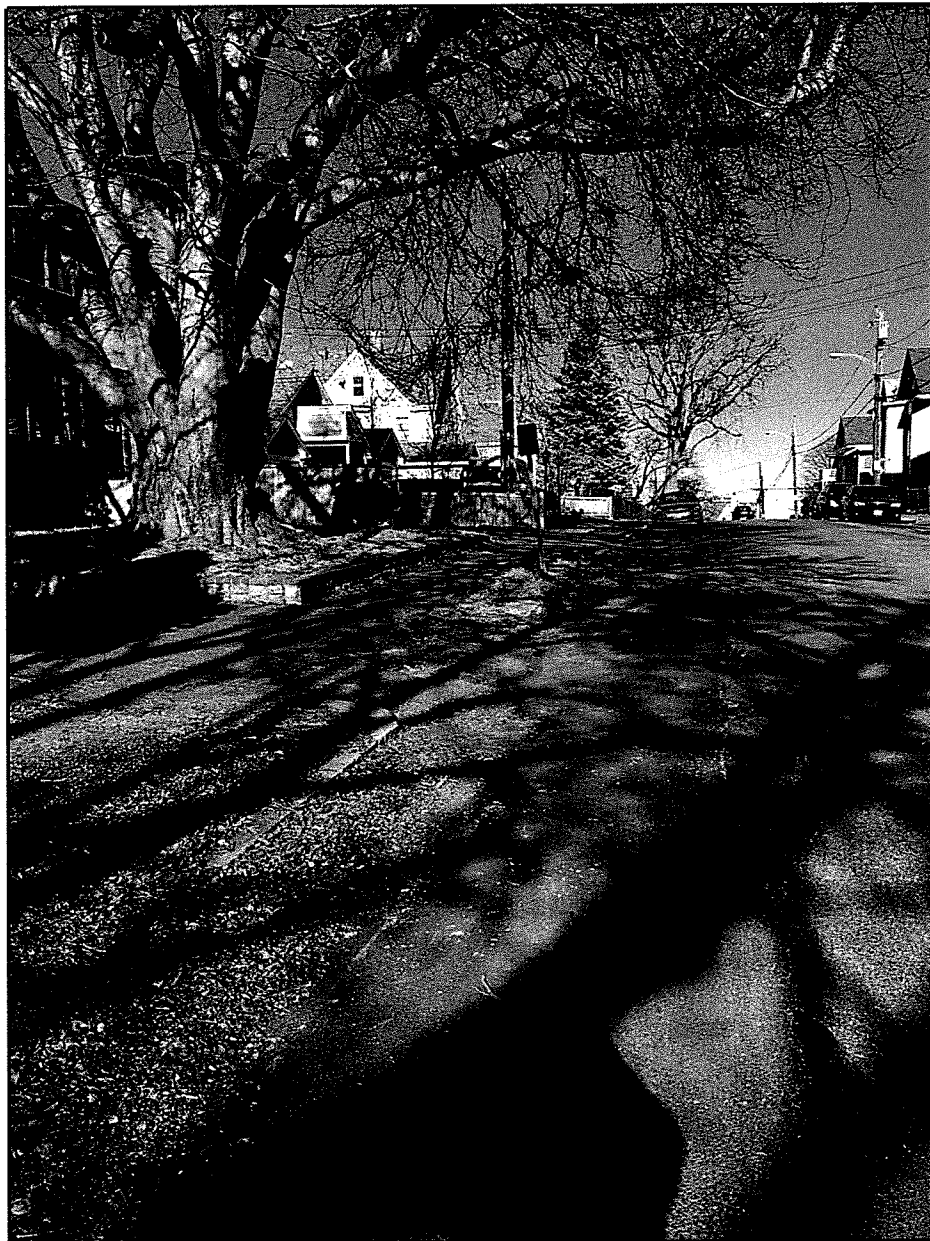
Heading north towards James St.

Area of water main break in 2013 shown. Water main replaced in 2014. Settlement and alligator cracking ahead related to water main break.

Roadway in poor condition

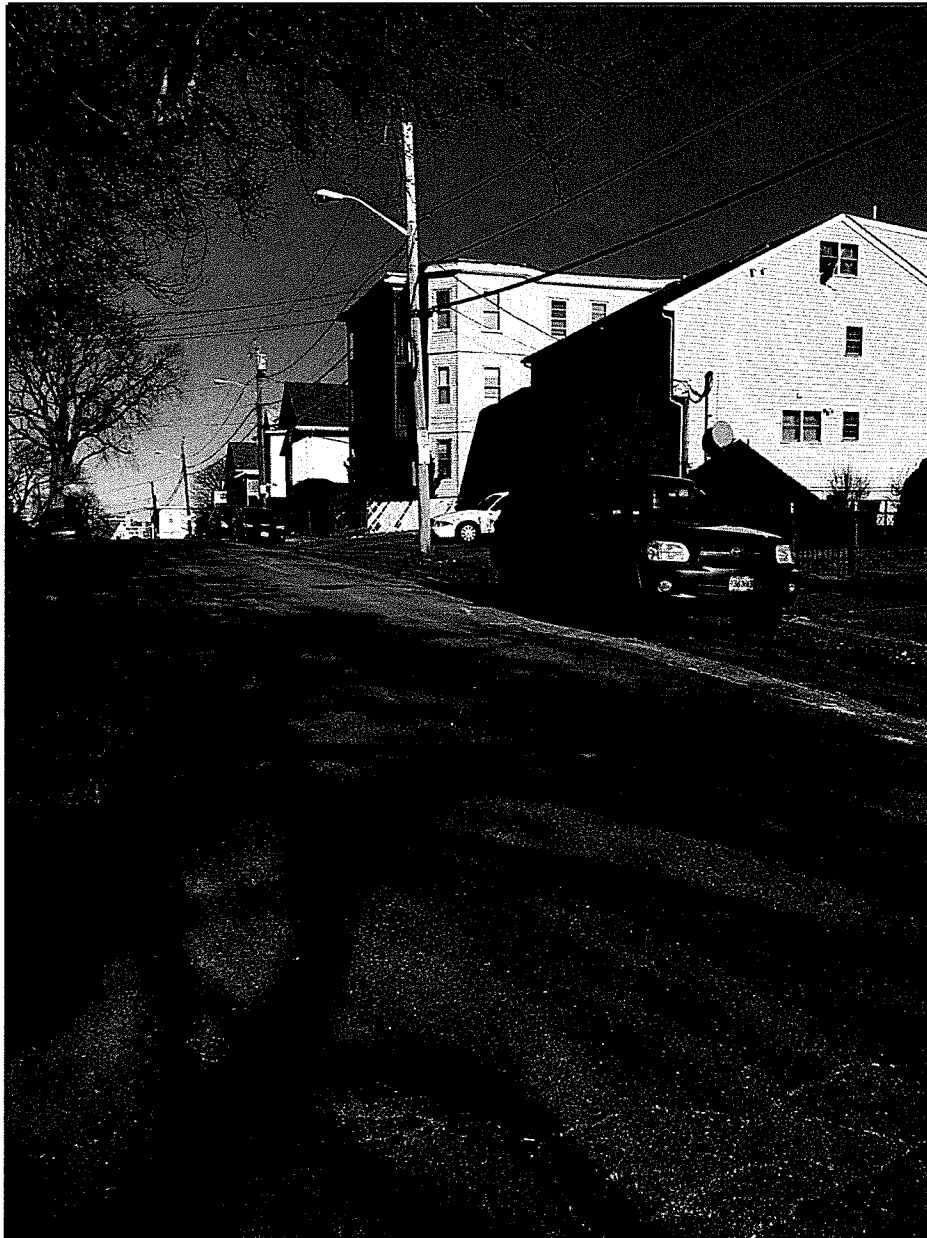
Same location as last photo looking at east side of the road.

Multiple trenches shown, cracking pronounced in the vicinity of the trenches.

Road sustained heavy damage during water main break.

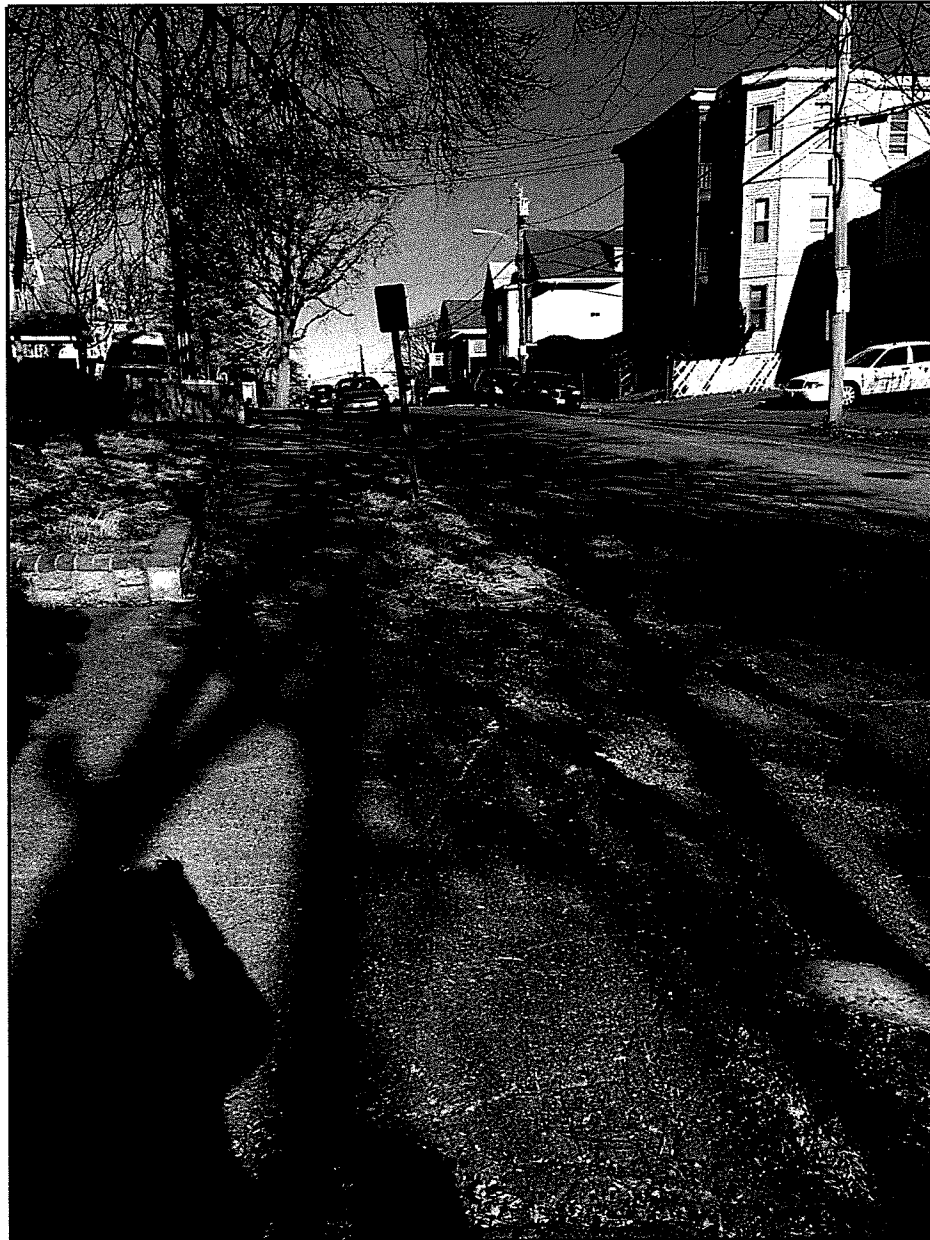
Photo highlighting poor conditon of sidewalk.

Roadway unraveling, cracking spreading, alligator cracks forming.

Roadway in poor condition..

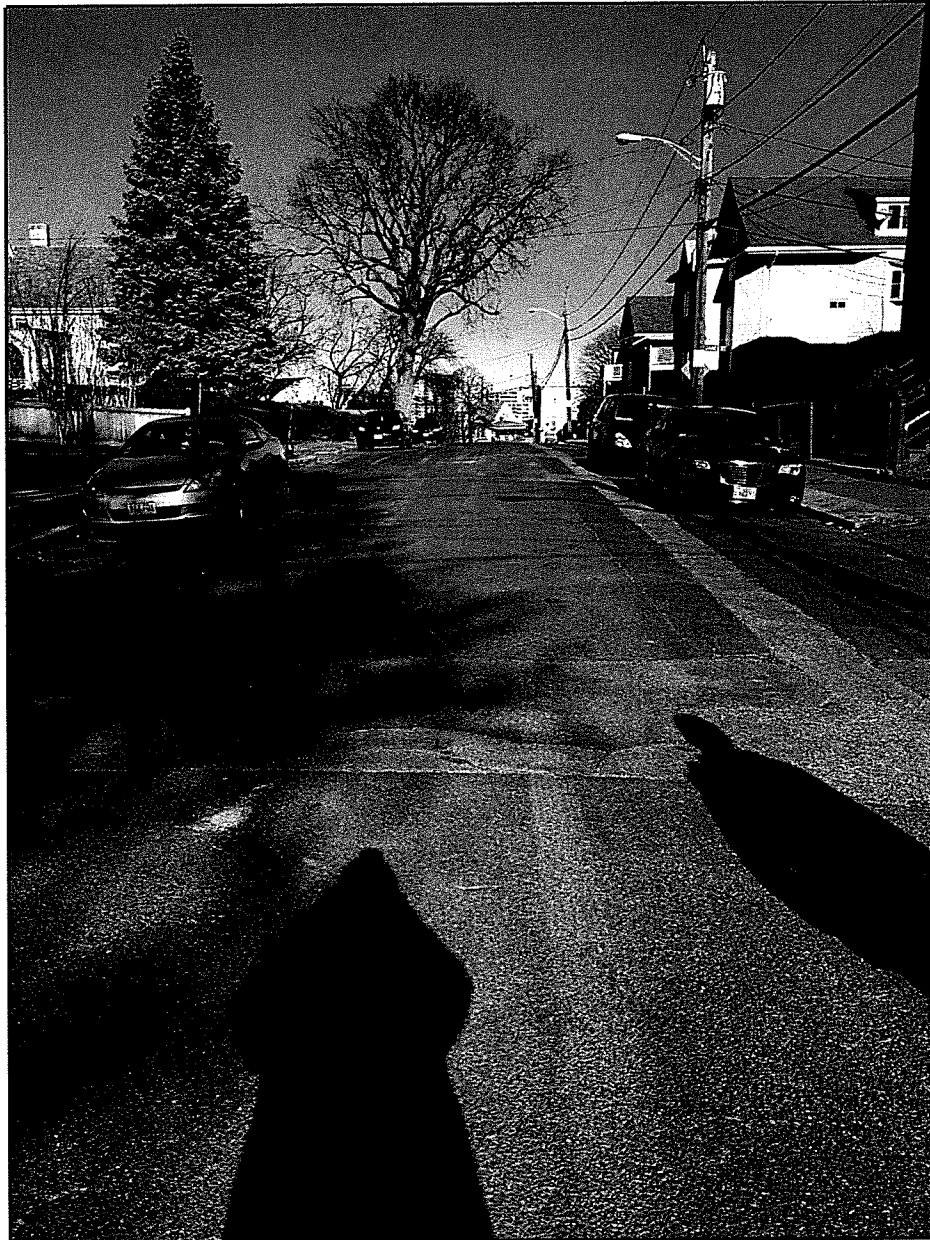
Continuing north towards James Street

We are now north of the water main break.
Roadway in decent condition. Multiple utility
trenches shown. Trenches are beginning to fail,
although extreme settlement of trenches not
seen.

Driveability poor due to trenches

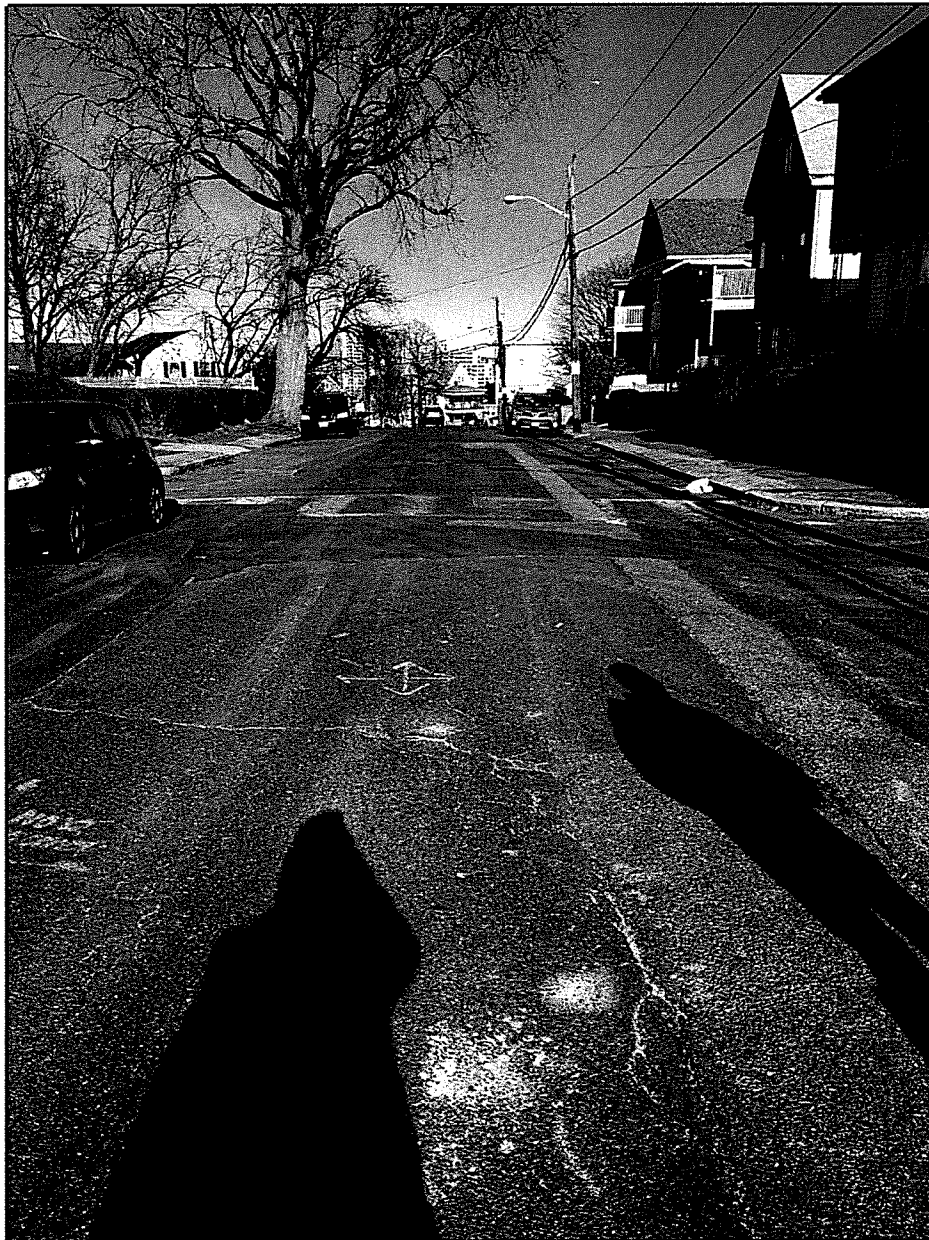
Just south of James street.

Gas and water trenches shown, transverse and
alligator cracking spreading.

Road poor due to multiple trenches.

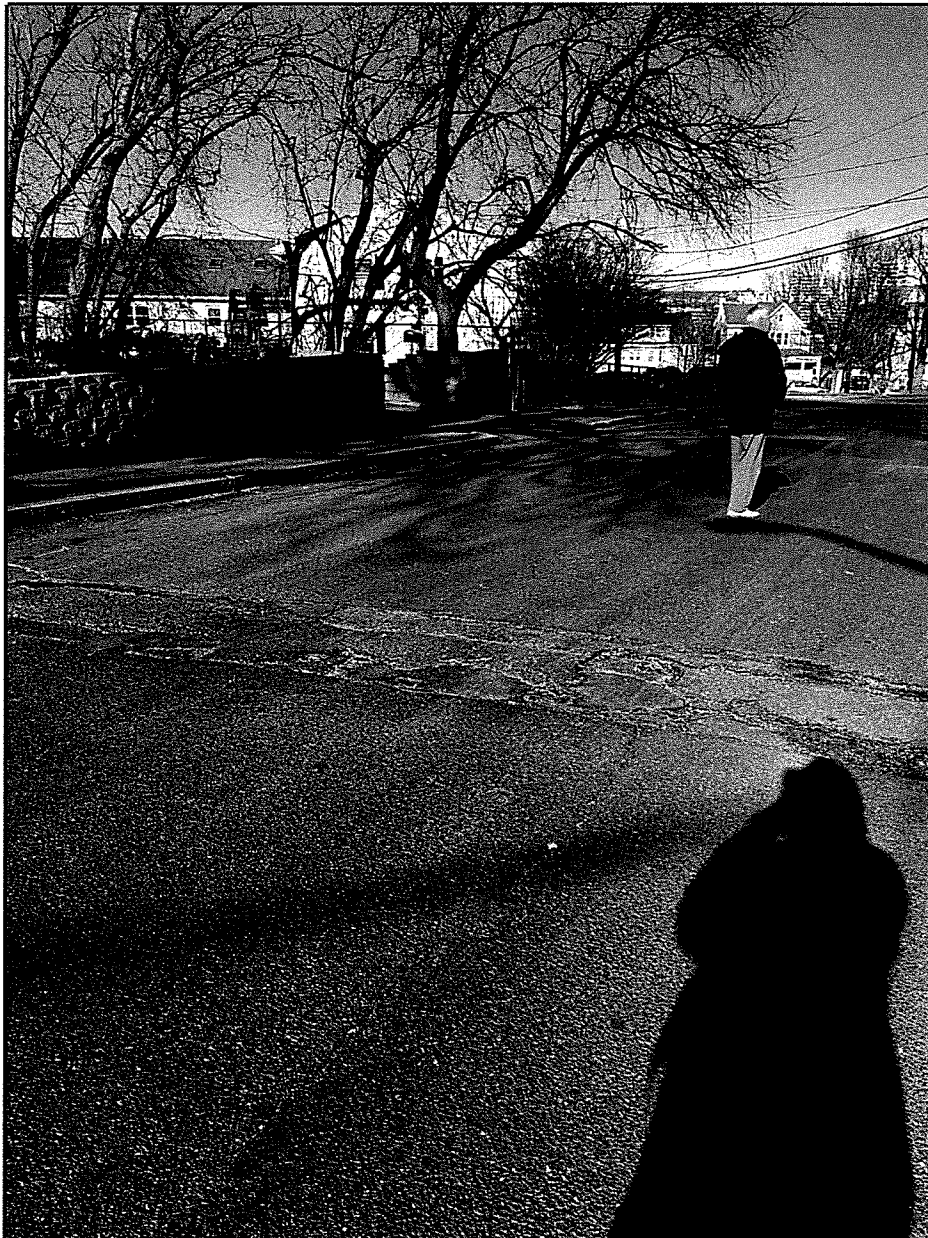
Beyond James St. heading north.

Failed transverse trench shown. Longitudinal cracking developing.

Curbing and asphalt sidewalk shown in good condition. Mostly sidewalk in poor condition.

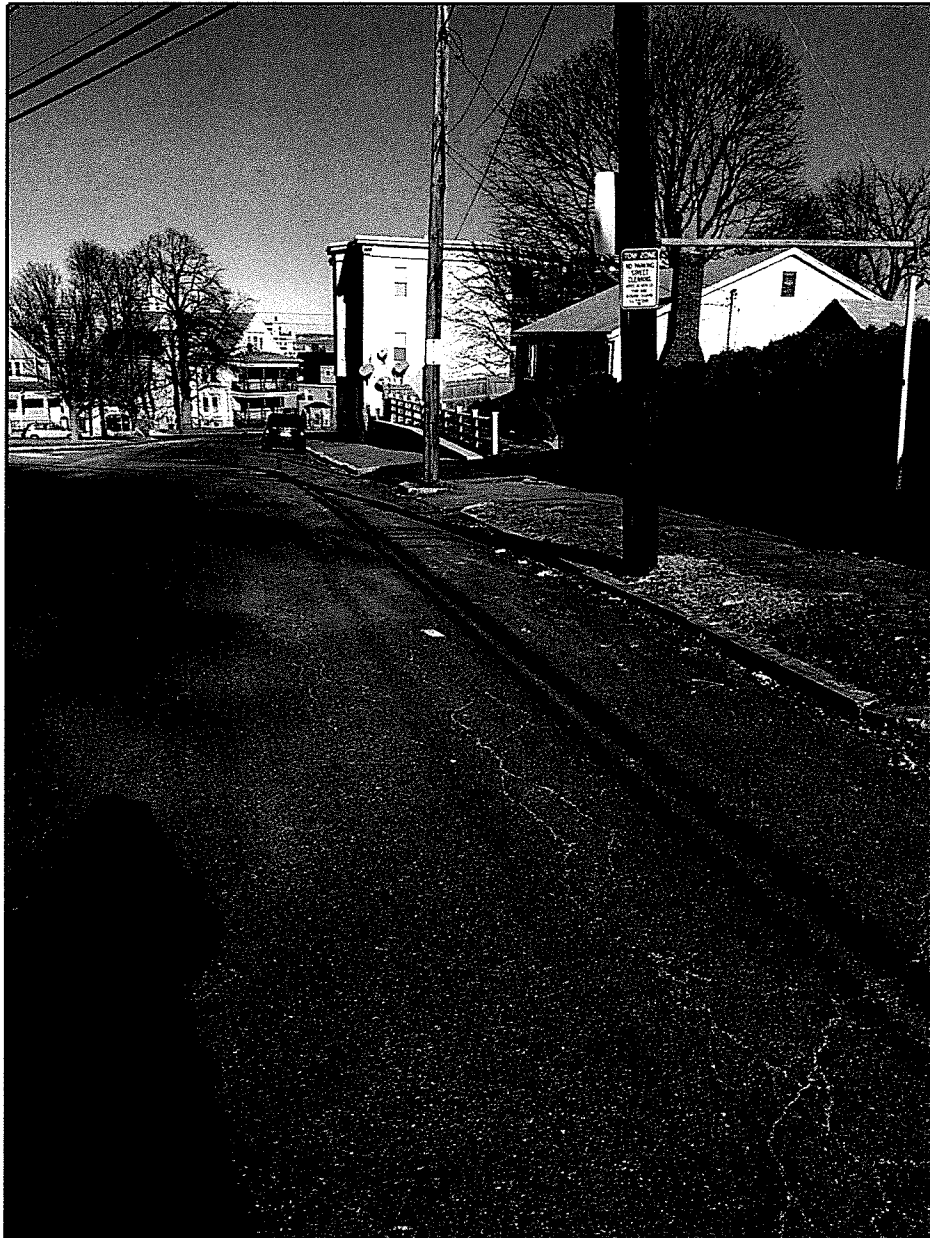
Heading north towards Centennial.

Curbing in poor condition. Sidewalk in poor condition. Edge settlement and development of alligator cracking seen.

Poor edge condition turns to very poor ahead.

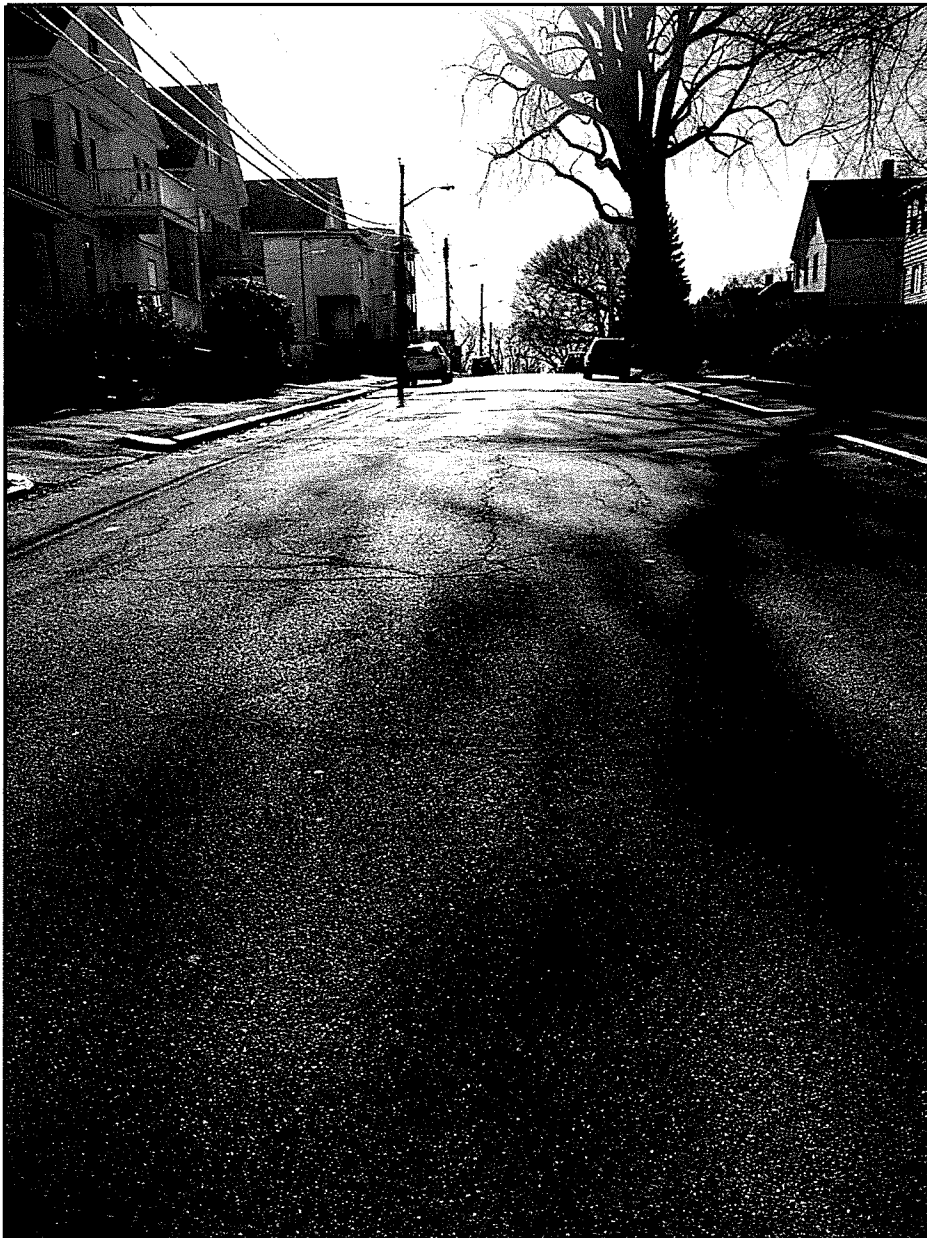
Looking back towards dend end

Longitudinal and transverse crack more visible in this picture. Cracks starting to expand. Area beyond pavement management measures.

Roadway in poor condition overall.
Sidewalks in poor condition overall.
Curbing in poor condition overall.

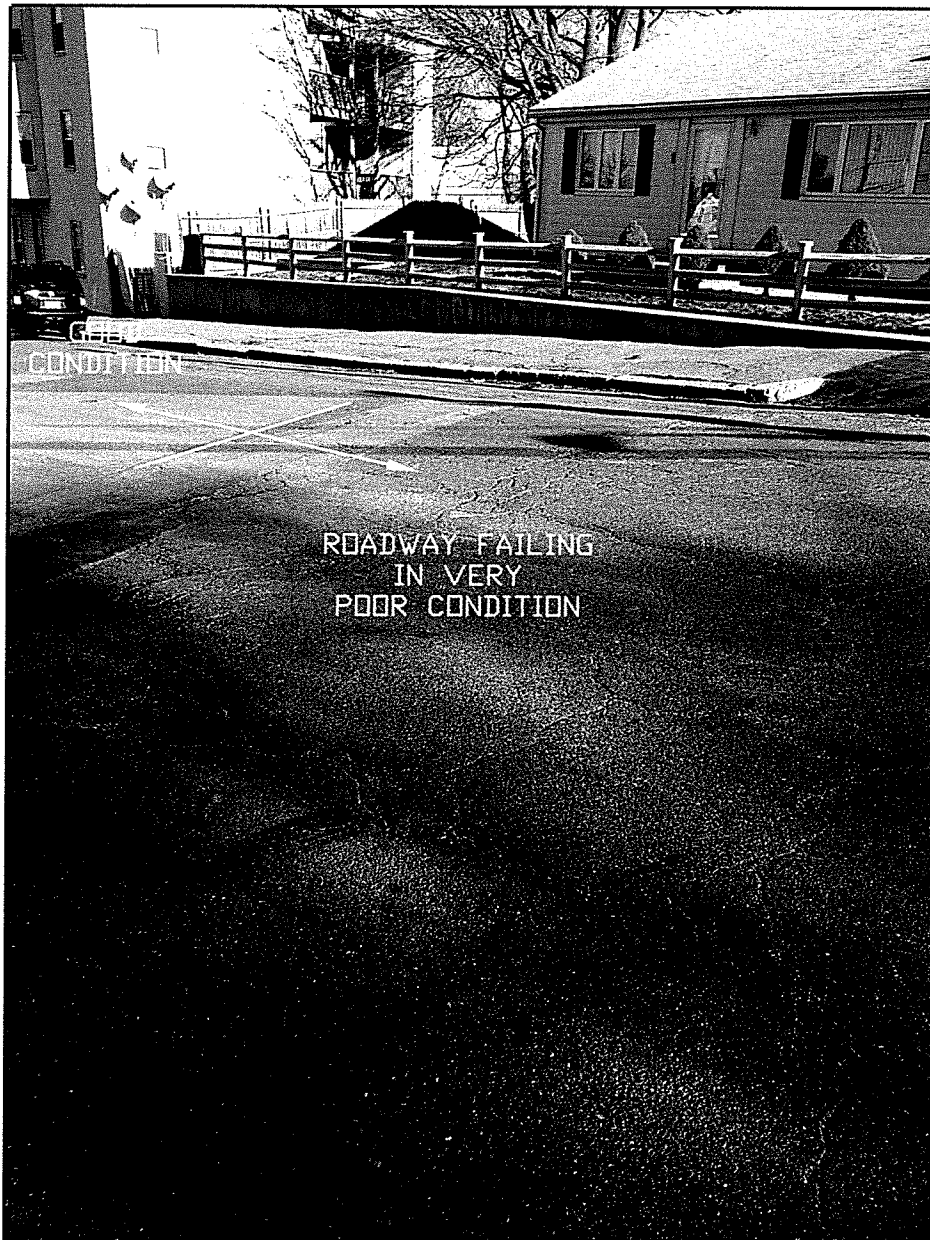
Looking towards proposed limit near Centennial traffic island.

Roadway in very poor condition south of the line shown.

Cracking very pronounced and spreading.
Roadway beyond pavement management practices.
