PHASE 2 – FEASIBILITY ANALYSIS

PEARL AVENUE

REVERE BEACH PARKWAY TO SUMMER STREET

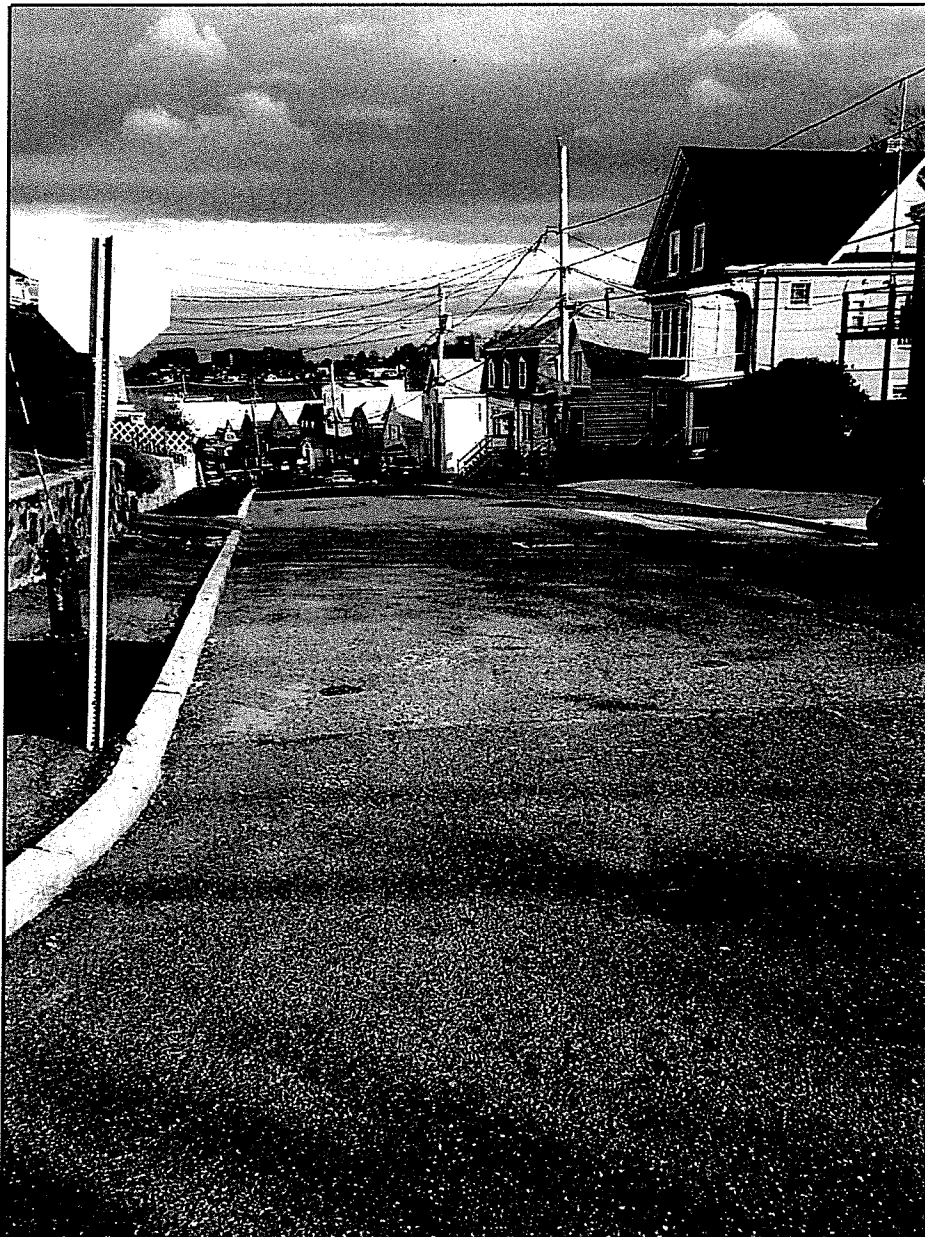
At Summer St. looking east.

Section of road sufficiently wide and previously developed.
Granite curbing exists with sidewalks of various materials.

Roadway in decent condition.

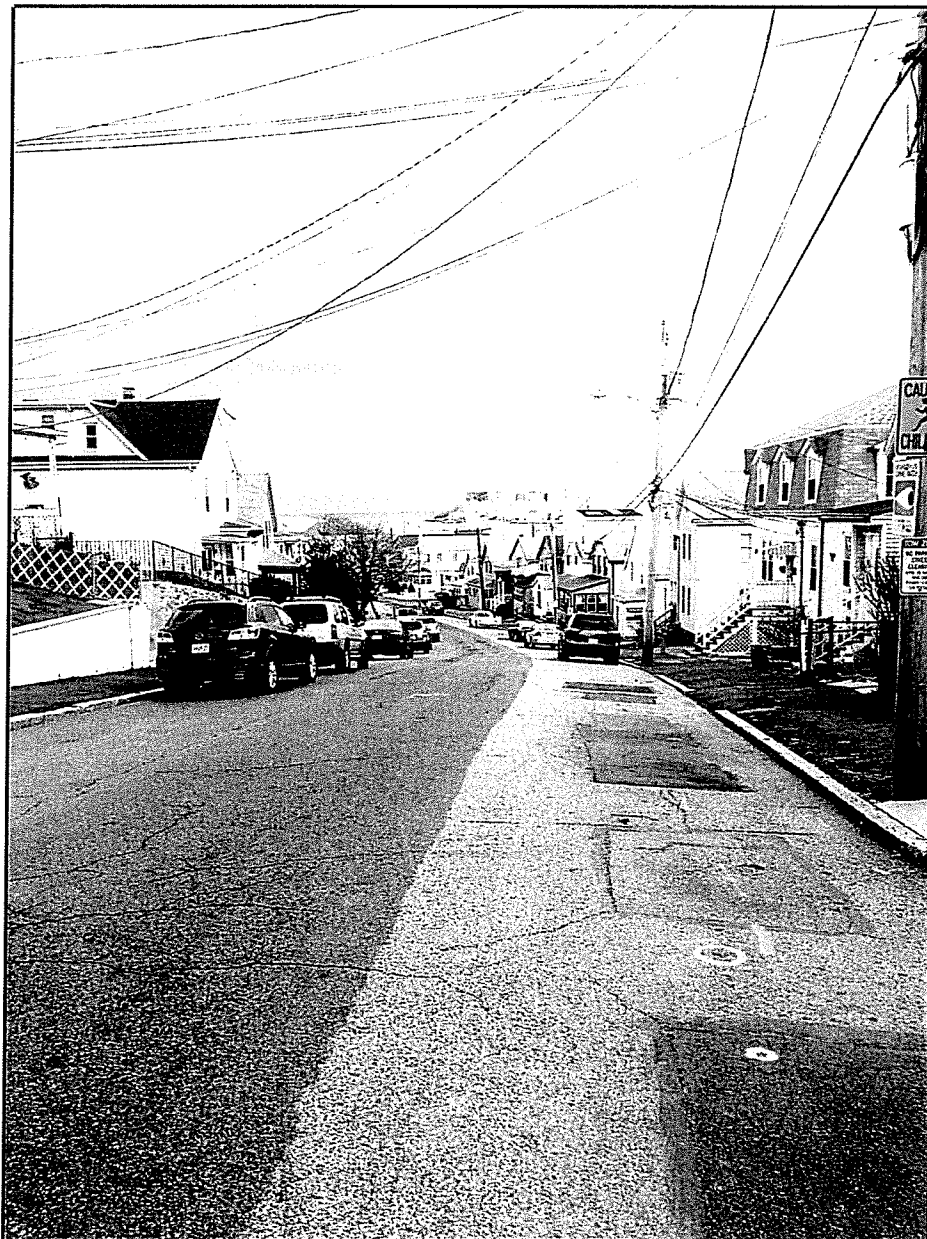
Utility patches on south side of the road in decent condition. Alligator cracking and potholes ahead. Sidewalks are of varying materials, curbing in decent condition but reveal is low,.

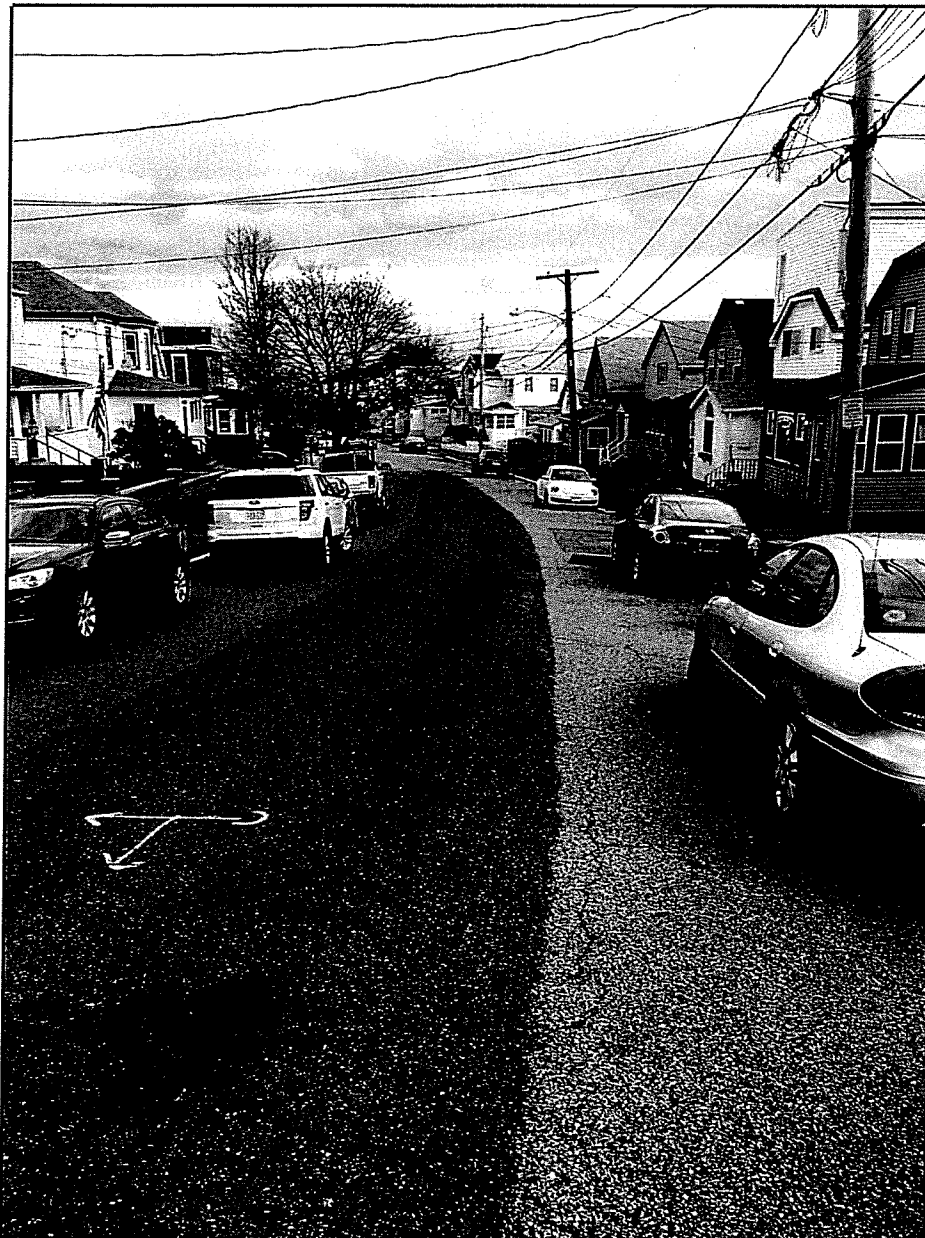
Continuing east.

Alligator cracking giving way to pot holes shown.

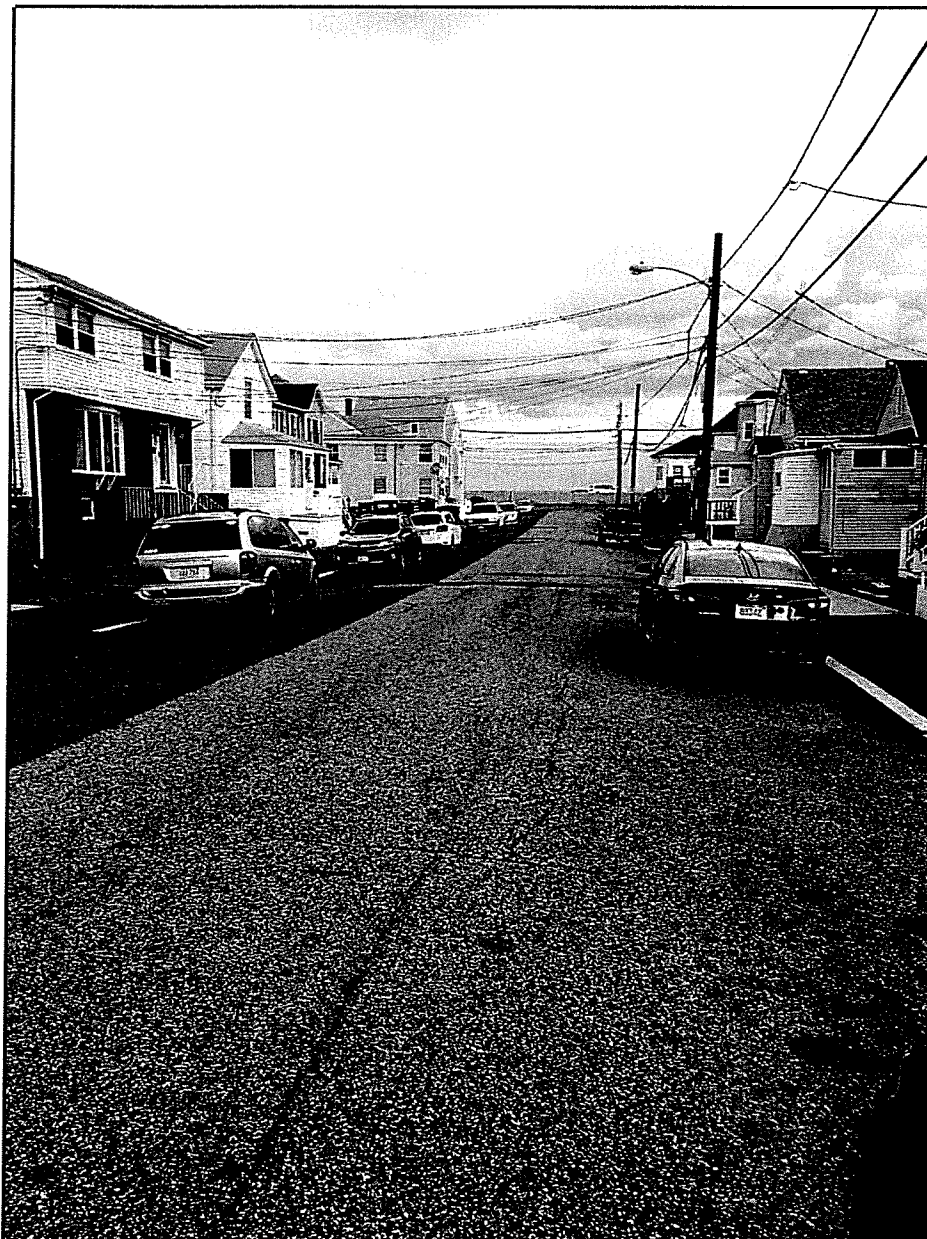
Continuing east on Pearl Ave.

Roadway cracking but in driveable condition. Small area shown in picture breaking up and will become potholes. Longitudinal trenches shown are beginning to fail.

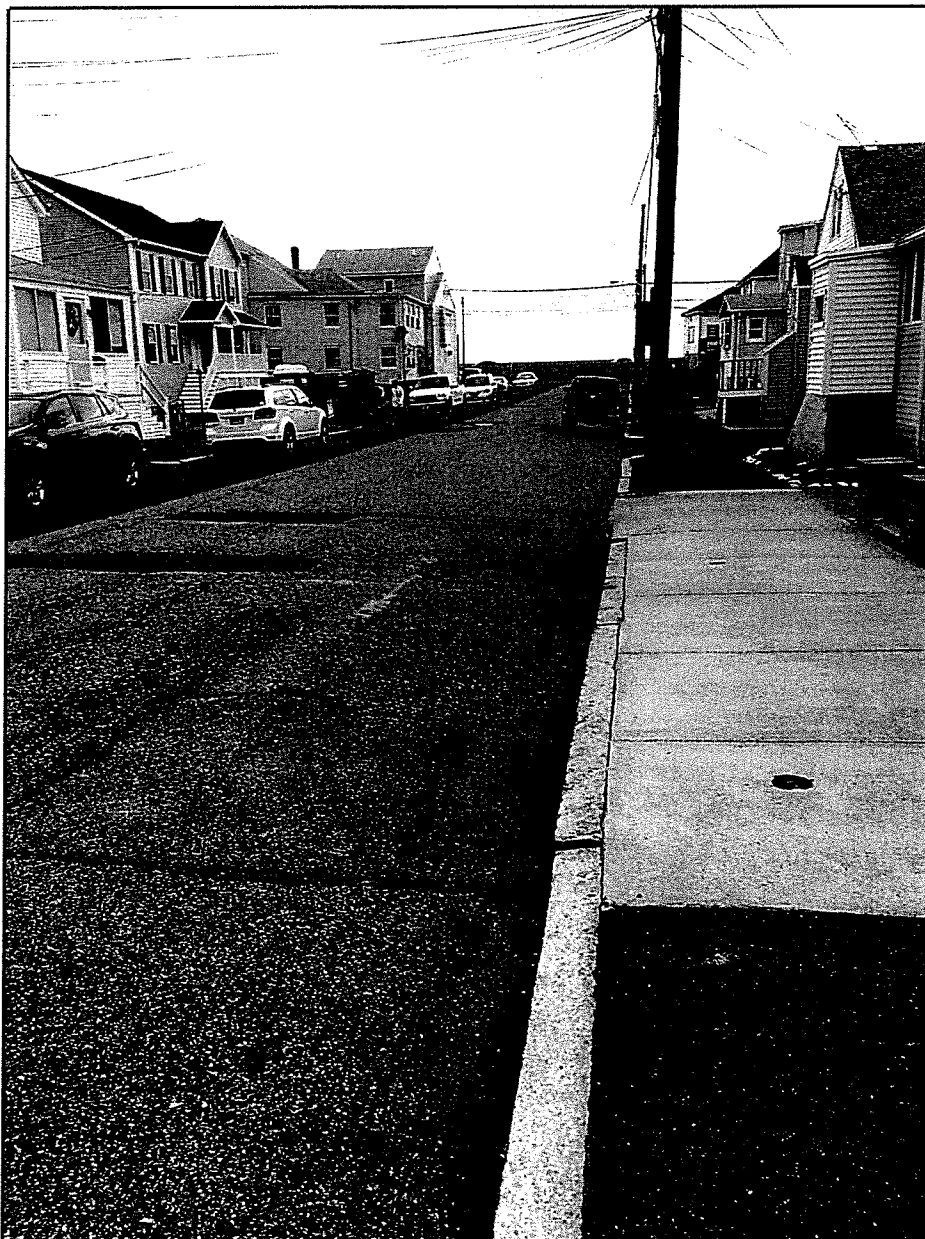
Looking east towards the sea wall

Photo highlighting poor section of roadway and sidewalks construct of both asphalt and concrete.

Curbing is out of line and shows settlement.
