PHASE 2 – FEASIBILITY ANALYSIS

KINGMAN AVENUE

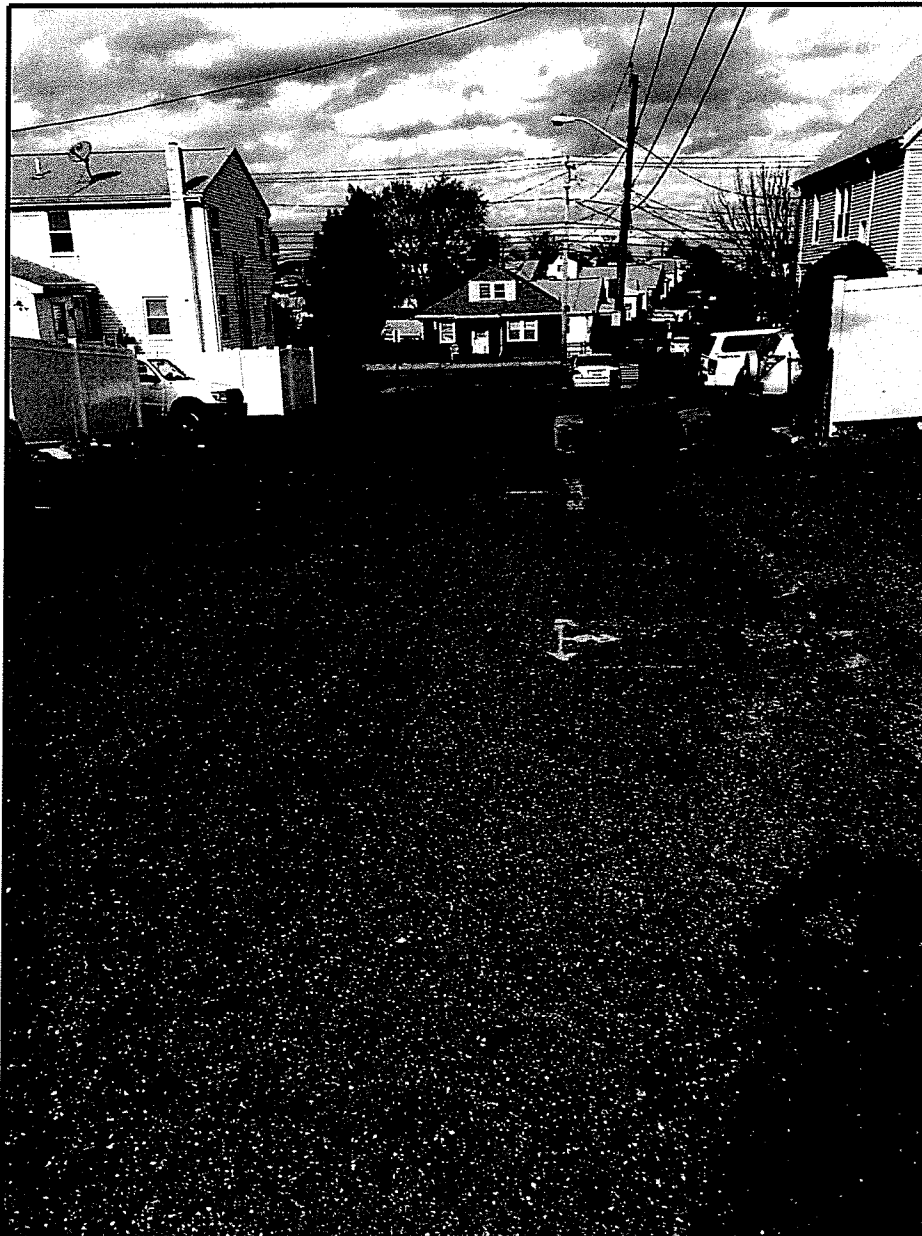
Kingman Street

Looking south towards Malden St. Alligator cracking is extensive giving way to potholes. Multiple pothole repairs shown. No formal curbing exists.

Curbing not an option due to high numbers of vehicles parking on asphalt shoulders.

1. Mill and pave roadway
2. Remove and replace shoulders with new asphalt road shoulders
3. Contact PWD about establishing maintenance program for the drain system.

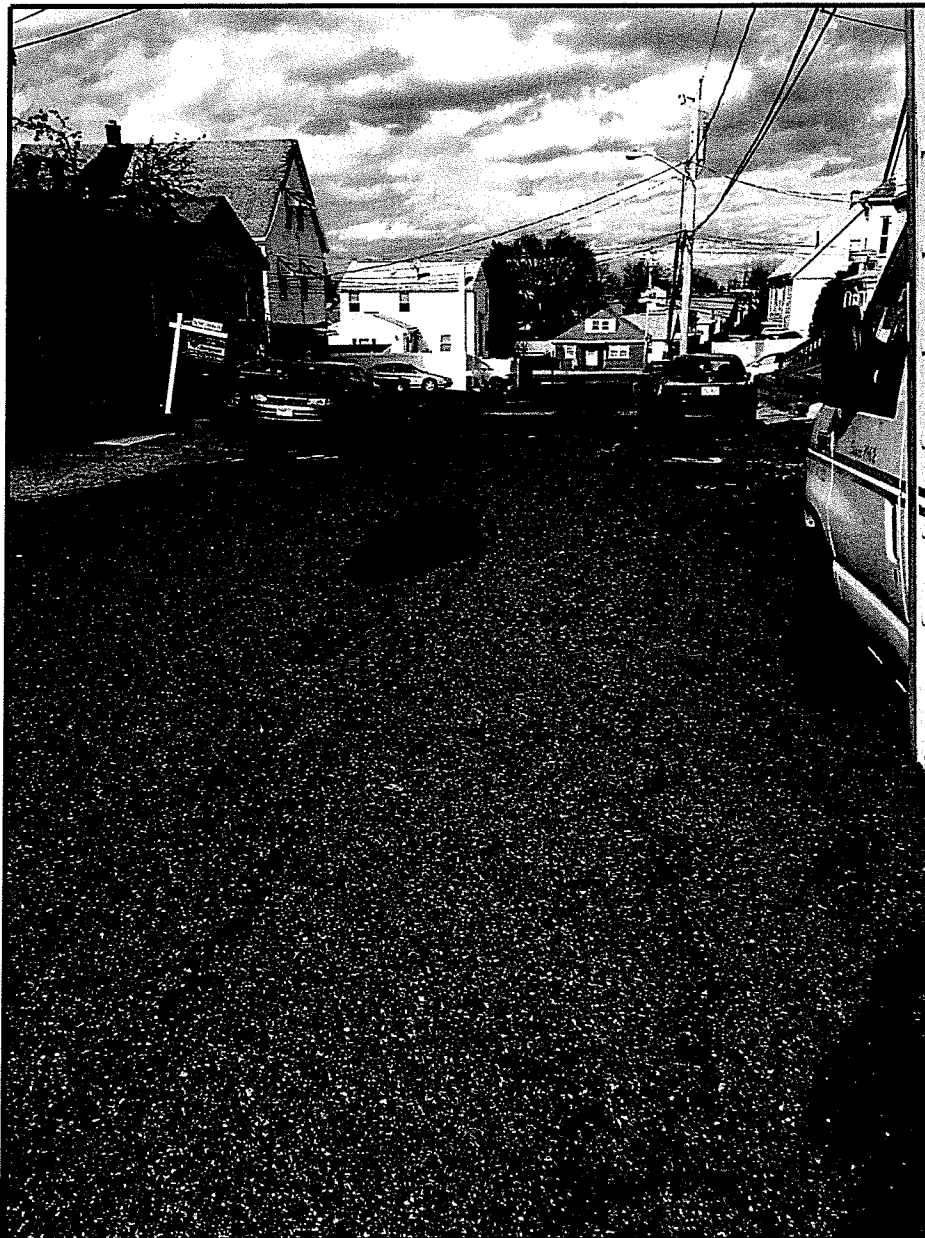
Kingman Street

Condition of roadway continues consistently.

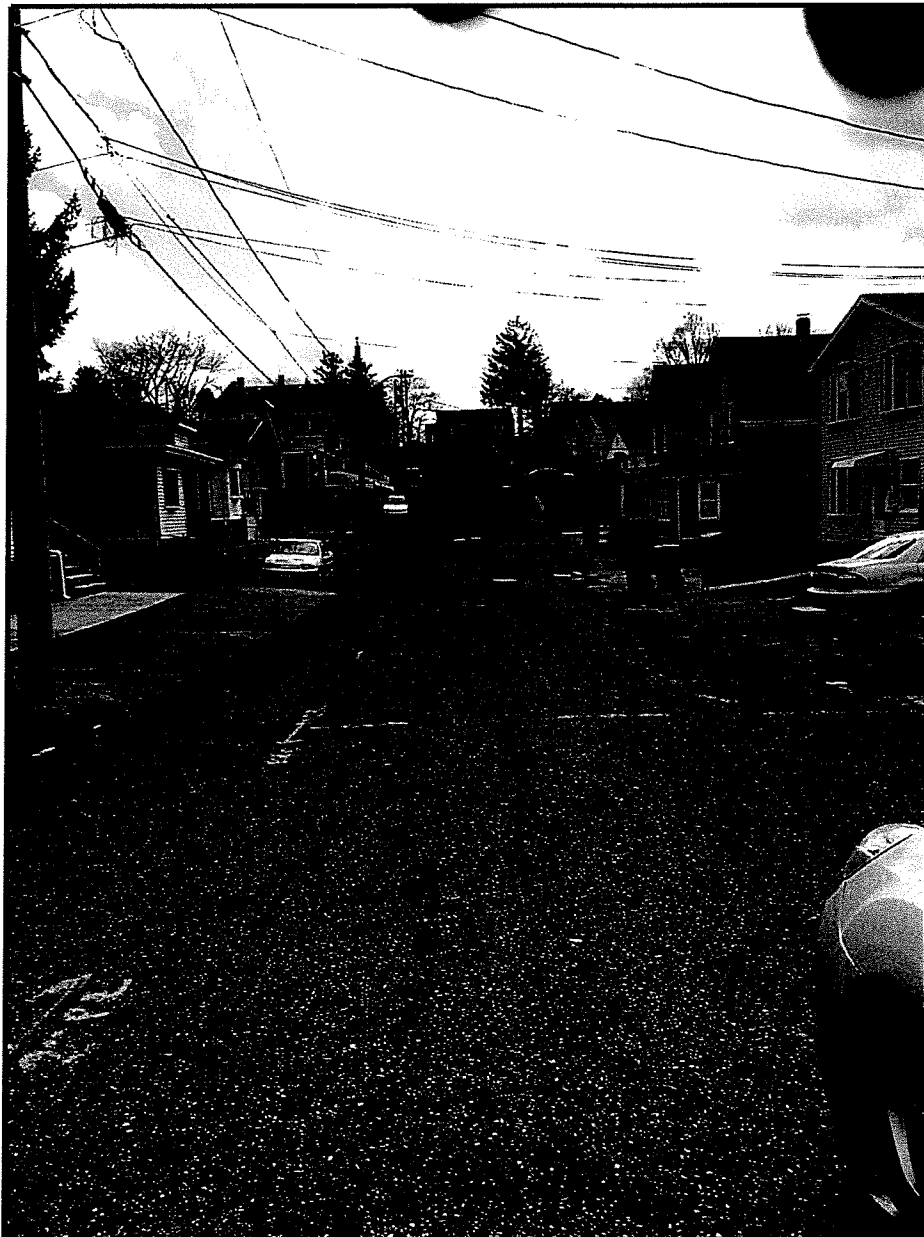
Kingman Street

Looking south towards Fenley Street.

Roadway cracking, pothole repairs on upper and lower end of the street. Asphalt shoulders / sidewalks in poor condition.
