PHASE 2 – FEASIBILITY ANALYSIS

HICHBORN STREET

(R.B. PARKWAY TO LEE BURBANK HWY)

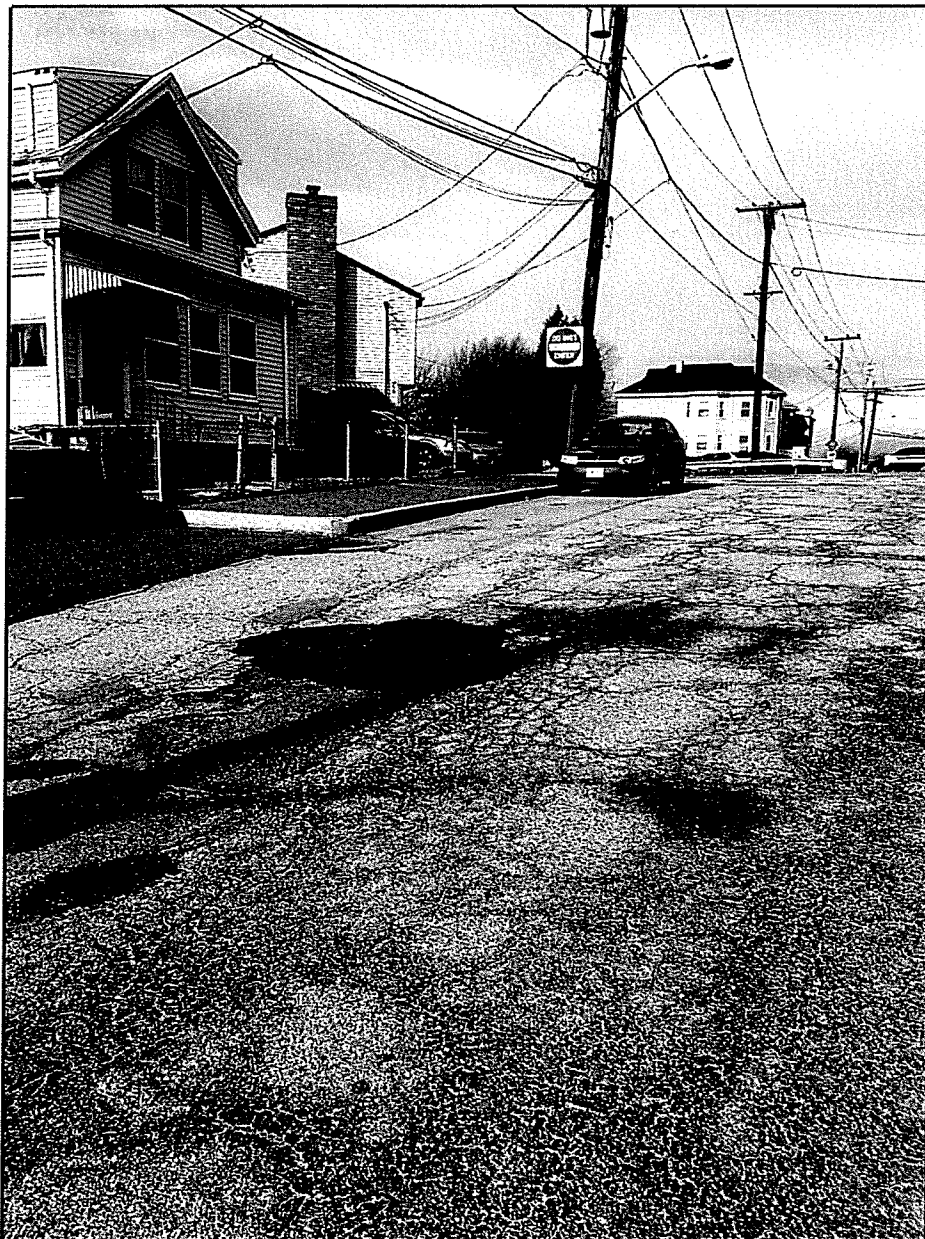
Hichborn Street

Looking towards 1A

Alligator cracking turning into potholes close to 1A

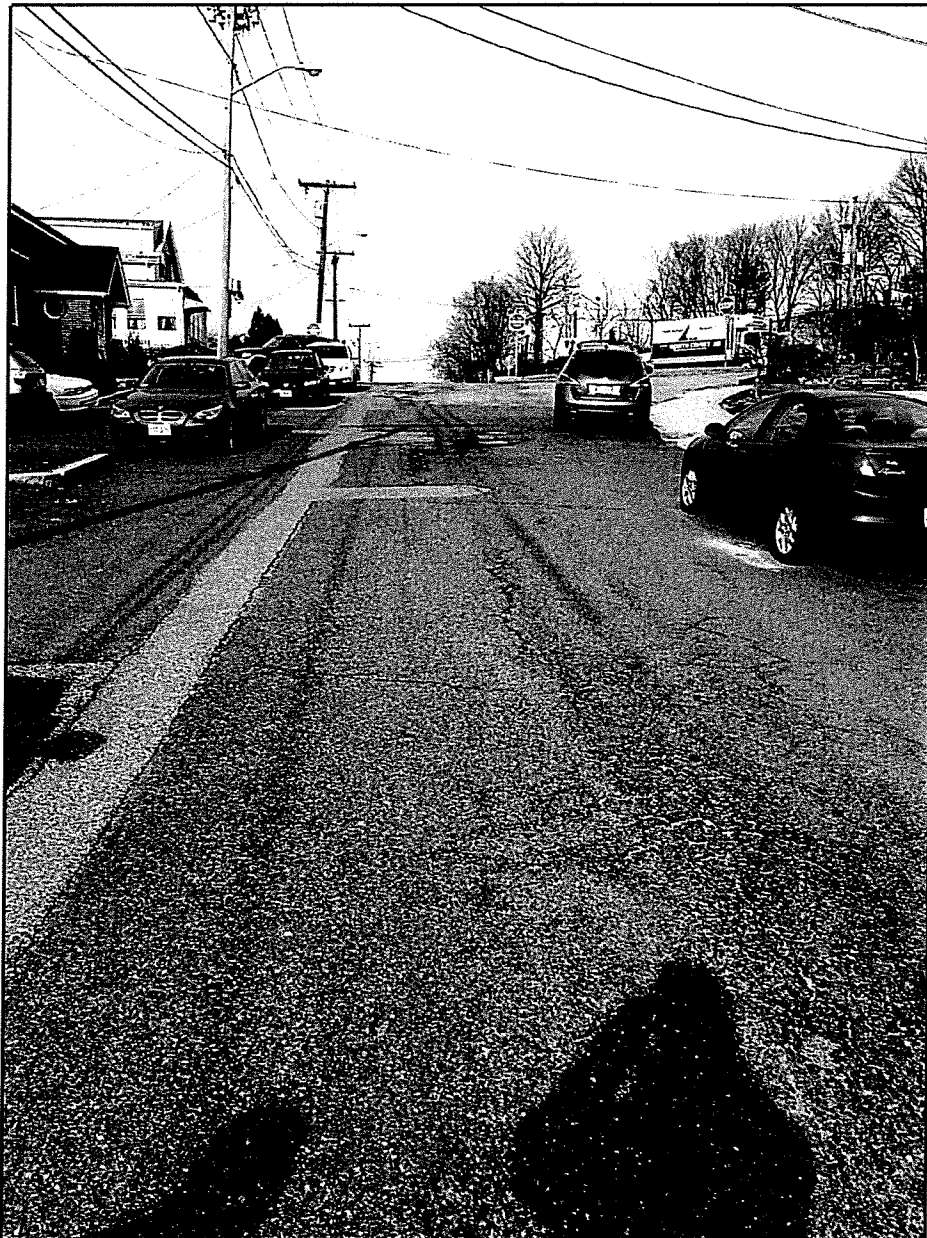
Hichborn Street

Looking towards 1A

Photo shows failing gas trench & longitudinal and transverse cracking.

Granite curb and sidewalks in decent condition.

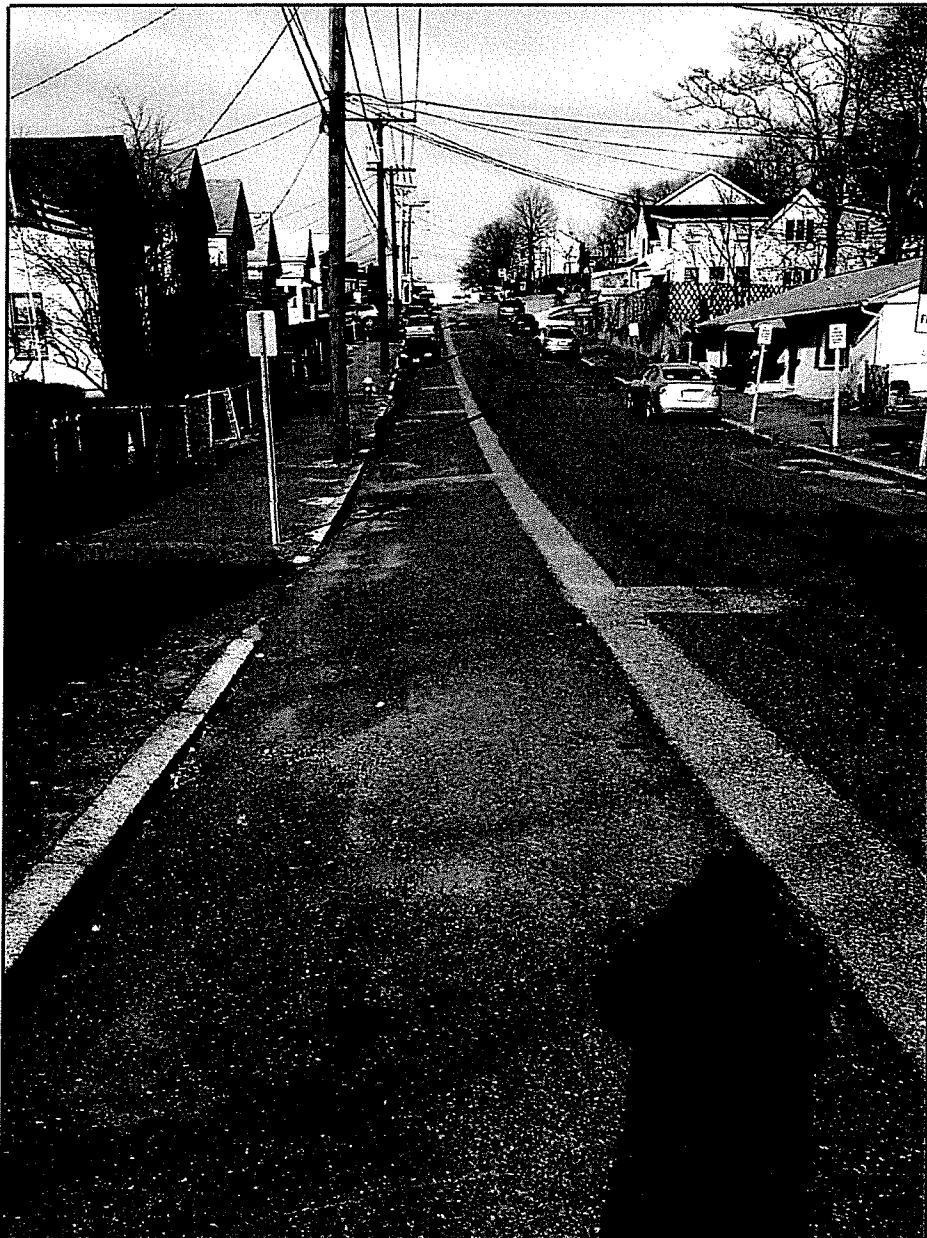
Hichborn Street

Heading south, looking north towards 1A

Grass trench in good shape, roadway beginning to break, but not nearly as bad as the 1A intersection.

Asphalt sidewalks in poor condition.

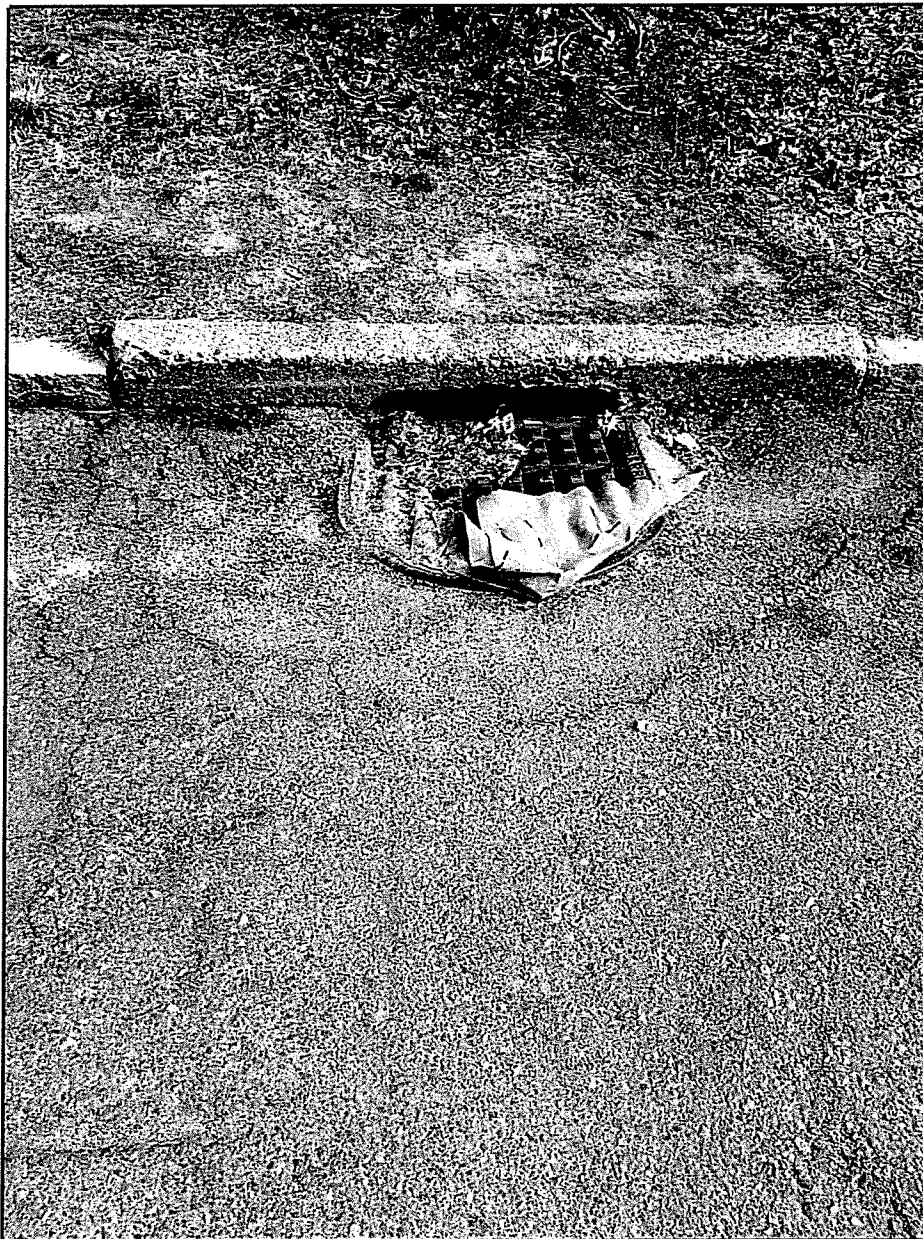
Hichborn Street

Photo shwoing sediment control left in catch basin,
most likely from gas main installation.

Sediment controls likely casusing poor drainage function
on the street.

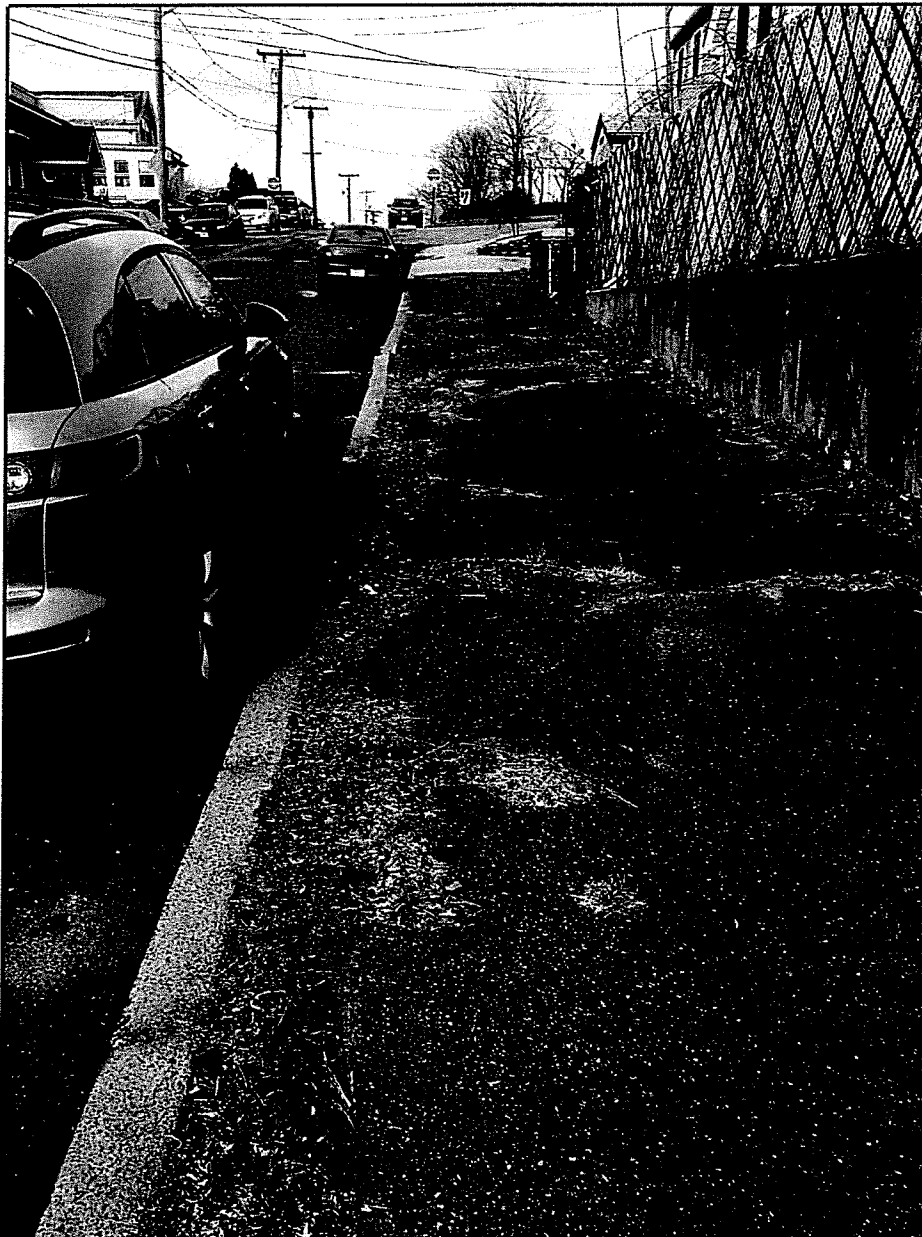
Hichborn Street

Photo highlighting various curbing materials on the street and section of sidewalk in poor condition.

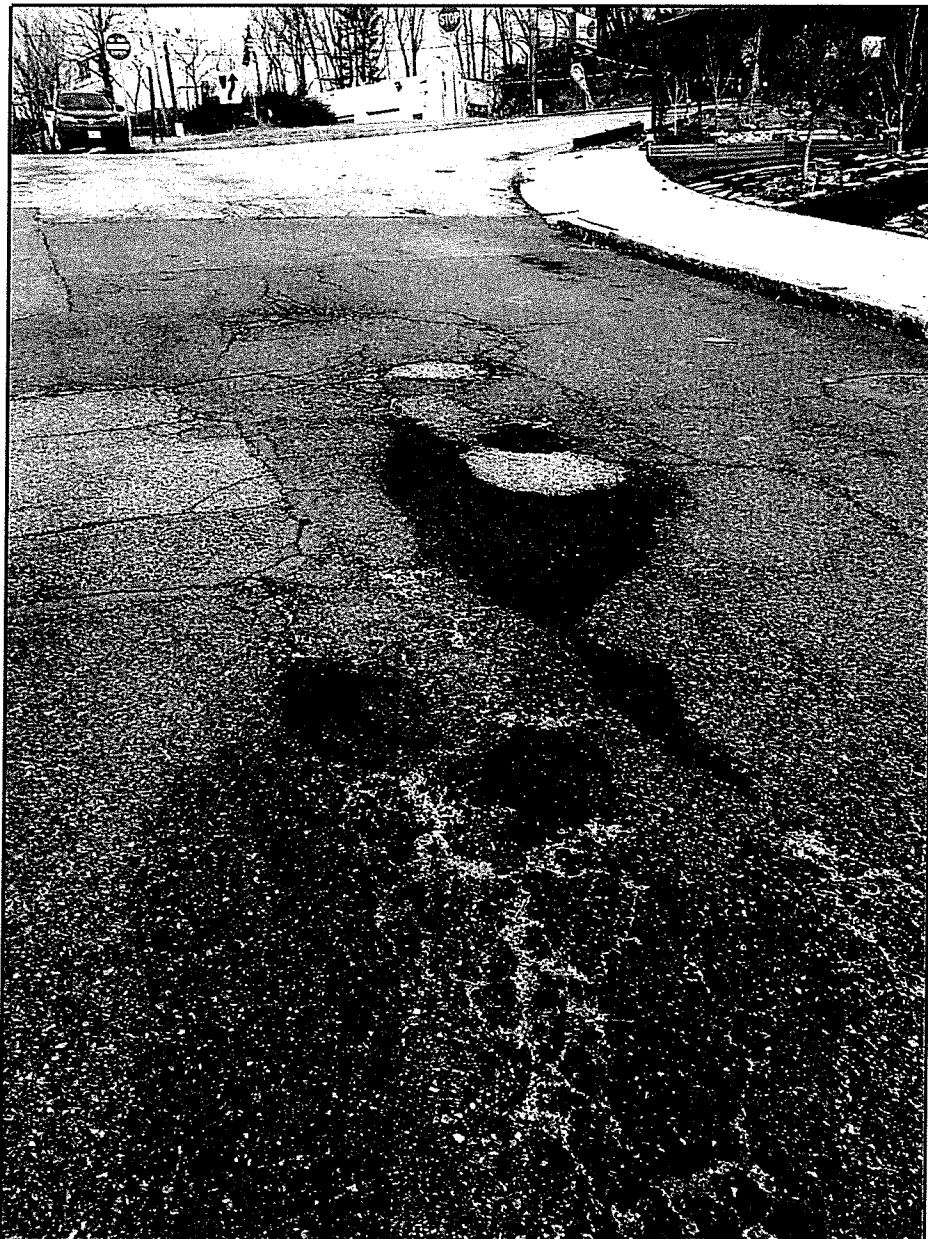
Hichborn Street

Photo highlighting worst section of roadway close to 1A
