PHASE 1 - FEASIBILITY ANALYSIS

Florence Ave.

(Entire Road)

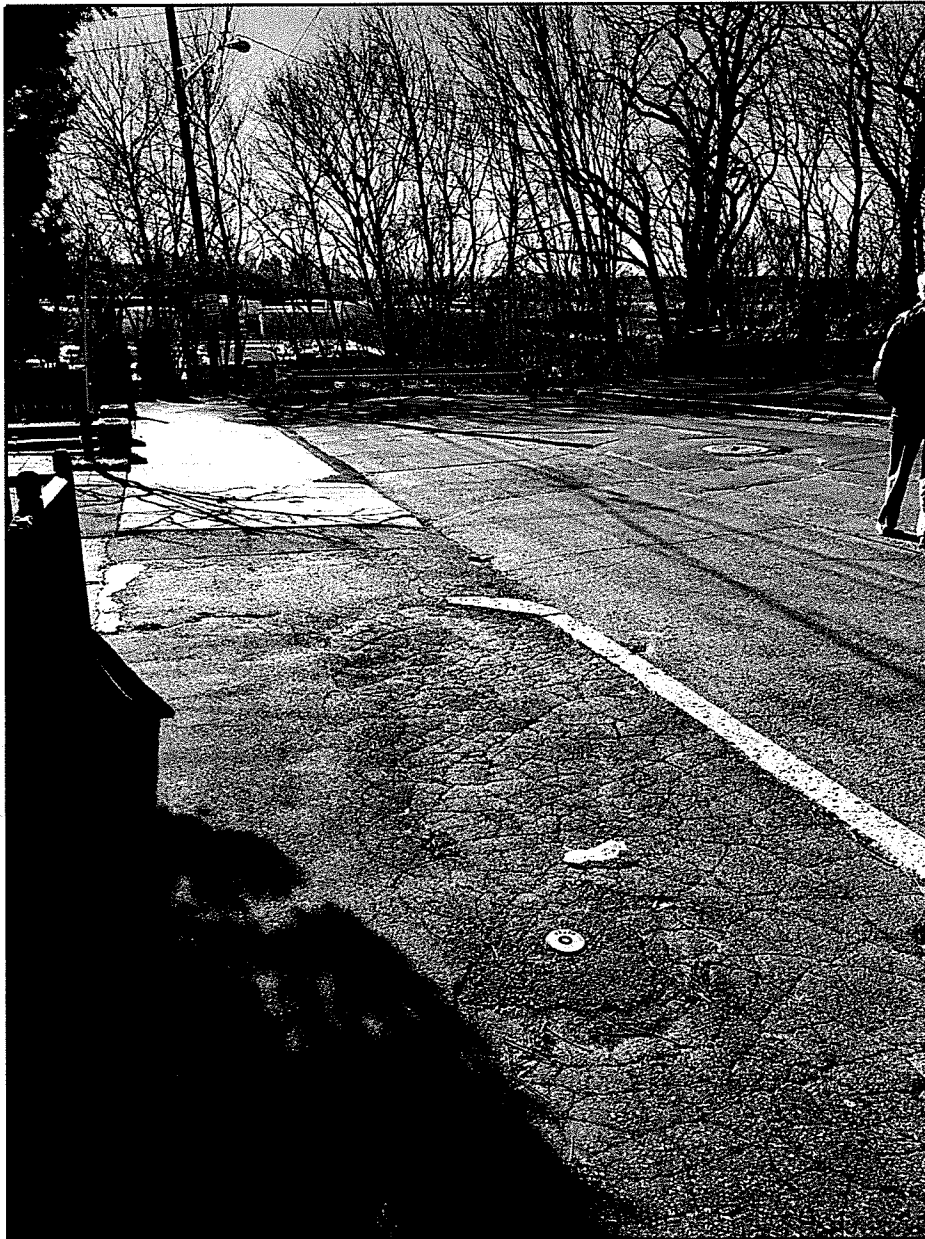
At dead end looking south

Sidewalks of various materials, curbing reveal minimal. Road showing settlement, transverse and longitudinal cracking and various utility trenches.

Condition Poor

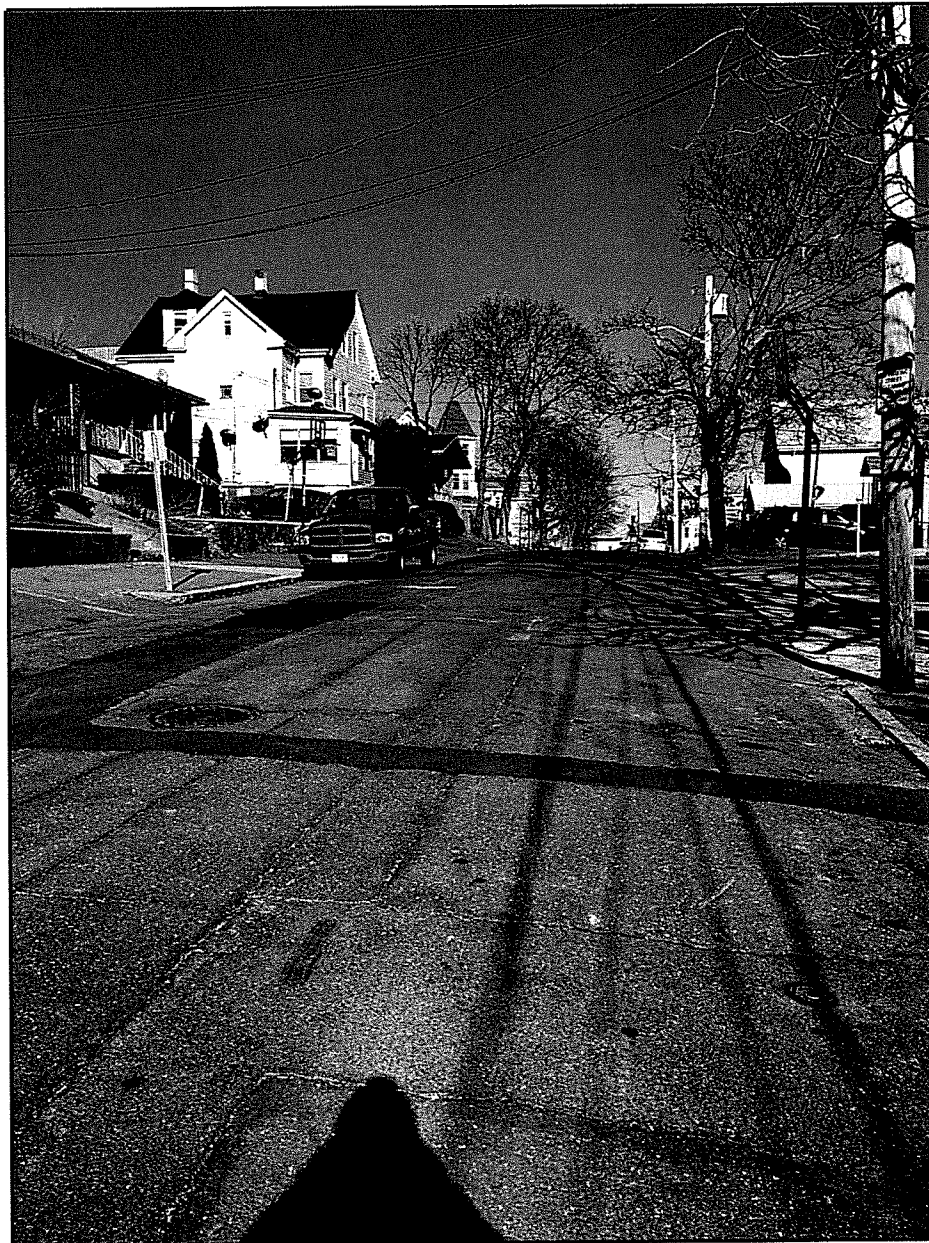
Heading north, away from dead end

Note minimal curb reveal on right side and varying sidewalk materials.

Road has multiple utility trenches (water and gas). Cracking not extensive in this photo. Rideability poor.

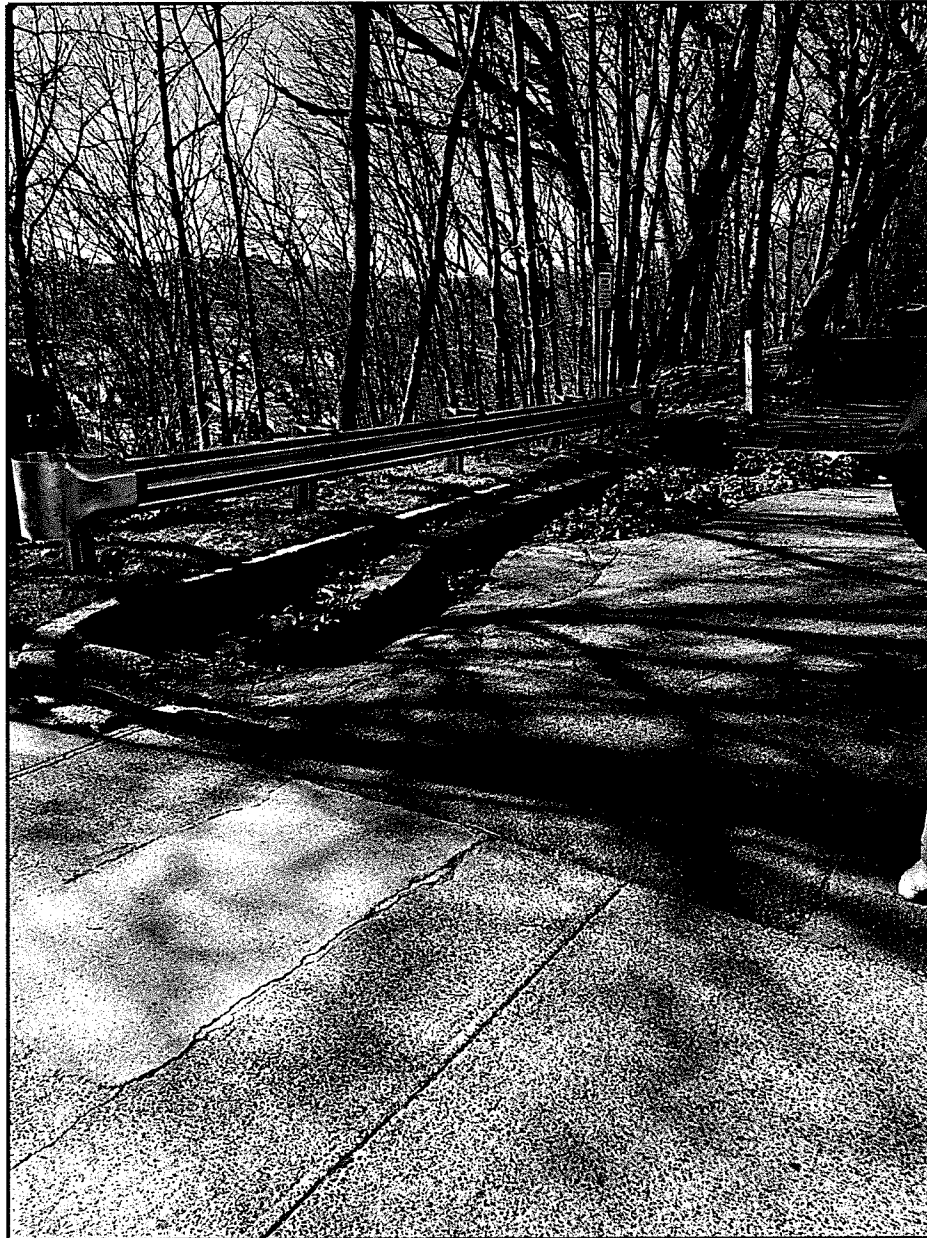
Dead End

Photo shows adequate drainage at the end of the road including catch basins and granite curb.

Other dead ends in this area lack the curbing which directs the water into the drain system.

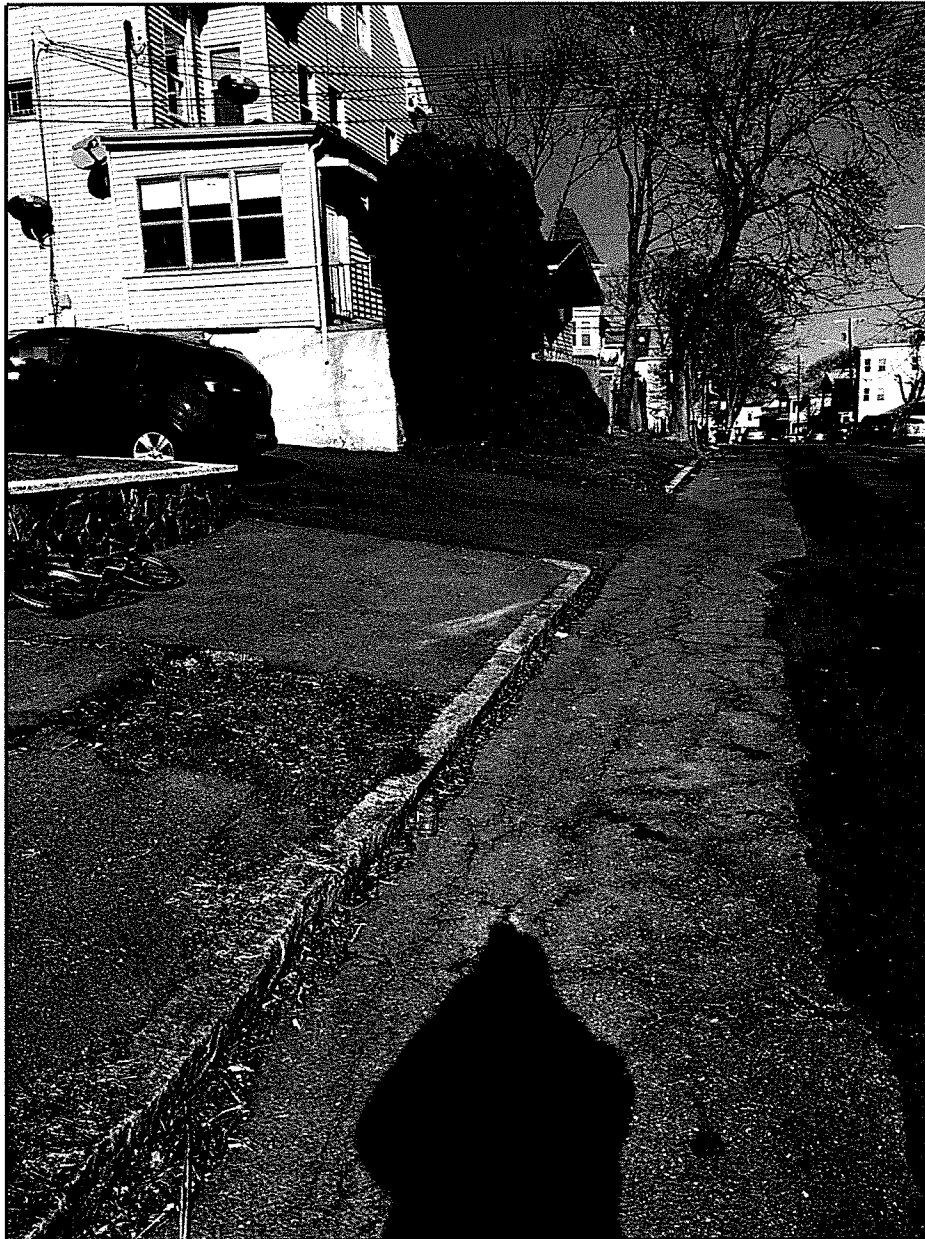
Continuing north, towards James St.

Sidewalk shown in poor condition. Old tree pit, roots have heaved sidewalk, cross slope does not meet ADA standards. Note sidewalk does not continue ahead.

Alligator cracking developing as well as edge settlement of the roadway.

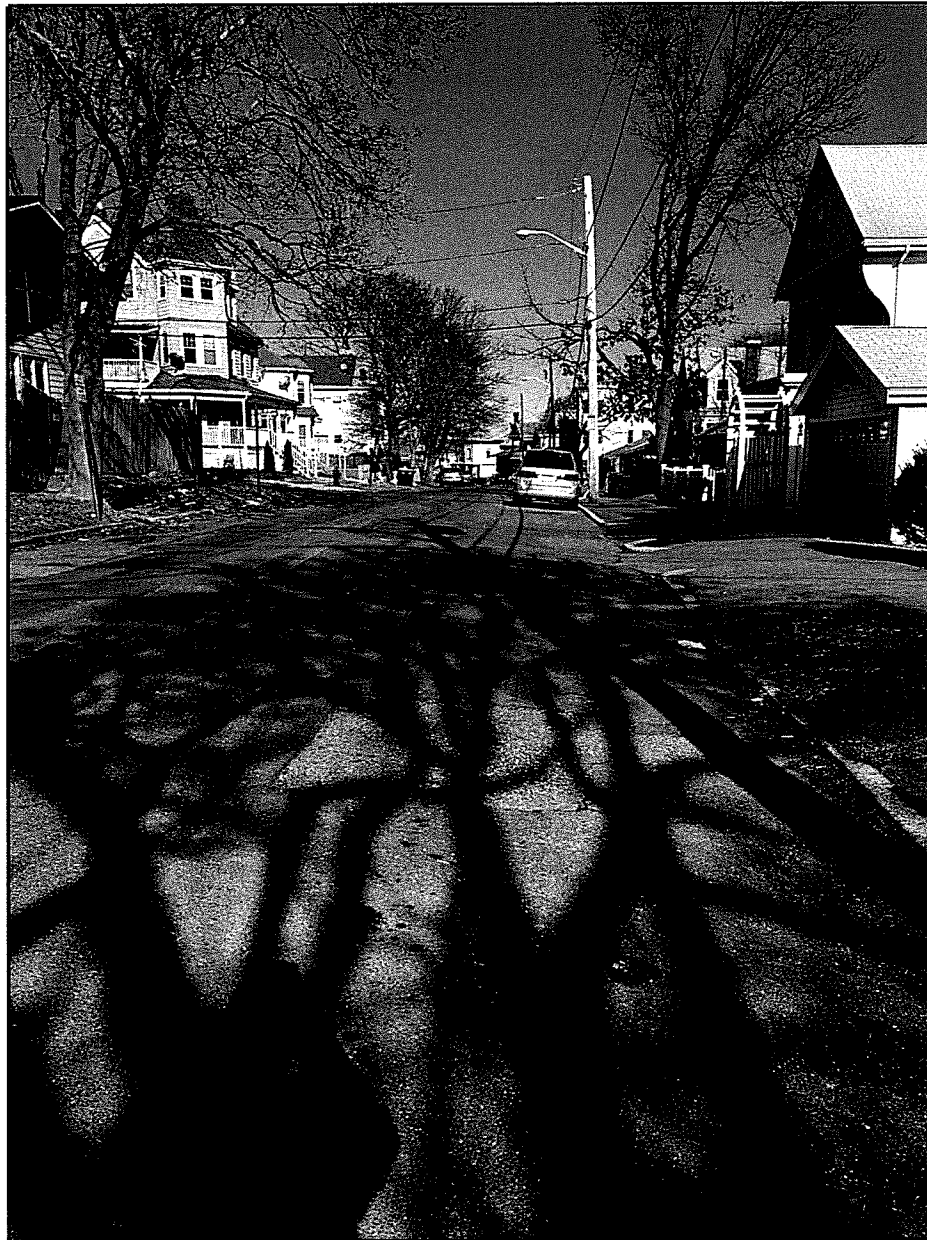
Heading north towards James, opposite side of the street as the last photo.

Minimal curb reveal and old stump shown.
Sidewalks in good condition, but lack curb reveal.
Inconsistent sidewalk materials.

Roadway has various utility trenches, gas trench shown showing settlement.

Rideability poor, condition somewhat stable.

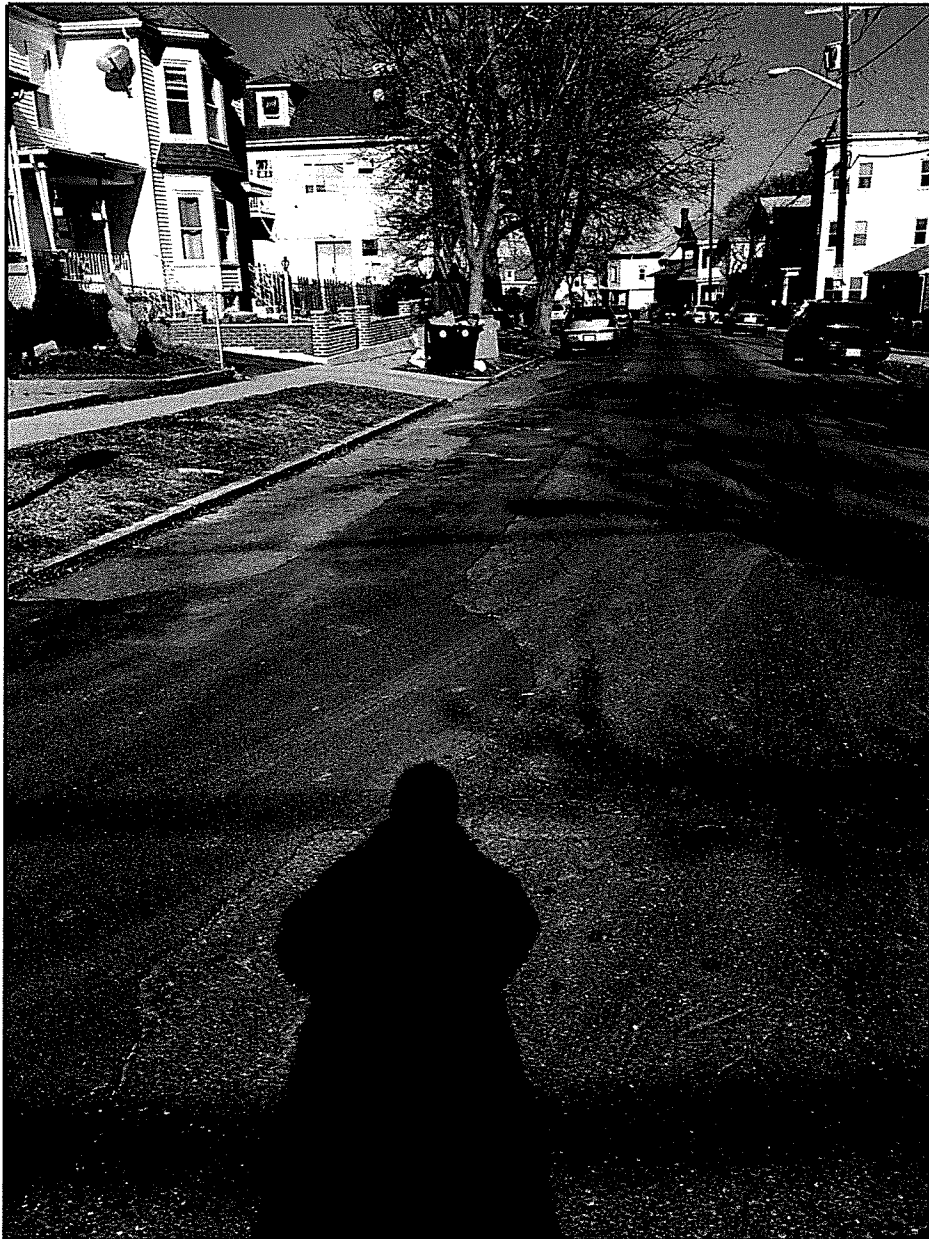
At James Street looking north

Water main replacement patch shown. Patch in good condition. Longitudinal and transverse cracks opening up. Alligator cracking becoming more pronounced.

Condition Poor

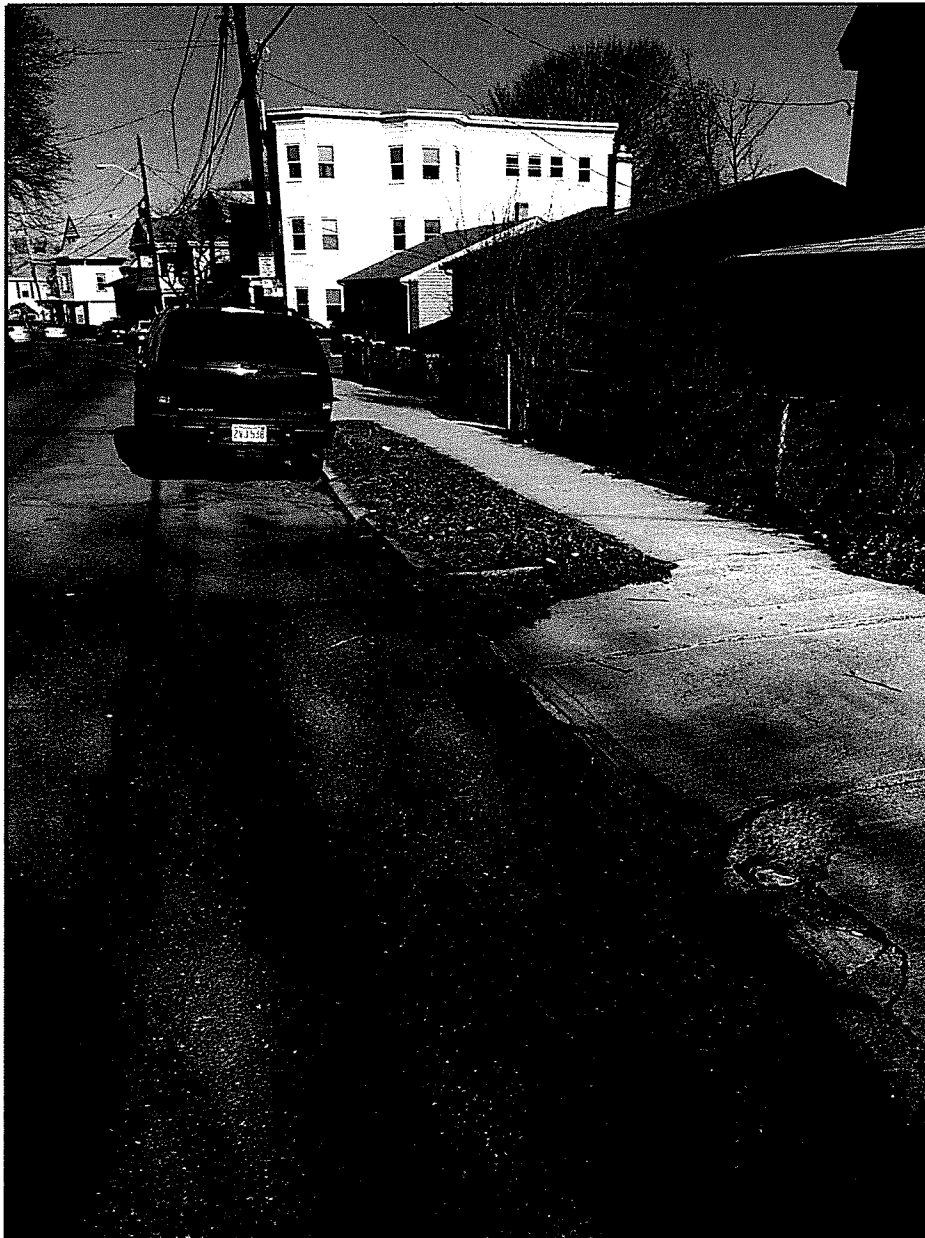
Continuing North, towards Centennial Ave.

Note settlement of curbing and low curb reveal.
Concrete sidewalks in relatively good condition.
Sidewalk material consistent as we progress
north, and condition is good.

Condition of roadway improves through this small
section but deteriorates quickly as we approach
Centennial Ave.

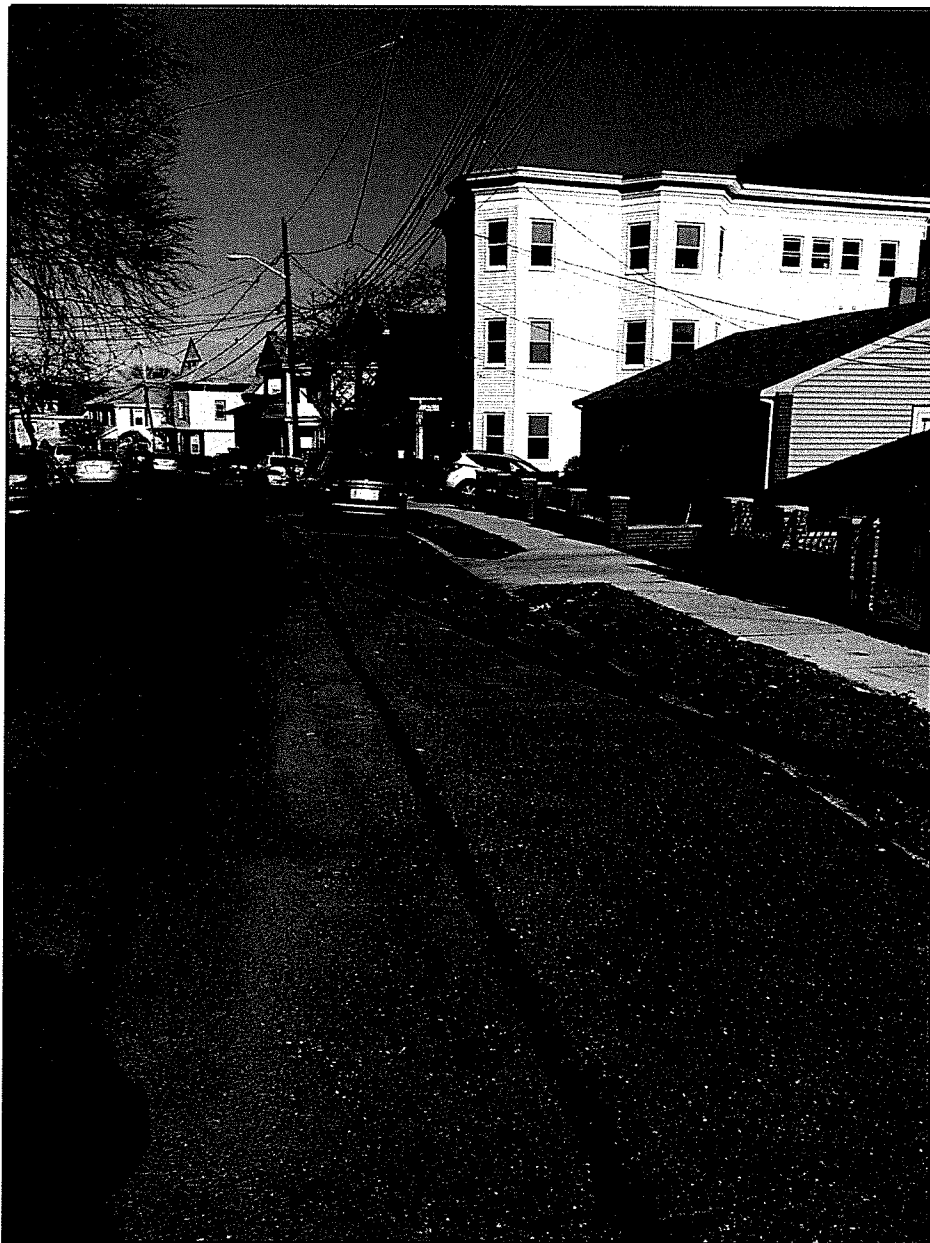
Heading north towards Centennial.

Roadway in decent condition. Cracks developing, but have not begun to open.

Sidewalk in good condition but curb lacks reveal.
Control of storm water poor due to lack of adequate curb reveal.

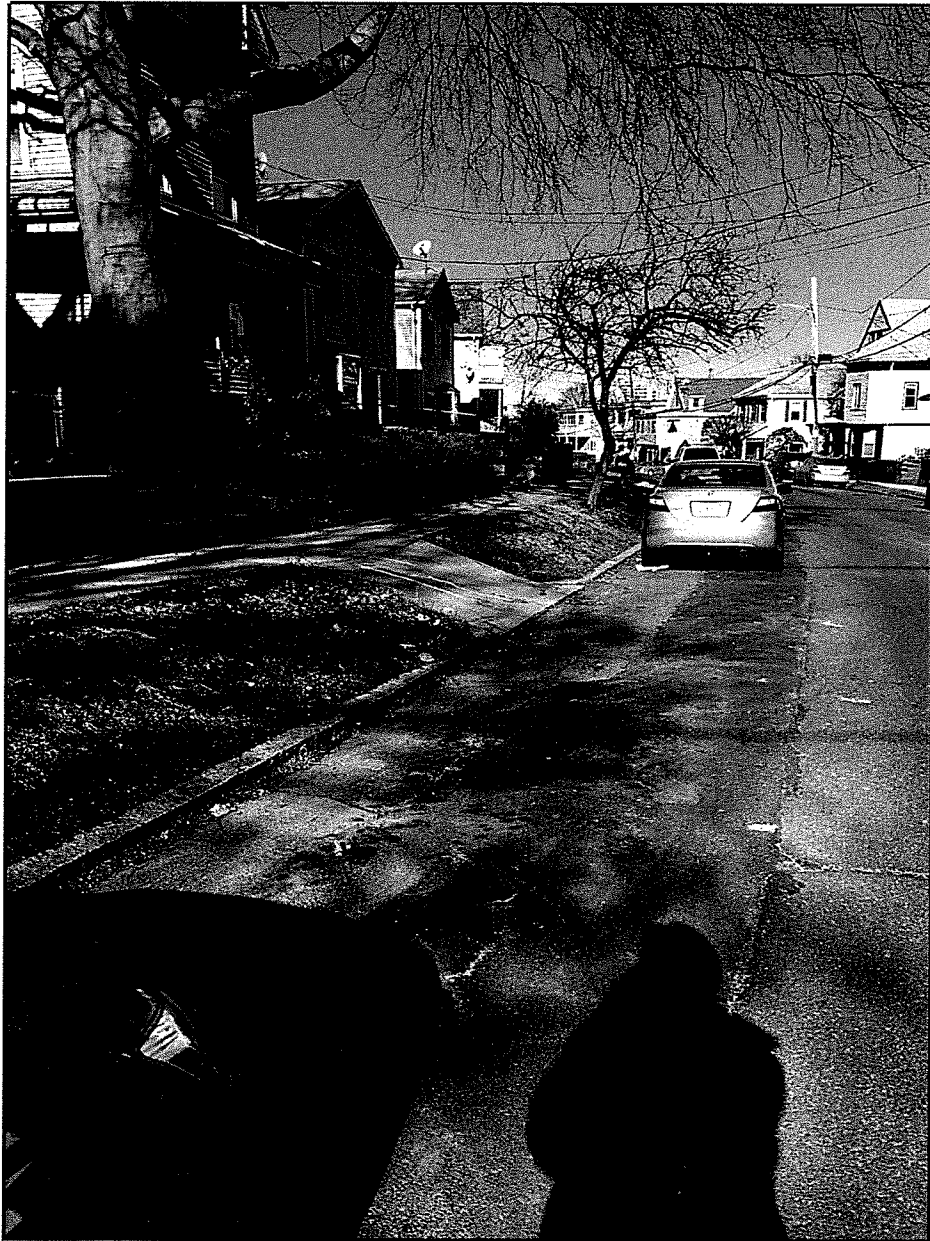
Heading north

West side of road in worse condition. Water main trench shown. Trench in good condition, but settlement and cracking seen at the edges and transverse crack shown.

Note extreme slope of driveway and evidence of vehicles bottoming out.

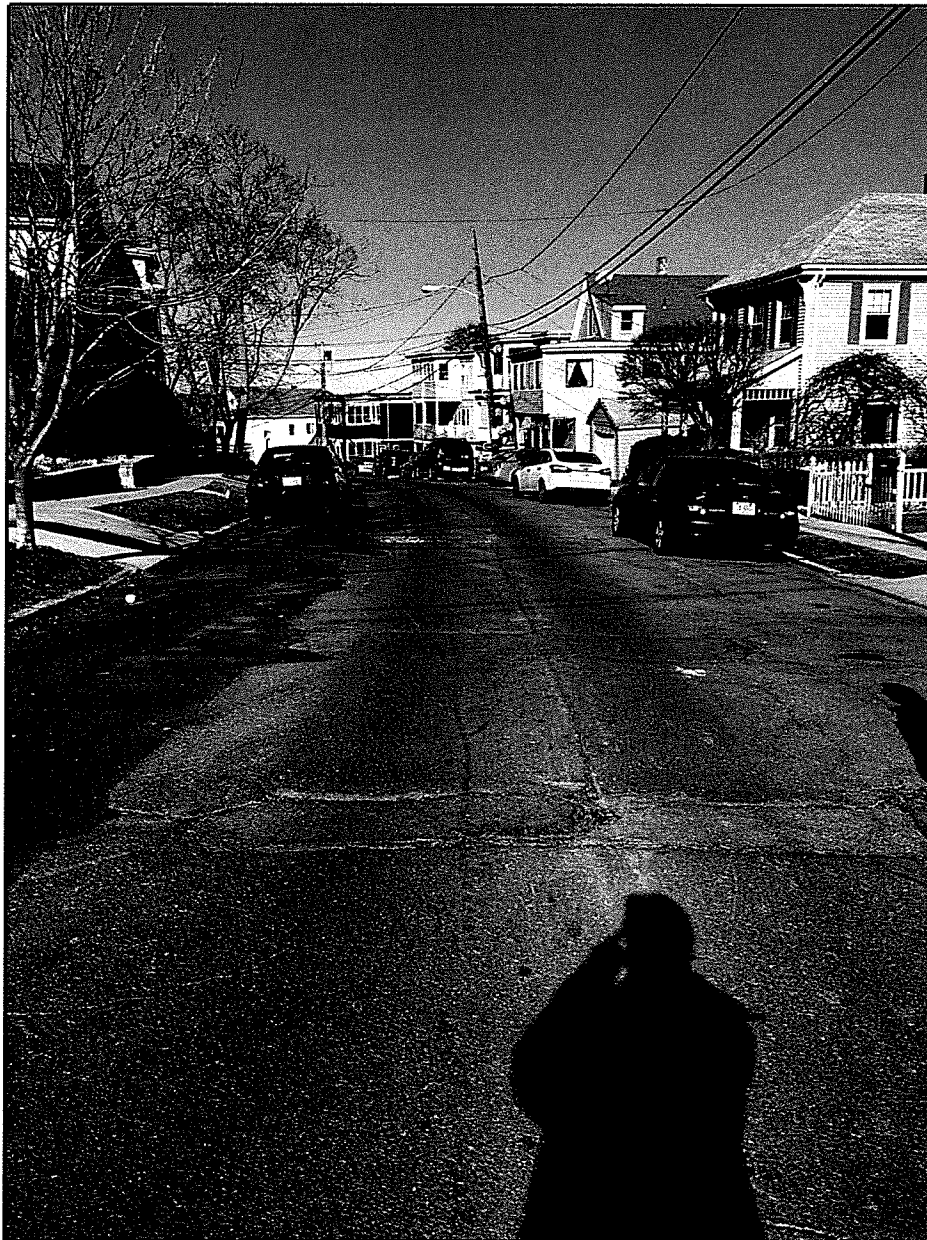
Continuing north towards Centennial

Pavement condition worsens, longitudinal and transverse cracks developing. Transverse trench failing, edge settlement seen. Alligator cracking developing. Rideability very poor from this point north.

Sidewalk condition good, curbing lacks reveal.

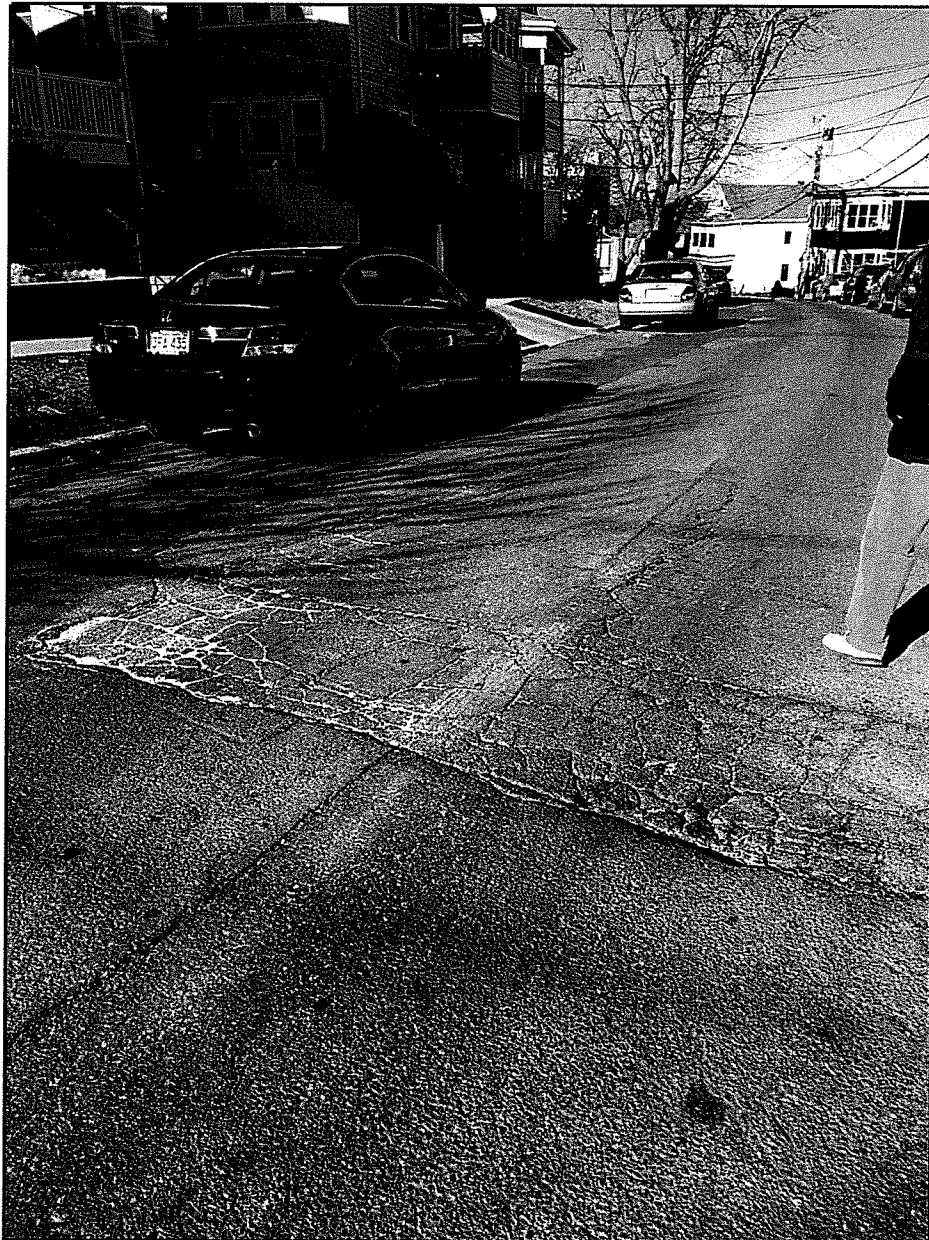
Continuing north towards Centennial.

Failed transverse trench shown. Longitudinal cracks opening up, failures spreading.

Road in poor / very poor condition

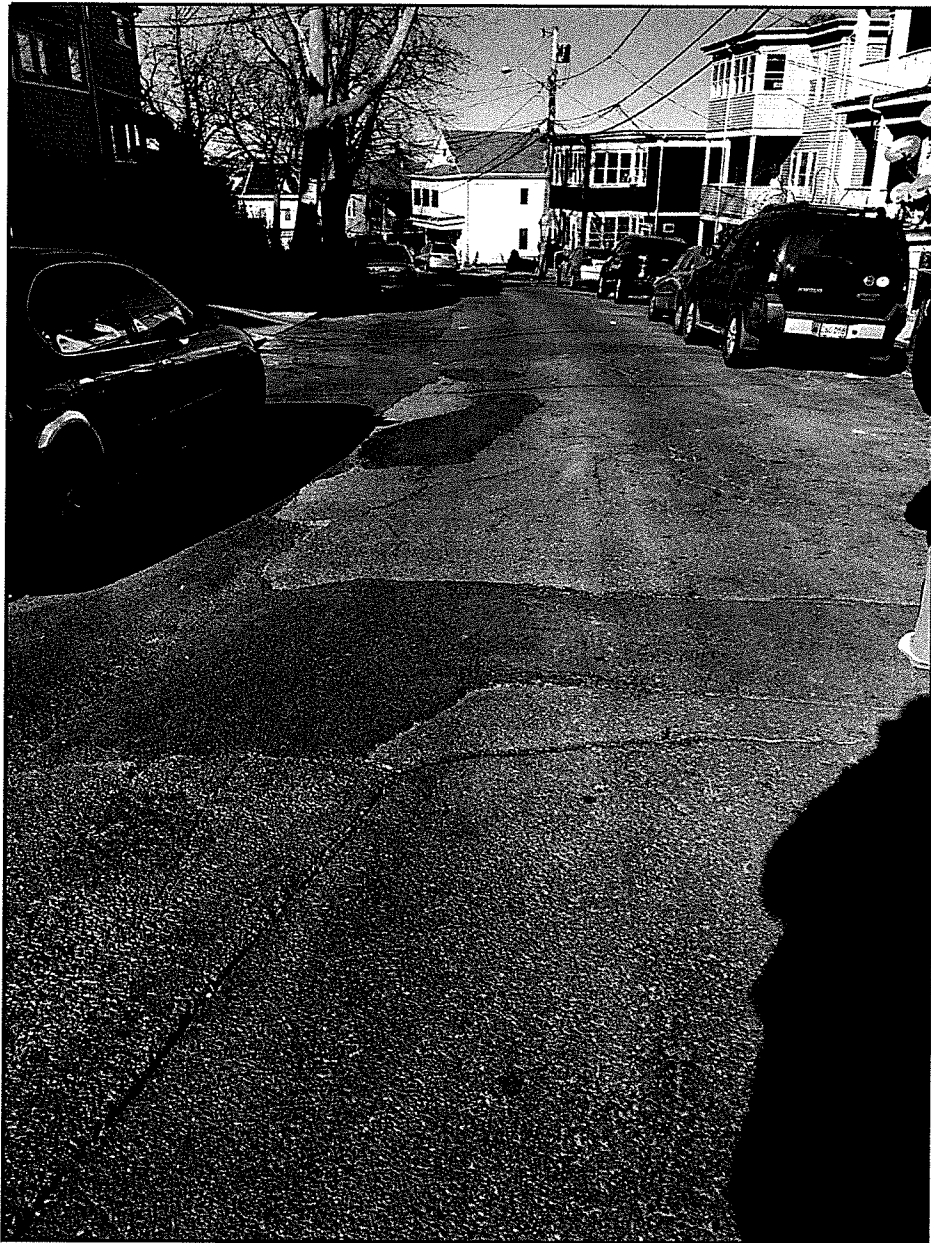
Continuing north towards Centennial

Pavement failures mentioned earlier continue and intensify

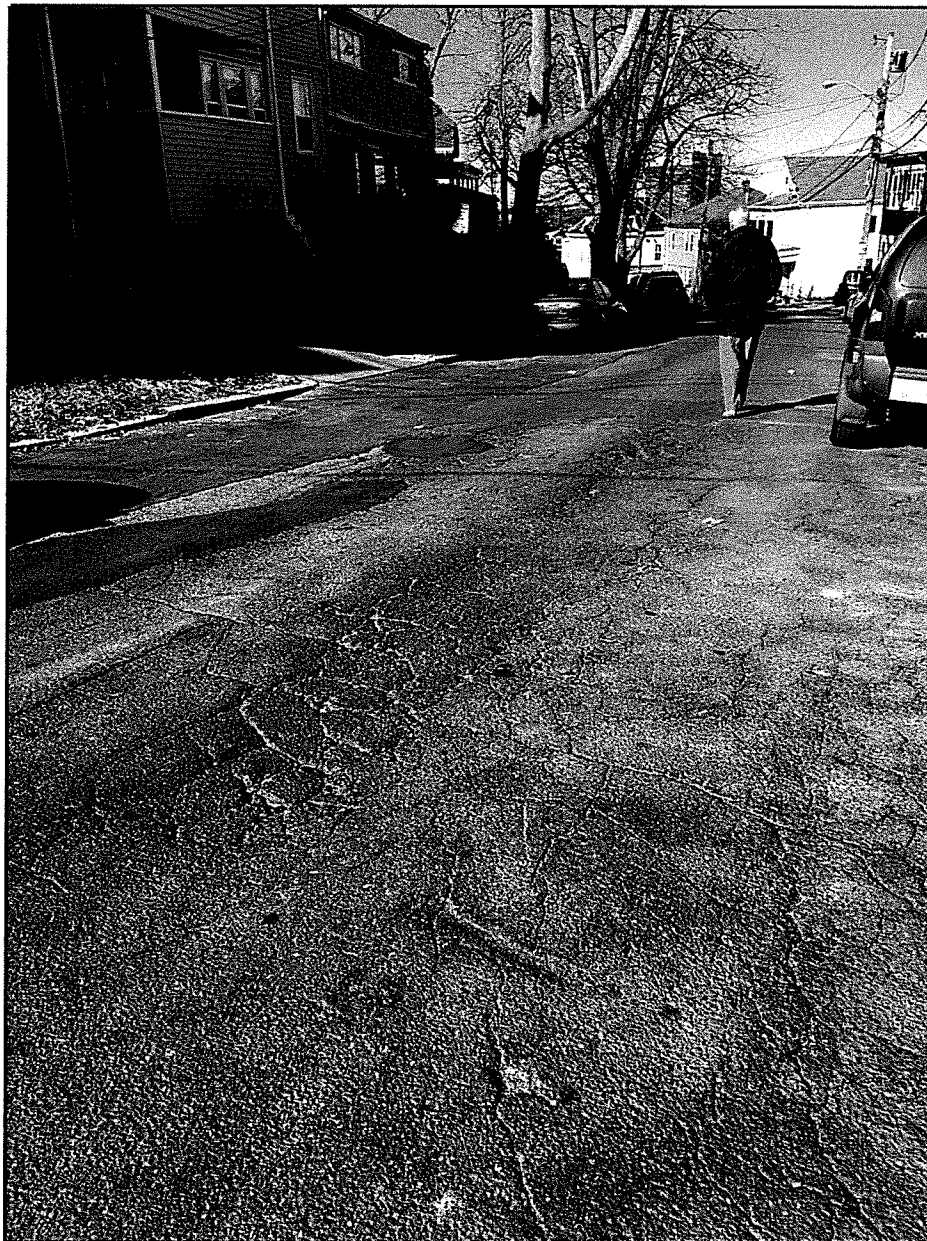
Continuing north towards Centennial

Pavement failures mentioned earlier continue and intensify.

Alligator cracking and settlement becoming more pronounced.

Road very poor. Curbing very poor.

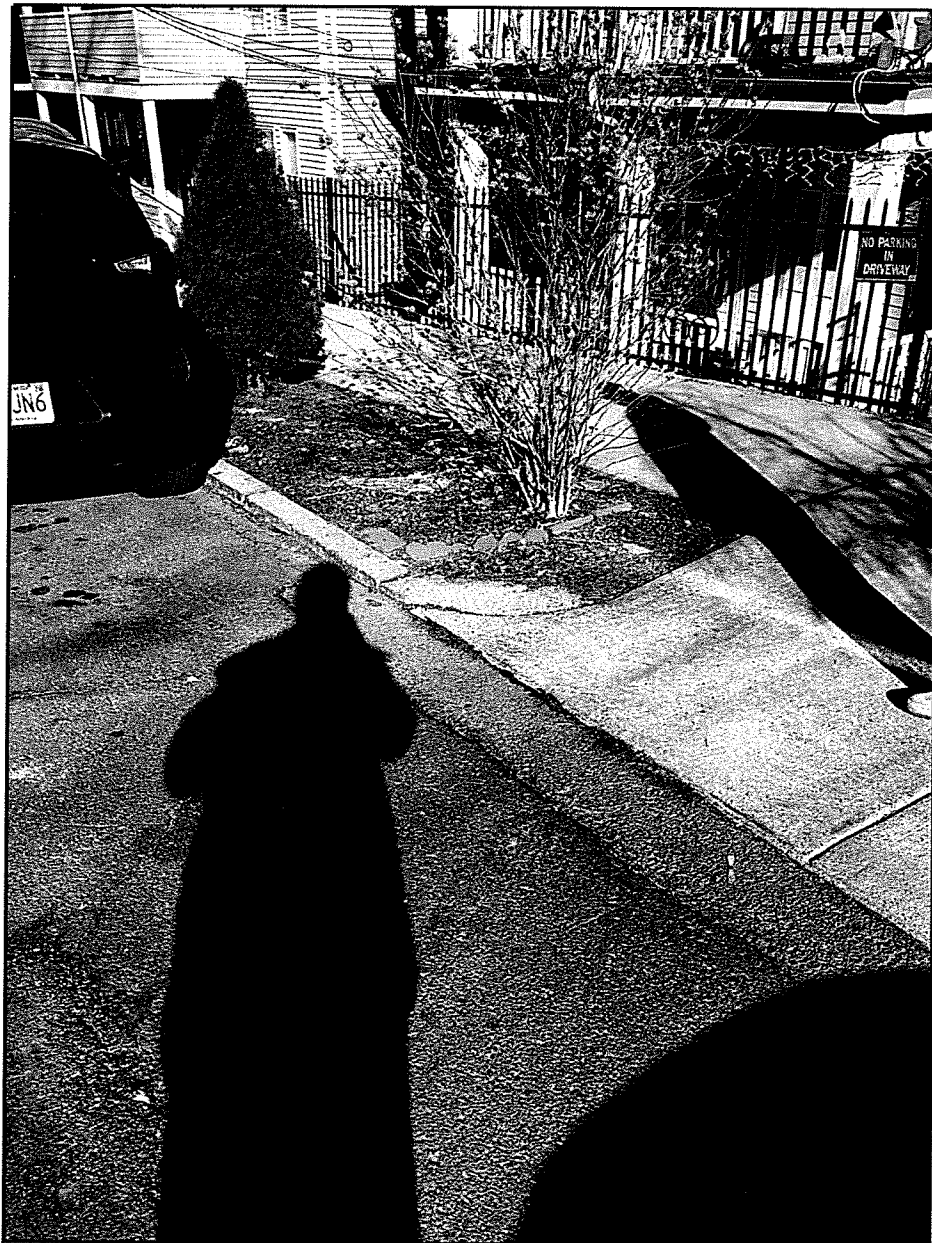
Photo highlighting typical driveway condition on the low (east) side of the road. Curb could be removed and reset mostly without damaging sidewalks. Driveway aprons will need to be reconstructed if curbing is reset.

Sidewalks in good condition.

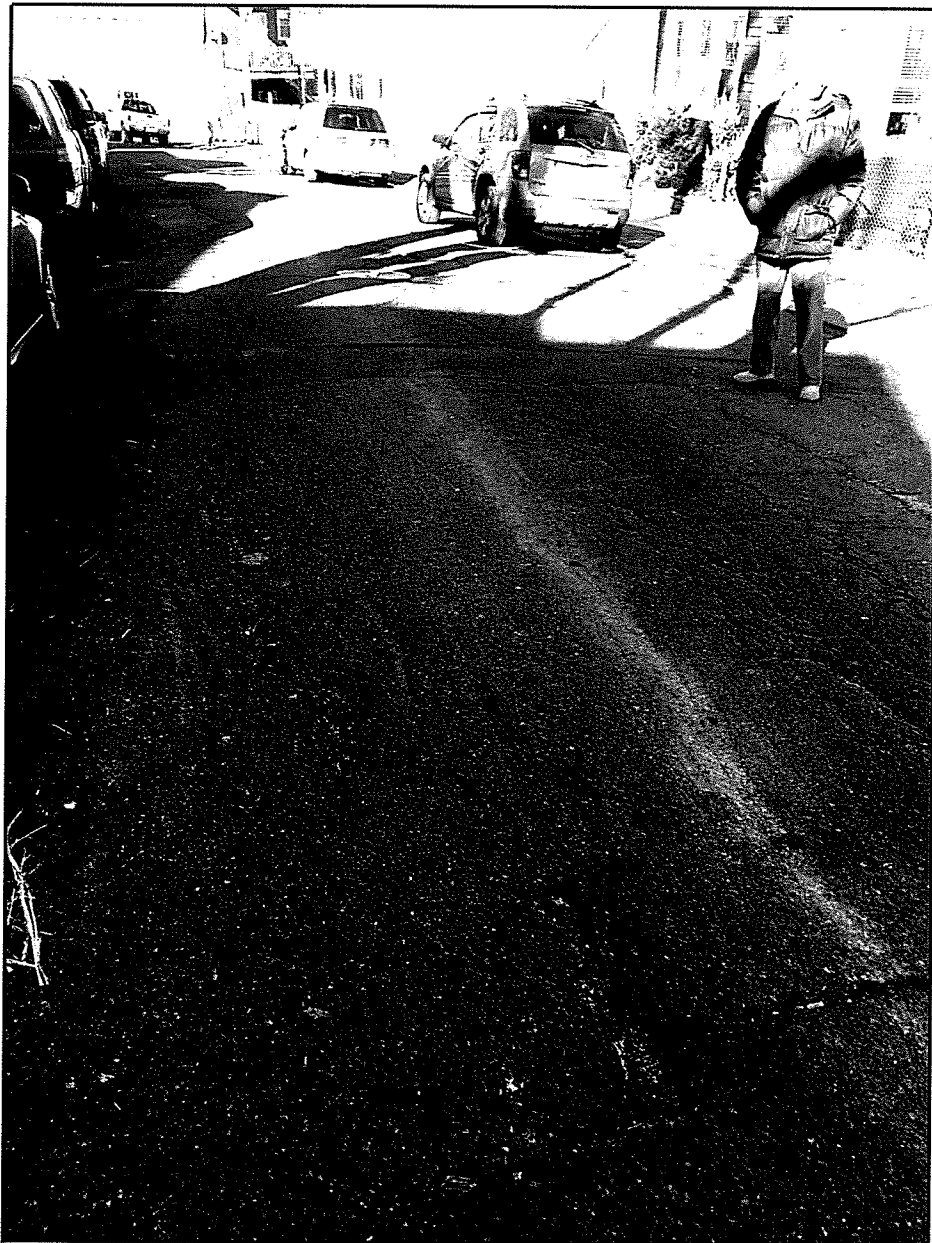
Continuing north towards Centennial.

Failure of roadway shown. Cracks opening up,
potholes beginning to form.

Driveability very poor, roadway has failed.

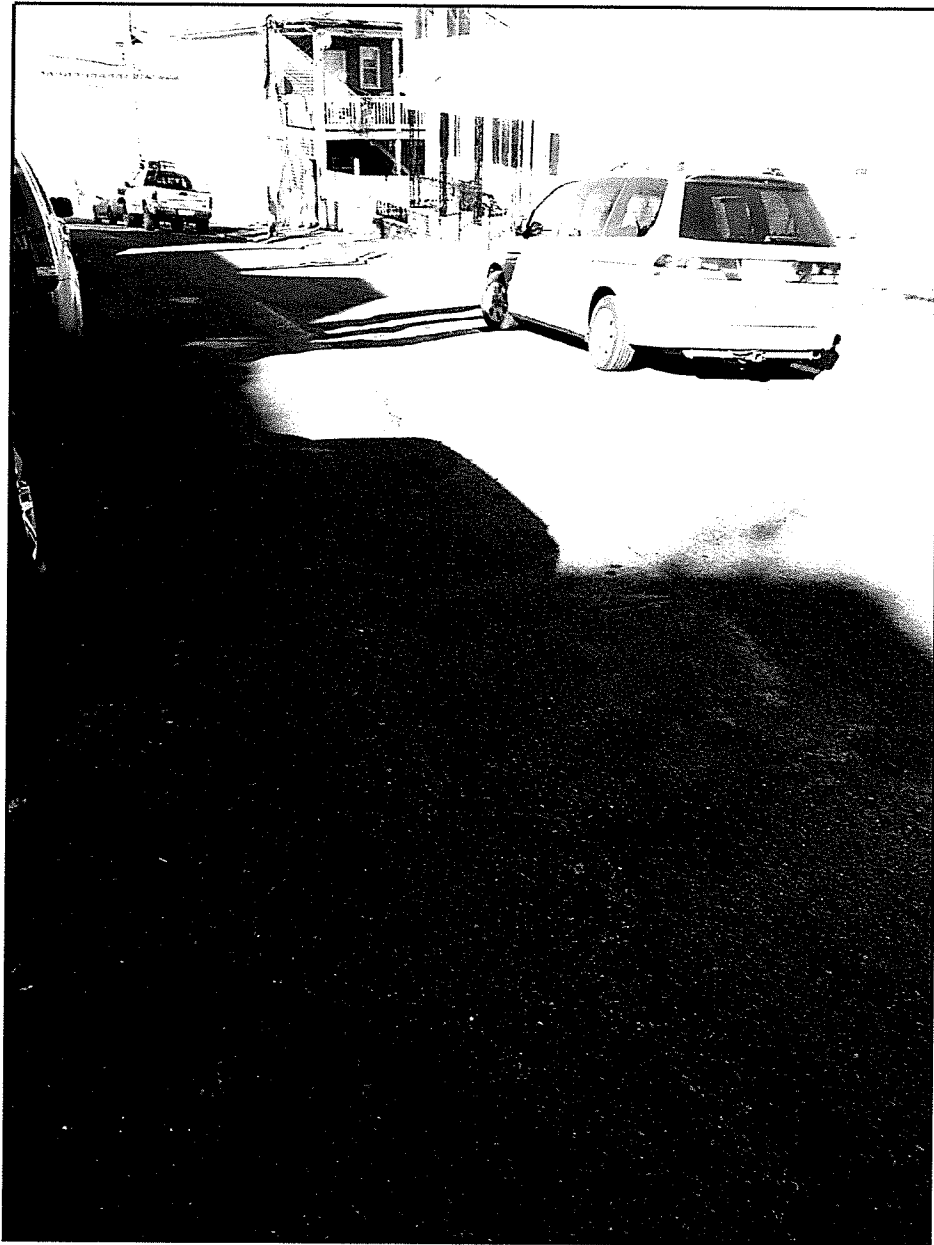
Continuing north

Very poor condition of the roadway continues..

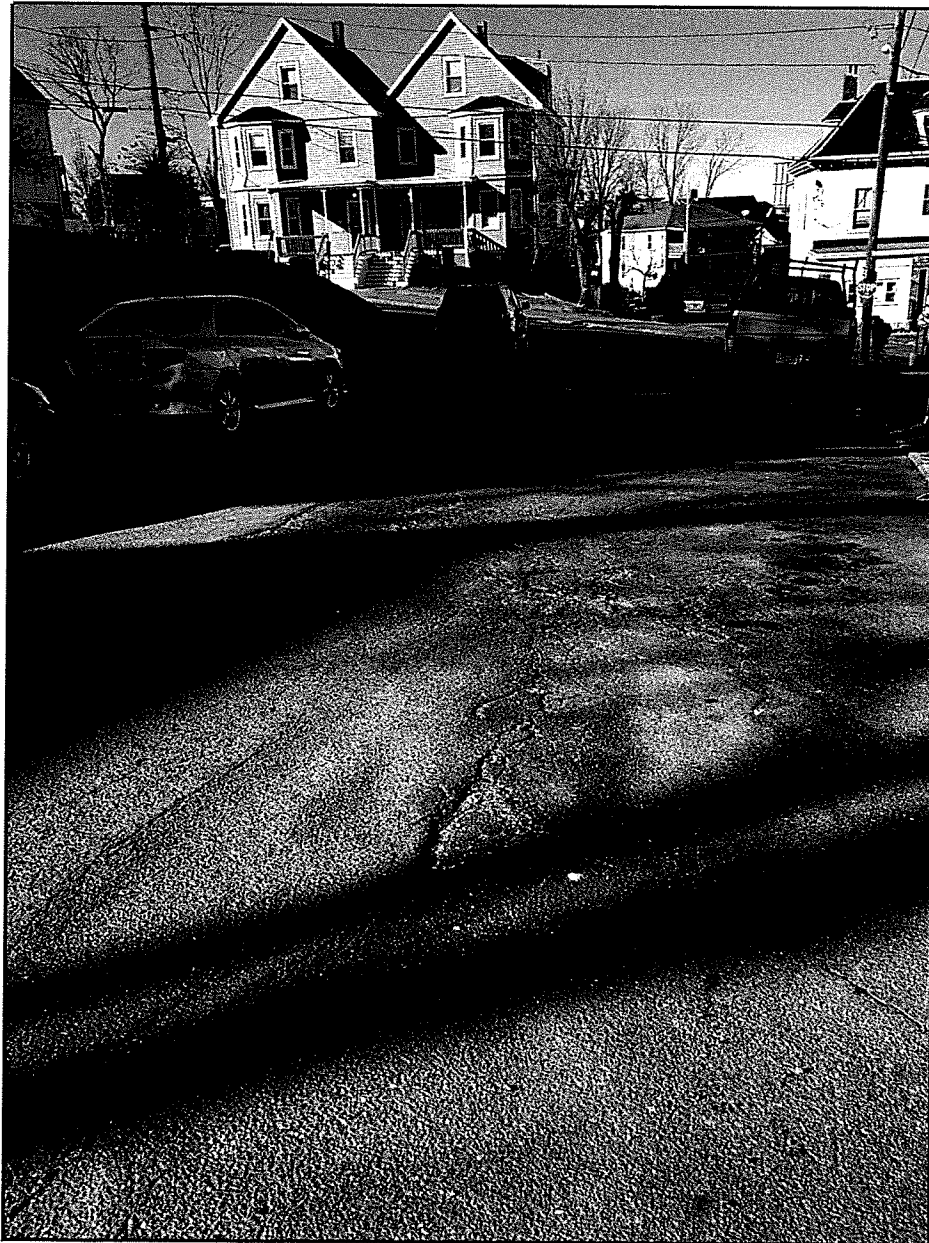
Approaching Centennial Ave.

Very poor condition of the road continues. Road unraveling. Note pothole. Solid asphalt seen below top course.

Because we do not seem exposed macadam under top course of pavement, this road may support milling and paving with other repairs as necessary.

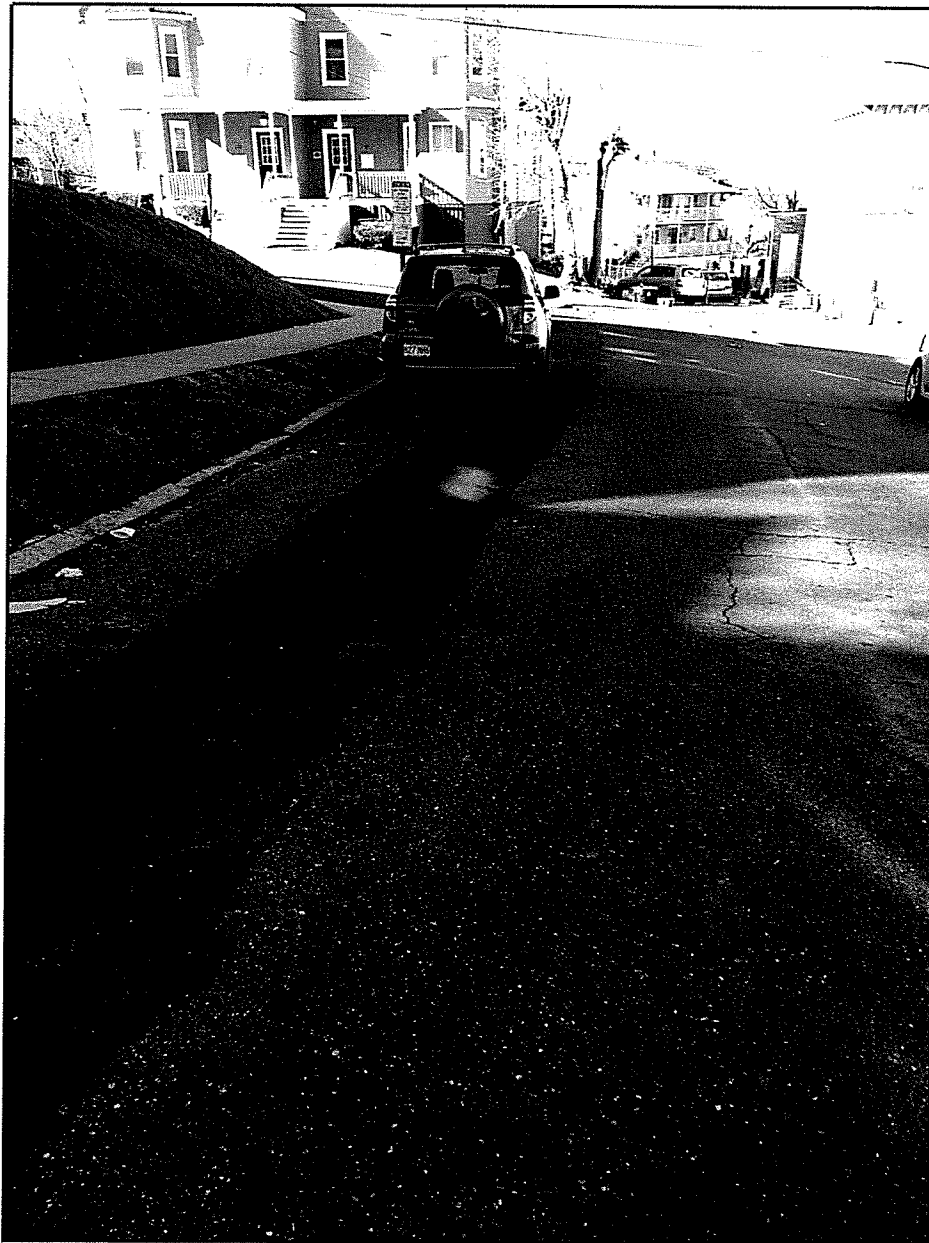
Approaching Centennial Ave.

Expansive longitudinal and transverse cracking, cracks are expanding. Unfortunately this road is beyond pavement management and has failed to a point where a new road surface is necessary.

Note continued good condition of sidewalks but poor condition of the curbing. Curbing should be removed and reset.

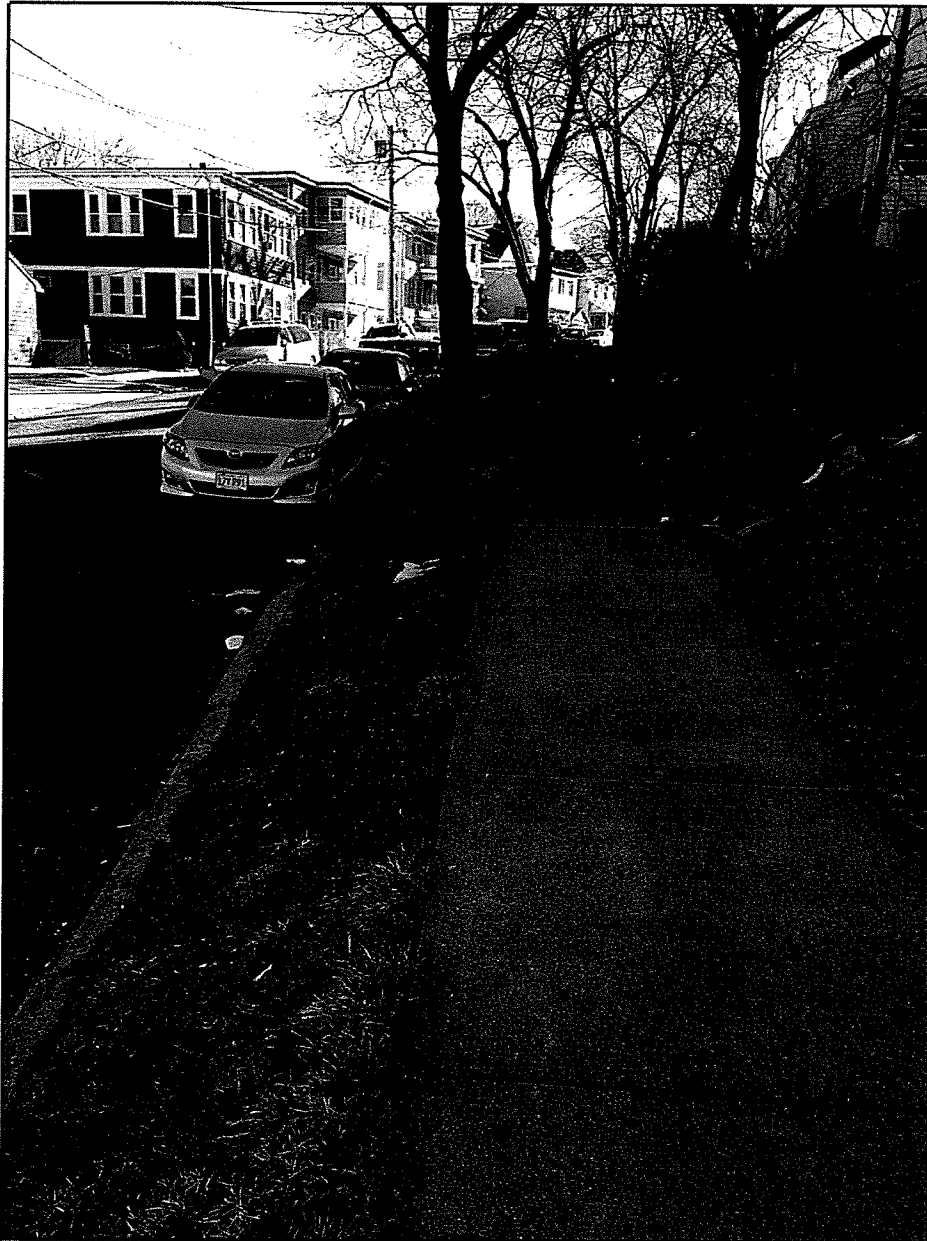
Photo highlighting good conditon of sidewalk, view from near Centennial looking south.
