PHASE 1 - FEASIBILITY ANALYSIS

Florence Ave.

(Entire Road)

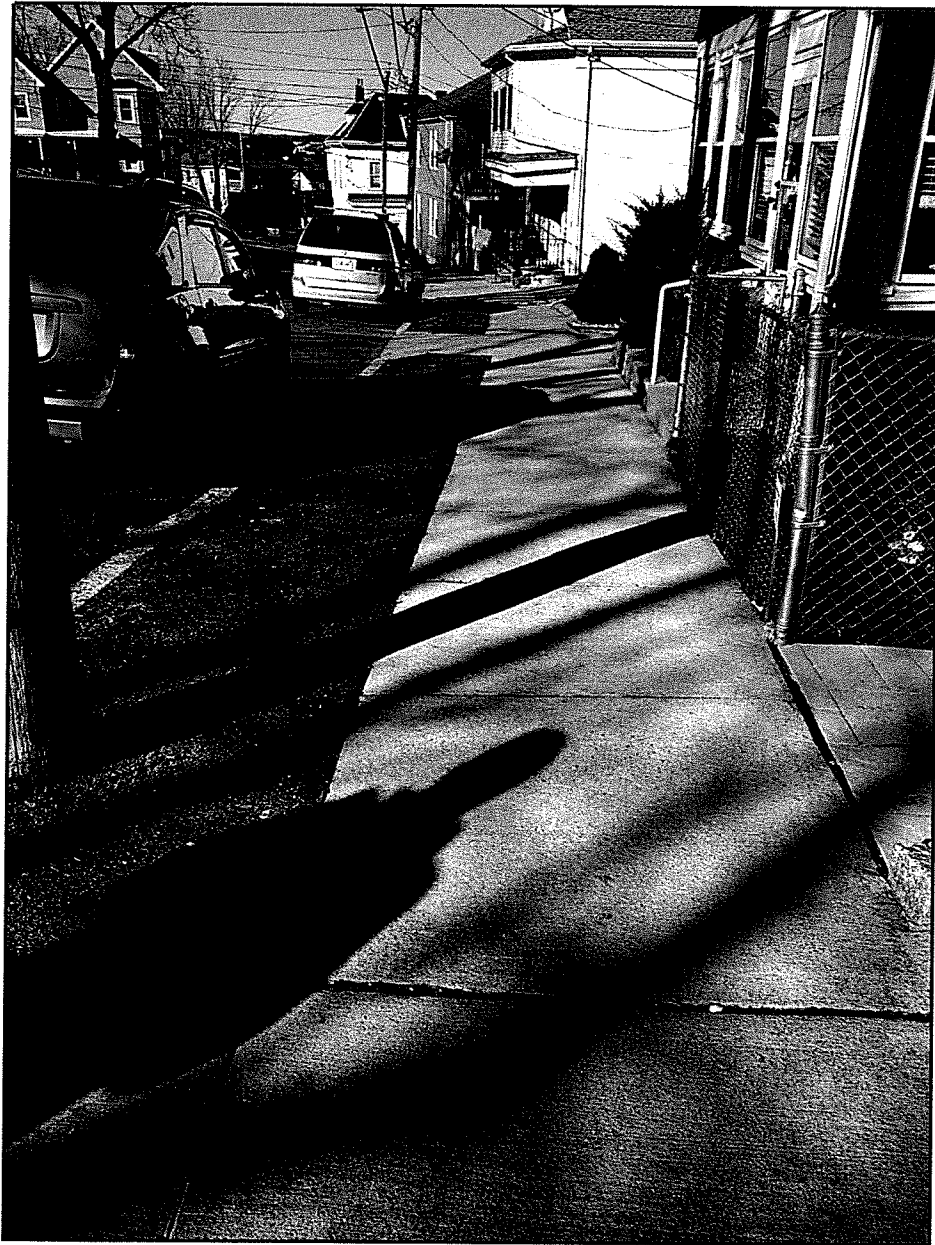
Photo highlighting good condition of sidewalks

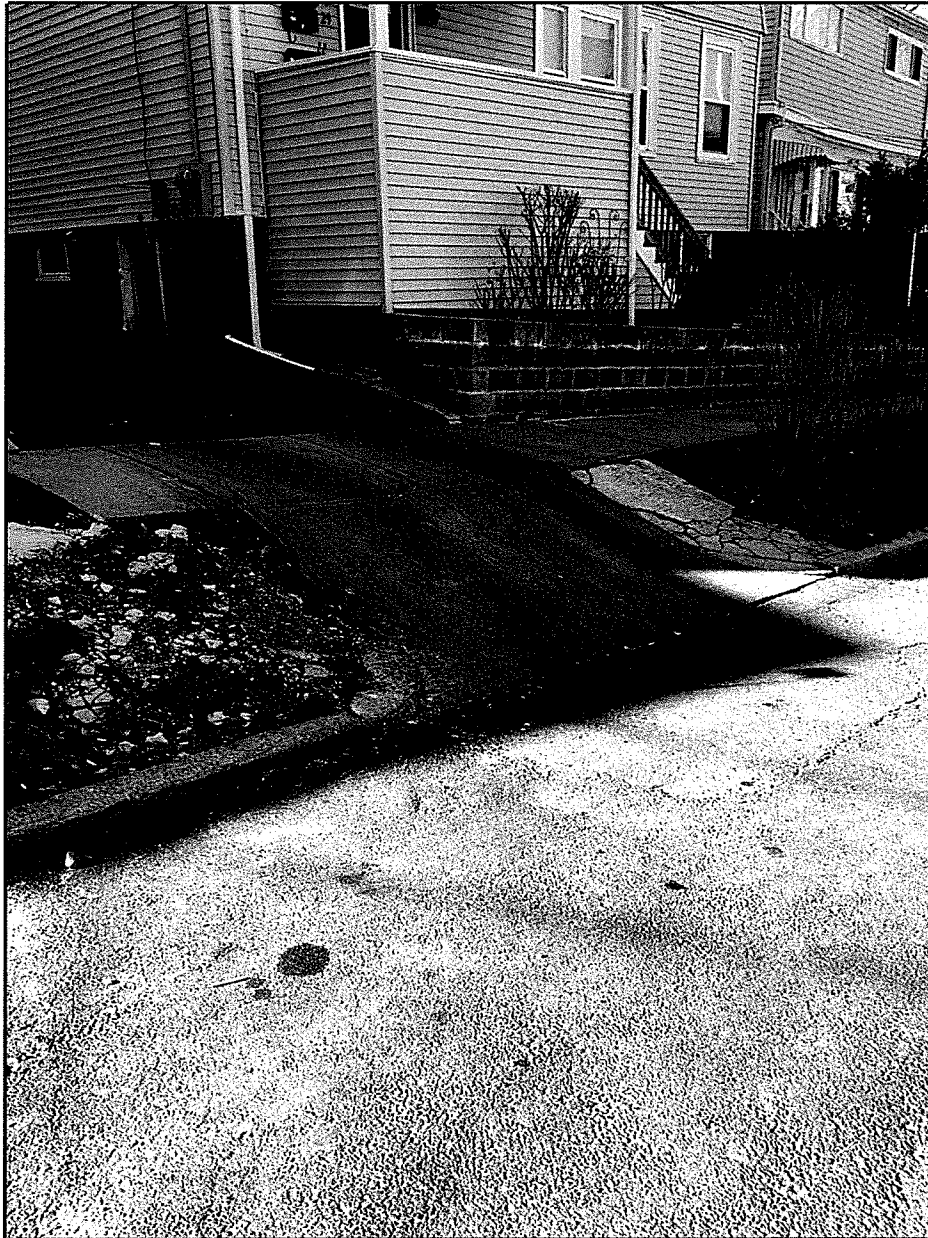
Photo highlighting typical condition of driveway apron on the high (west) side of the street. Steep slopes create challenges when it comes to repairing the road as a whole.
