PHASE 1 - FEASIBILITY ANALYSIS

Genesee Street

(Park Ave. to Mountain Ave.)

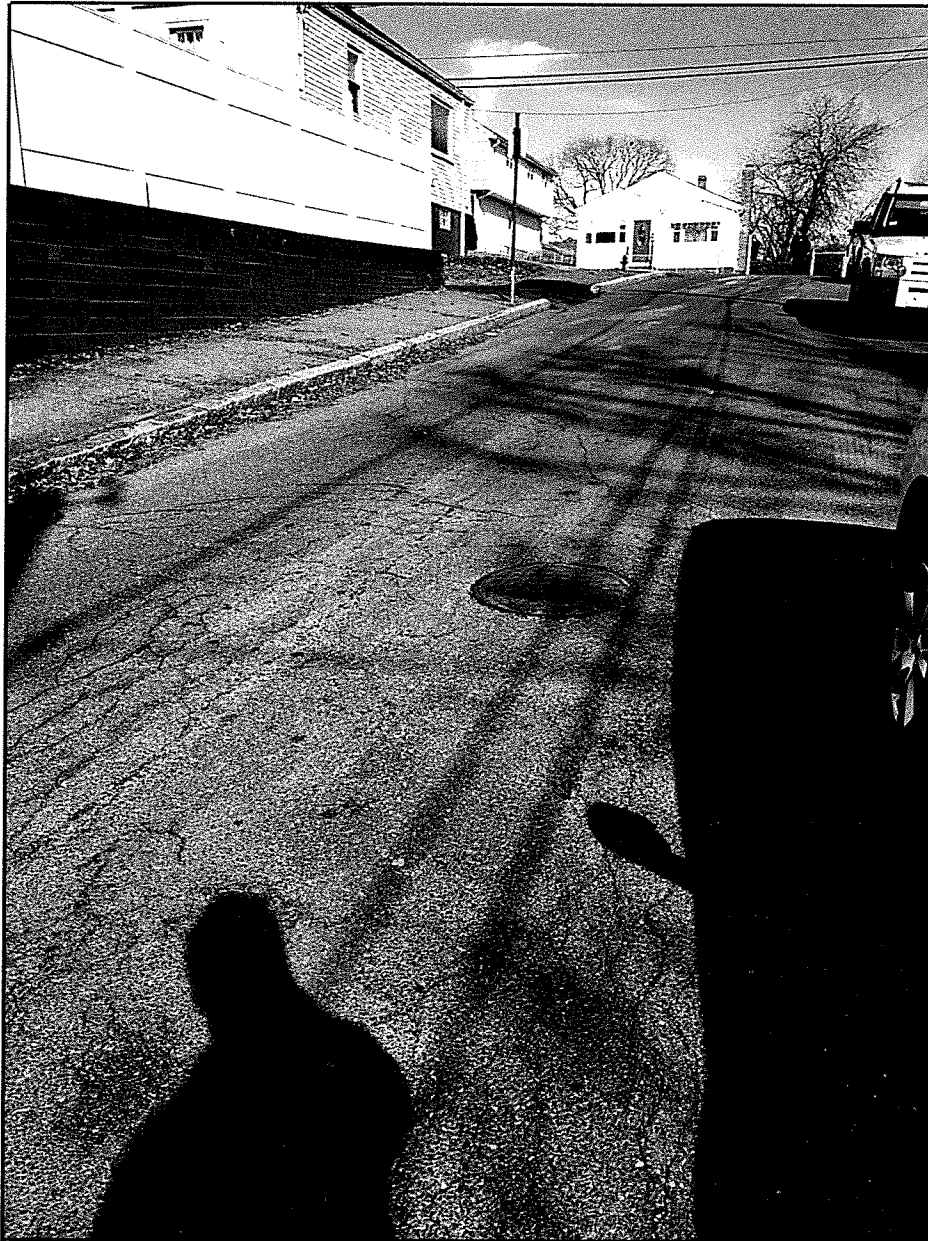
Looking north to Mountain Ave.

Photo shows typical condition of roadway,
alligator cracking is extensive.

Driveway curb stones do not taper down to
grade at many driveways on this street.

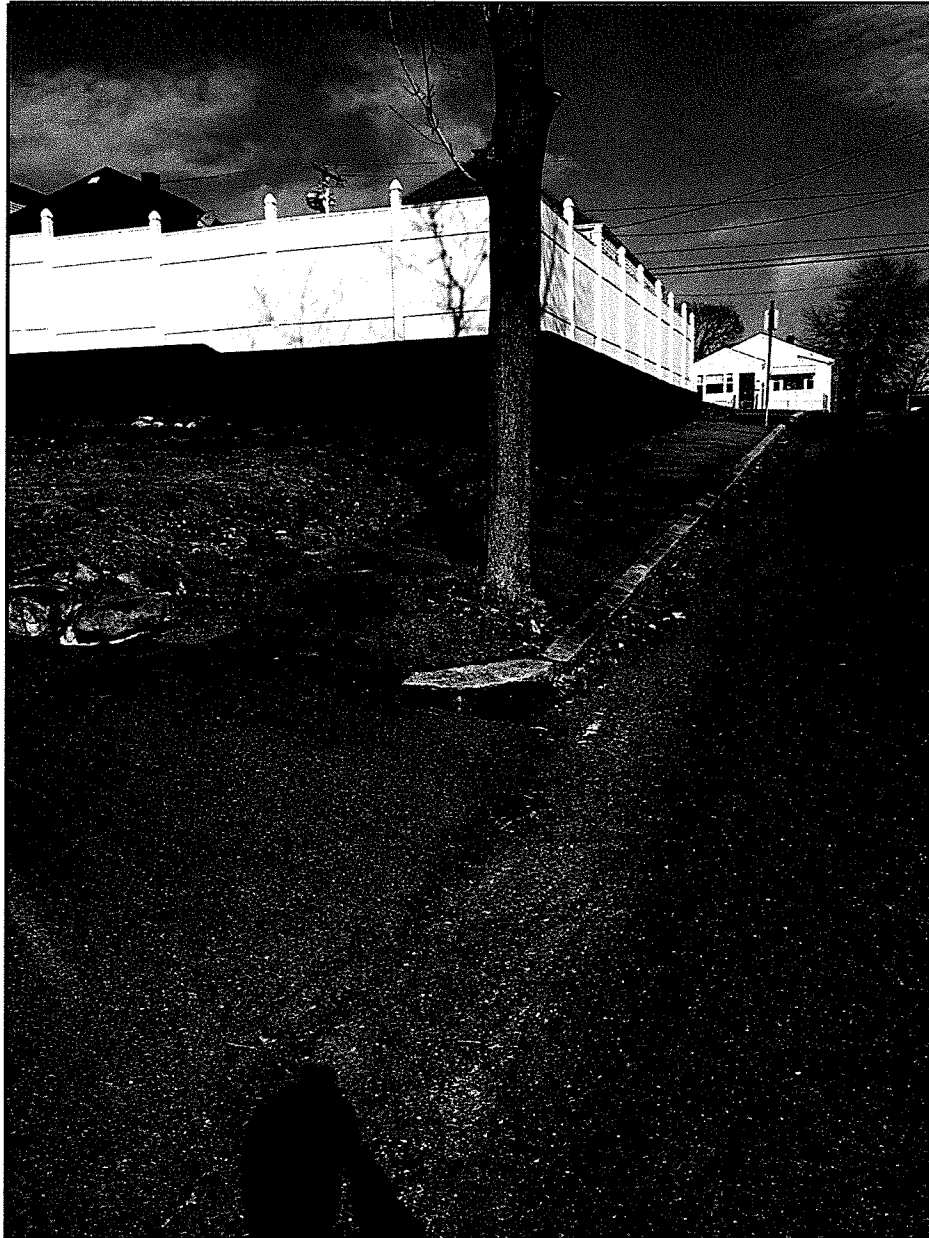
Looking north towards Mountain Ave.

Tree roots protruding out of the sidewalk.
Note corner stone at this driveway,
driveways are inconsistent.

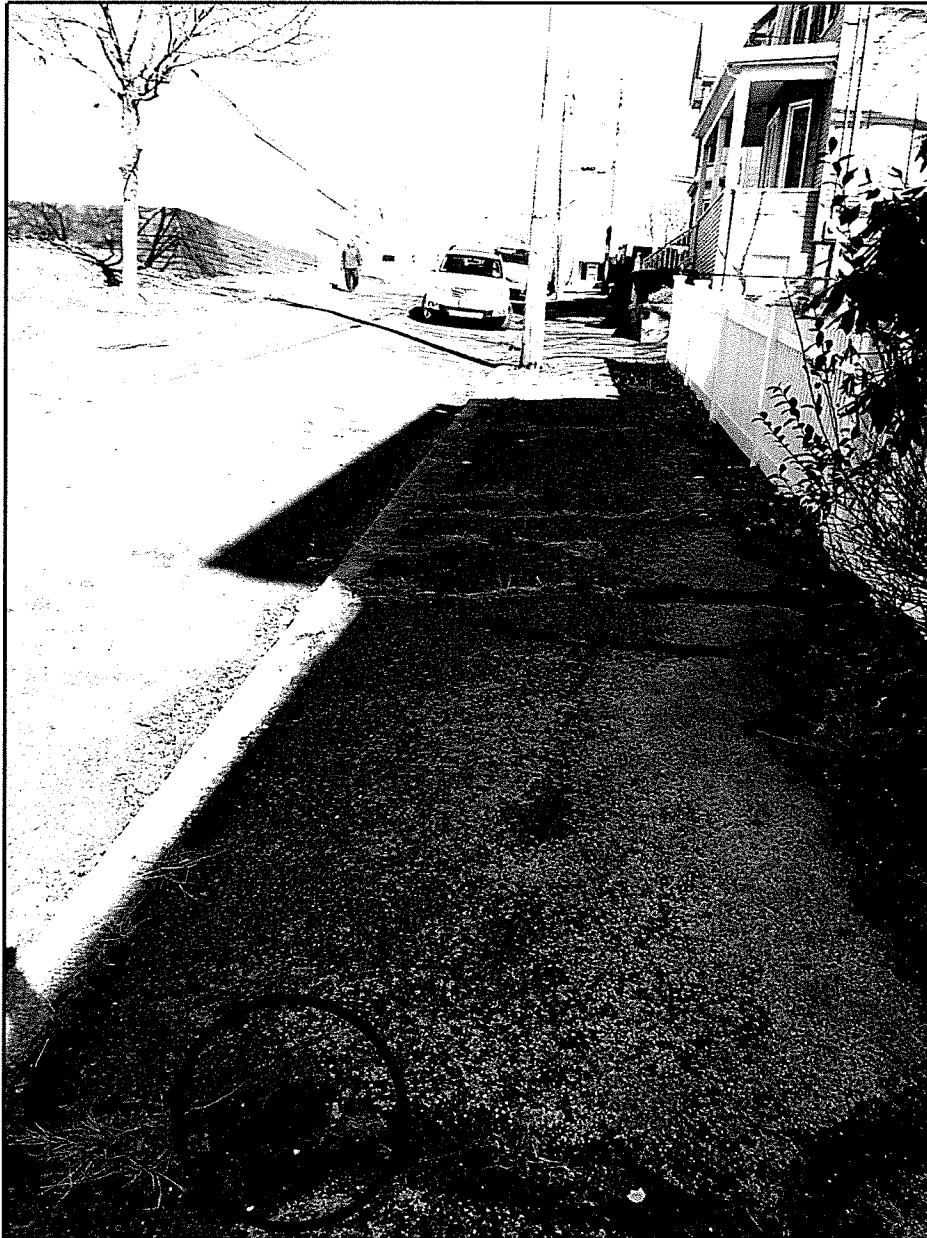
Looking north towards Mountain Ave.

Photo shows section of poor sidewalk.

Note, water service curb stop protruding out of asphalt due to settlement of walks. This tripping hazard exists in more than one location on this street.

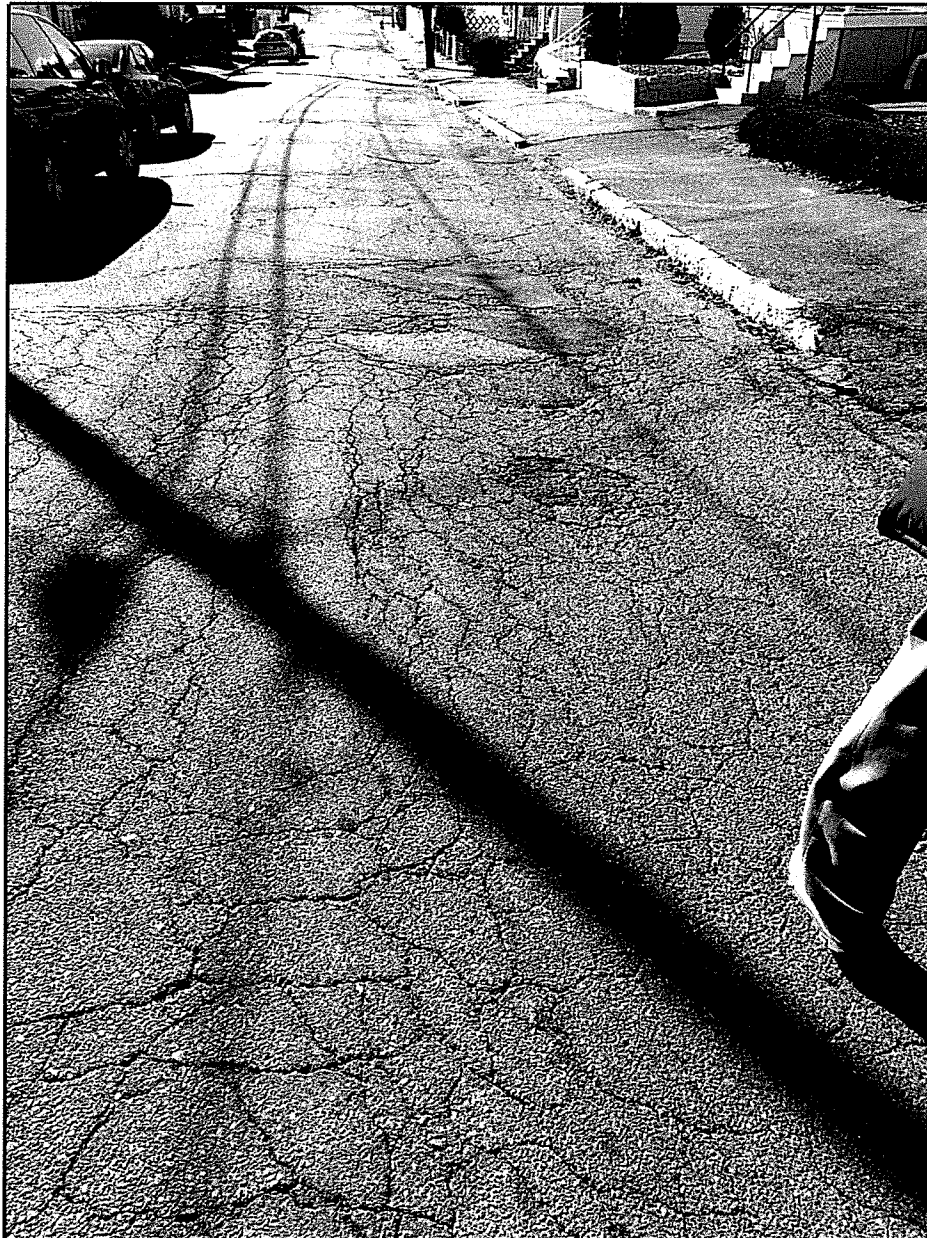
Looking south towards Park Ave.

The pavement surface suffers from extensive alligator cracking and differential settlement. The base of the road is exposed in several 'pothole' areas as highlighted in photo 8. Extensive alligator cracking can be seen in photos 4, 5 and 6 & the differential settlement is obvious in photo 7.

Photo shows poor condition of roadway. Extensive settlement, alligator cracking and pothole repairs. Condition of the road base is questionable.

Note inconsistency of driveway stones.

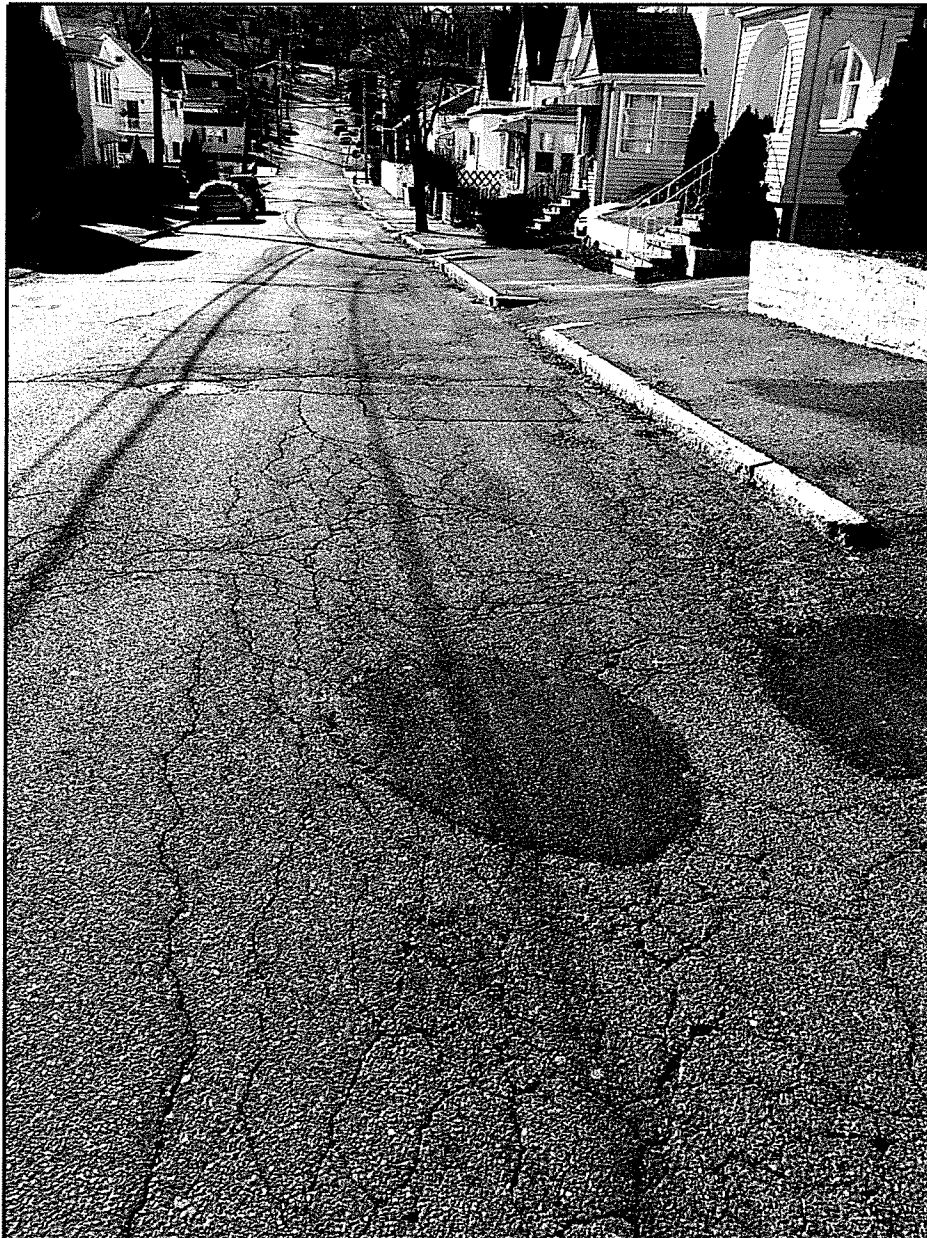
Looking south towards Park Ave.
(One driveway south of last picture)

Photo shows poor condition of roadway.
Extensive settlement, alligator cracking and
pothole repairs. Condition of the road base
is questionable.

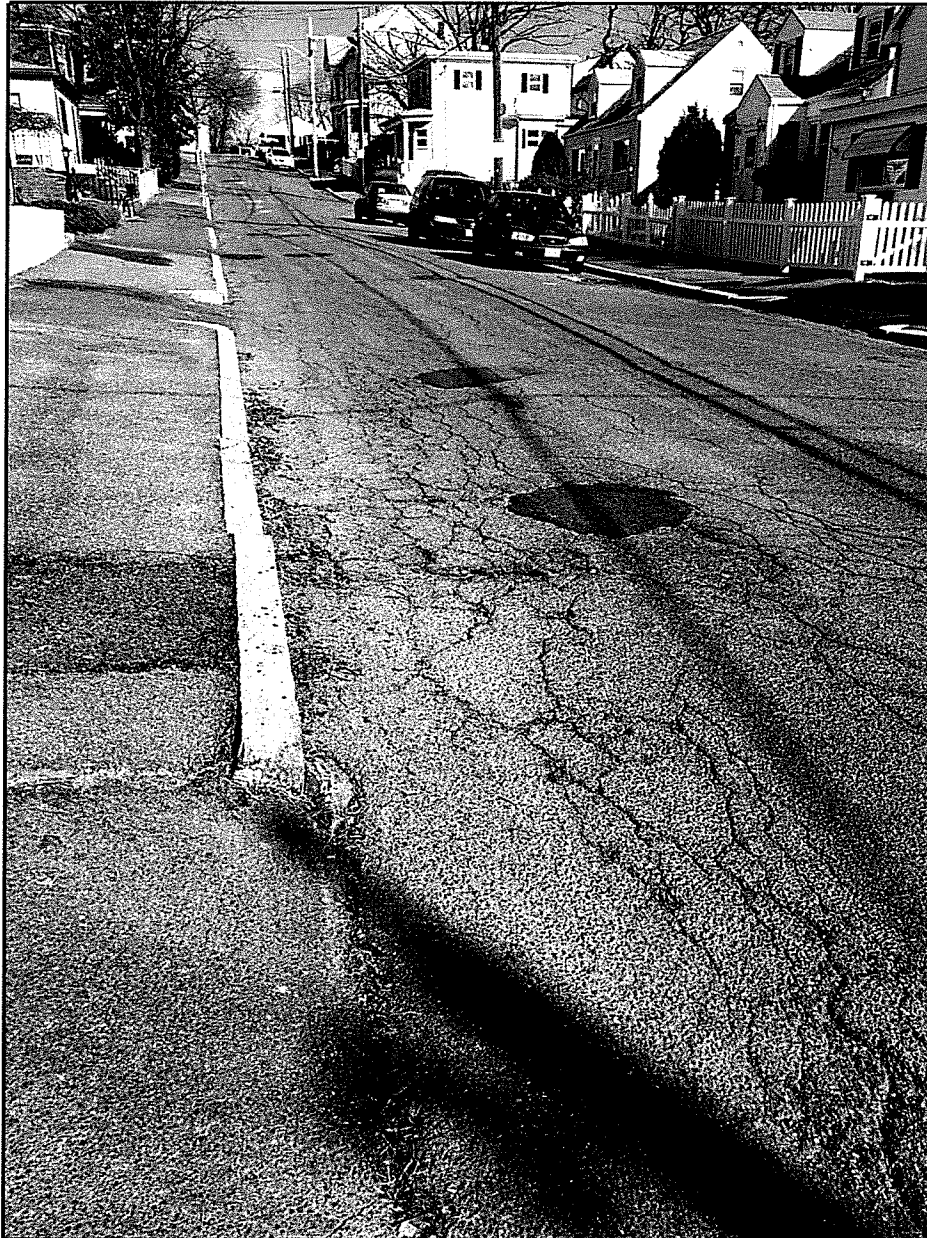
Looking north towards Mountain Ave.

Photo shows same roadway location from opposite side. Note inconsistencies in asphalt sidewalk. Curb 'rolling' over towards street. Curbing should be removed and reset in concrete.

Existing walks do not meet ADA cross slope requirements, resetting of curbing will help alleviate this issue by raising the front of the walkways.

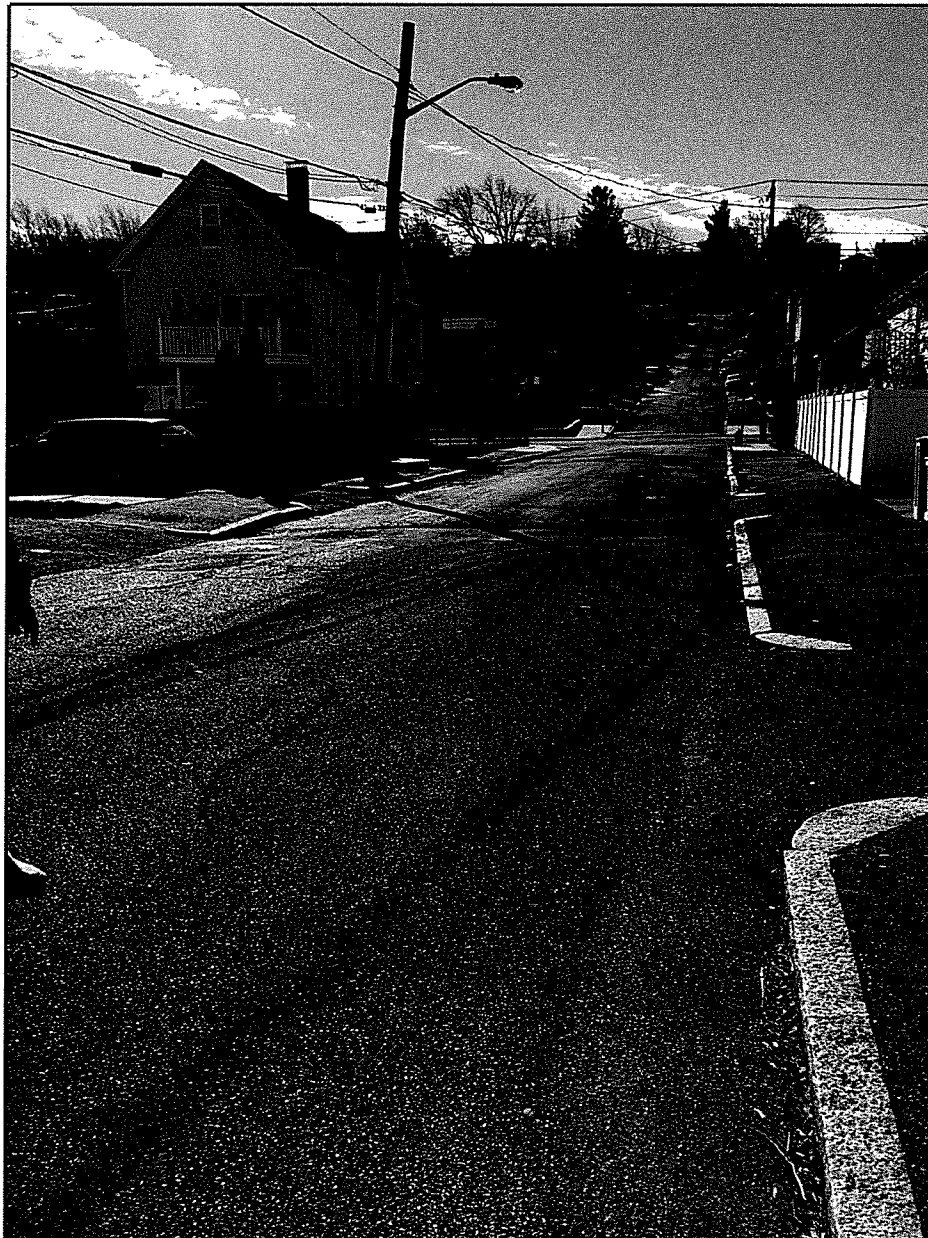
Looking south towards Park Ave.

Photo highlighting typical condition of curb. Extensive settlement and 'rolling' over of curb present on the street. Sidewalks in poor condition.

Curb should be removed and reset in concrete.

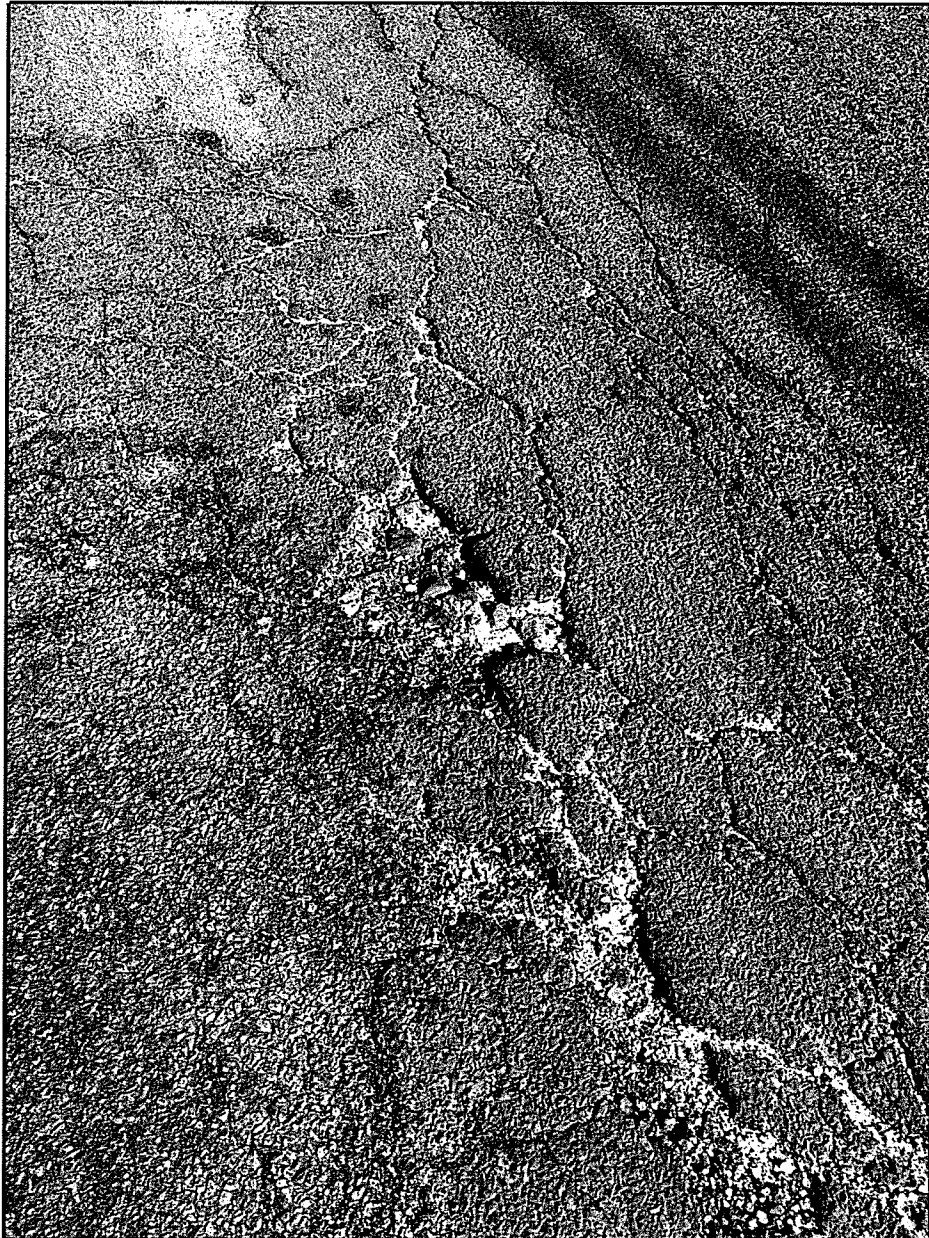
Photo of failed roadway surface.

Note exposed macadam. Typical in this group of side streets between Mountain and Park Ave.

It is recommend that full depth reclamation of the road ultimately be completed concurrently with the resetting of the granite curb and reconstruction of the sidewalks in concrete.

If milled, roadway surface will be down to macadam base. If roadway is milled macadam will likely become exposed. Will require level course, binder and top course of pavement
