PHASE 1 - FEASIBILITY ANALYSIS

Glendale Road, Oak Island Road & Woodland Road

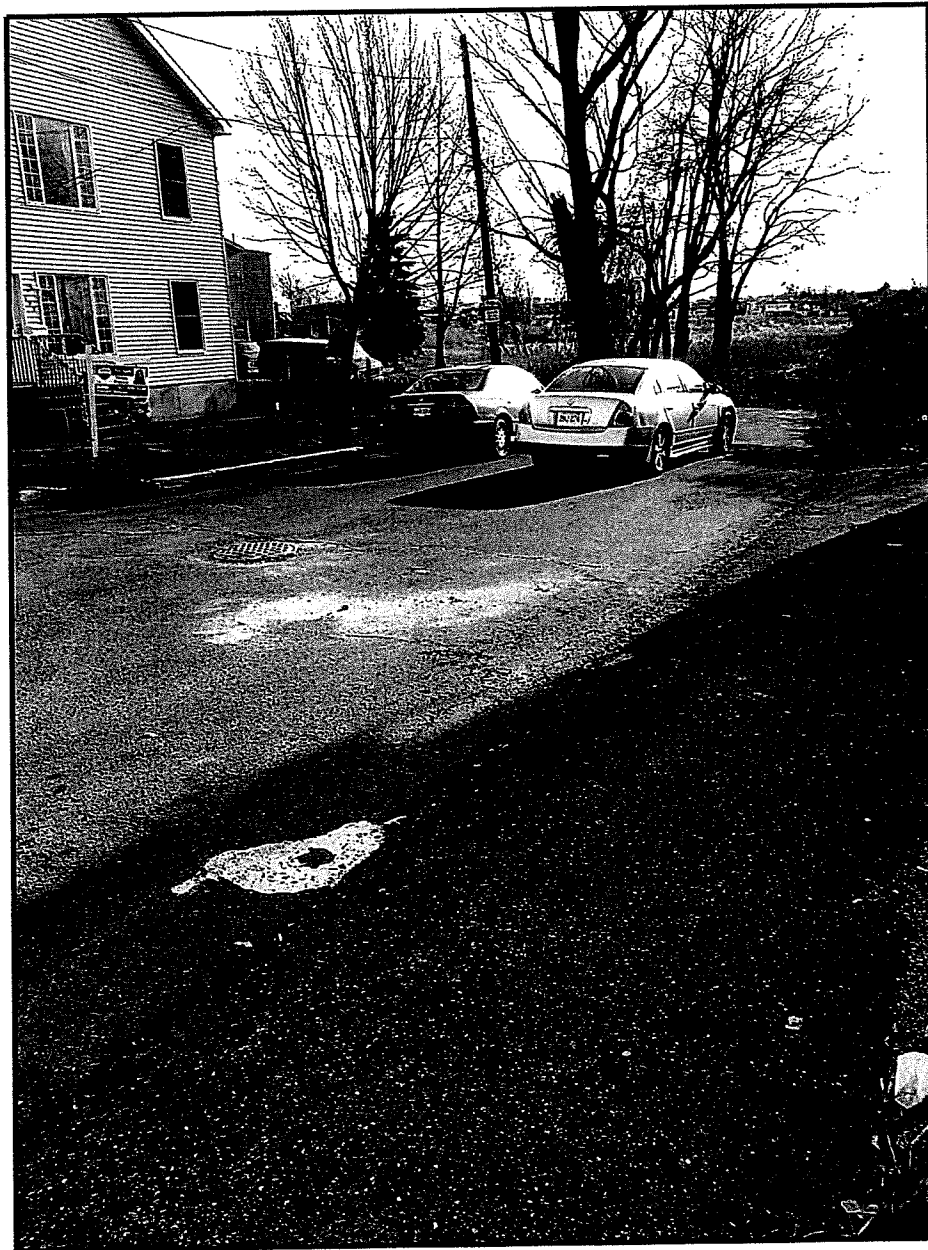
At Gladys Street looking south

Road and sidewalk in decent condition. Road showing signs of settlement and cracking, as is to be expected of a road constructed on marshy land. Condition typical for this area of Revere. Sidewalks in decent condition..

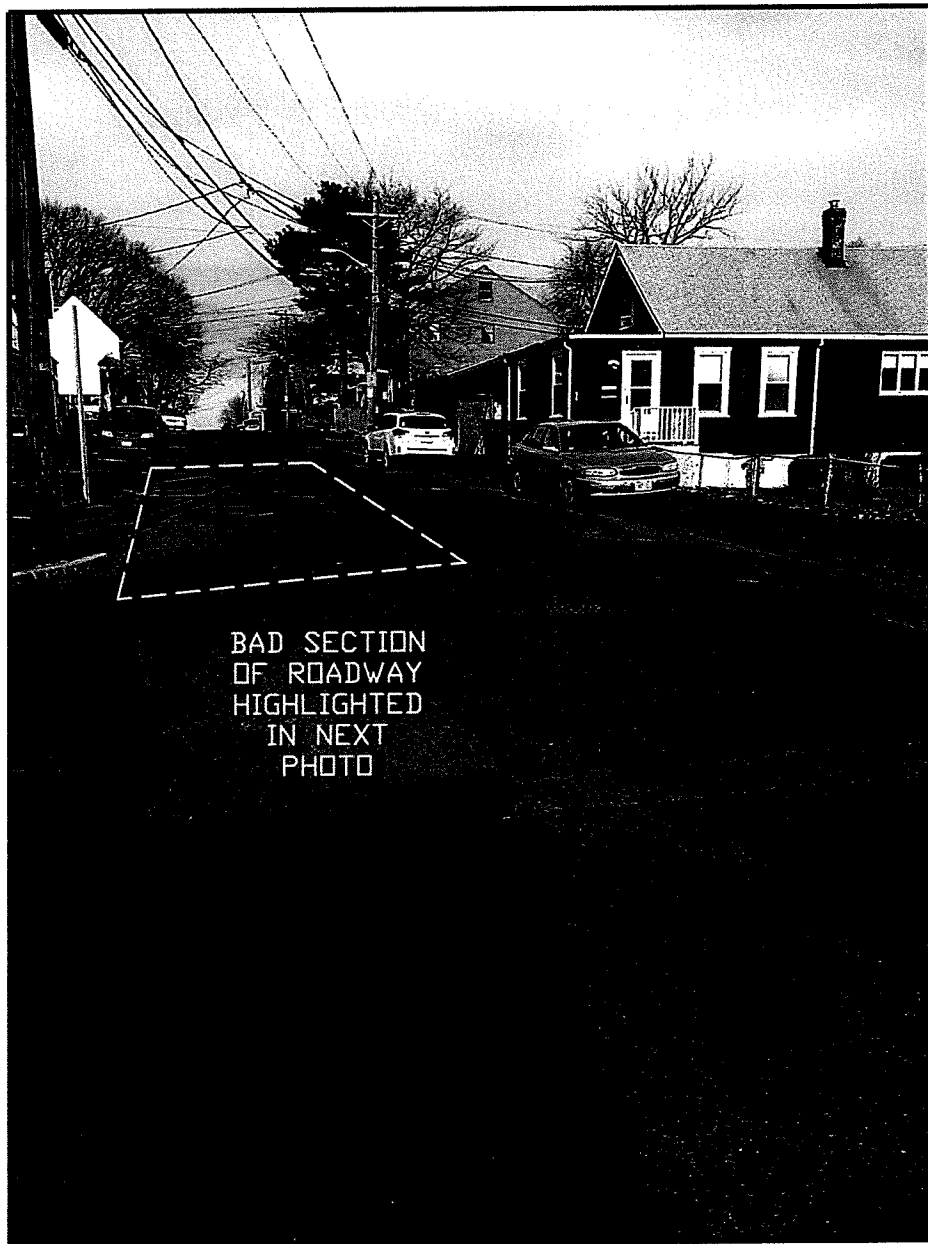
At Gladys Street looking north

Road showing signs of settlement and cracking.
Condition is inconsistent on the street.

Note gas trench bisecting Glendale Road. Road
mostly in decent condition, conditions surrounding
gas trenches tend to be worse than other
locations.

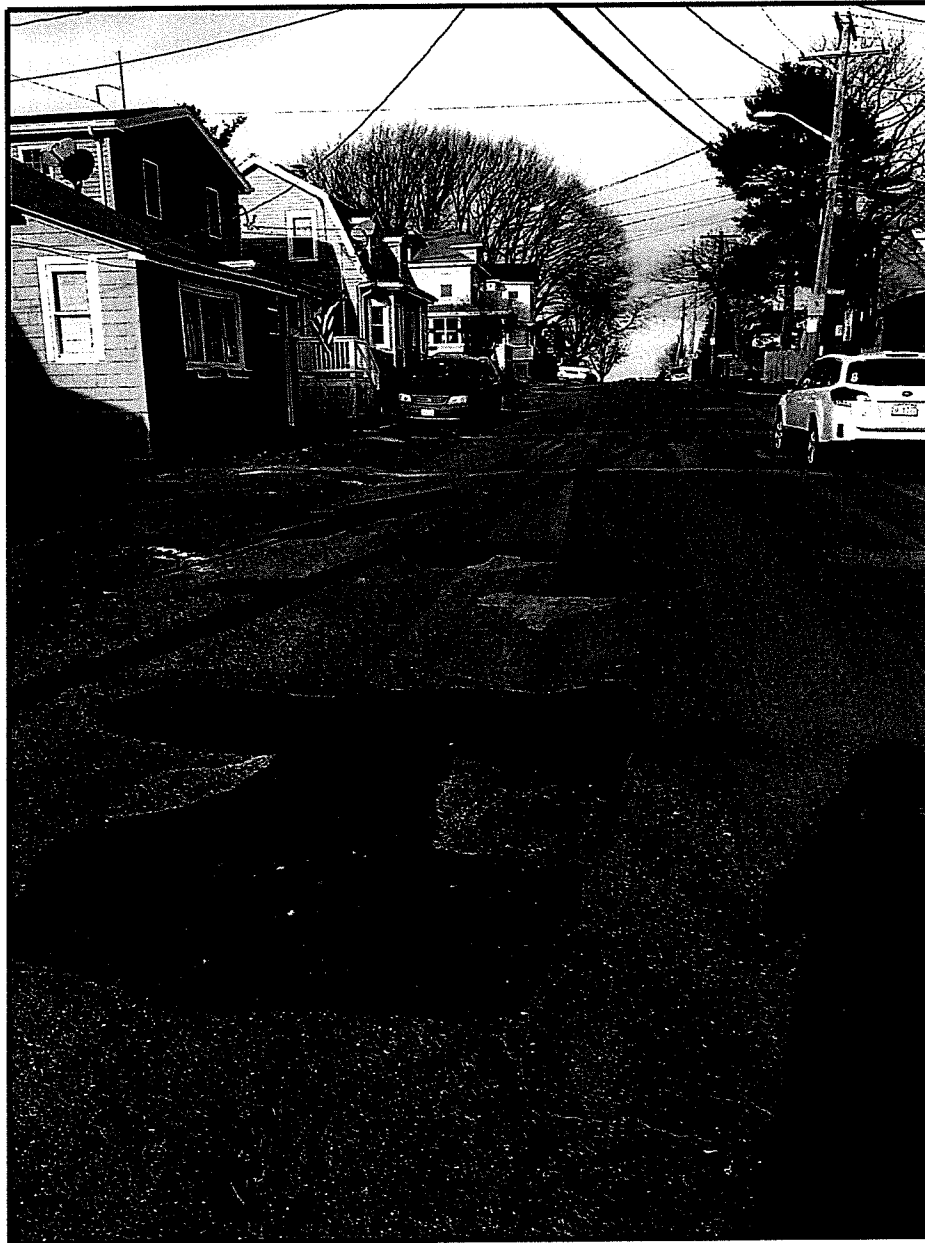
Continuing north on Glendale Street

Photo shows section of pavement with extensive pothole repairs, cracking and settlement. Integrity of base questionable in this location specific location. Area should be dug out and reconstructed to properly fix this condition.

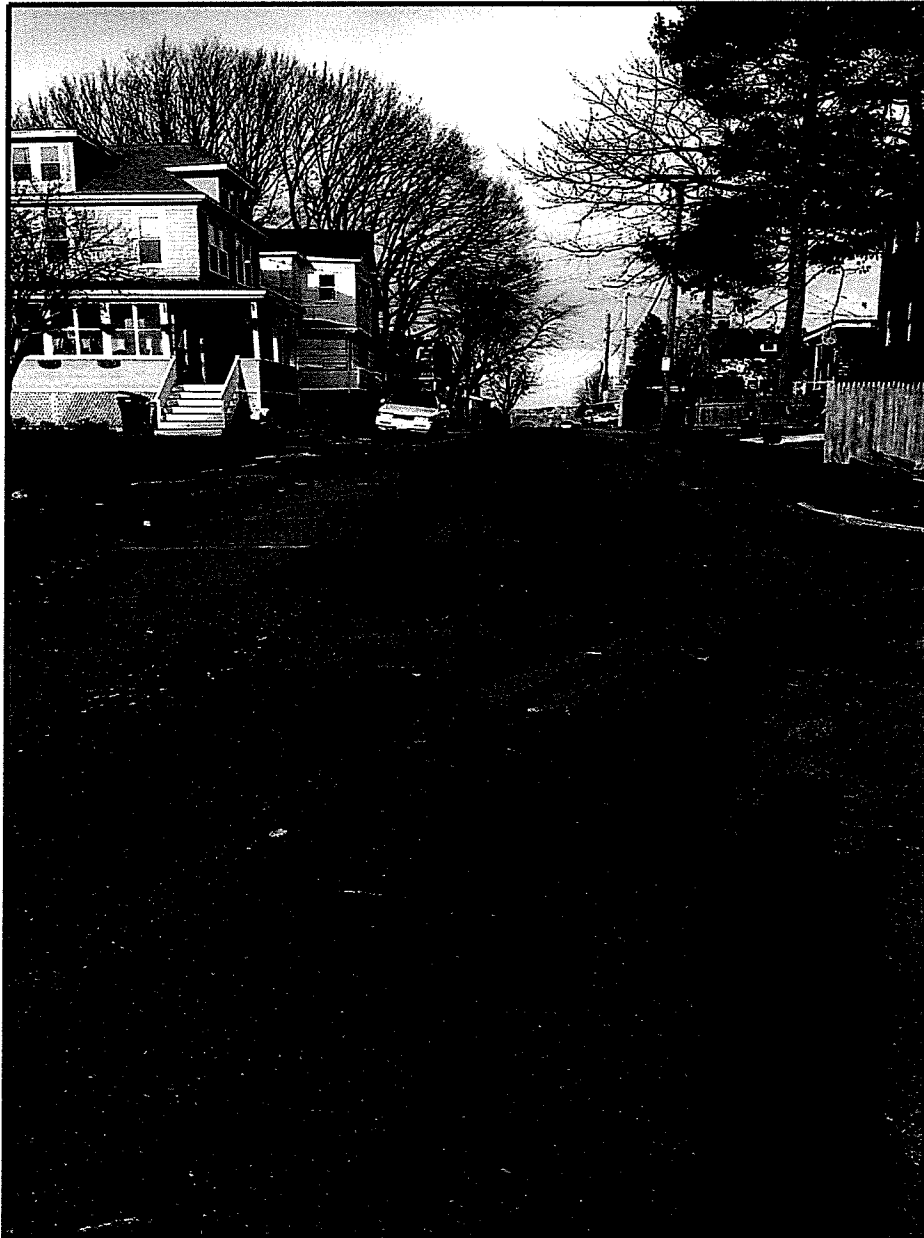
At Oak Island Street looking north

Typical condition of roadway and sidewalks shown. Sidewalks have been overlaid in the past. Edges of sidewalks at the road tend to be deteriorating, typical with an overlay of this nature. Additional overlay not an option.

Note gas trench shown on the right. Condition in gutter adjacent to gas trench worsens as you continue north.

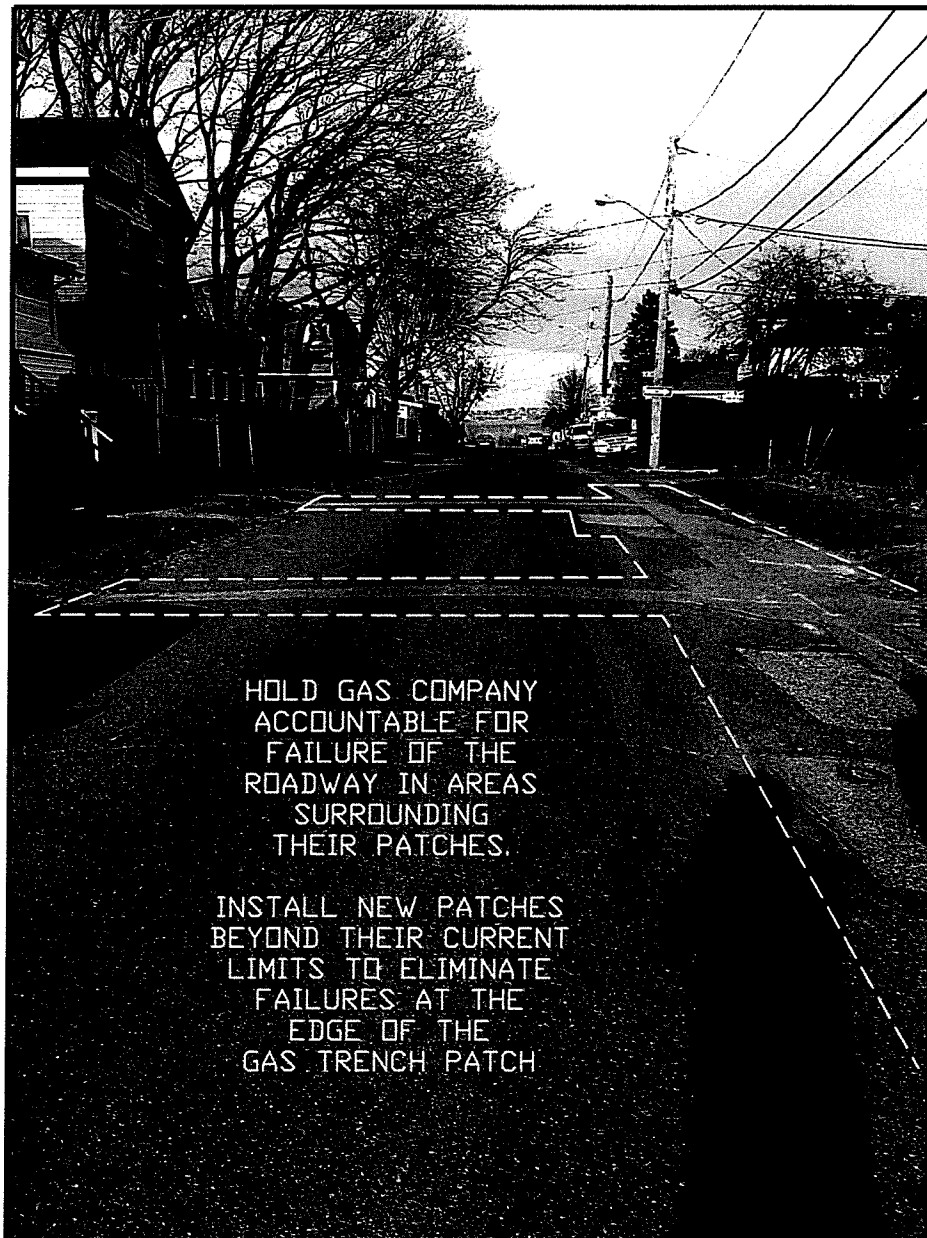
Looking north towards Alice St Intersection

Roadway in fairly good condition except for the areas surrounding the gas trenches. This section of the eastern edge of Glendale St. is settling and deteriorating more rapidly than other areas.

Recommend persuing gas company to replace trench patches with refreshed patches installed with cutbacks beyond the limits of the trench as shown in the photo.

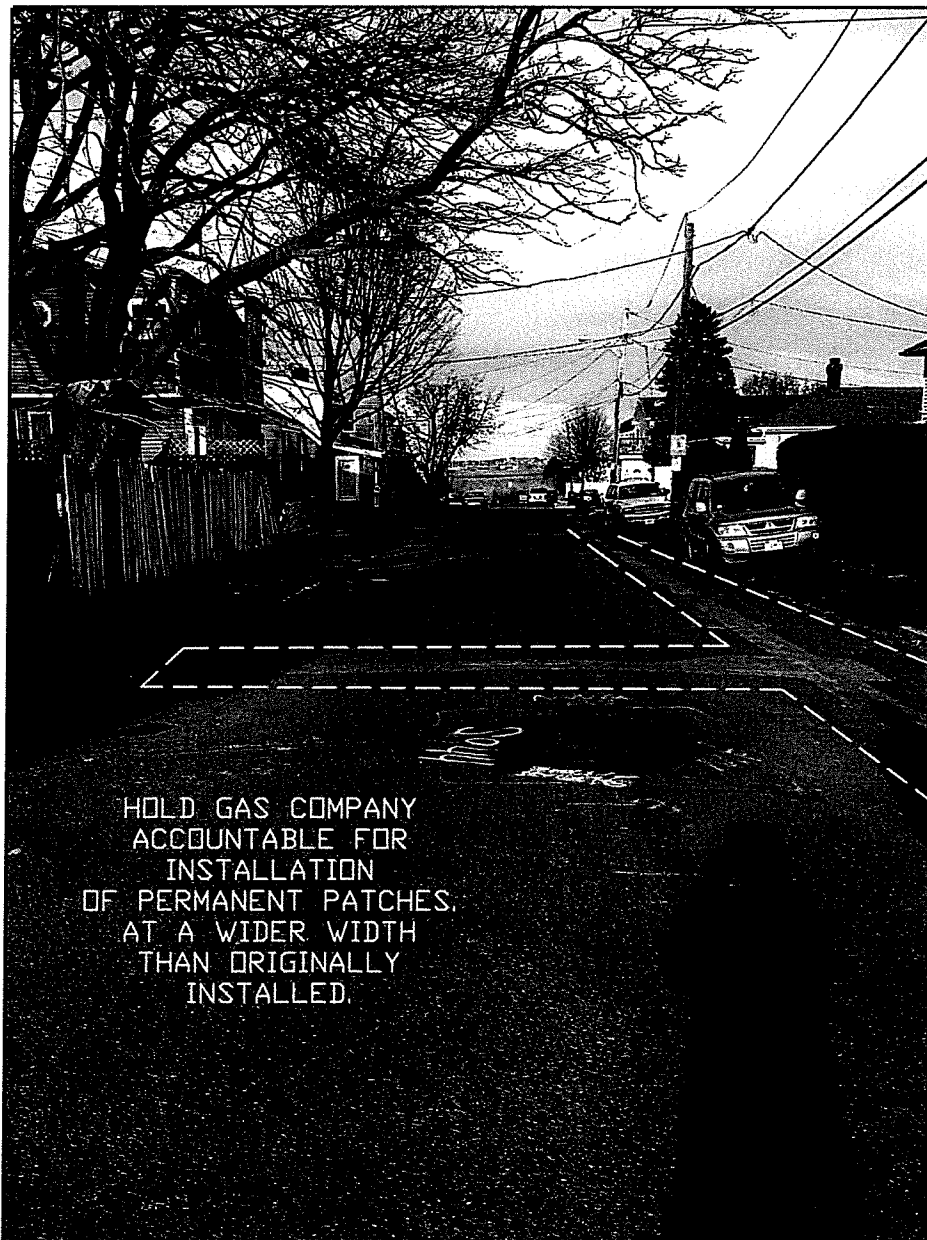
Looking towards Vera St.

Road mostly in good condition except for minor cracking shown. Condition surrounding gas trench patch better in this area, but still recommend persuing gas company to install cleaner permanent patches. Install new patches wider than existing patches.

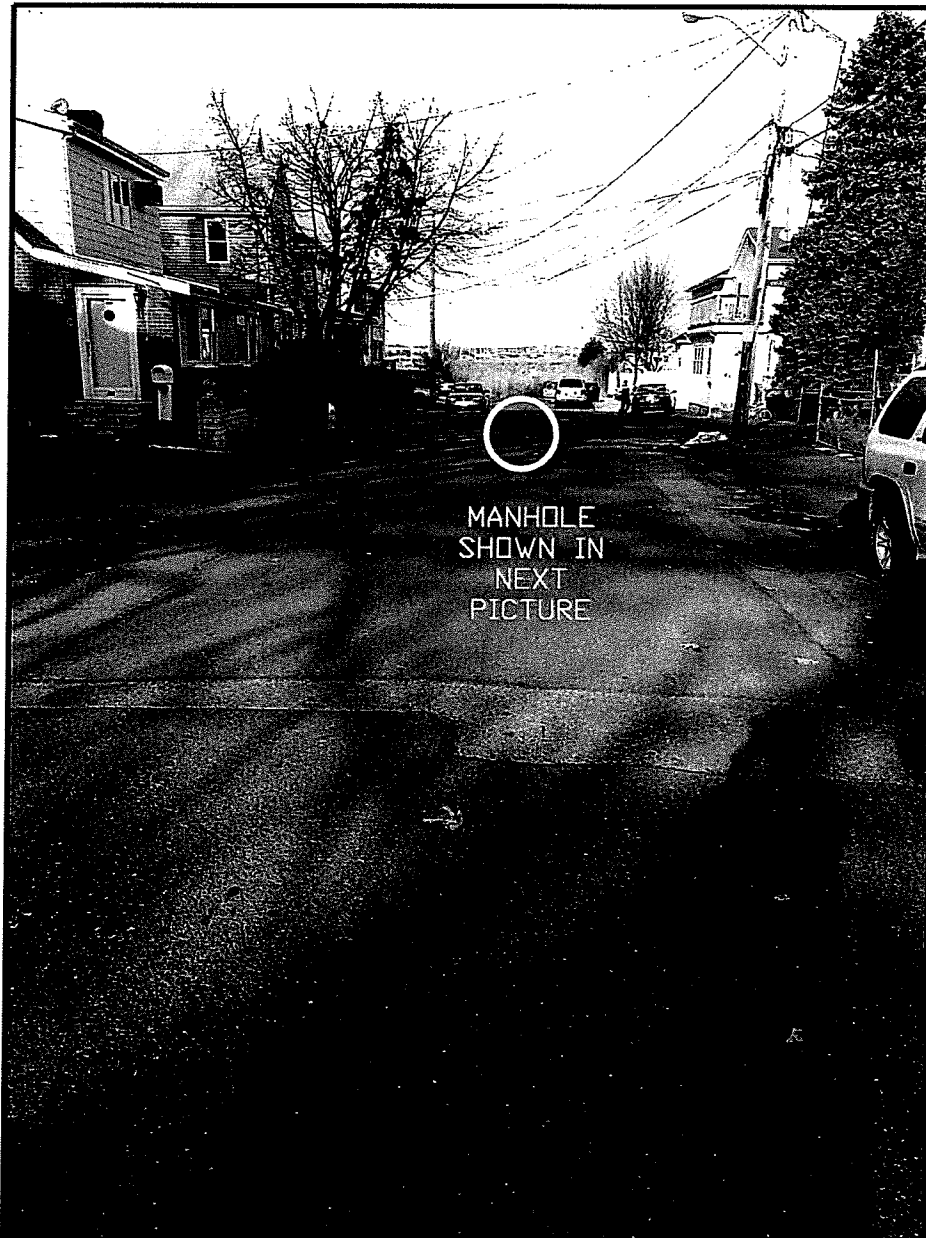
Looking towards Vera St.

Roadway continues to be in good condition except for the gas trench and areas immediately surrounding the trench.

Gas trench patches in this neighborhood appear to be temporary, gas company should be held accountable for install of permanent patches.

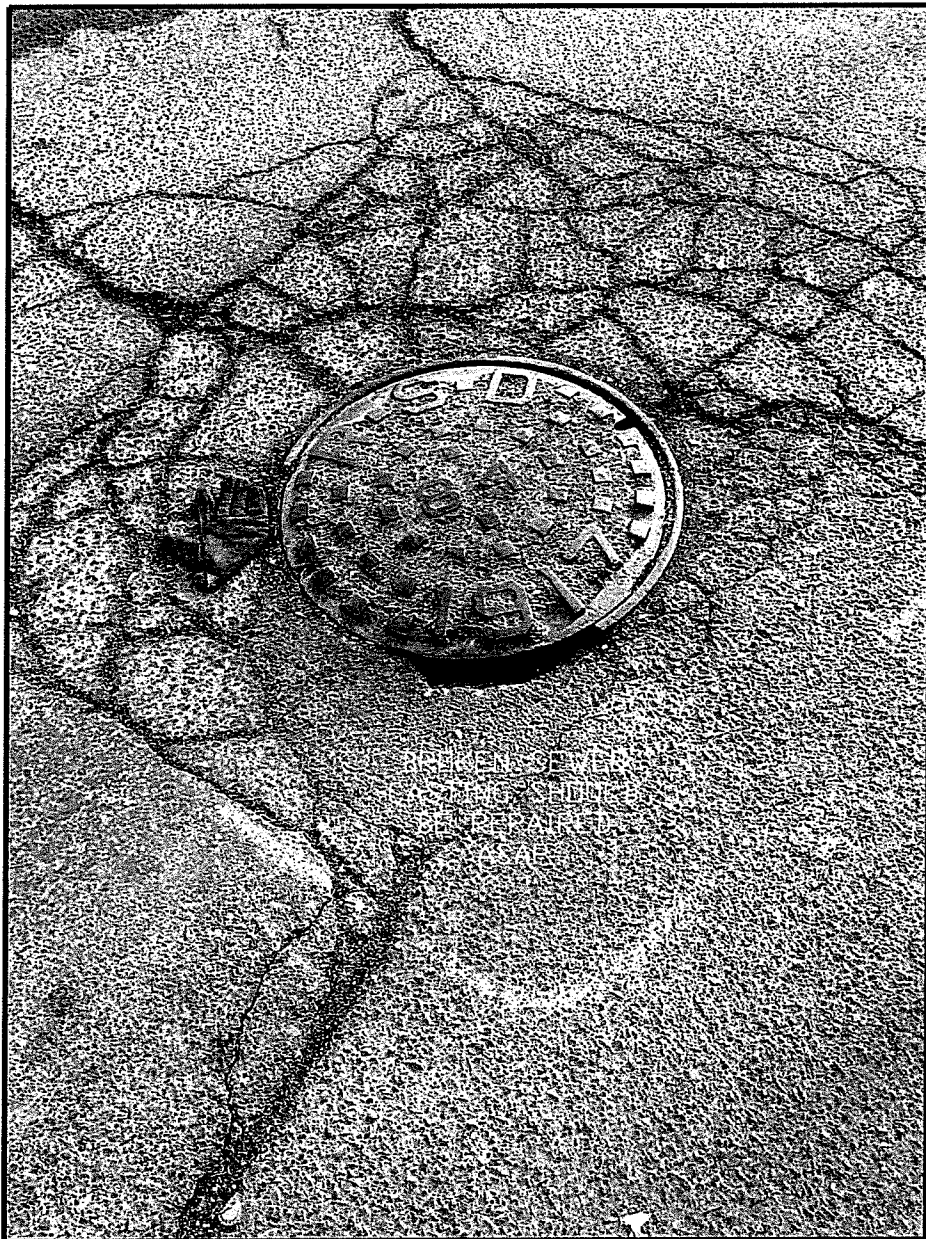
At Vera Street

Manhole casting is cracked.
opening into manhole structure visible.
Casting needs to be replaced, possible
safety hazard if condition continues to
worsen.

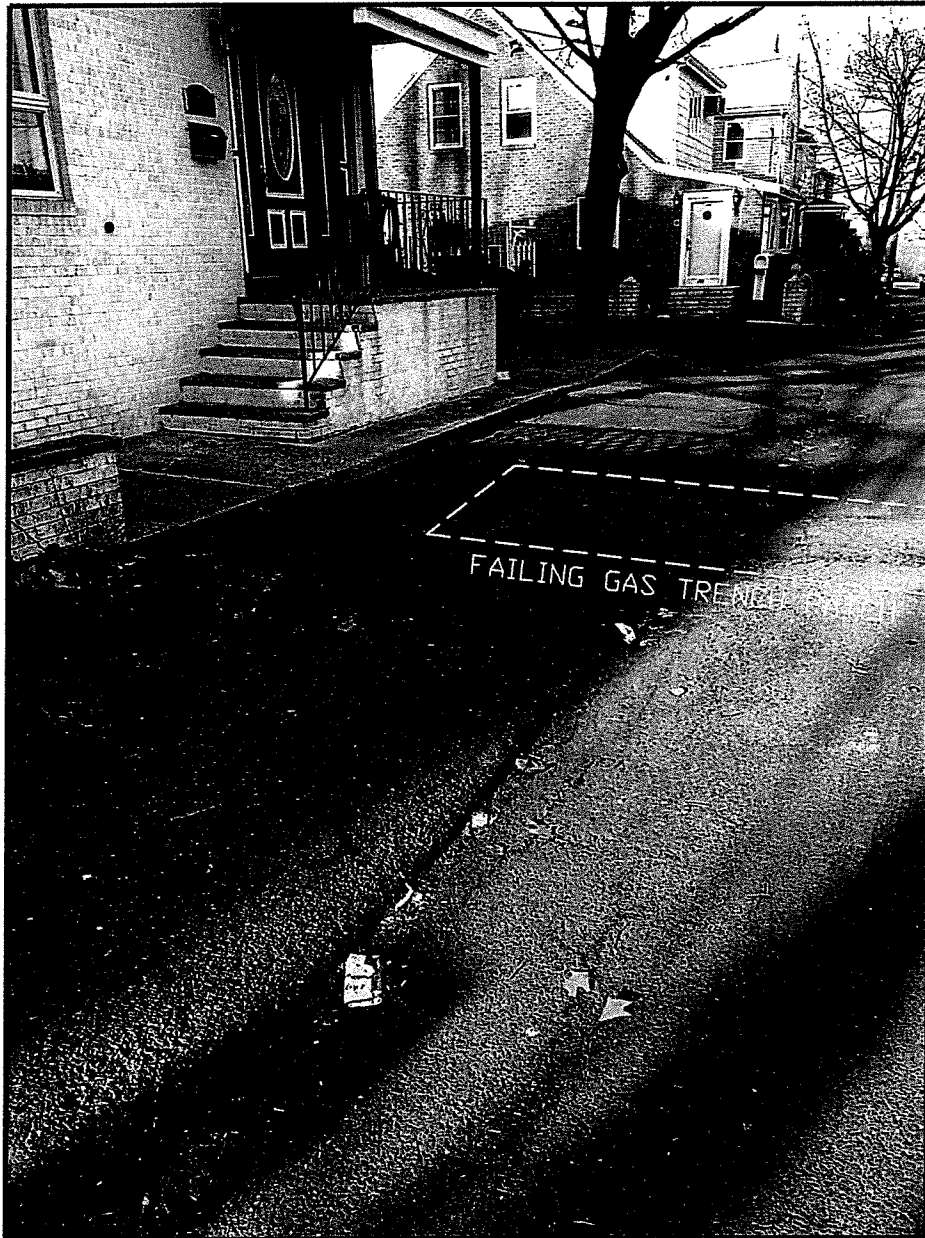
Just south of Vera Street

Photo highlights section of bad sidewalk.

Note gas trenches extend beyond the roadway into the sidewalks as well and such patches show signs of settlement, typical for the neighborhood.

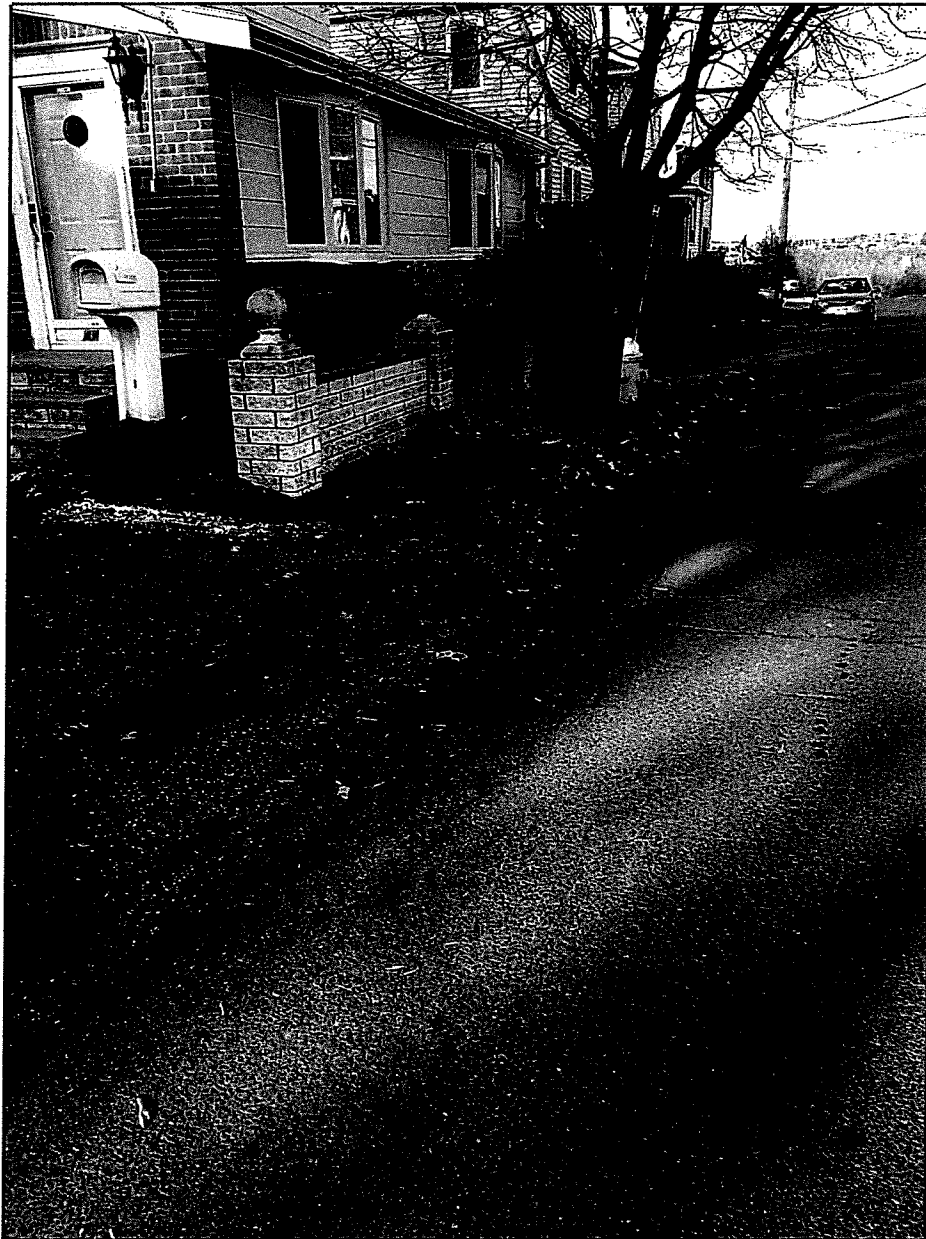
Continuing north on Glendale

Poor condition of sidewalk continues.

Possibly related to drainage issue.

If asphalt deterioration is caused by standing stormwater, drainage issues should be addressed prior to repairing the sidewalks. Otherwise, integrity of the base is questionable in this location. Note alligator cracking, symptom typical of soft base material.

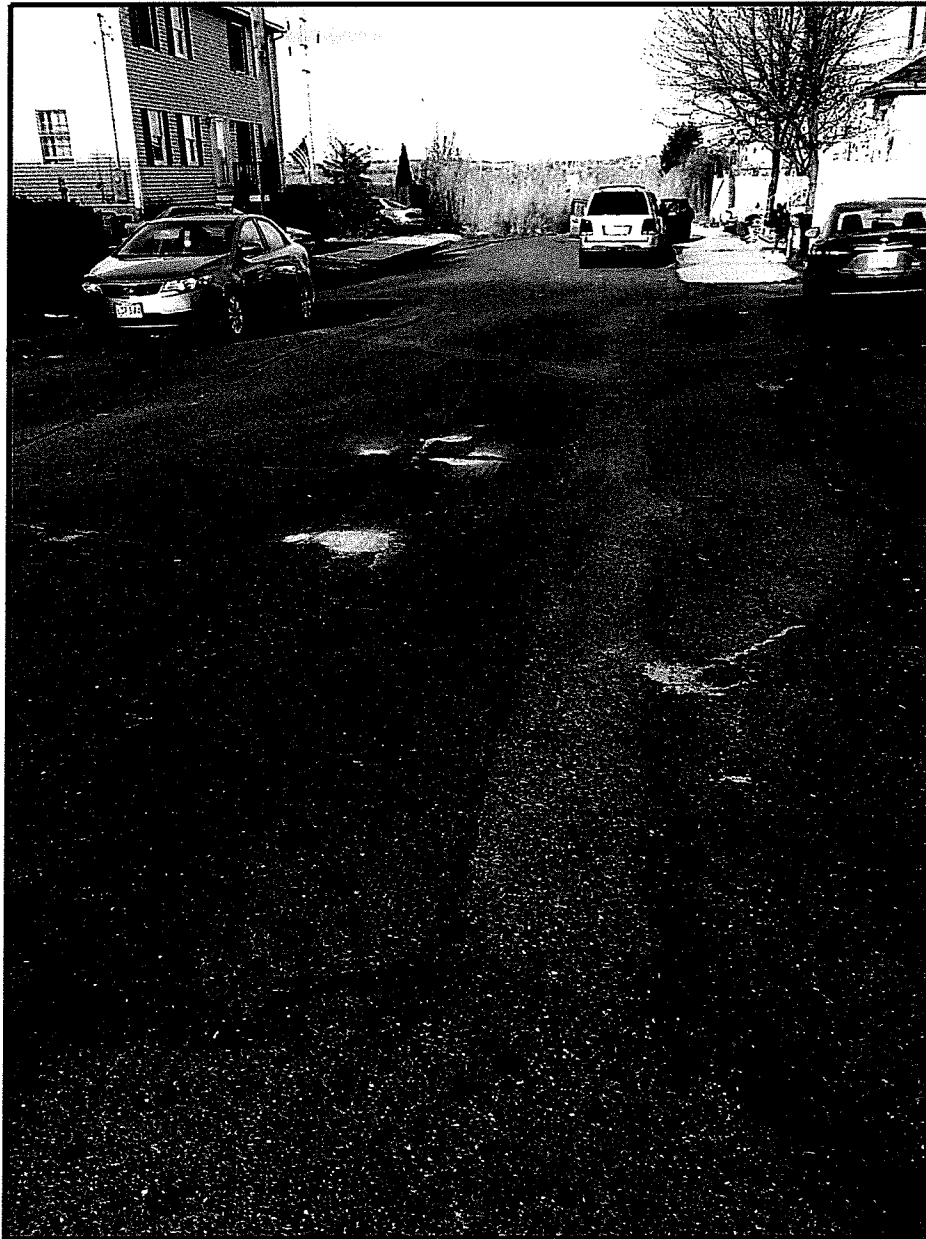
At Vera looking north towards dead end.

Extensive alligator cracking at this intersection
Integrity of road base questionable.

Long term solution is excavating
area of settlement and extensive cracking
and reinstalling base and asphalt.

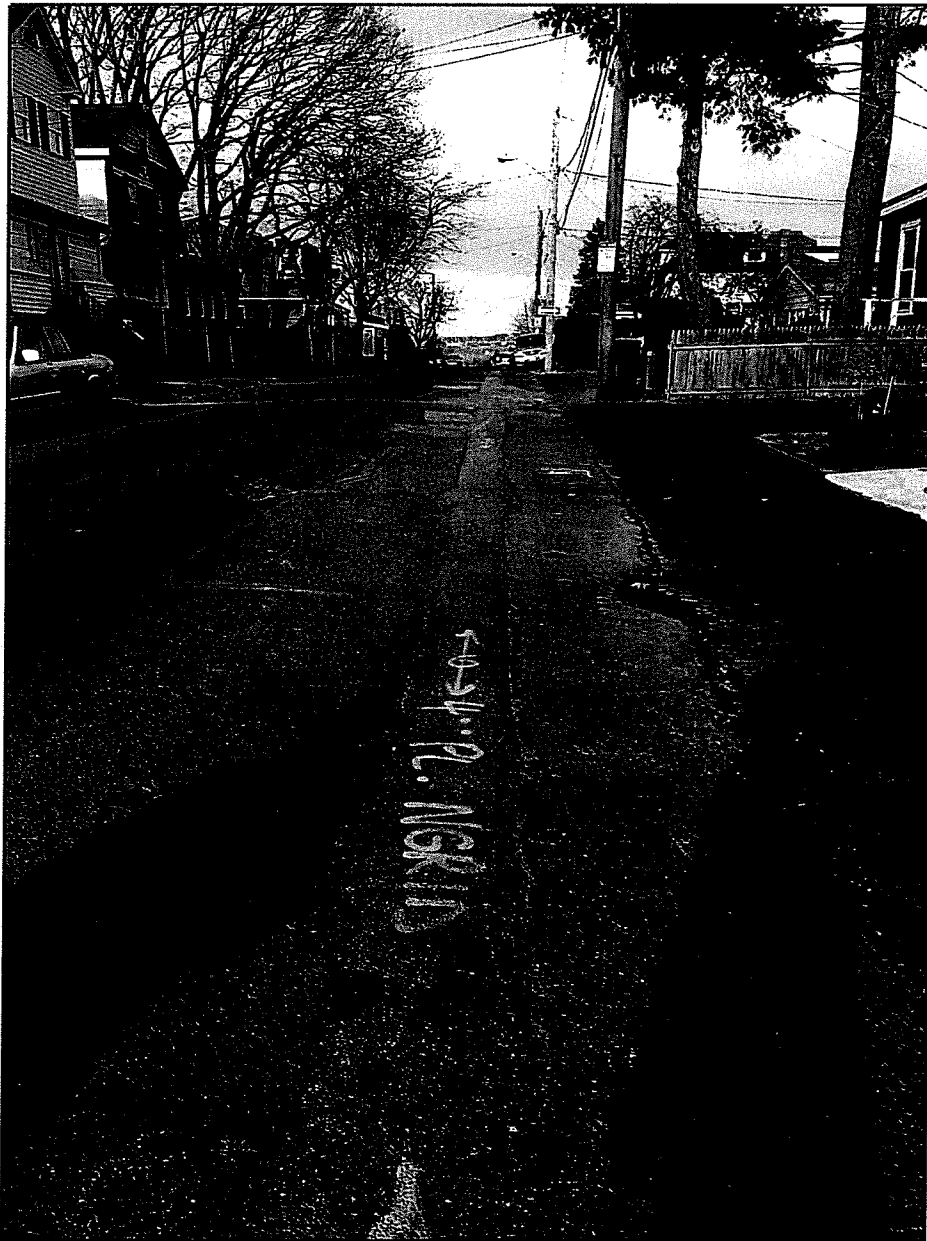
Looking at south side of Warren Street.

Photo highlights proposed handicap ramp area. Note, back of sidewalk must drop in order to install ramp. This will cause issues at chain link fence, fence footings may become exposed, fence may require replacement after ramp is installed. Driveway apron will also likely need to be replaced to meet new grade of ramp system.

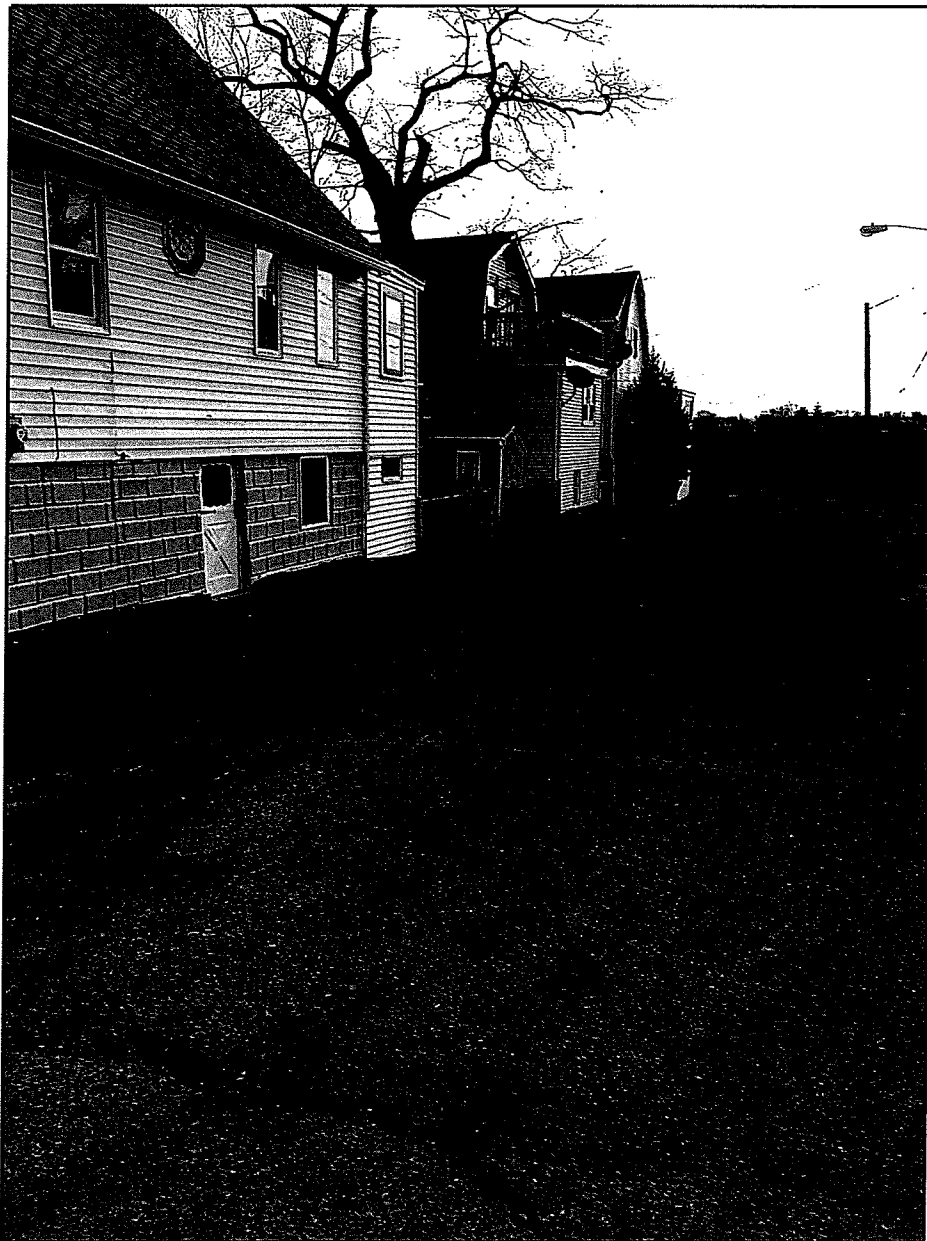
At Oak Island Road looking south

Road and sidewalks cracking and beginning to break up. Condition continues to the marsh

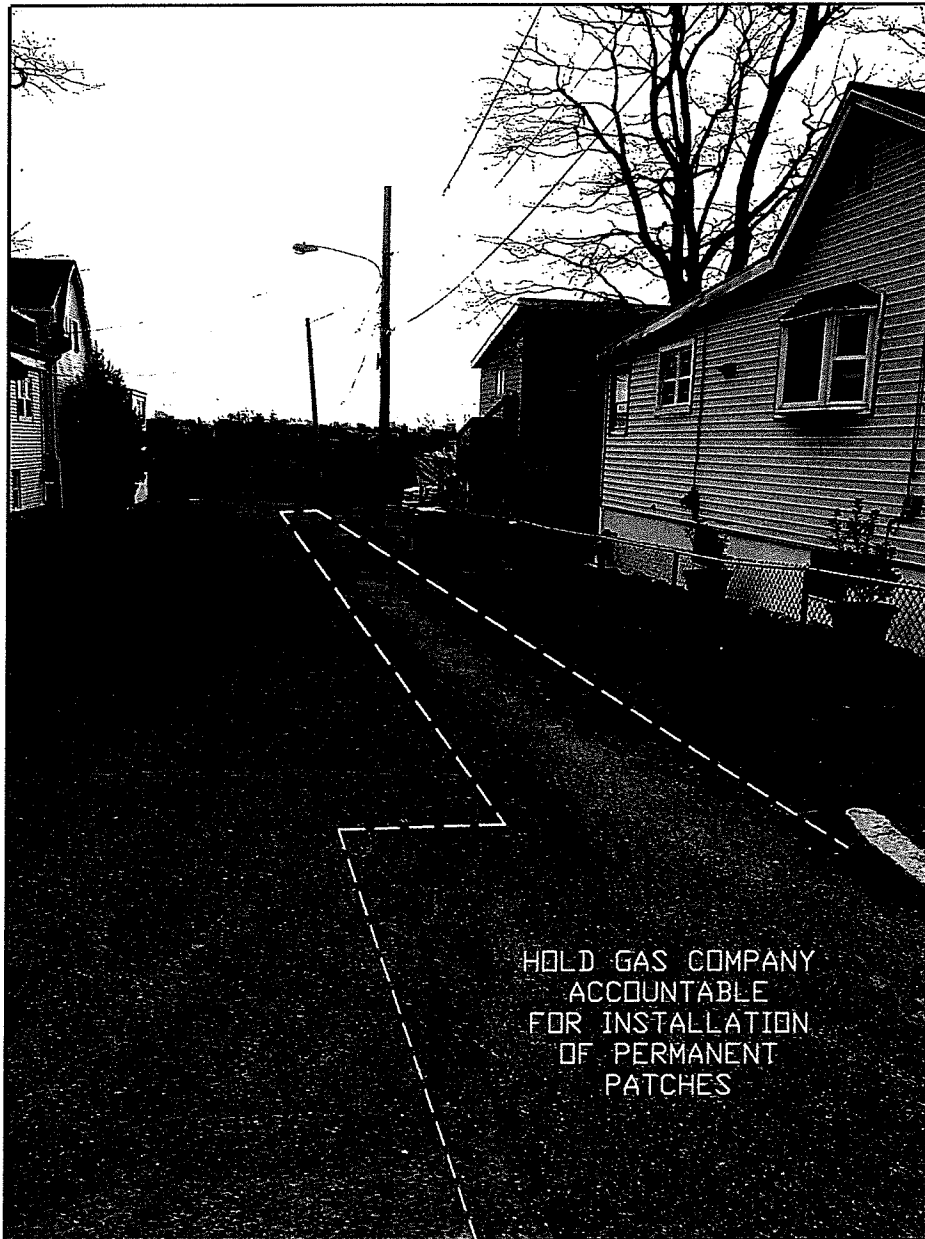
At Oak Island Road looking south

Roadway cracking and settling. Gas trench shown in photo showing signs of settlement.

Typical in the neighborhood, the gas company could be held accountable to cut back and reinstall their trenches. Such effort may improve the overall feel of the road in some sections.

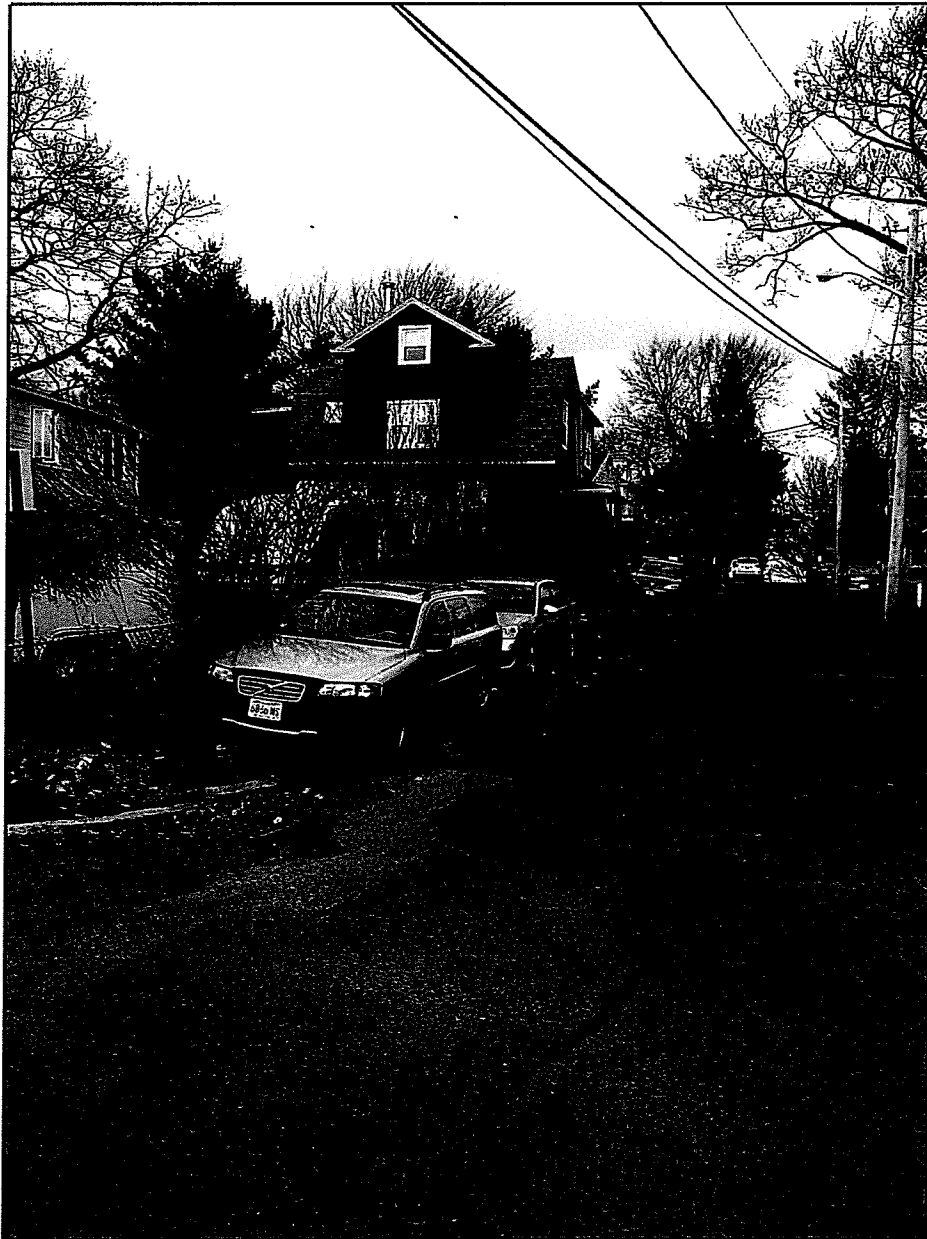
At Oak Island Road looking north

Intersection of Oak Island Road and Woodland Road in very poor condition and requires reconstruction of curb, sidewalk and roadway.

Effectiveness of drainage at this intersection should be investigated.

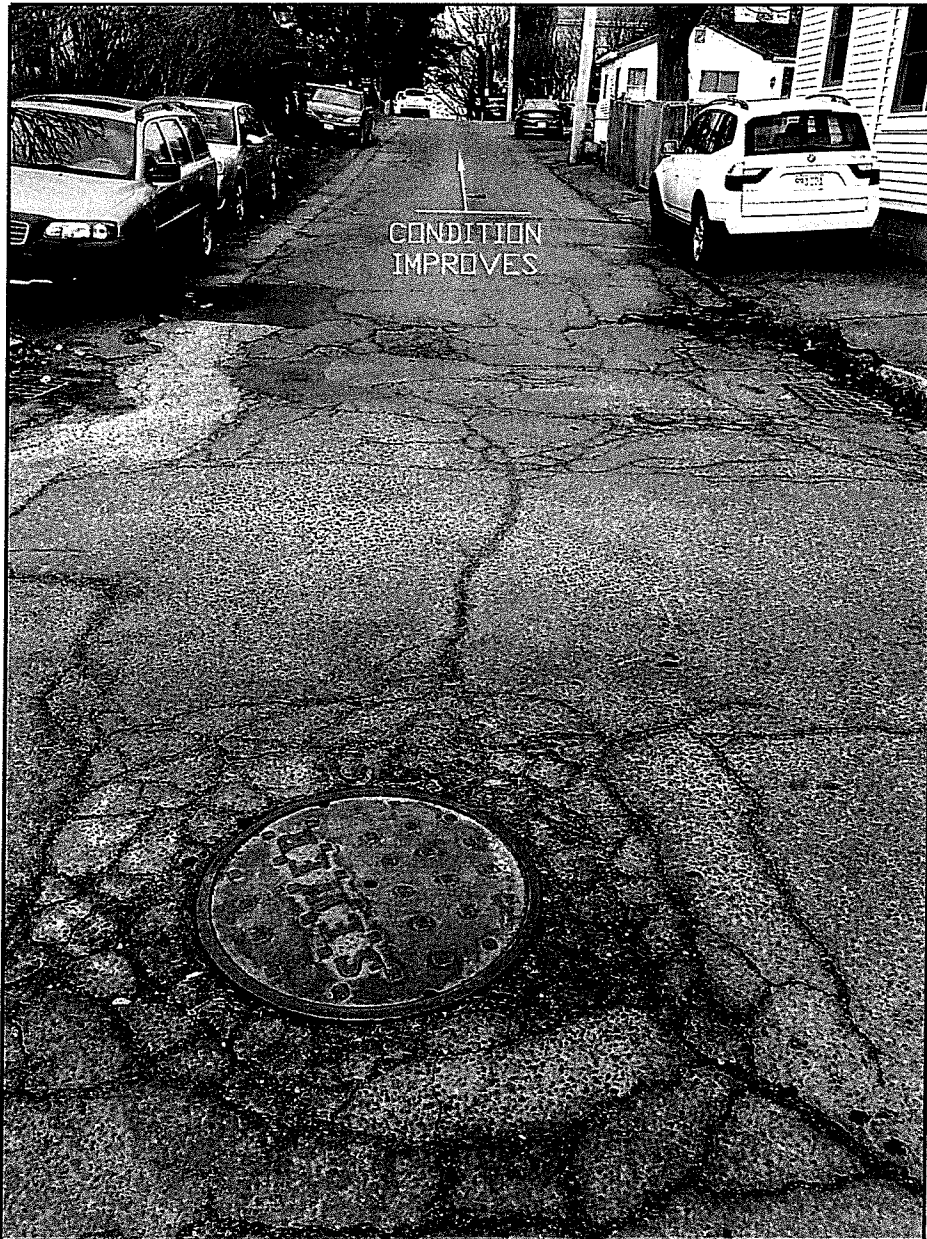
At Oak Island Road looking north

Intersection of Oak Island Road and Woodland Road in very poor condition and requires reconstruction of curb, sidewalk and roadway.

Condition of Woodland Road improves as you move beyond the intersection.

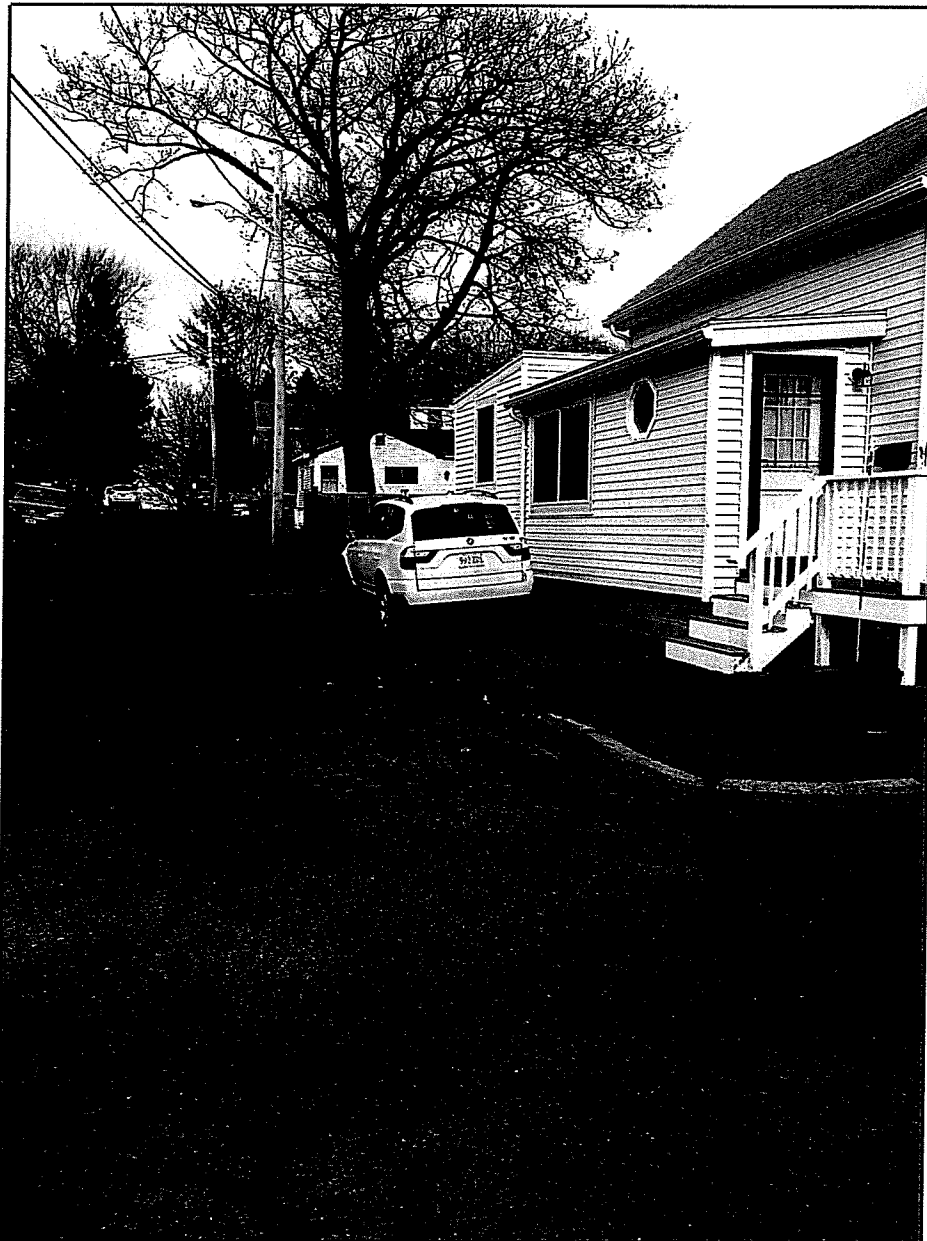
At Oak Island Road looking north

Intersection of Oak Island Road and Woodland Road in very poor condition and requires reconstruction of curb, sidewalk and roadway.

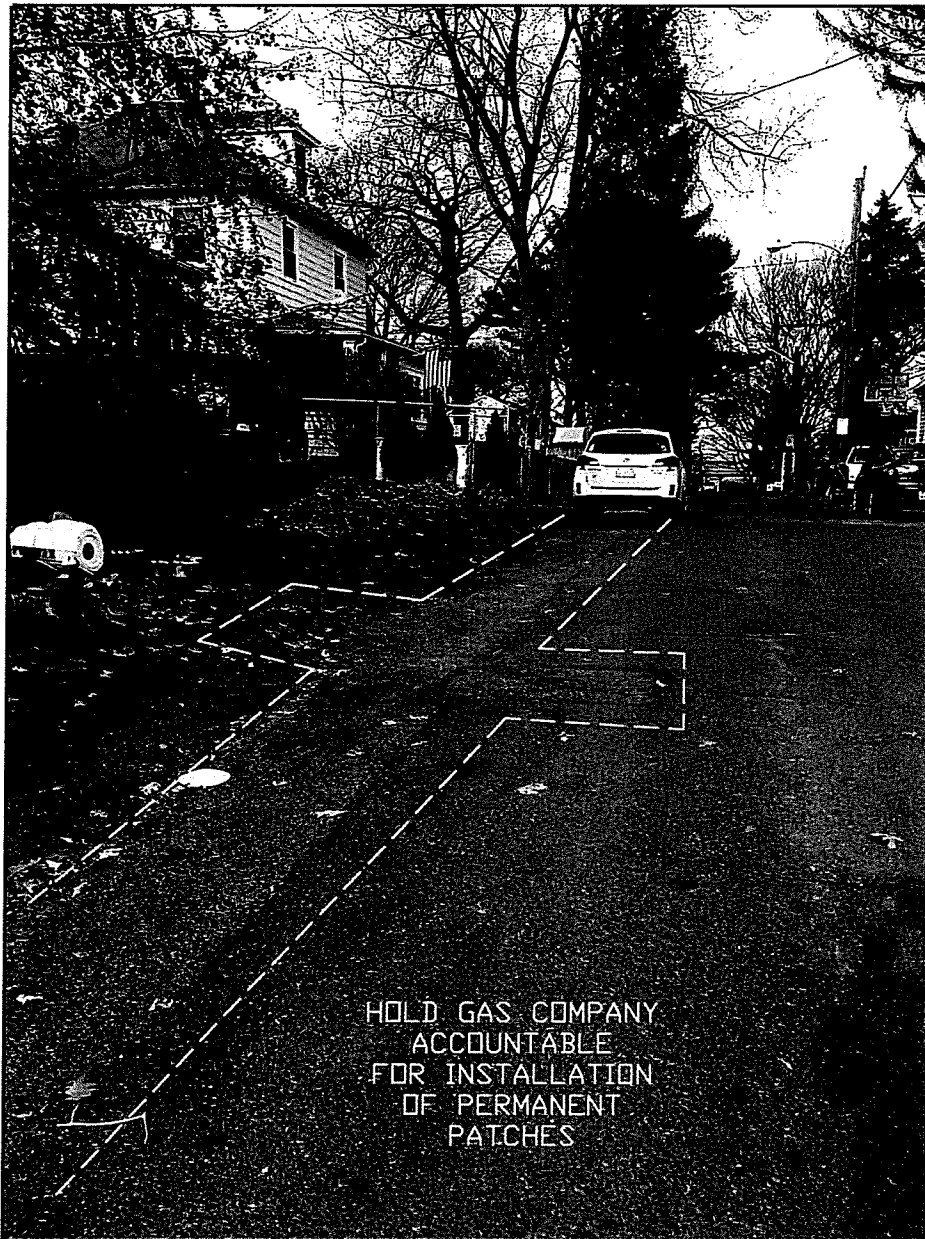
Continuing north on Woodland Road

Condition of the road and sidewalks improve as
you move away from the Oak Island Road
Intersection.

Road showing minor cracking and gas trench
settlement.

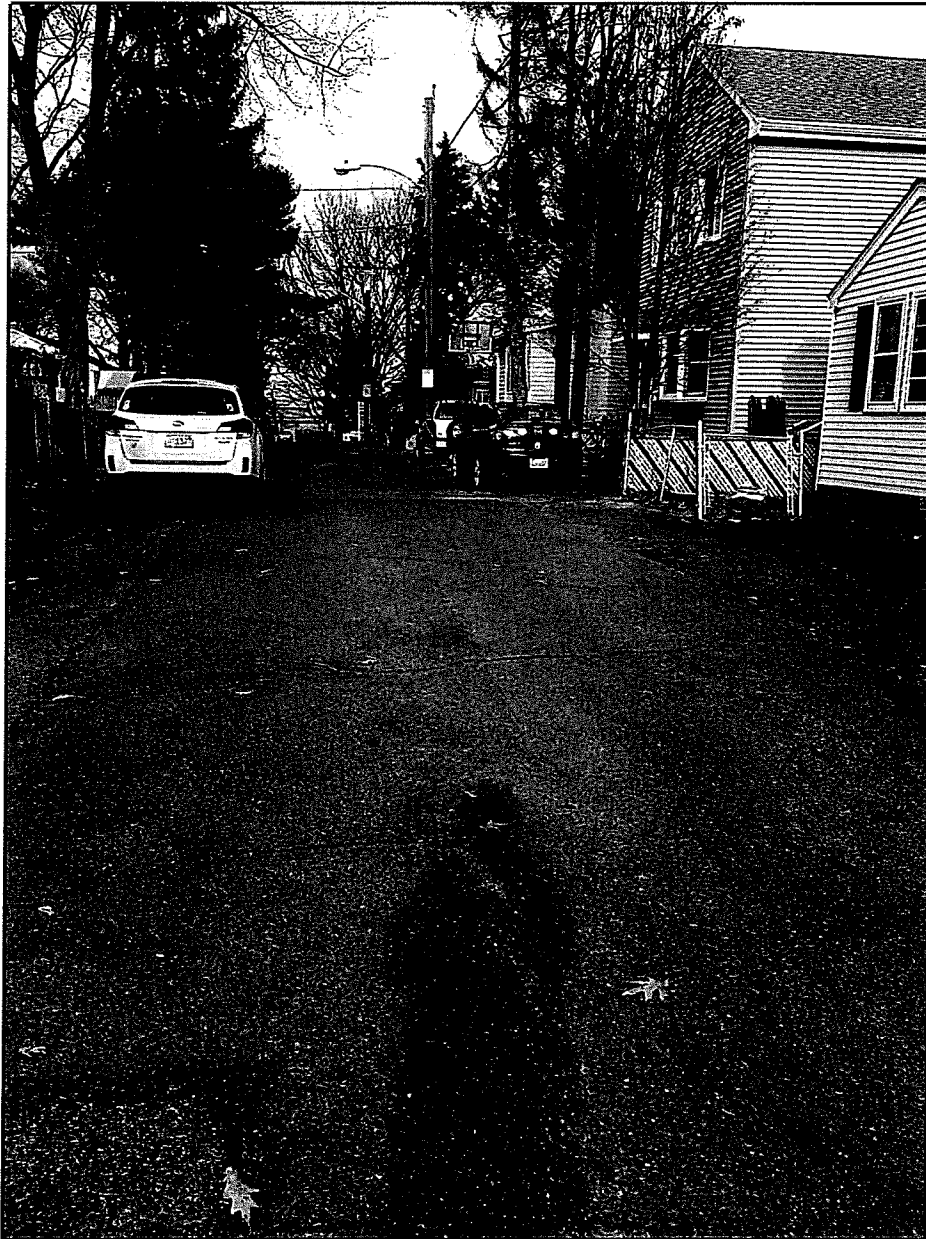
Continuing north on Woodland Road

Decent condition of roadway and sidewalks continues north. Gas trench condition continues. The City of Revere should hold the gas company accountable to install permanent patches, cutting back into the roadway in the process by appx 1' to 2' on either side of the trench.
