PHASE 1 - FEASIBILITY ANALYSIS

Glendale Road, Oak Island Road & Woodland Road

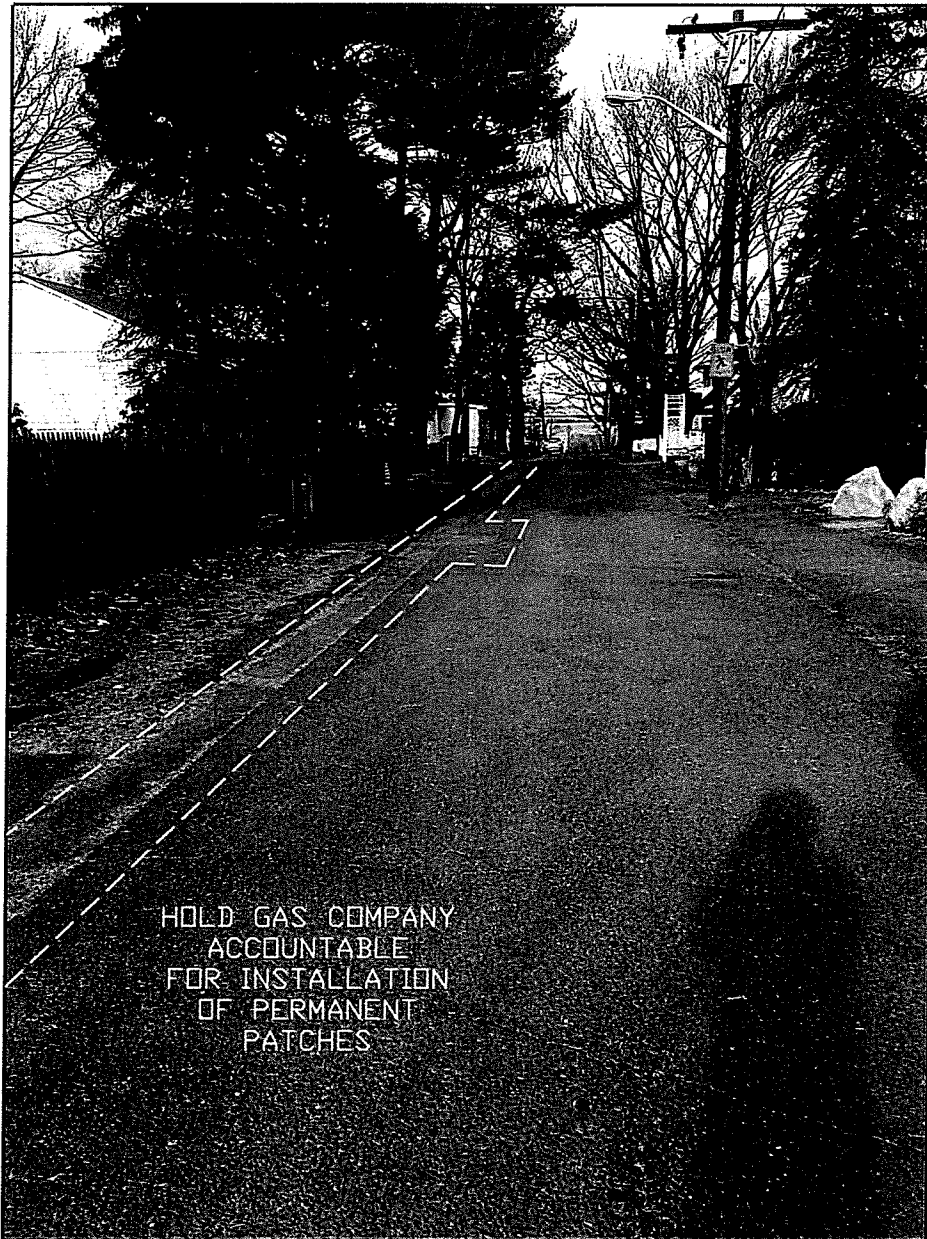
Continuing north on Woodland Rd.

Decent condition of the roadway and sidewalks continues. Condition deteriorates at the dead end shown in next picture. Permanent gas trench patches would improve the quality of the roadway in this location.

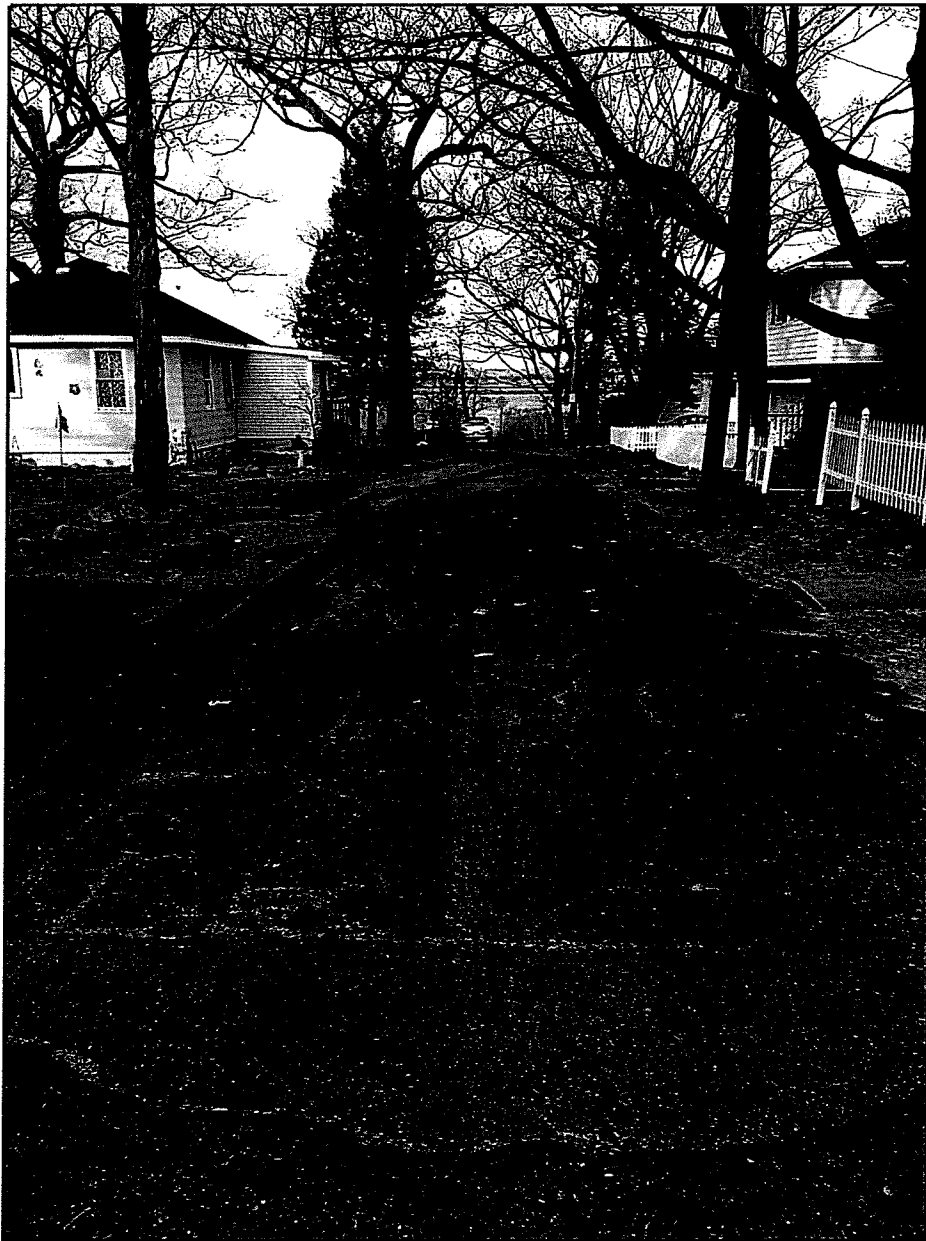
Continuing North to dead end of Woodland Rd.

Condition of the road quickly deteriorates as you approach the dead end. Roadway in worse condition than the gas trench.

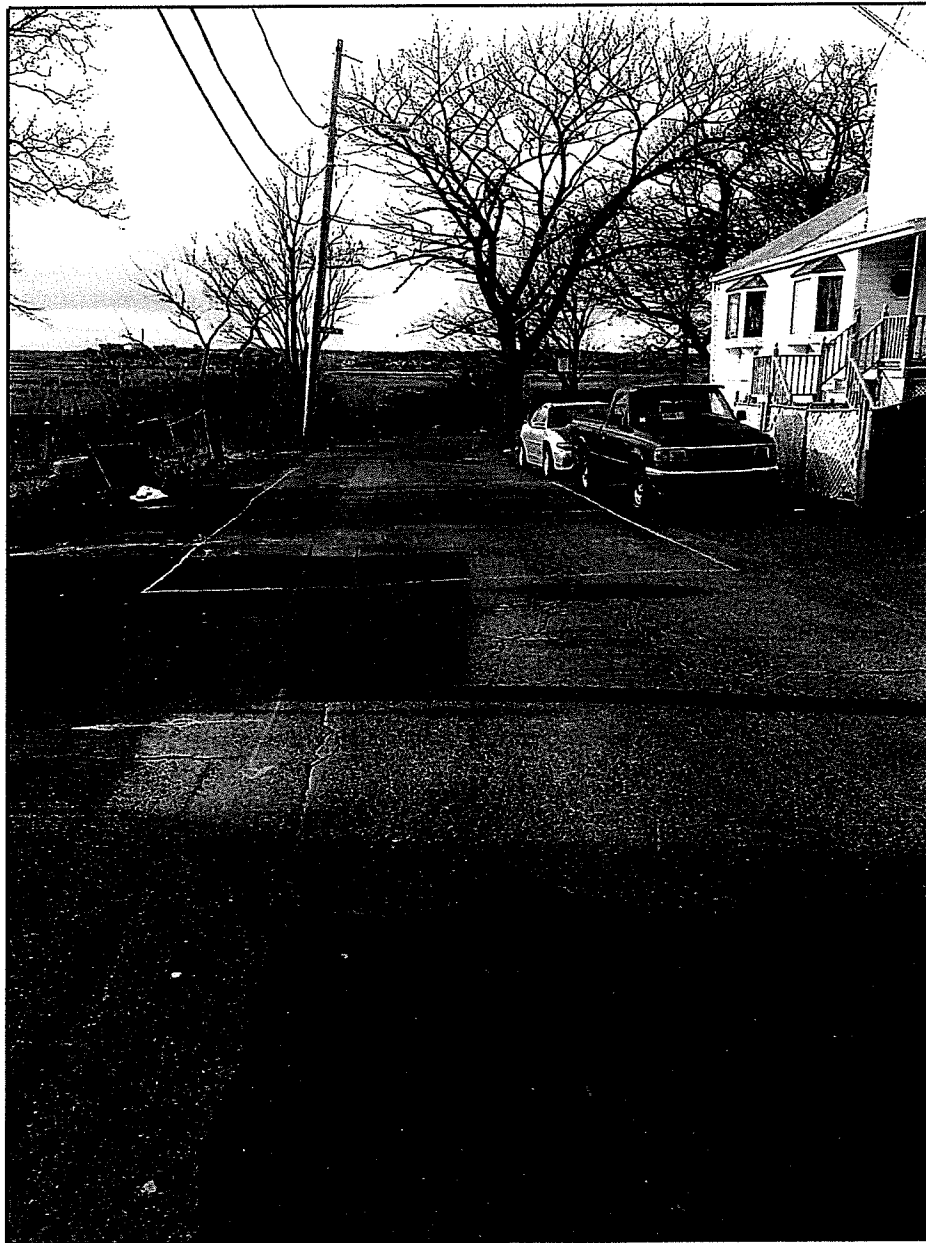
Looking northwest towards marsh

Gas trench shown in good condition compared to remained of road. Note patch shown at bottom of the picture. Alligator cracking likely to continue and road will begin to break up

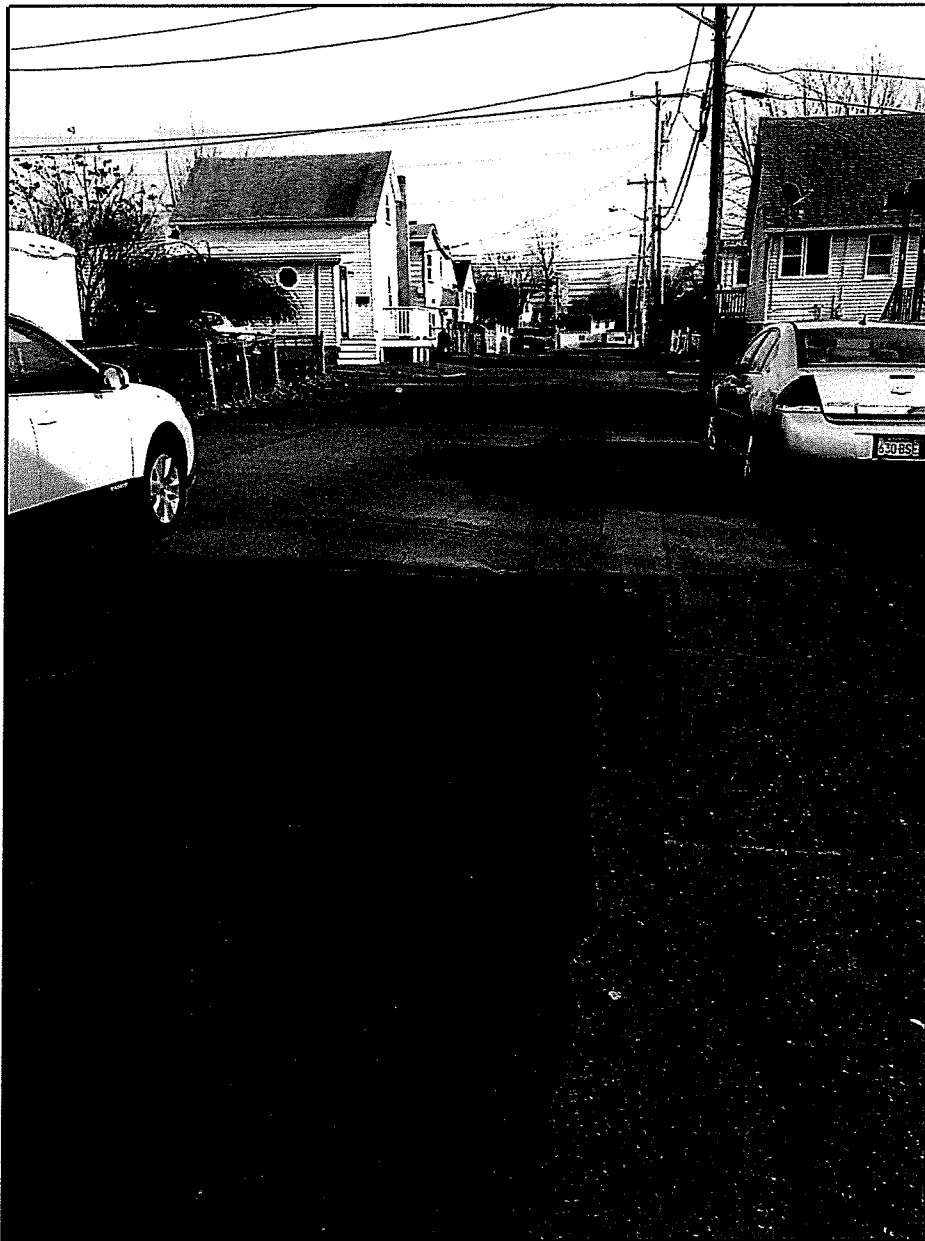
Looking southeast towards North Shore Road

Patch in good condition, gas trench showing signs of settlement, remainder of road breaking up and showing signs of settlement

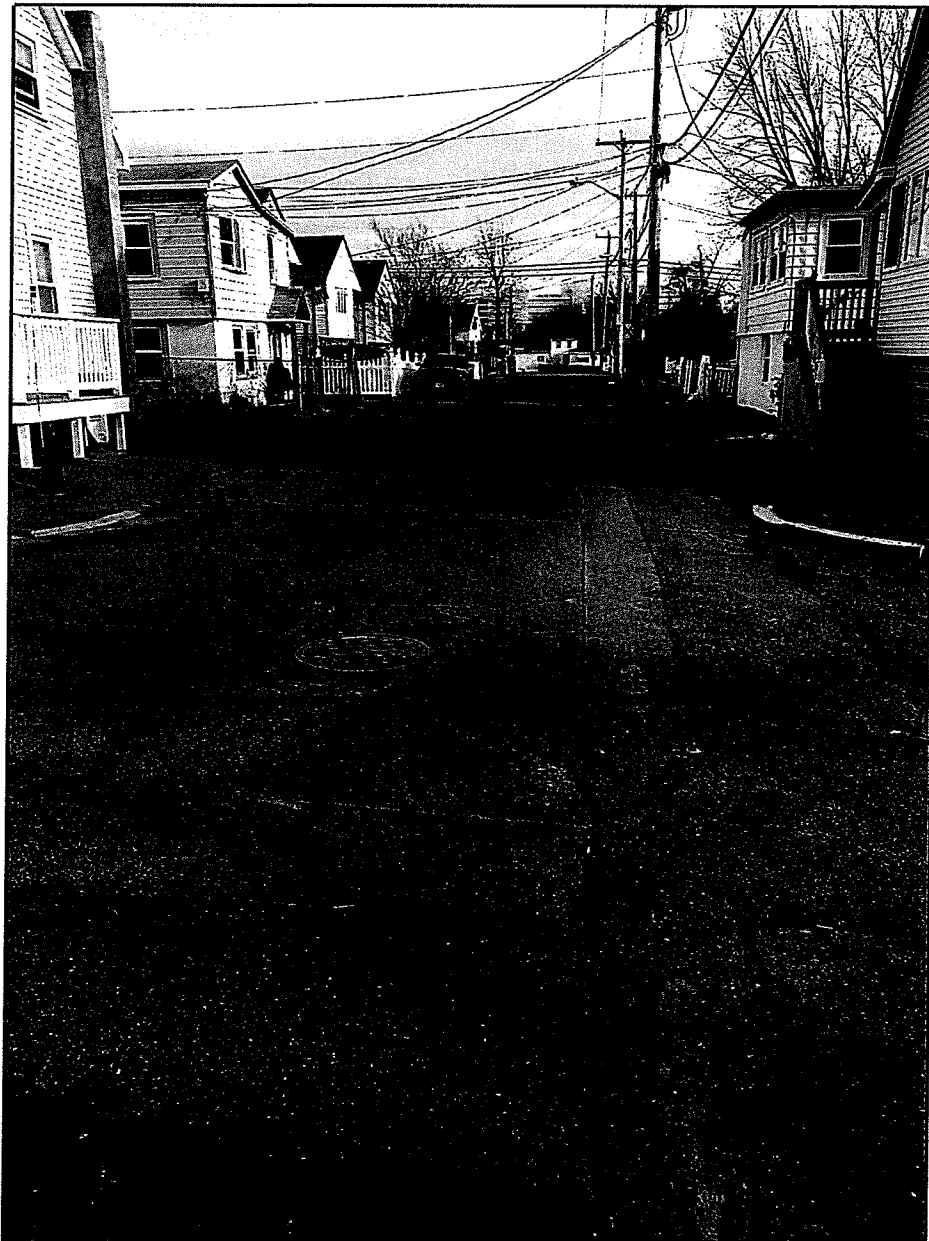
Intersection of Woodland Road

This intersection in poor condition. Curb inconsistent, pavement breaking up and settling.

Drainage exists on left side of intersection only.
Catch basins not in photo.

Asphalt sidewalks breaking up in poor condition.

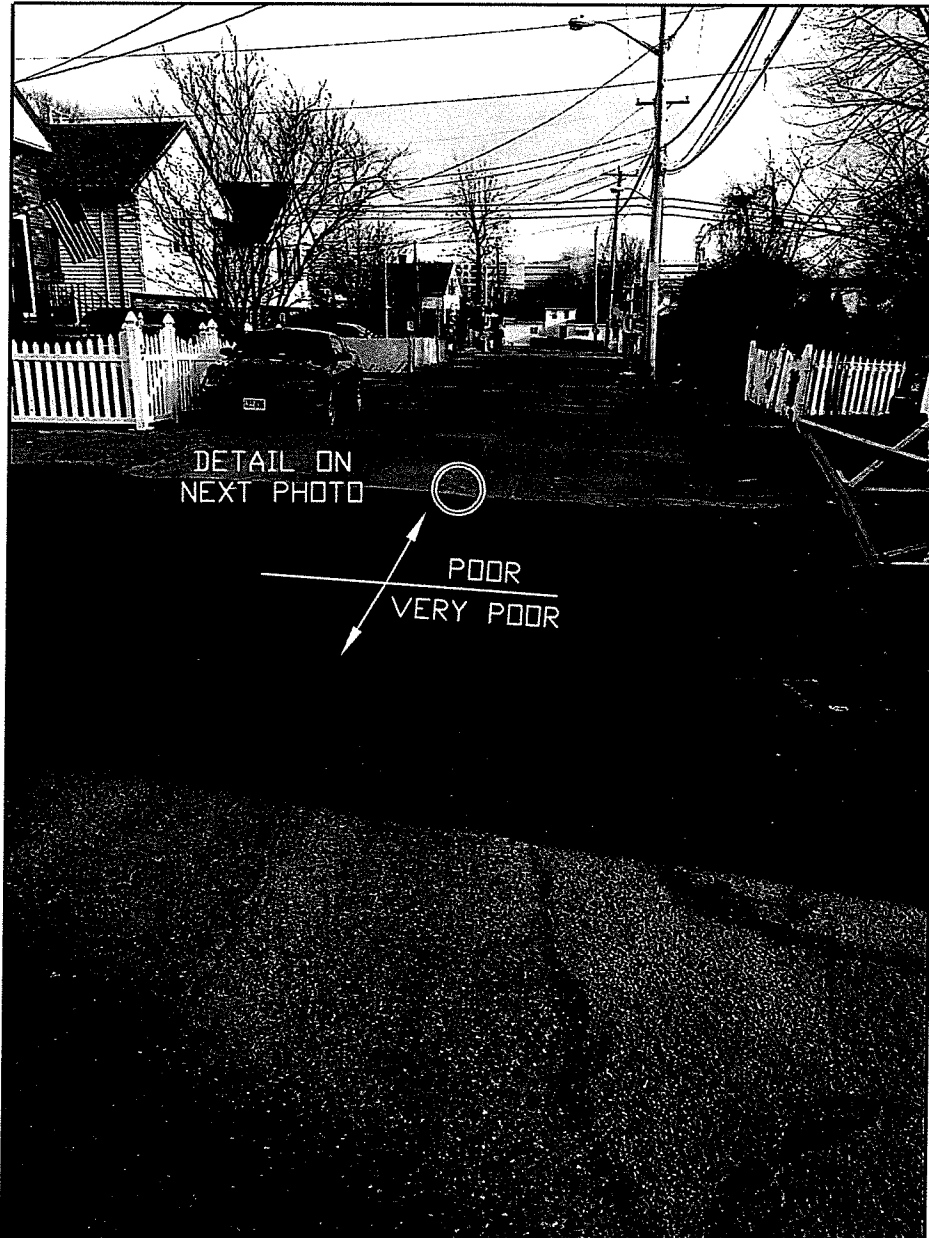
Continuing towards Glendale St.

Road changes from very poor to poor beyond Woodland Ave. Gas trench showing settlement.

Sidewalks inconsistent and breaking up.

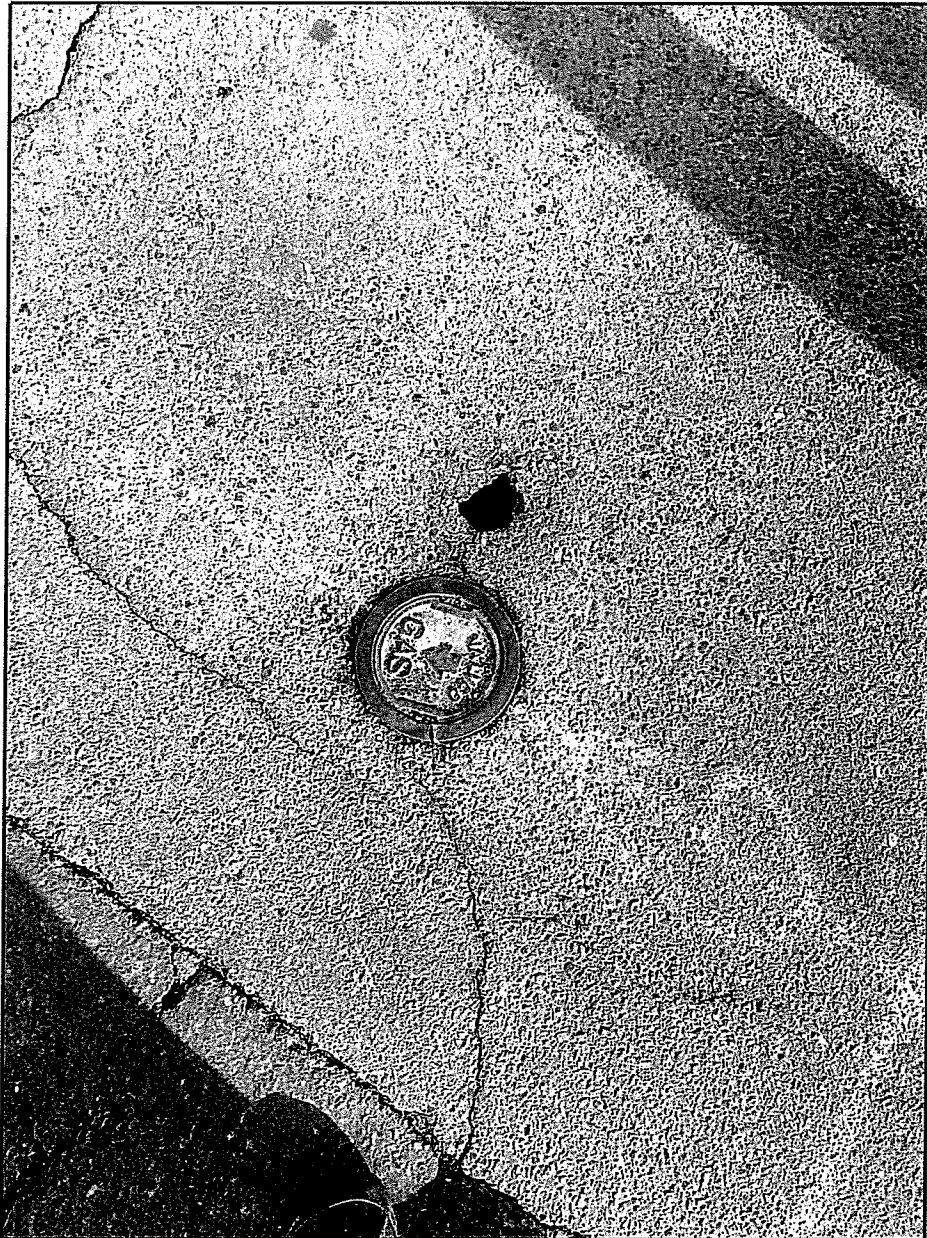
Evidence of sink hole at gas valve riser.

Contact Gas Company to address before condition worsens.

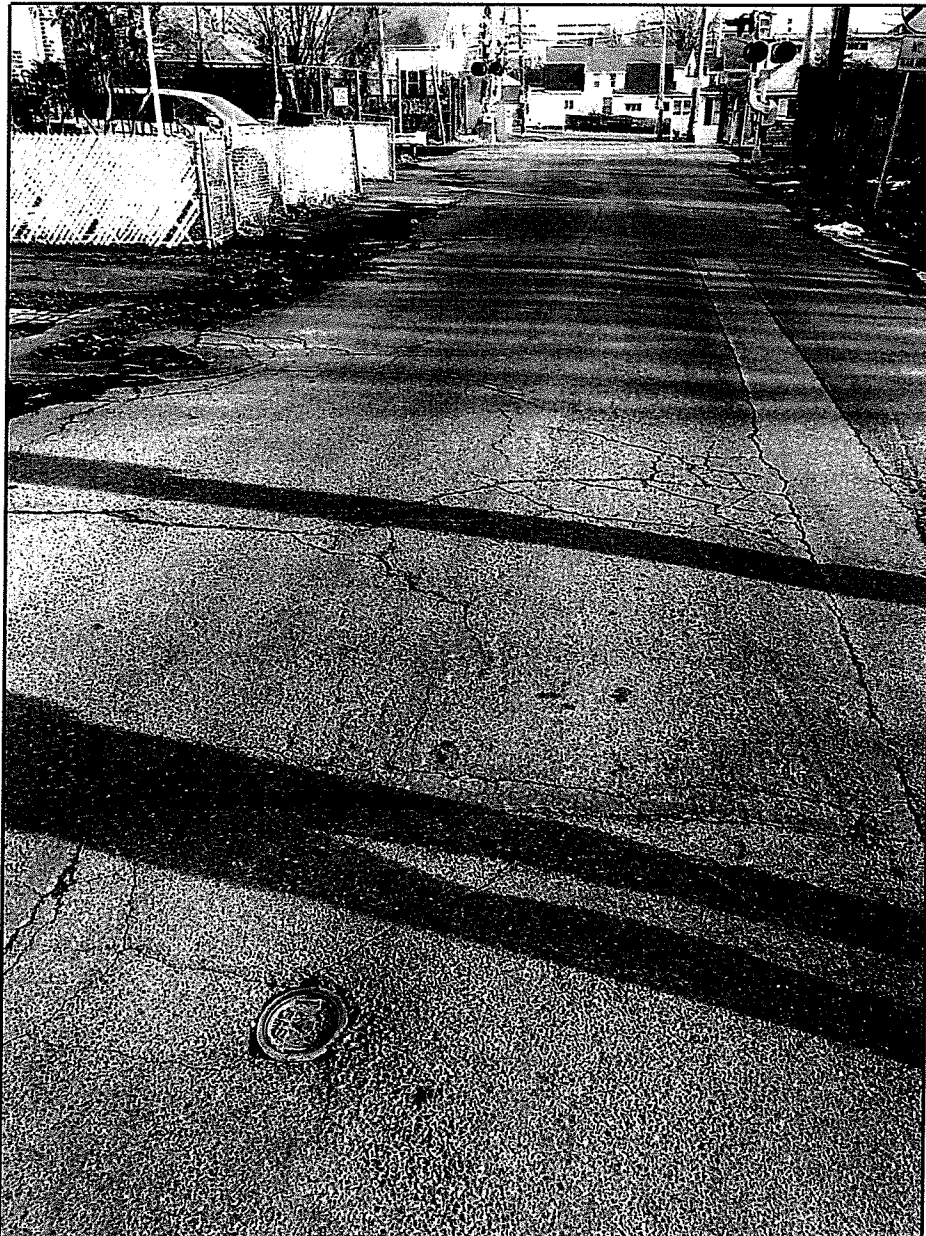
Continuing southeast towards traintracks

Typical condition of roadway continues, gas trench seems to holding up better than remainder of road. Road cracking up, showing signs of settlement.

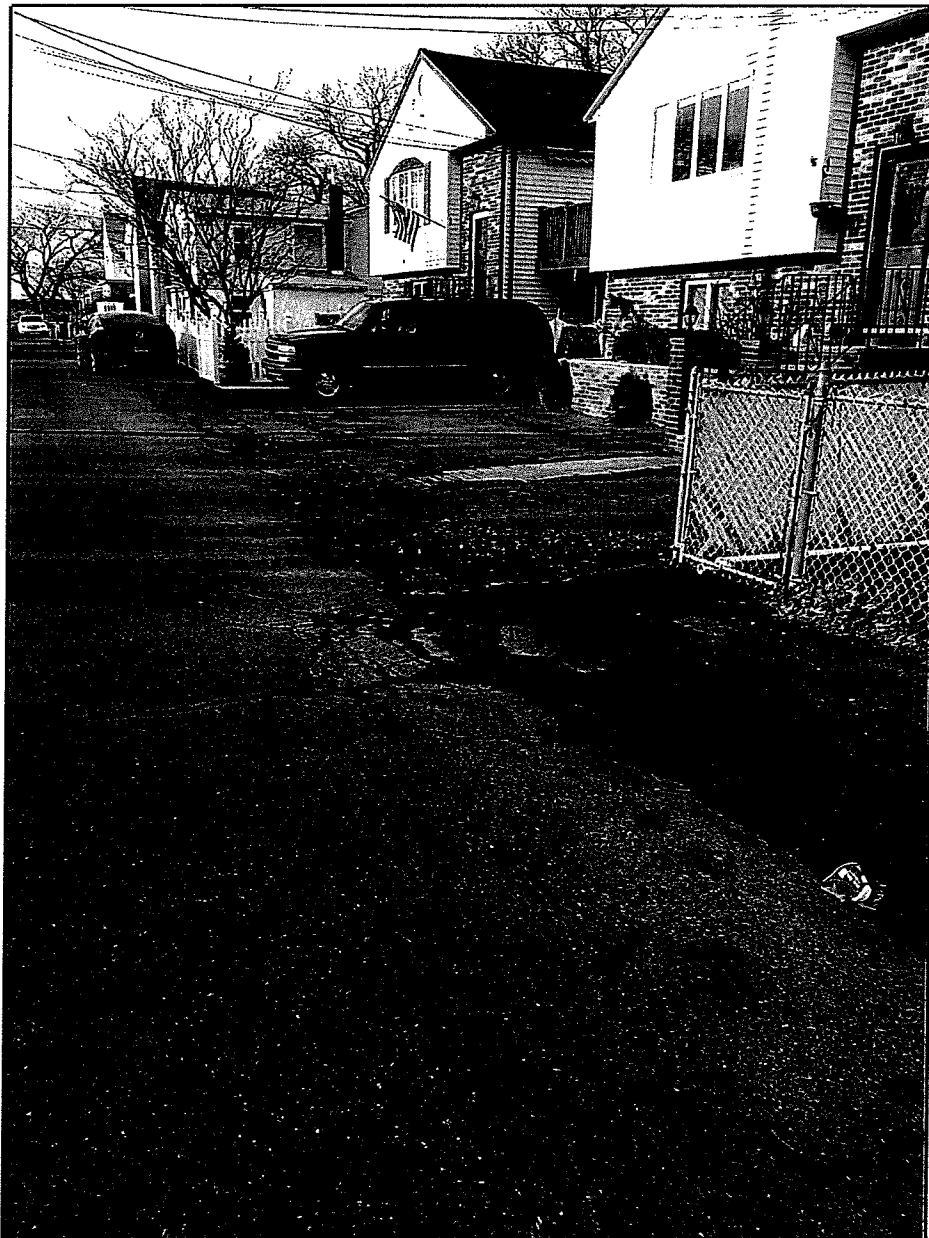
Looking towards marsh, standing at traintracks

Possible evidence of water damage to sidewalk and roadway. Problem may be solved by adjusting grade of road, more investigation necessary before a determination can be made.

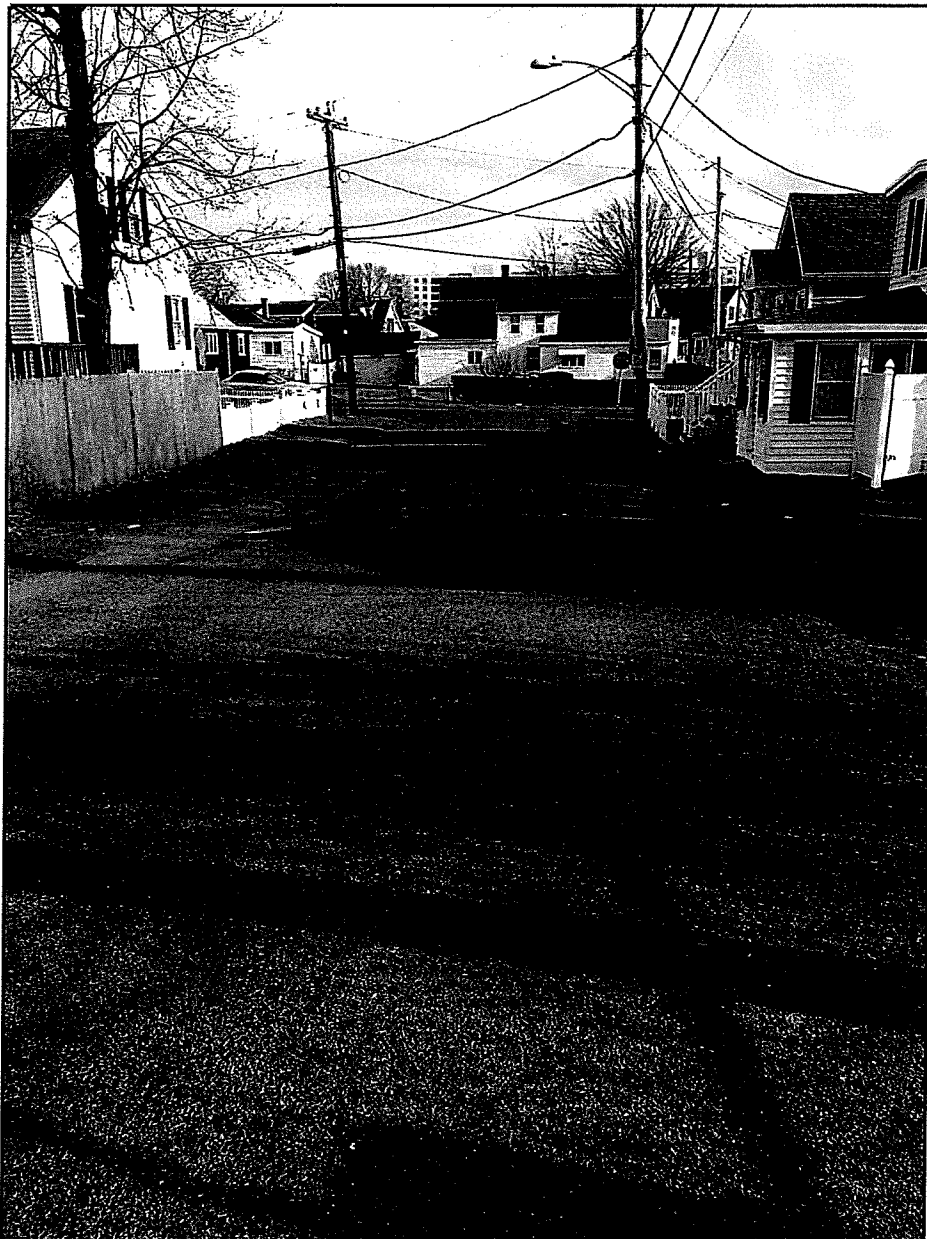
South of traintracks looking
towards Glendale Street.

Condition of the roadway is better between the
train tracks and Glendale compared to the
section north of the tracks. Despite being
better, this section does show settlement and
cracking.

Sidewalks inconsistent and in poor condition

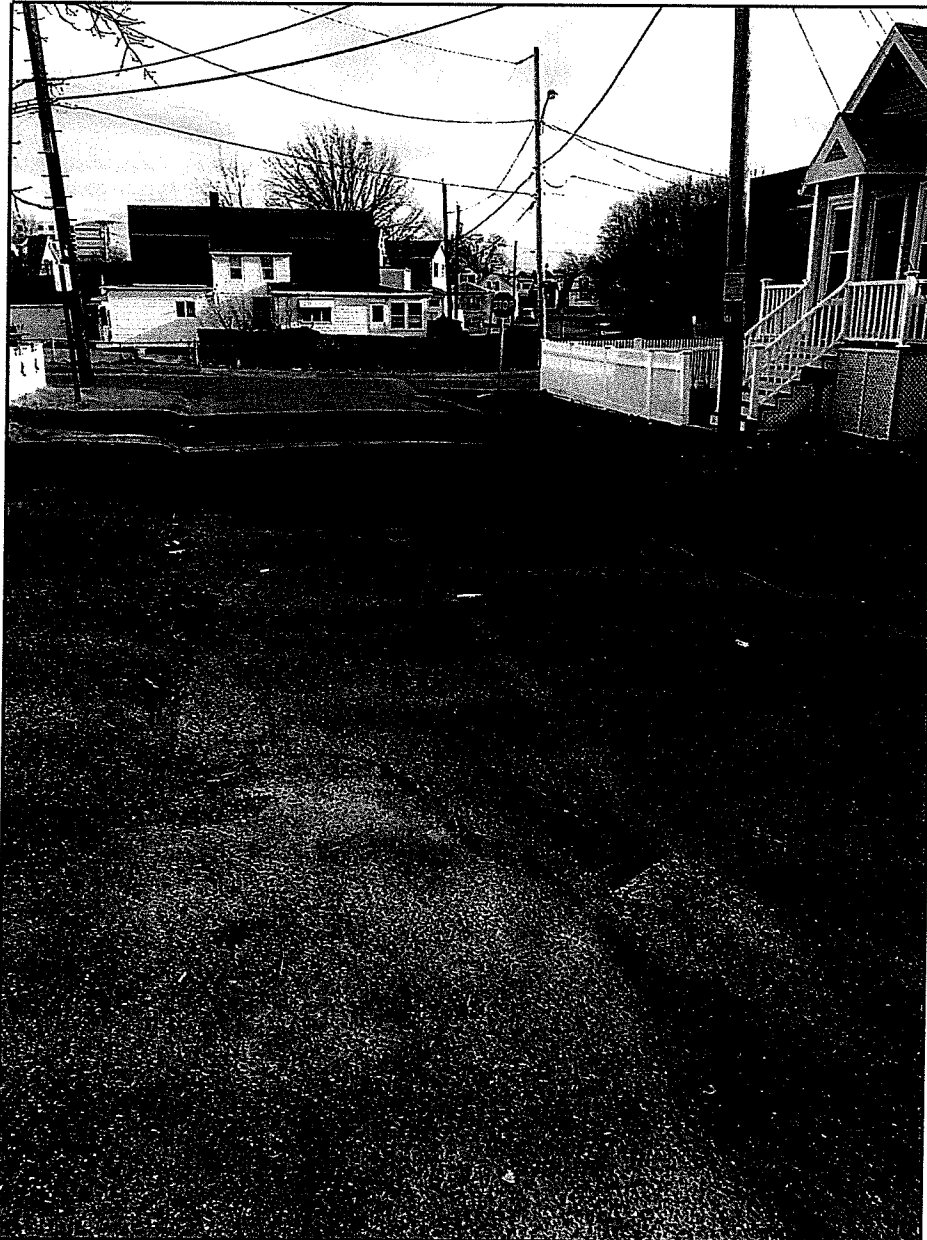
Looking southeast towards Glendale Street

Typical condition of the roadway is shown, road is cracking and settling. Sidewalks breaking up.
