## PHASE 1 - FEASIBILITY ANALYSIS

### South Cambridge Street

(Vane St. to Park Ave.)

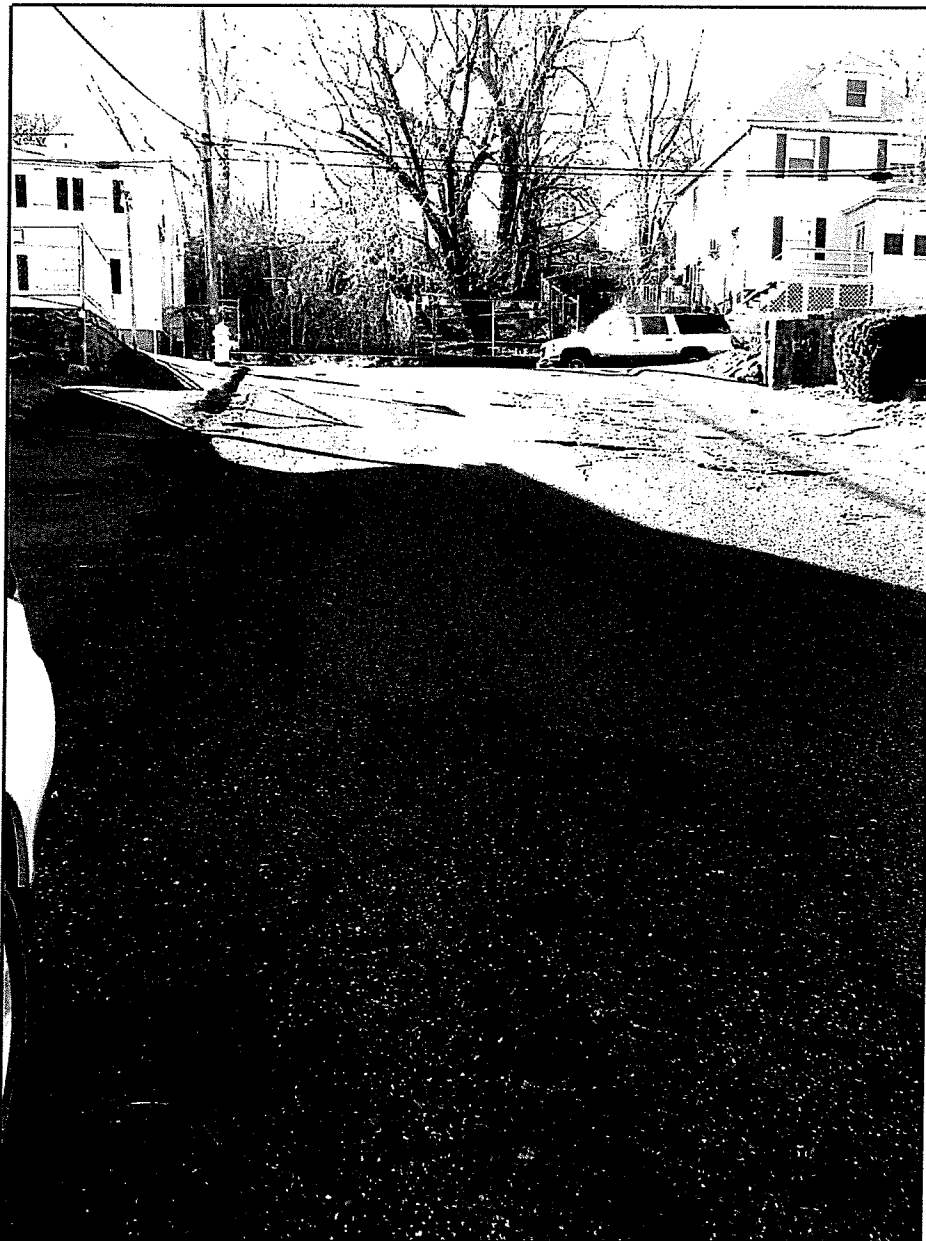
## South Cambridge Street

Looking south towards Vane Street.  
Road and 'sidewalks' both in very  
poor condition. Sidewalks are not  
continuous southerly to Warren St.

Asphalt raveling, showing aggregate loss and  
creaking apart.

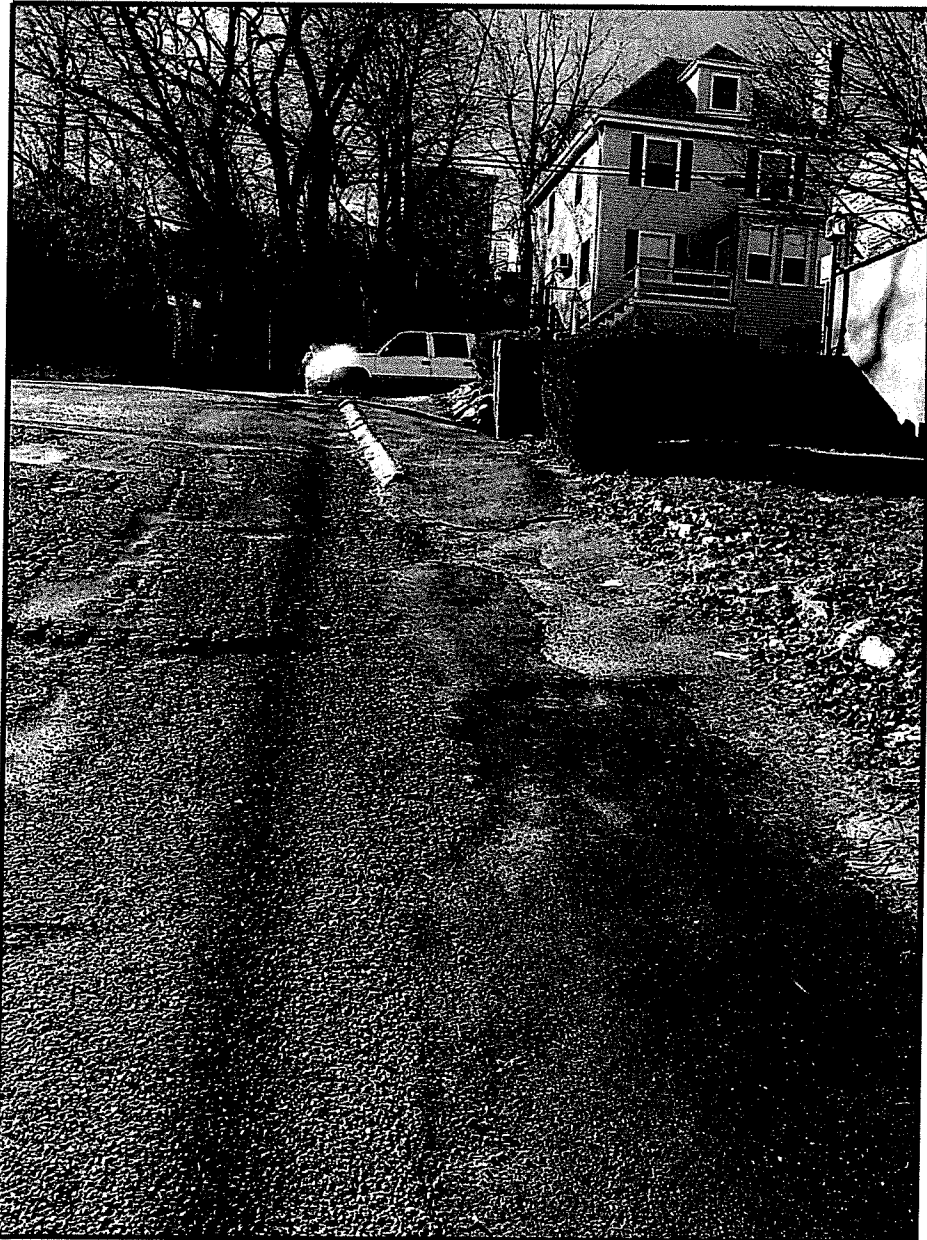
## South Cambridge Street

Looking south towards Vane Street.  
Road and sidewalks both in poor condition.  
Note, asphalt berm at Vane Street.

Asphalt raveling, lose of aggregate seen, road is  
breaking up.

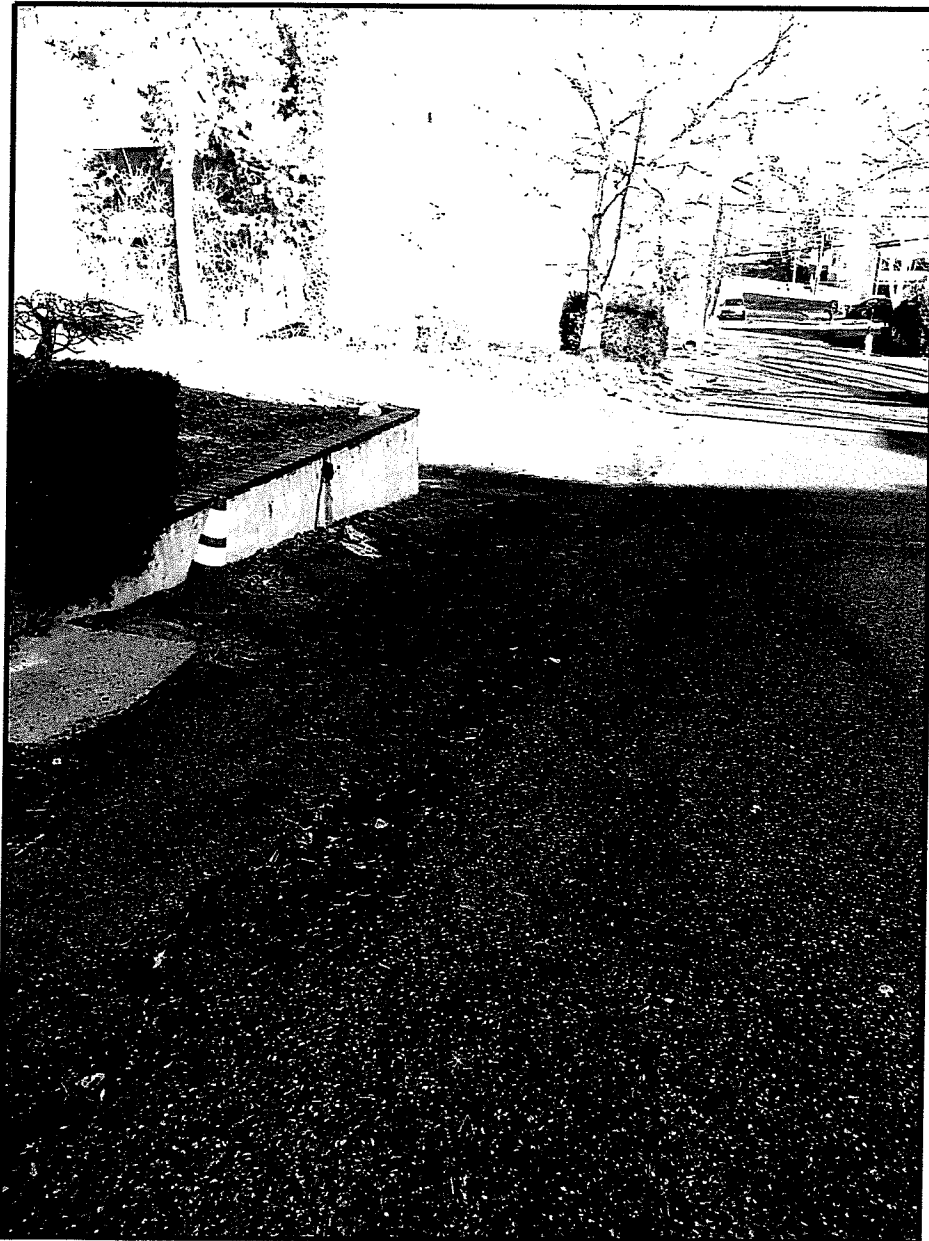
## South Cambridge Street

Looking north towards Warren St.

No formal sidewalk existing, road  
blends into property line.

Condition of the road is very poor, road raveling  
and breaking apart at the edges.

Walk doesn't continue beyond this driveway

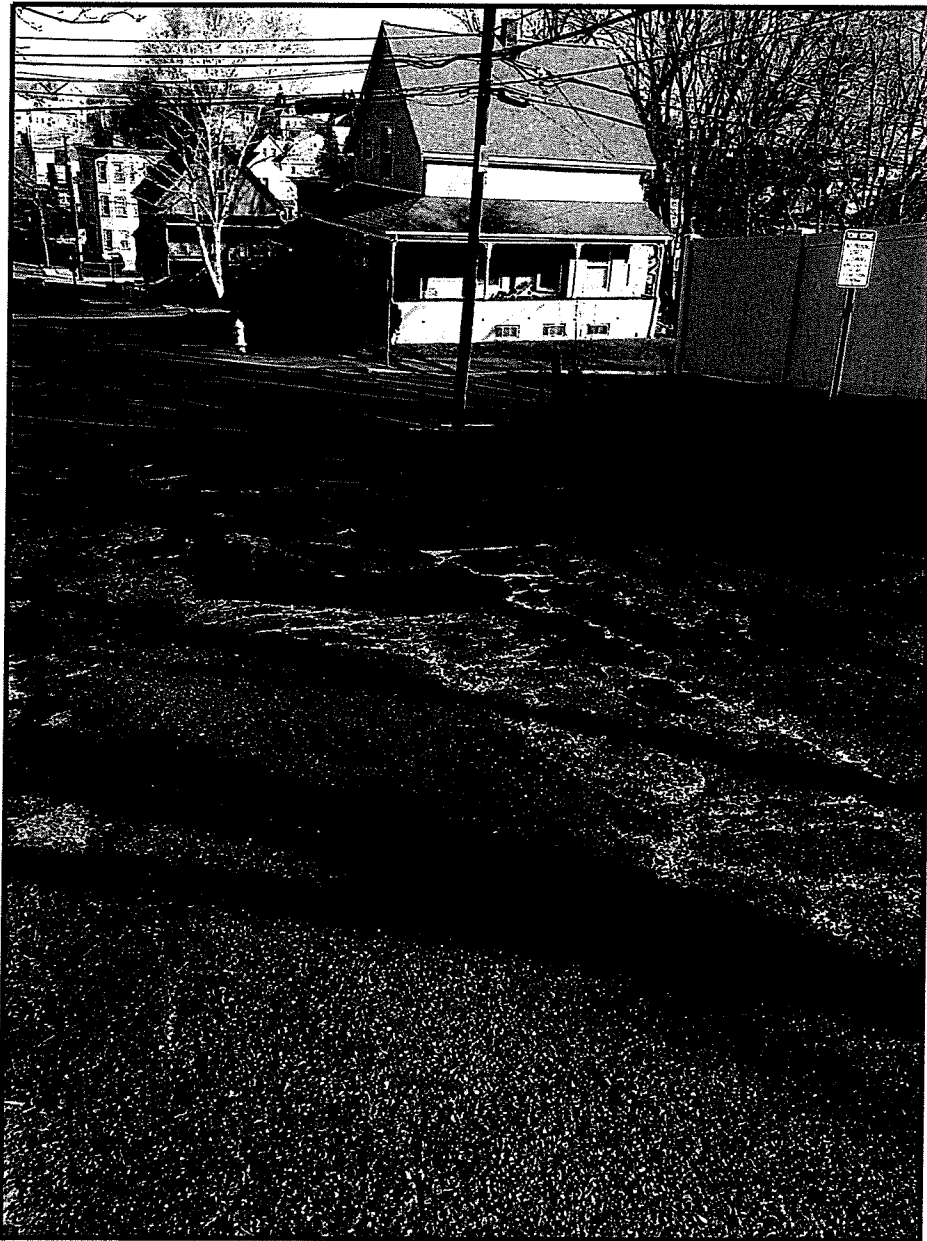
## South Cambridge Street

Looking north towards Warren St.

No formal sidewalk existing.

Slope of grass area shown too steep to install formal walk.

Walk installation would require retaining wall.

Multiple pothole repairs shown, road has failed in this location.

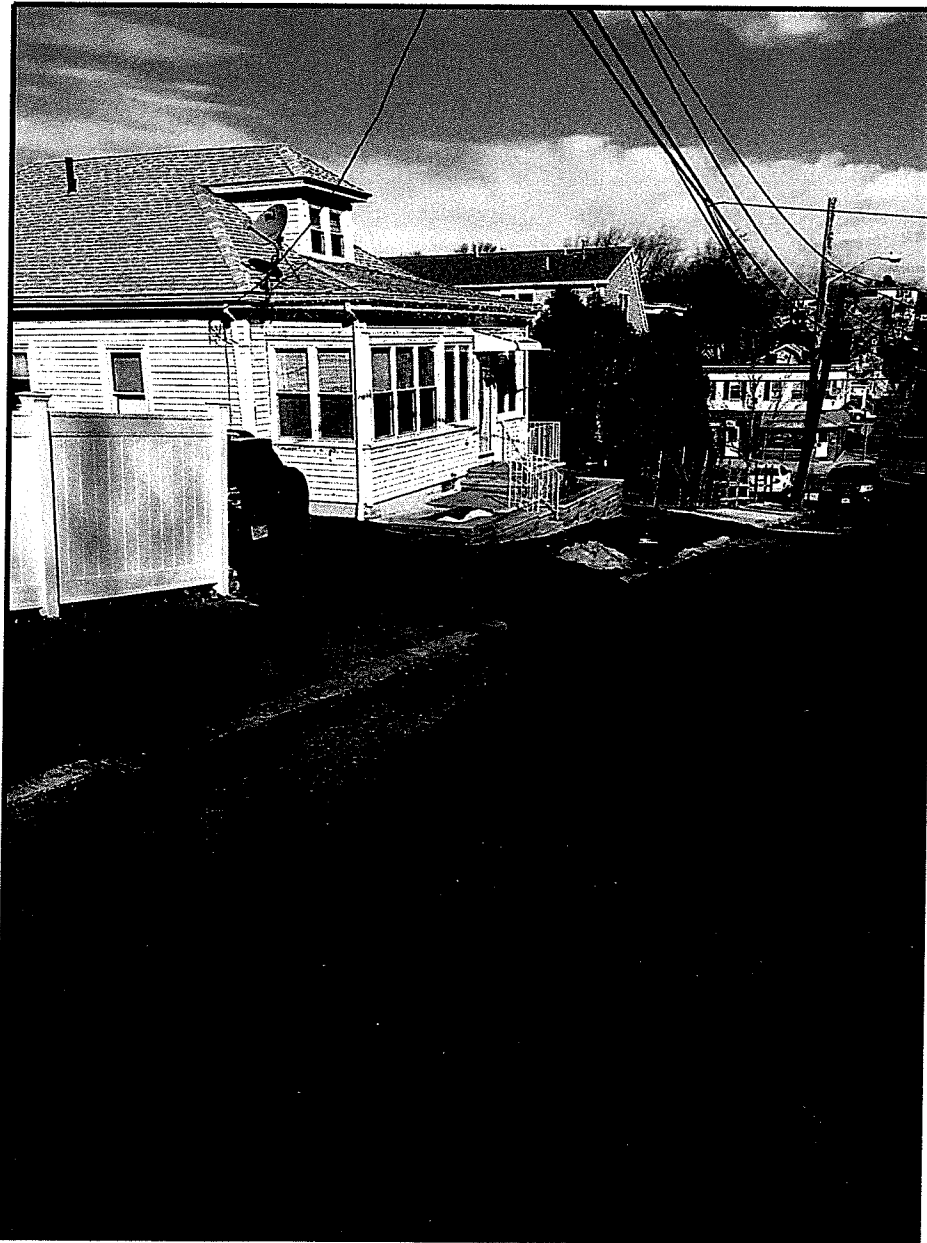
## South Cambridge Street

Standing south of Warren St. looking  
towards Park Ave.

Granite curb (west side only)  
settled and needs to be  
removed and reset.

Meeting ADA cross slope may expose  
bottom of retaining wall shown.

Road condition poor, cracking extensive.

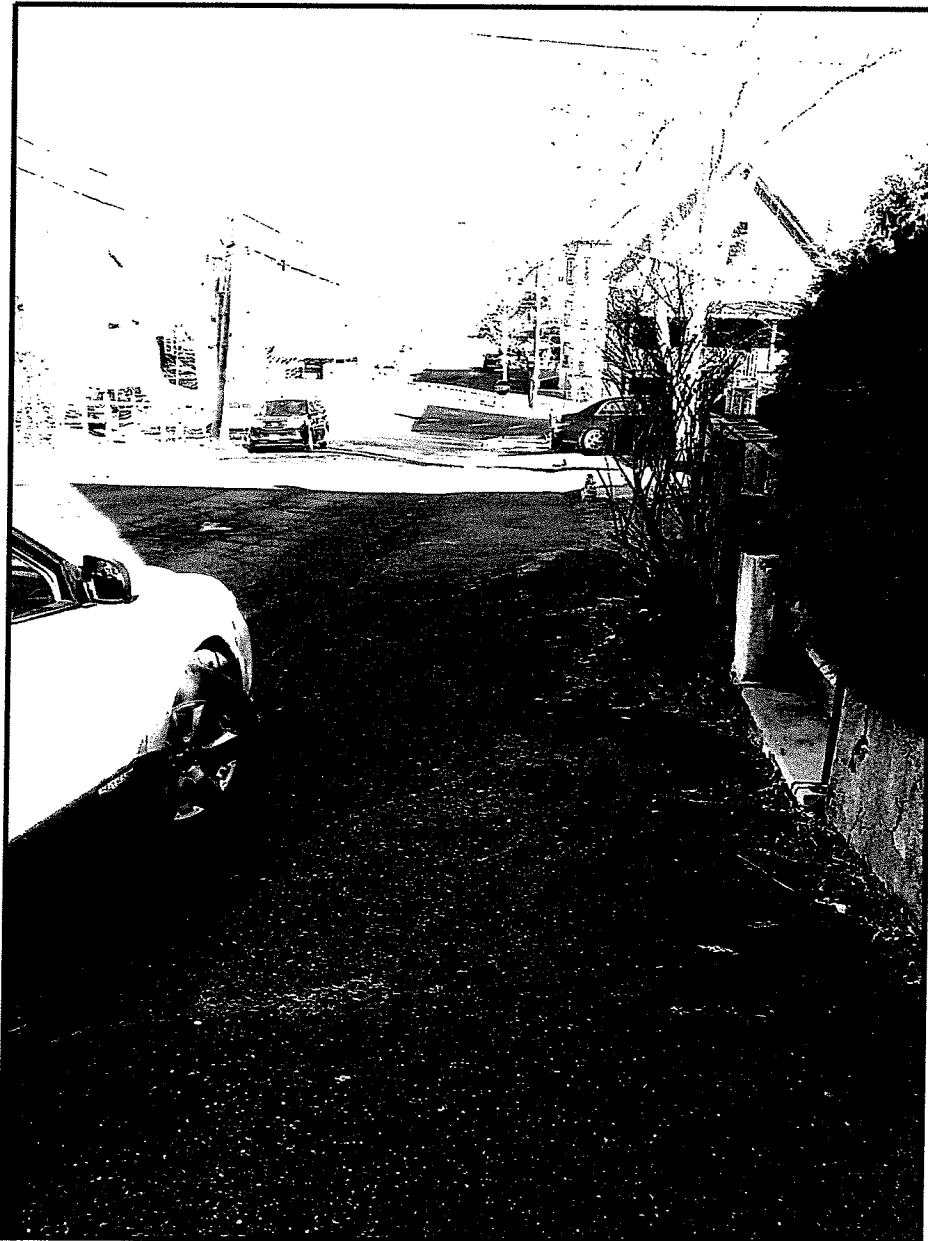
## South Cambridge Street

Standing south of Warren St. looking  
towards Park Ave.

No curbing exists on east side of the street.

Sidewalks in poor condition  
Roadway in very poor condition

Recommend installing granite curb  
to match west side. Curb and sidewalk  
install may create grading issues at private  
property.

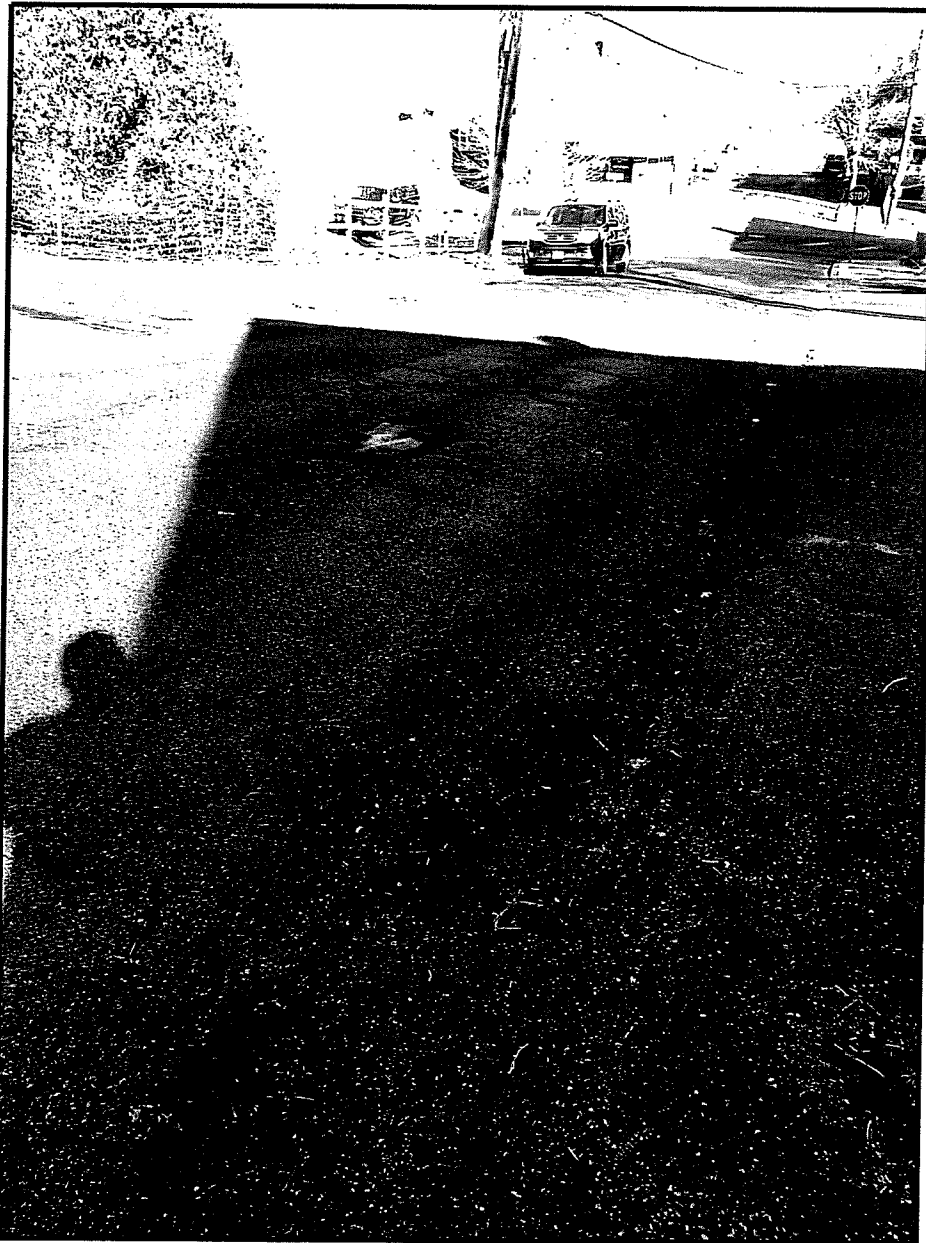
## South Cambridge Street

Standing south of Warren St. looking  
towards Park Ave.  
Roadway surface is badly broken up and  
in very poor / failed condition.  
Typical condition of majority of South  
Cambridge St. roadway..

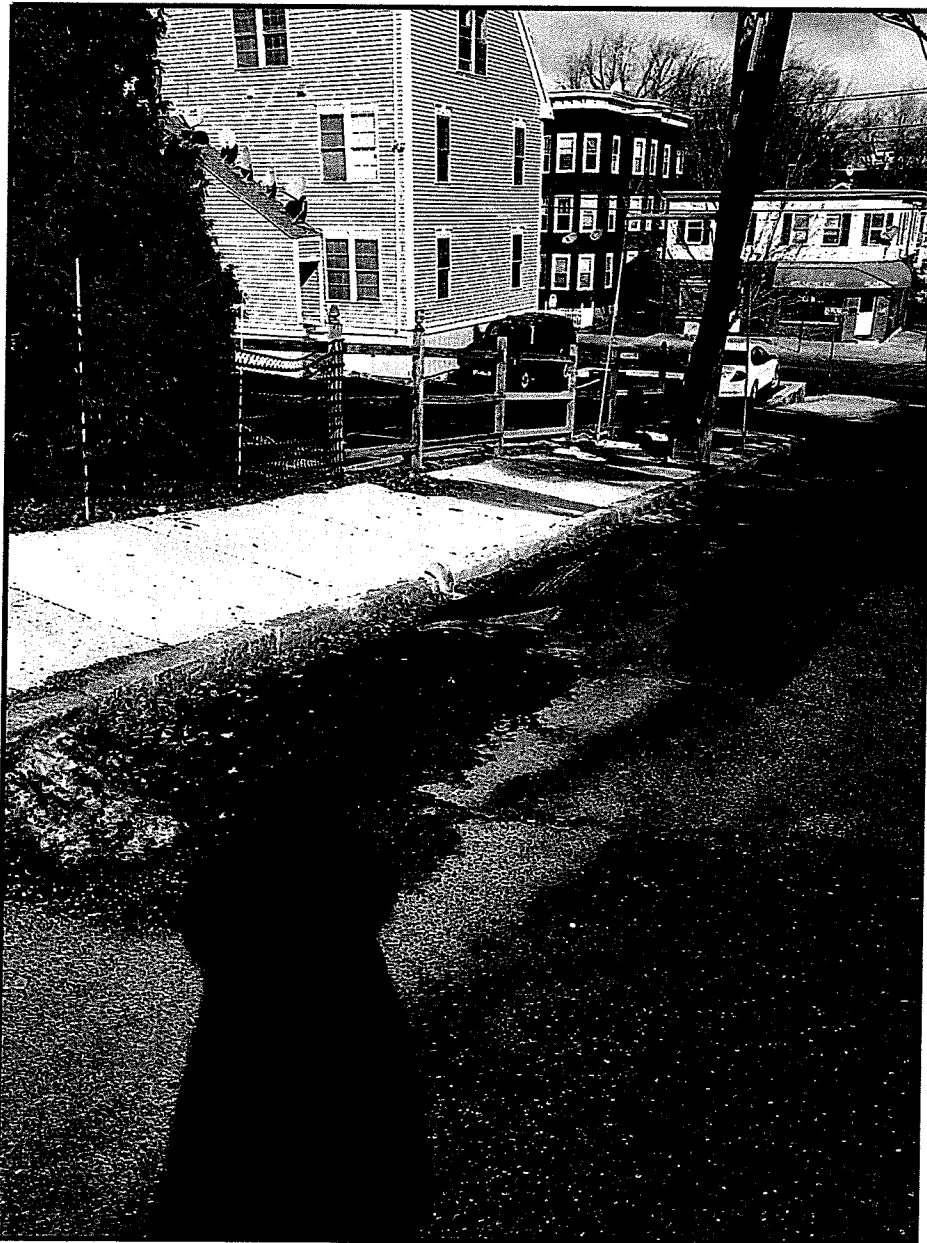
## South Cambridge Street

Standing south of Warren St. looking  
towards Park Ave.

Photo shows sidewalk spot repair  
and roadway patch due to water main break.  
Patches completed summer 2015.

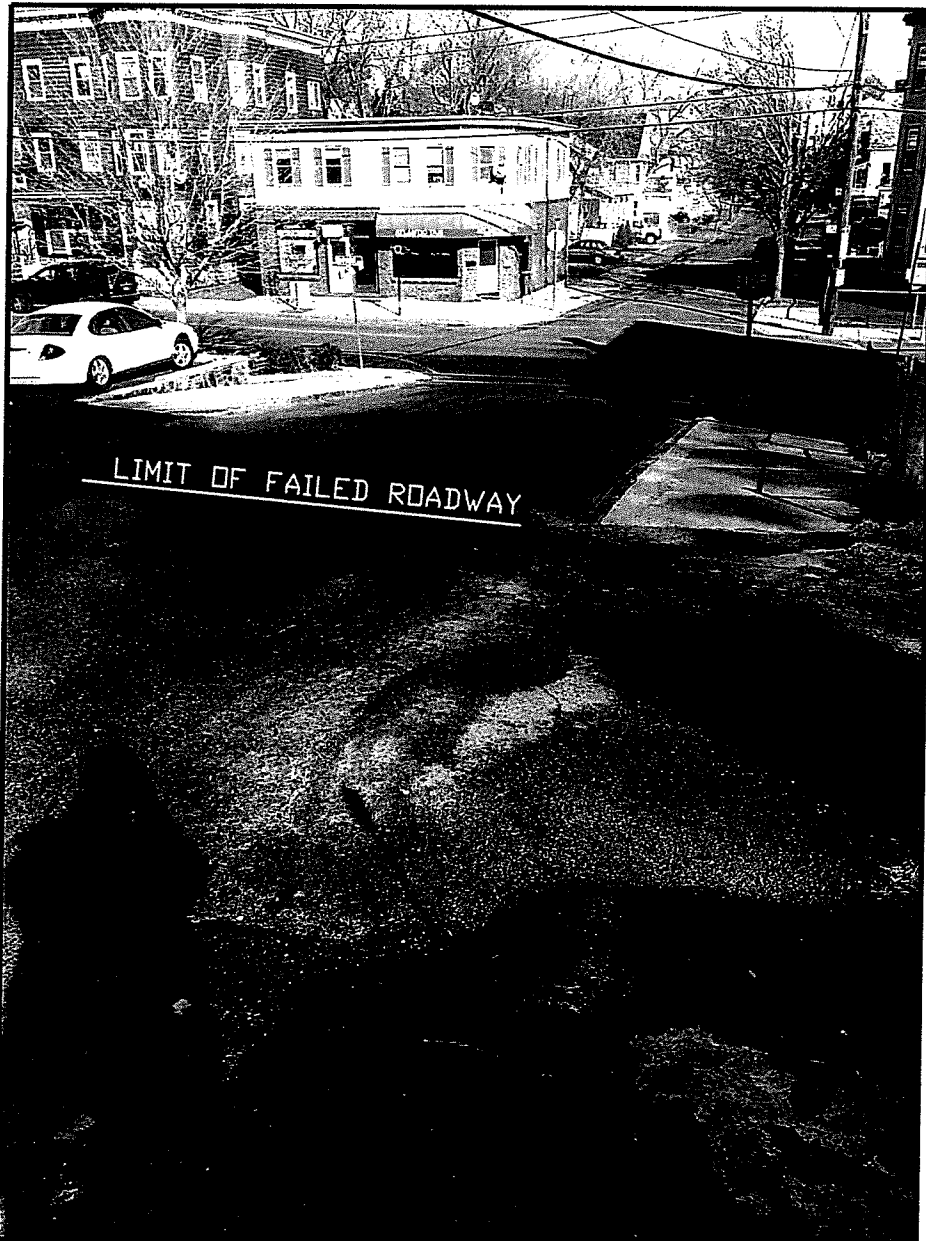
## South Cambridge Street

Standing south of Warren St. looking  
towards Park Ave.

Photo shows granite curb and conc.  
sidewalks wrapping around Park Ave.

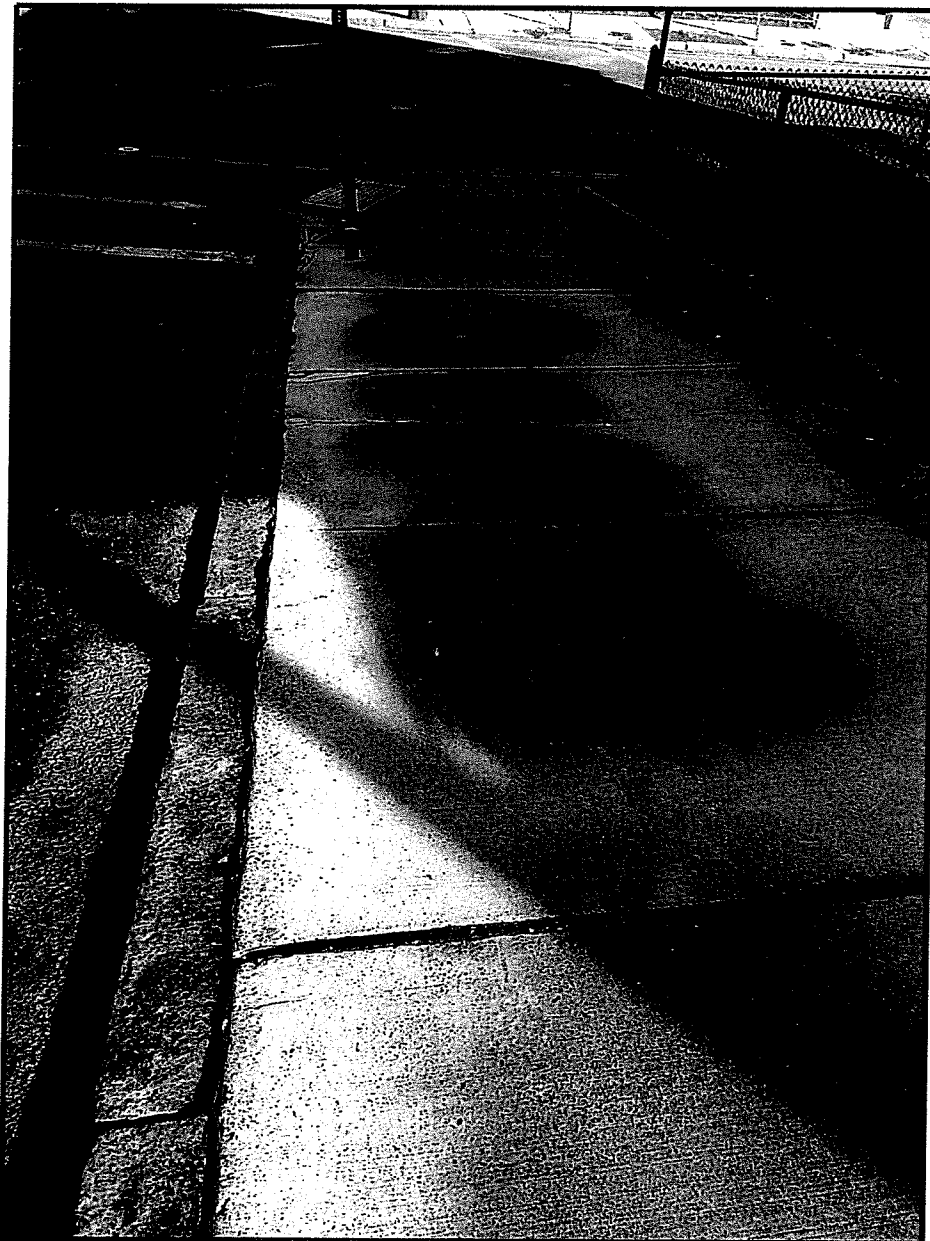
## South Cambridge Street

Standing south of Warren St. looking  
towards Park Ave.  
Concrete sidewalk on east side shown.  
Concrete is heaved above curd  
and cracking.  
Curb reveal appx. 3" +/-

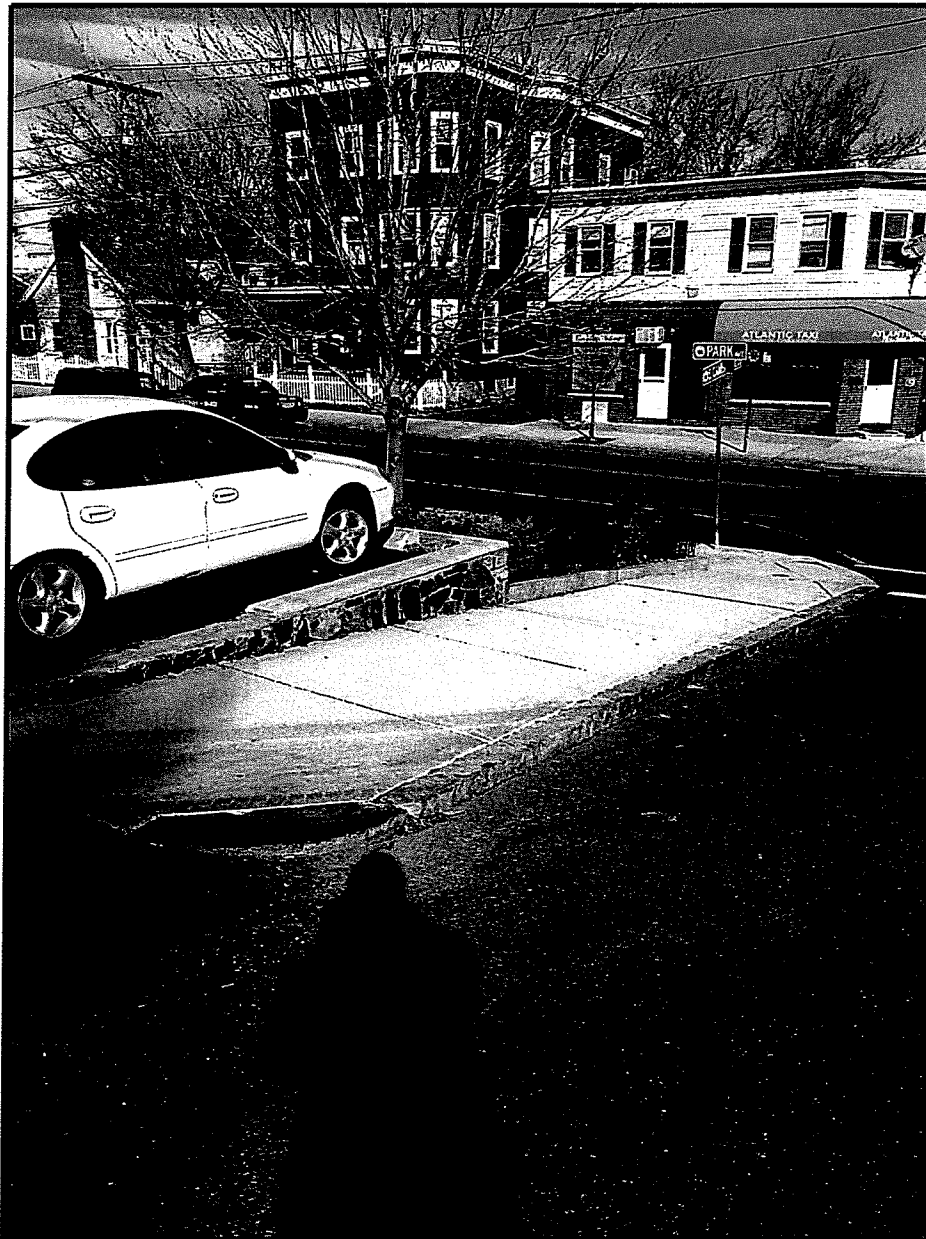
# South Cambridge Street

Park Ave. shown.  
Existing concrete sidewalk and granite  
curb and is good condition to remain  
(at this specific location).
